**RE: Final 2016 As-Built Completion Report Transmittal
Consent Decree No. 07-2-33672-9 SEA:
Site Name: BNSF Former Maintenance and Fueling Facility
Site Address: Skykomish, WA
Facility/Site ID No.: 2104
Cleanup Site ID No.: 34**

2016 AS-BUILT COMPLETION REPORT

BNSF FORMER MAINTENANCE AND FUELING FACILITY SKYKOMISH, WASHINGTON CONSENT DECREE NO. 07-2-33672-9 SEA

RE: **CARBON REPLACEMENT IN EAST VAULT OF WEST GATE OF HCC SYSTEM
BNSF FORMER MAINTENANCE AND FUELING FACILITY
SKYKOMISH, WASHINGTON
FARALLON PN: 683-043**

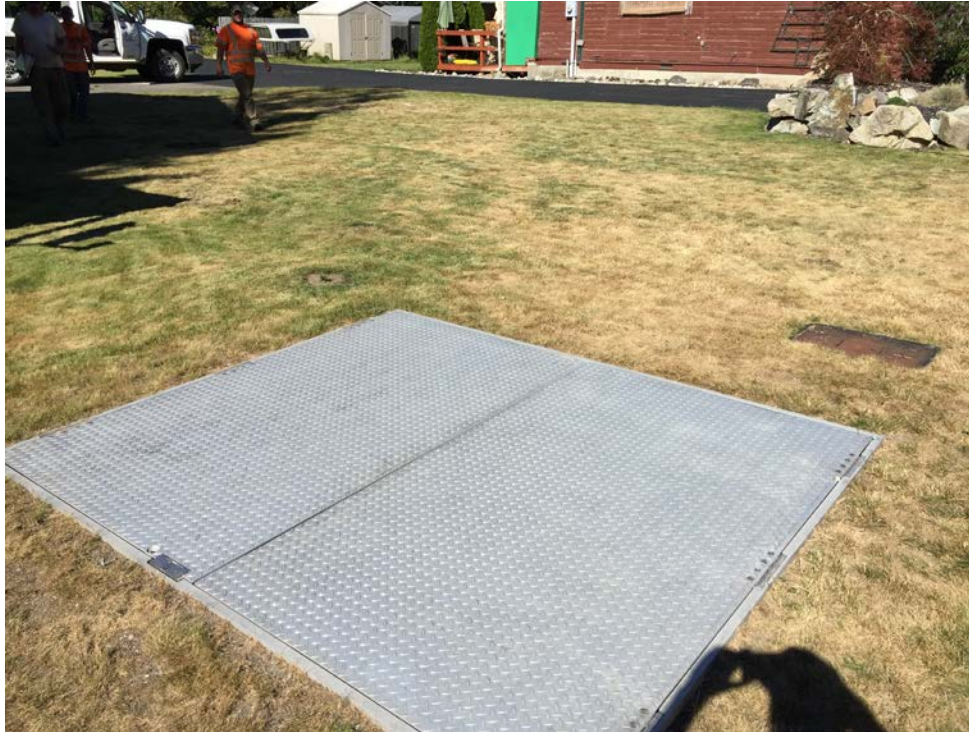
Photograph 1: Air sparge system vault prior to decommissioning activities.

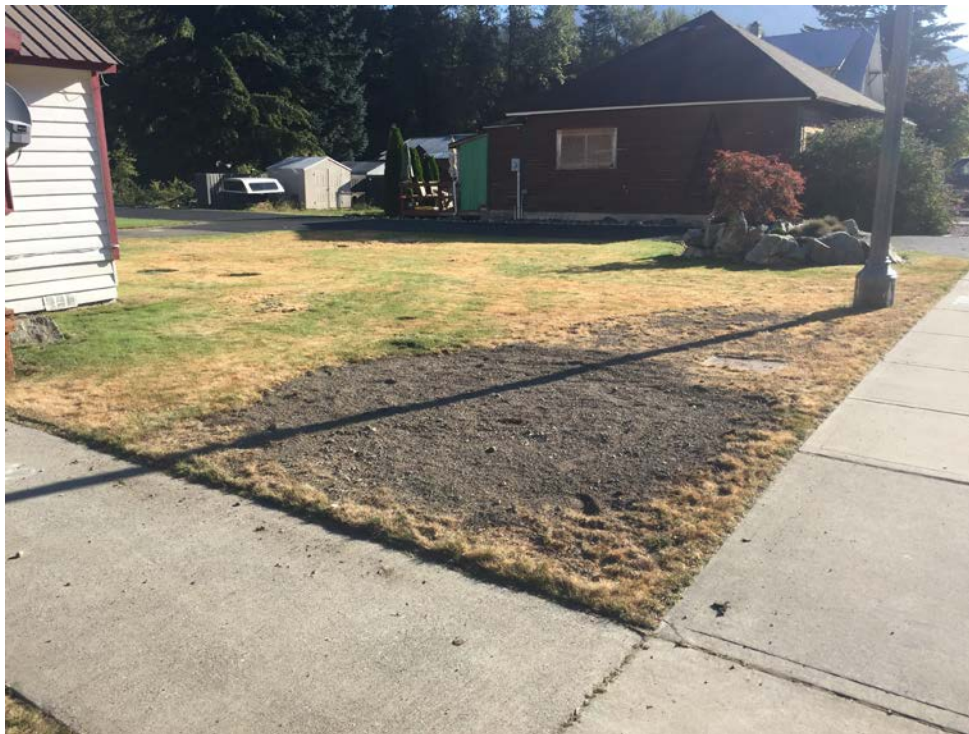
Photograph 2: Backfill following removal of the air sparge system vault.

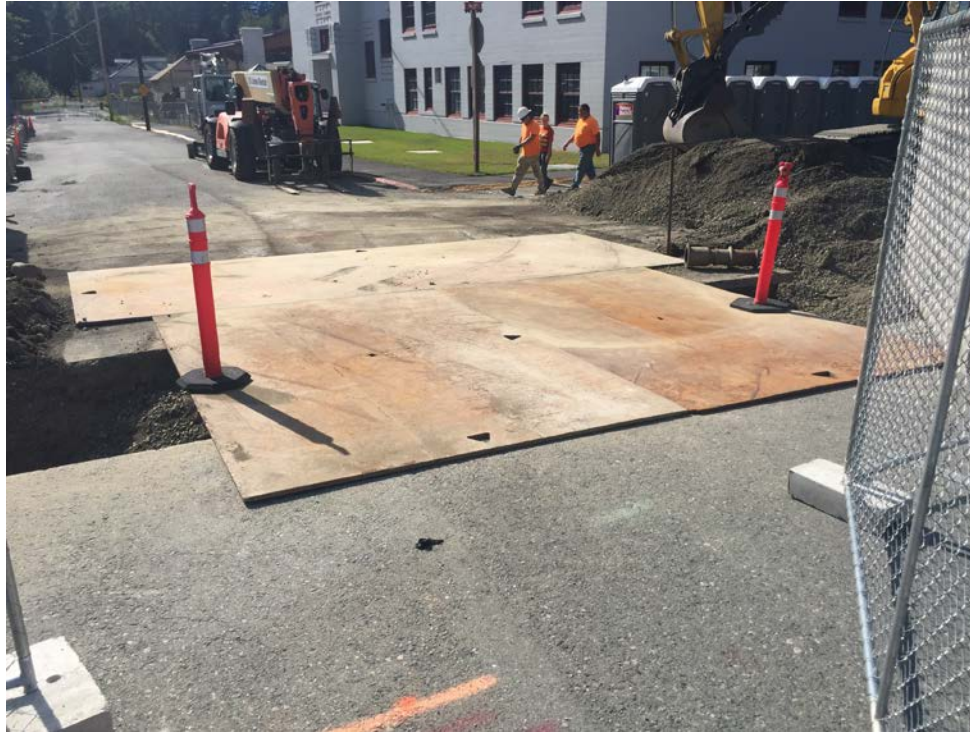
Photograph 19: Steel plates placed across trench for emergency access at Railroad Avenue.

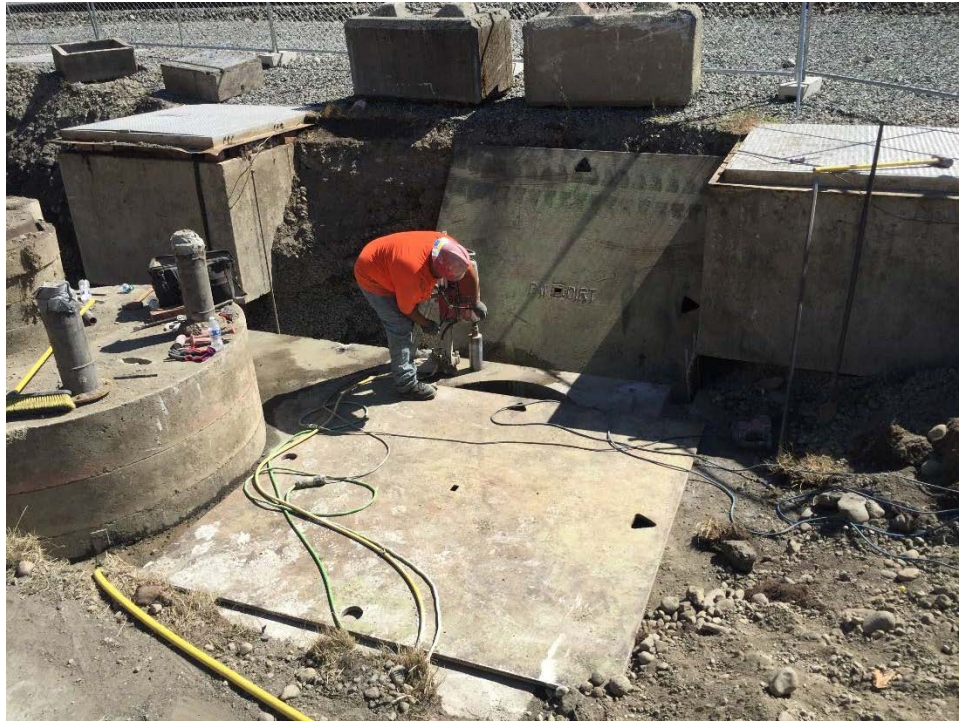
Photograph 5: Coring rebar dowel post connections.

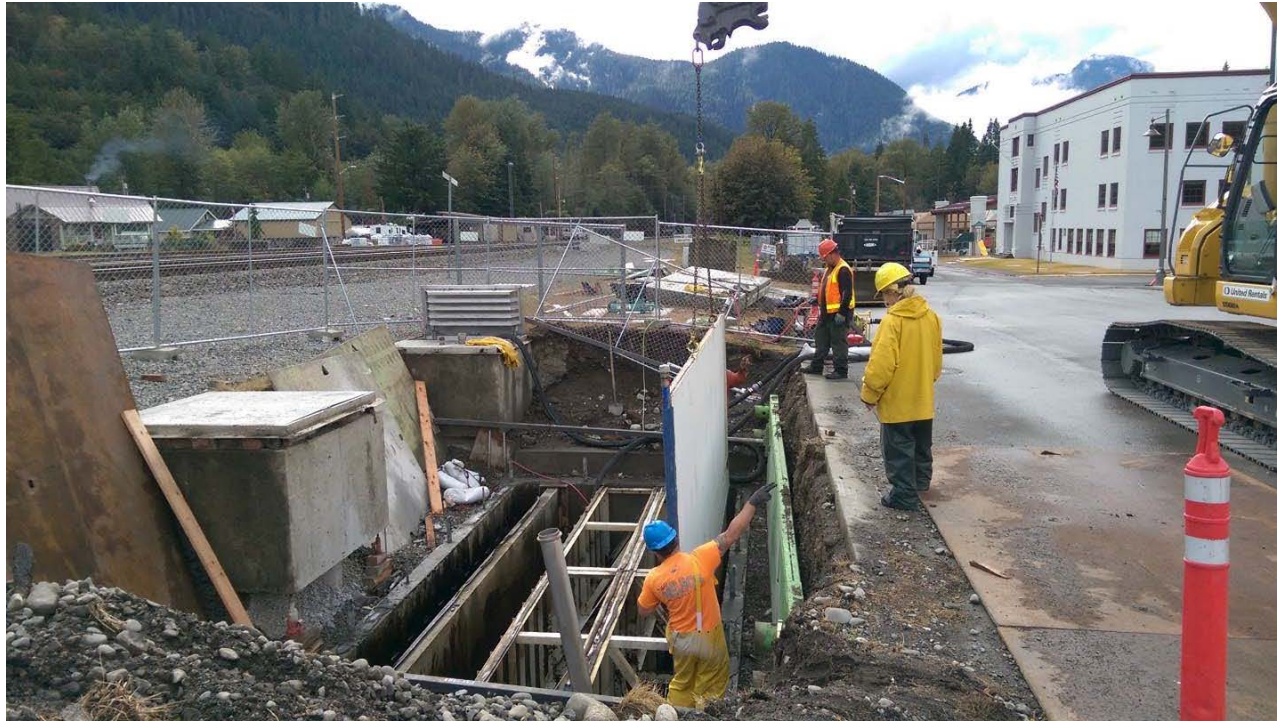
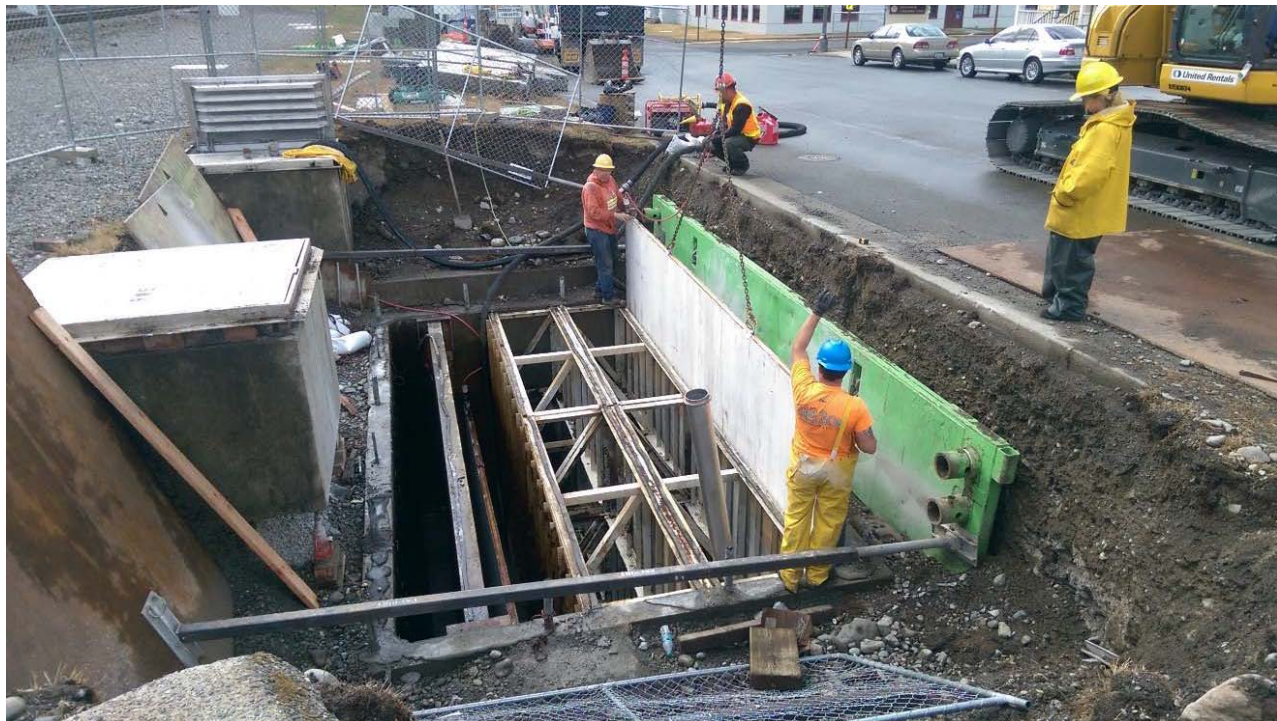
Two water-resistant barriers were constructed to limit the flow of water into both the up-gradient and down-gradient sides of the east vault. The water barriers were constructed of plywood, with a continuous 2-inch-diameter hose along the bottom and two sides. Once the barrier was lowered into place, the hose was inflated with air in an effort to create a water-tight seal. The presence of loose imported aggregate material along the bottom of the vault prevented attaining a water-tight seal at both barrier locations, so groundwater flow into the vault was reduced, but not eliminated.

Photograph 17: Installation of water barriers.

Photograph 18: Installation of water barriers.

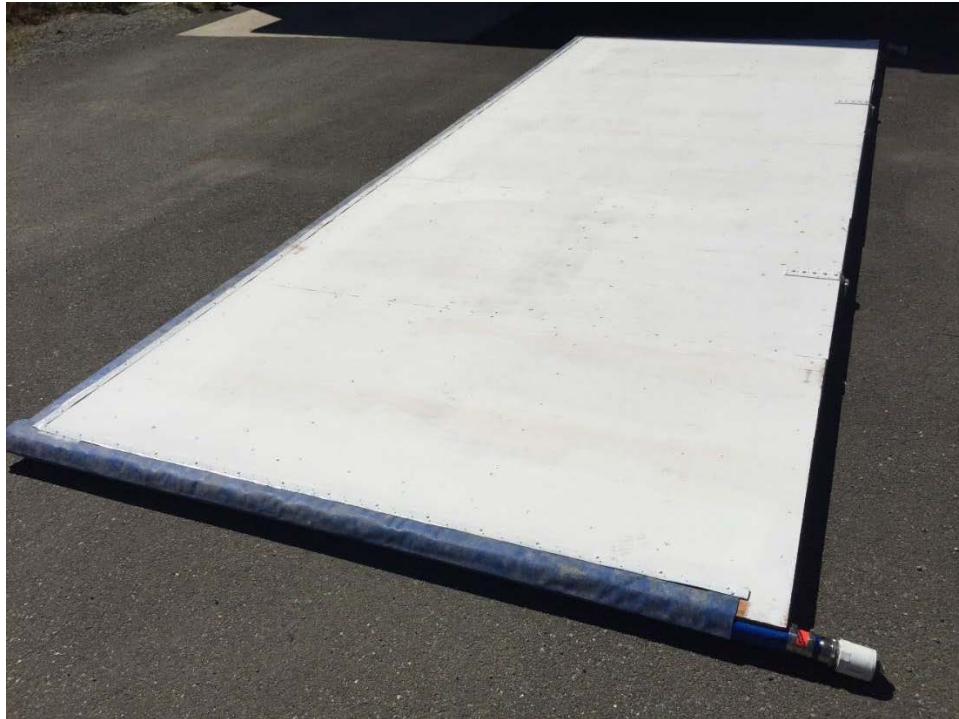
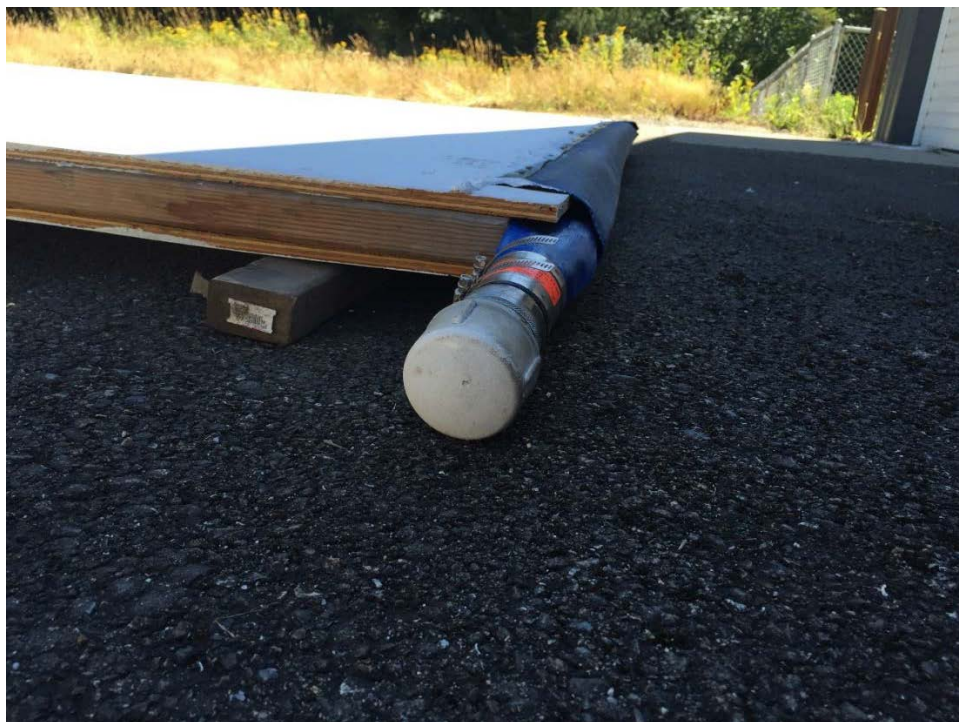
Photograph 19: Water barrier detail.

Photograph 20: Water barrier detail.

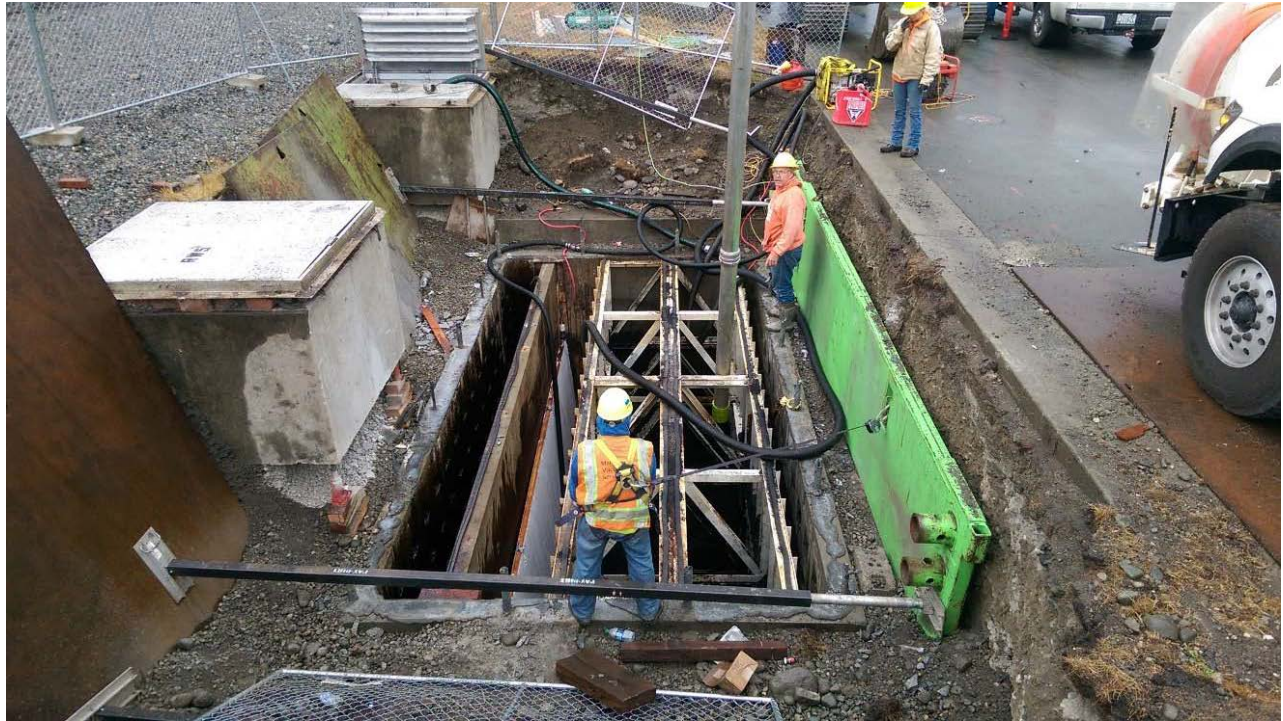
The water in the vault was then pumped to lower the water level in the GAC/pea gravel media chambers. A submersible pump was used to continuously pump water from the vault in the area up-gradient of the metal mesh enclosure at a rate of approximately 100 gallons per minute. The pumped water was conveyed through an existing unused 3-inch-diameter pipe to a 500-barrel weir settling tank near the HCC system groundwater treatment building on the southern side of the railyard. The water removed during the GAC/pea gravel media replacement process subsequently was treated by the HCC treatment system. The dewatering process had limited influence, lowering the water level to a total depth of approximately 2 feet in the east vault.

Photograph 21: Dewatering vault.

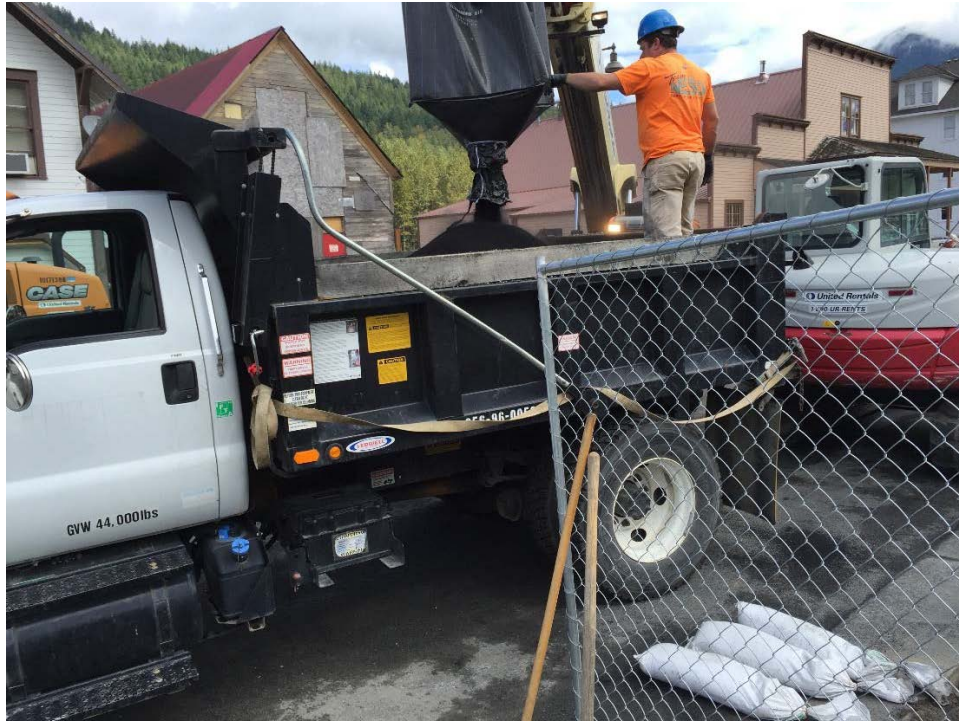
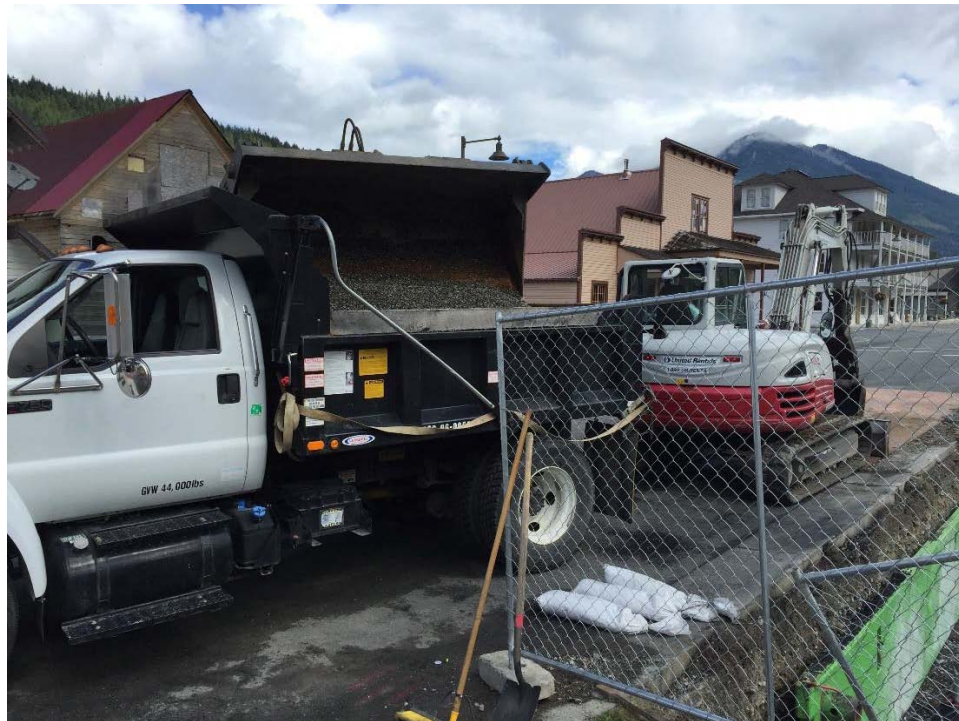
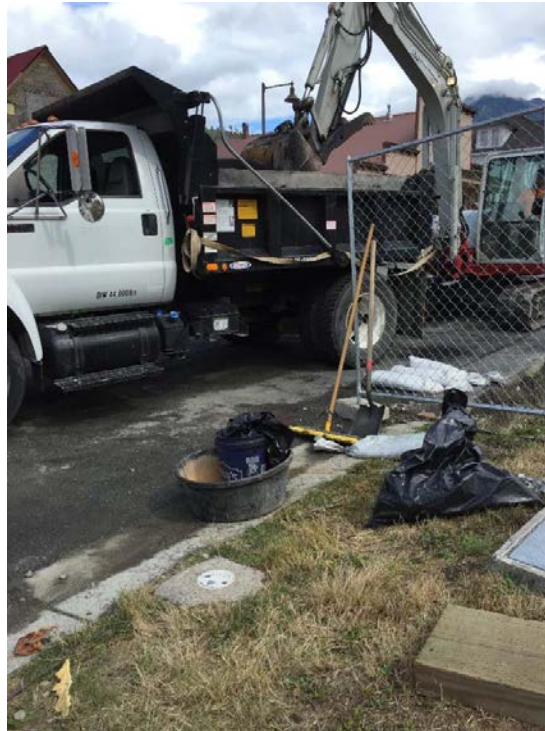
The GAC/pea gravel media used for replacement of the extracted material was blended to match the existing media mix at a 70:30 ratio by volume in small 3- to 5-cubic-yard batches using the excavator and a small dump truck. Care was taken to gently mix the materials using the excavator bucket to ensure that the integrity of the GAC in the mixture was maintained throughout the mixing and placement process. Following mixing, the excavator was used to place the new GAC/pea gravel media into the up-gradient and down-gradient vault chambers. The new material was added until it was approximately 12 inches from the top of the metal framework, matching the previous volume. The quantities of material placed in the GAC/pea gravel media chambers in the east vault of the West Gate were 12.5 tons of GAC and approximately 23 tons of pea gravel.

Photograph 23: Mixing GAC/pea gravel materials.

Photograph 24: Mixing GAV/pea gravel materials.

Photograph 25: Mixing GAC/pea gravel materials.

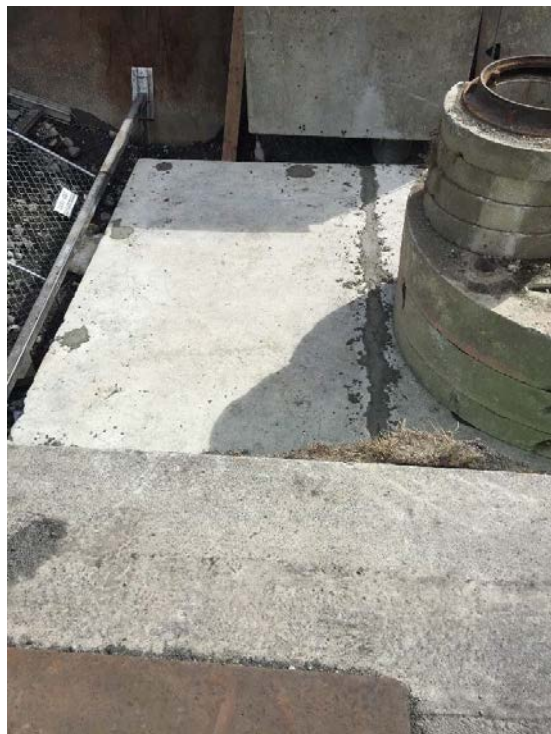
Following the GAC/pea gravel media replacement and final inspection of the vault, the lids to the vault were replaced using the existing gaskets on the top of the concrete vault walls. Before the lids were replaced, the original rebar dowel set pins, which had been installed on the top of the concrete vault walls during construction to guide and secure the vault lids during placement, were removed because they were deemed unnecessary given the configuration and bulk of the lids. The lid post holes for the set pins and the vault lid seams were grouted.

Photograph 32: Grouting rebar dowel holes and vault seam.
