**RE: Draft 2017 As-Built Completion Report Transmittal
Consent Decree No. 07-2-33672-9 SEA:
Site Name: BNSF Former Maintenance and Fueling Facility
Site Address: Skykomish, WA
Facility/Site ID No.: 2104
Cleanup Site ID No.: 34**

2017 AS-BUILT COMPLETION REPORT

BNSF FORMER MAINTENANCE AND FUELING FACILITY SKYKOMISH, WASHINGTON CONSENT DECREE NO. 07-2-33672-9 SEA

Construction activity at the Site in 2017 consisted of installing a new 6-inch-diameter water main beneath Sixth Street to replace an existing 2-inch-diameter water main. The general location of the 2017 construction activity is shown on Figure 1.

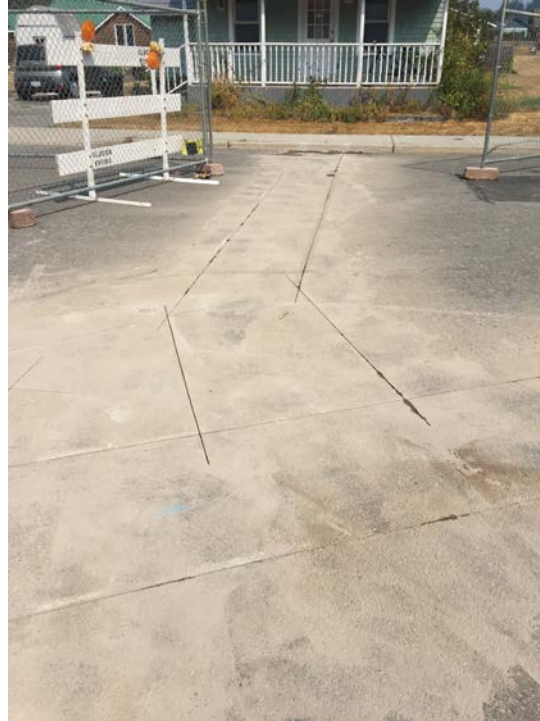
Photograph 1: Traffic control, fencing, and asphalt saw-cutting, looking east.

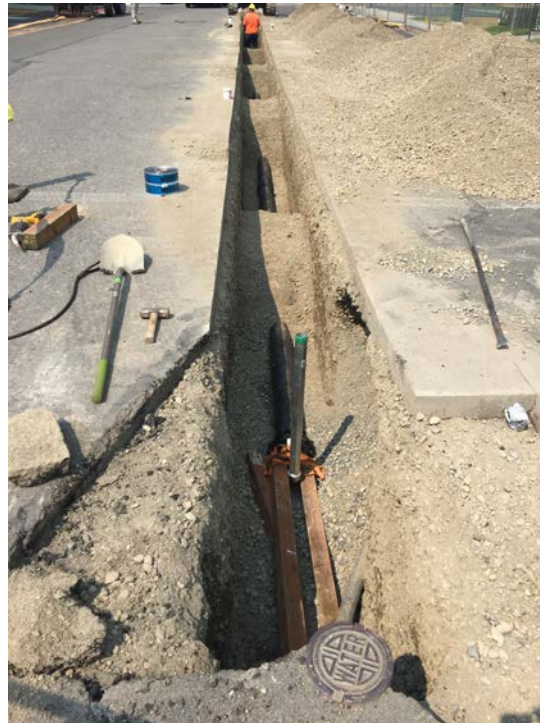
Photograph 2: Installation of new 6-inch ductile iron water main, looking north on Sixth Street.

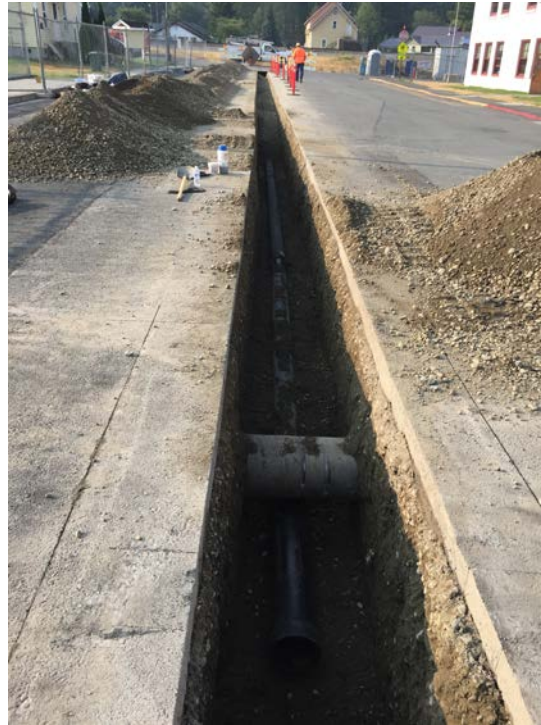
Photograph 3: Installed new water main below storm sewer line, looking south on Sixth Street.

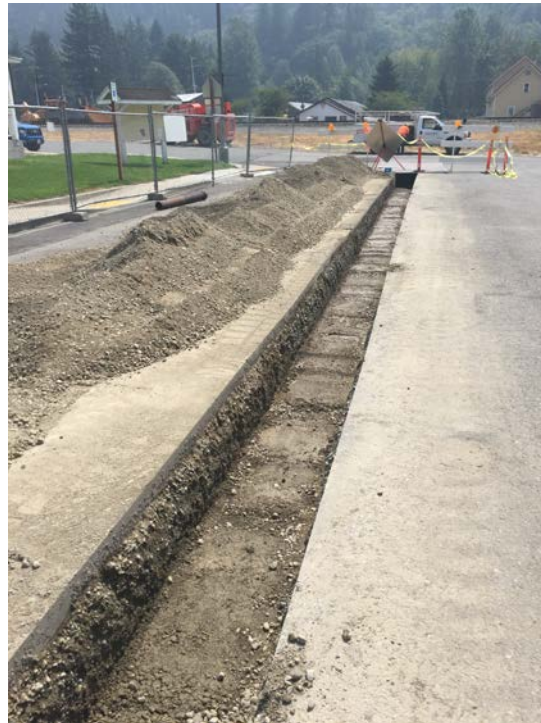
Photograph 4: Trench backfill and compaction activities at southern end of Sixth Street.

Following installation of the new water main, the trench excavation in Sixth Street was backfilled with aggregate fill material and compacted using a hydraulic plate compactor. The road surface

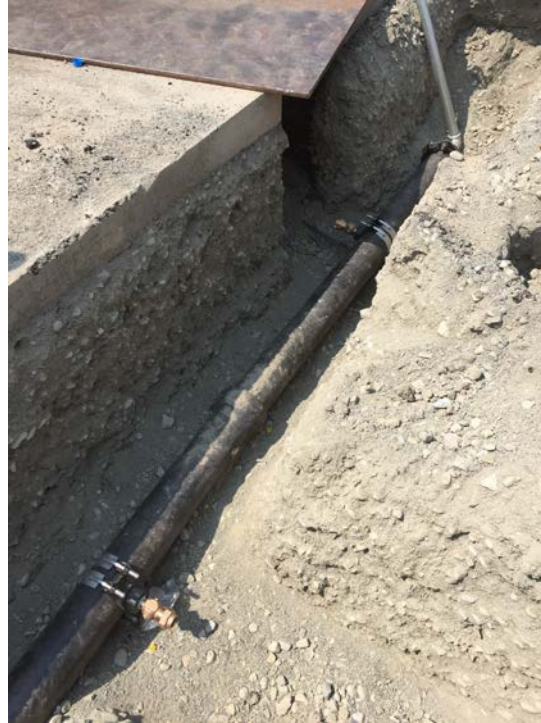
Photograph 5: Installation of lateral connection fittings on new water main.

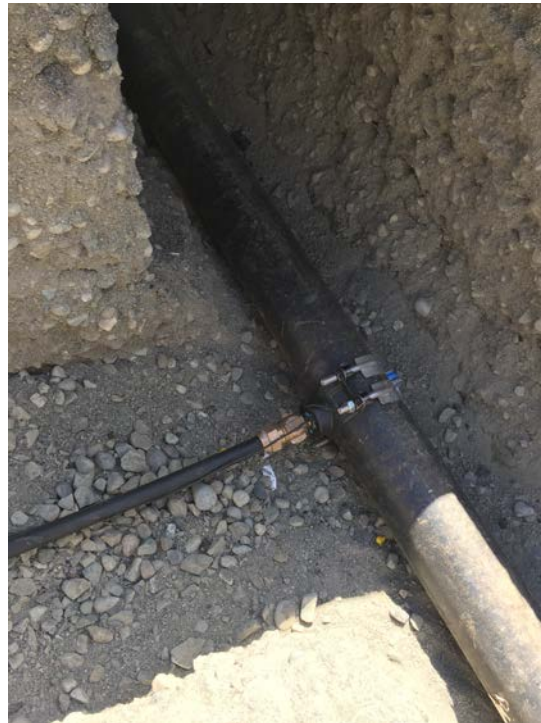
Photograph 6: Installation of water service laterals in Sixth Street.

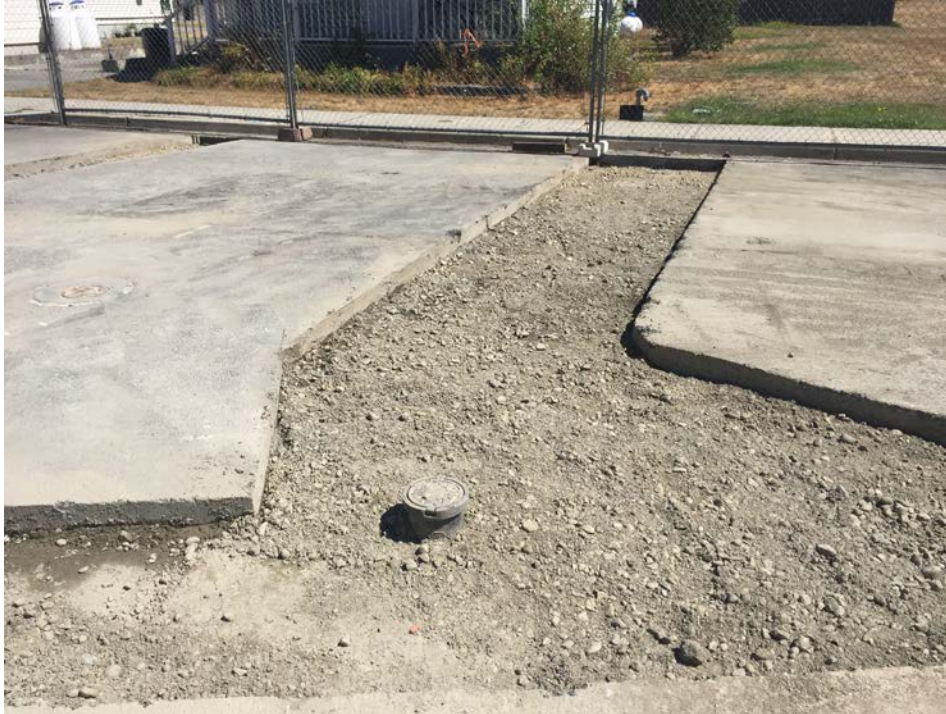
Photograph 7: Compacted backfill placement, looking east.

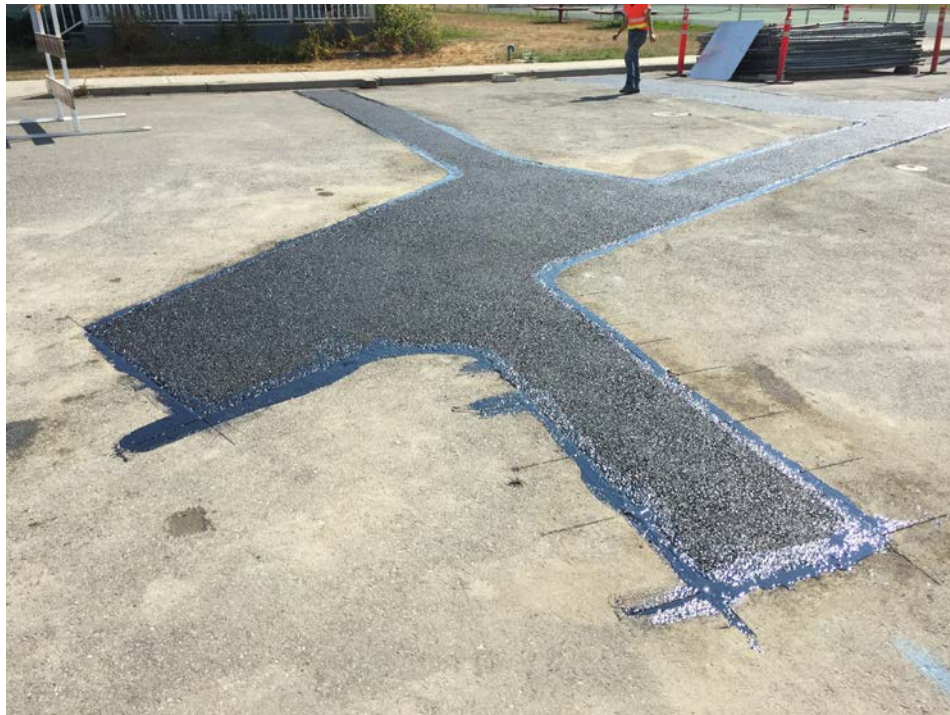
Photograph 8: New asphalt pavement and sealant, looking east.

was restored by placing new asphalt pavement along the trench to match the existing road grade. The edges of the new pavement were sealed with an asphalt sealant.
