STATE OF WASHINGTON
DEPARTMENT OF ECOLOGY

January 17, 2012

Re: Further Action at the following Site:

- **Site Name:** Lopez Village Market
- **Site Address:** 214 Lopez Road, Lopez Island
- **Facility/Site No.:** 87787992
- **VCP Project No.:** NW 2372

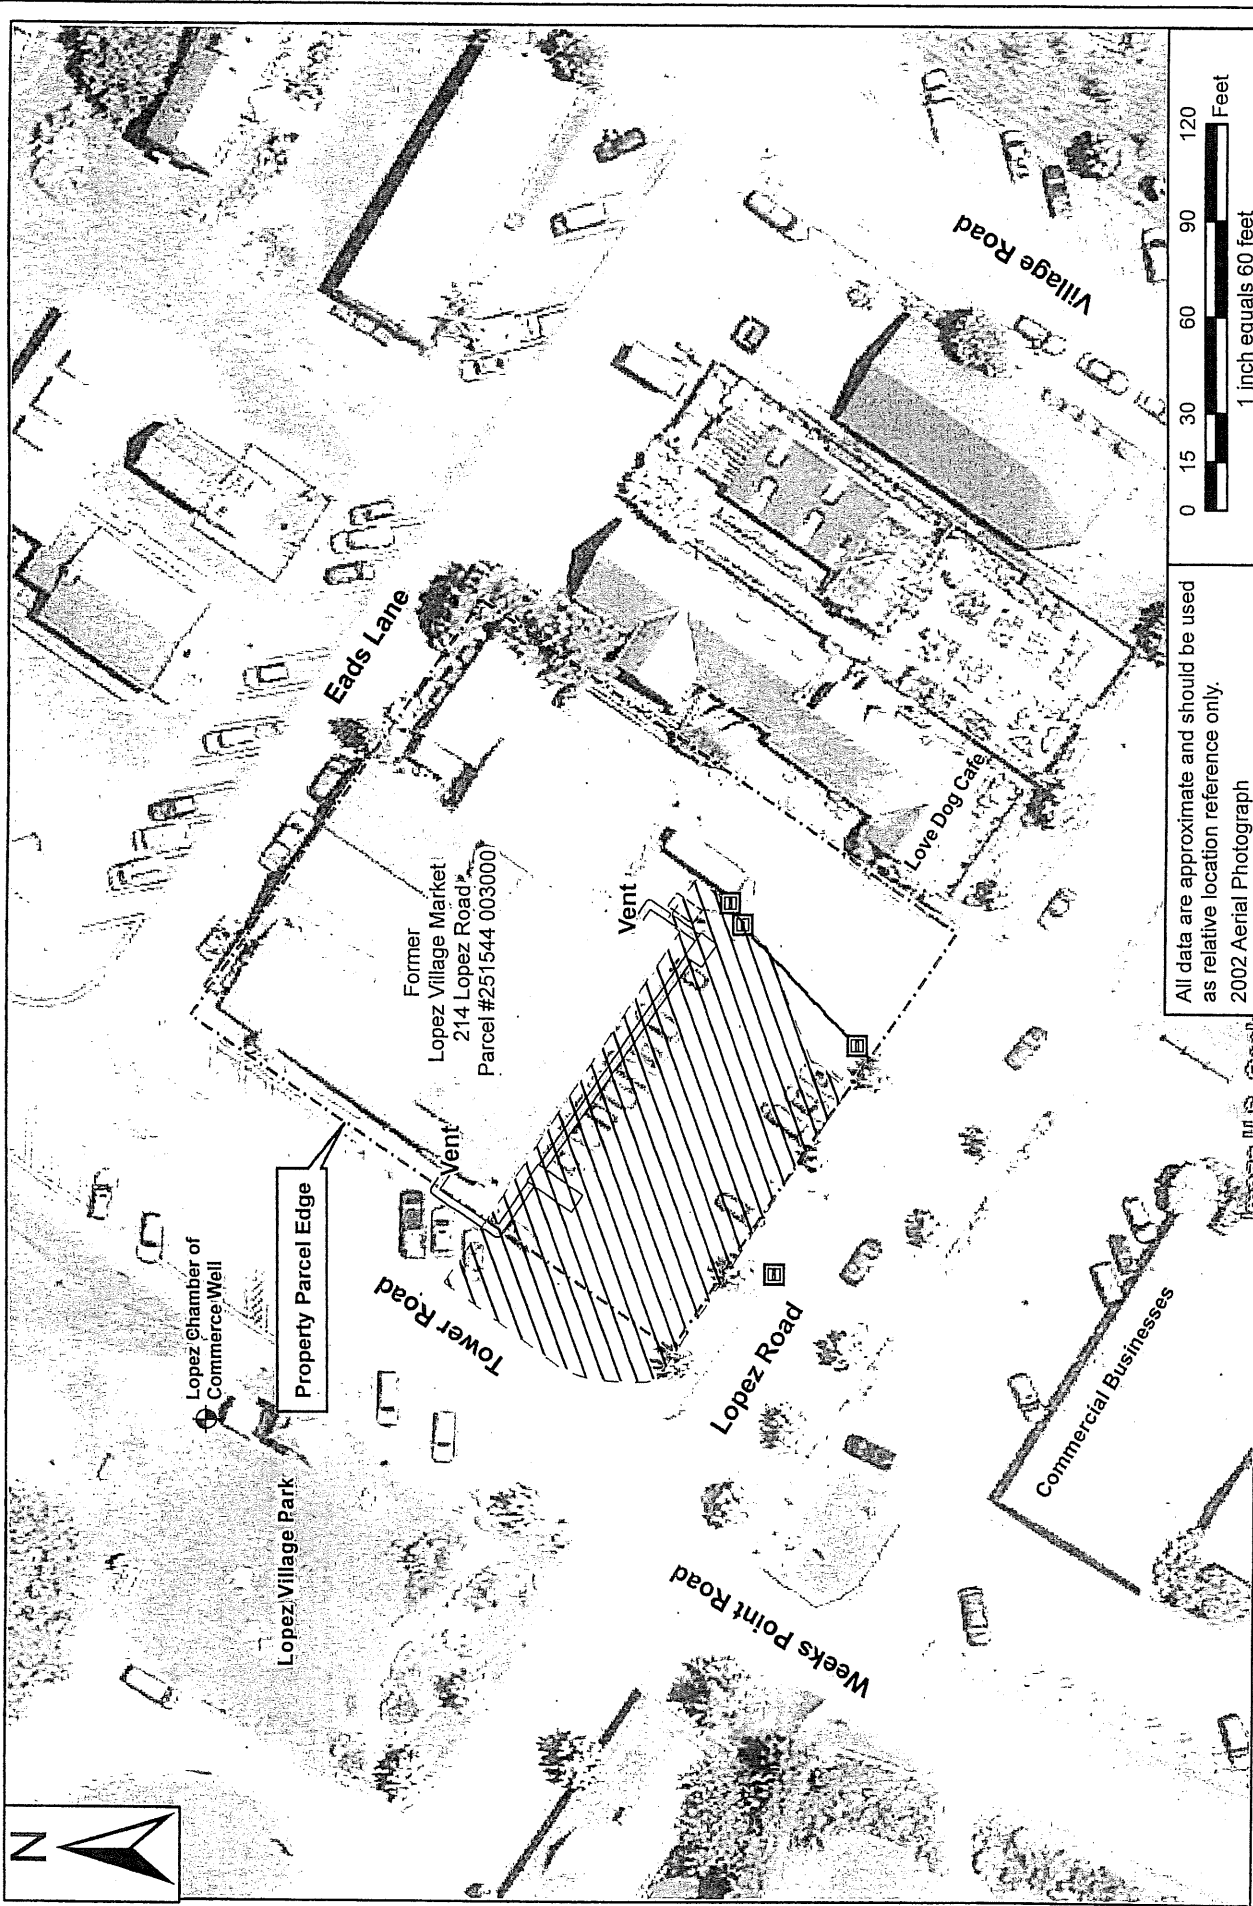
Figure 2

Site: The Site comprises a gasoline release to soil at the property located at 214 Lopez Road on Lopez Island (the Property). The Property and the Site are shown on the attached Site Map.

Release and Extent of Contamination - Soil: Soil at the Property has been impacted by gasoline releases at the two the UST locations, the dispenser location, and the underground fuel line connecting the two UST locations. The maximum detected concentrations were 1,300 mg/kg TPHg and 19 mg/kg benzene at the same location adjacent to the fuel line (B-1 at 9 feet). Ethylbenzene and xylenes were also detected at their highest concentrations at this location.

grained soils, as opposed to direct flow or transport in ground water. The full lateral extent of the Site has not been determined, but appears to be focused near the fuel line and the western tank. This portion of the Site consists of a contaminated area measuring at least 80 by 100 feet. A smaller contaminated area associated with the eastern tank and fuel dispenser measured about 20 by 25 feet in plan dimension.
