REPORT OF GEOTECHNICAL SERVICES
EAST PASCO FUEL TERMINAL
PASCO, WASHINGTON
FOR
CHEVRON U.S.A., INC.

**GeoEngineers
Incorporated**

June 22, 1987

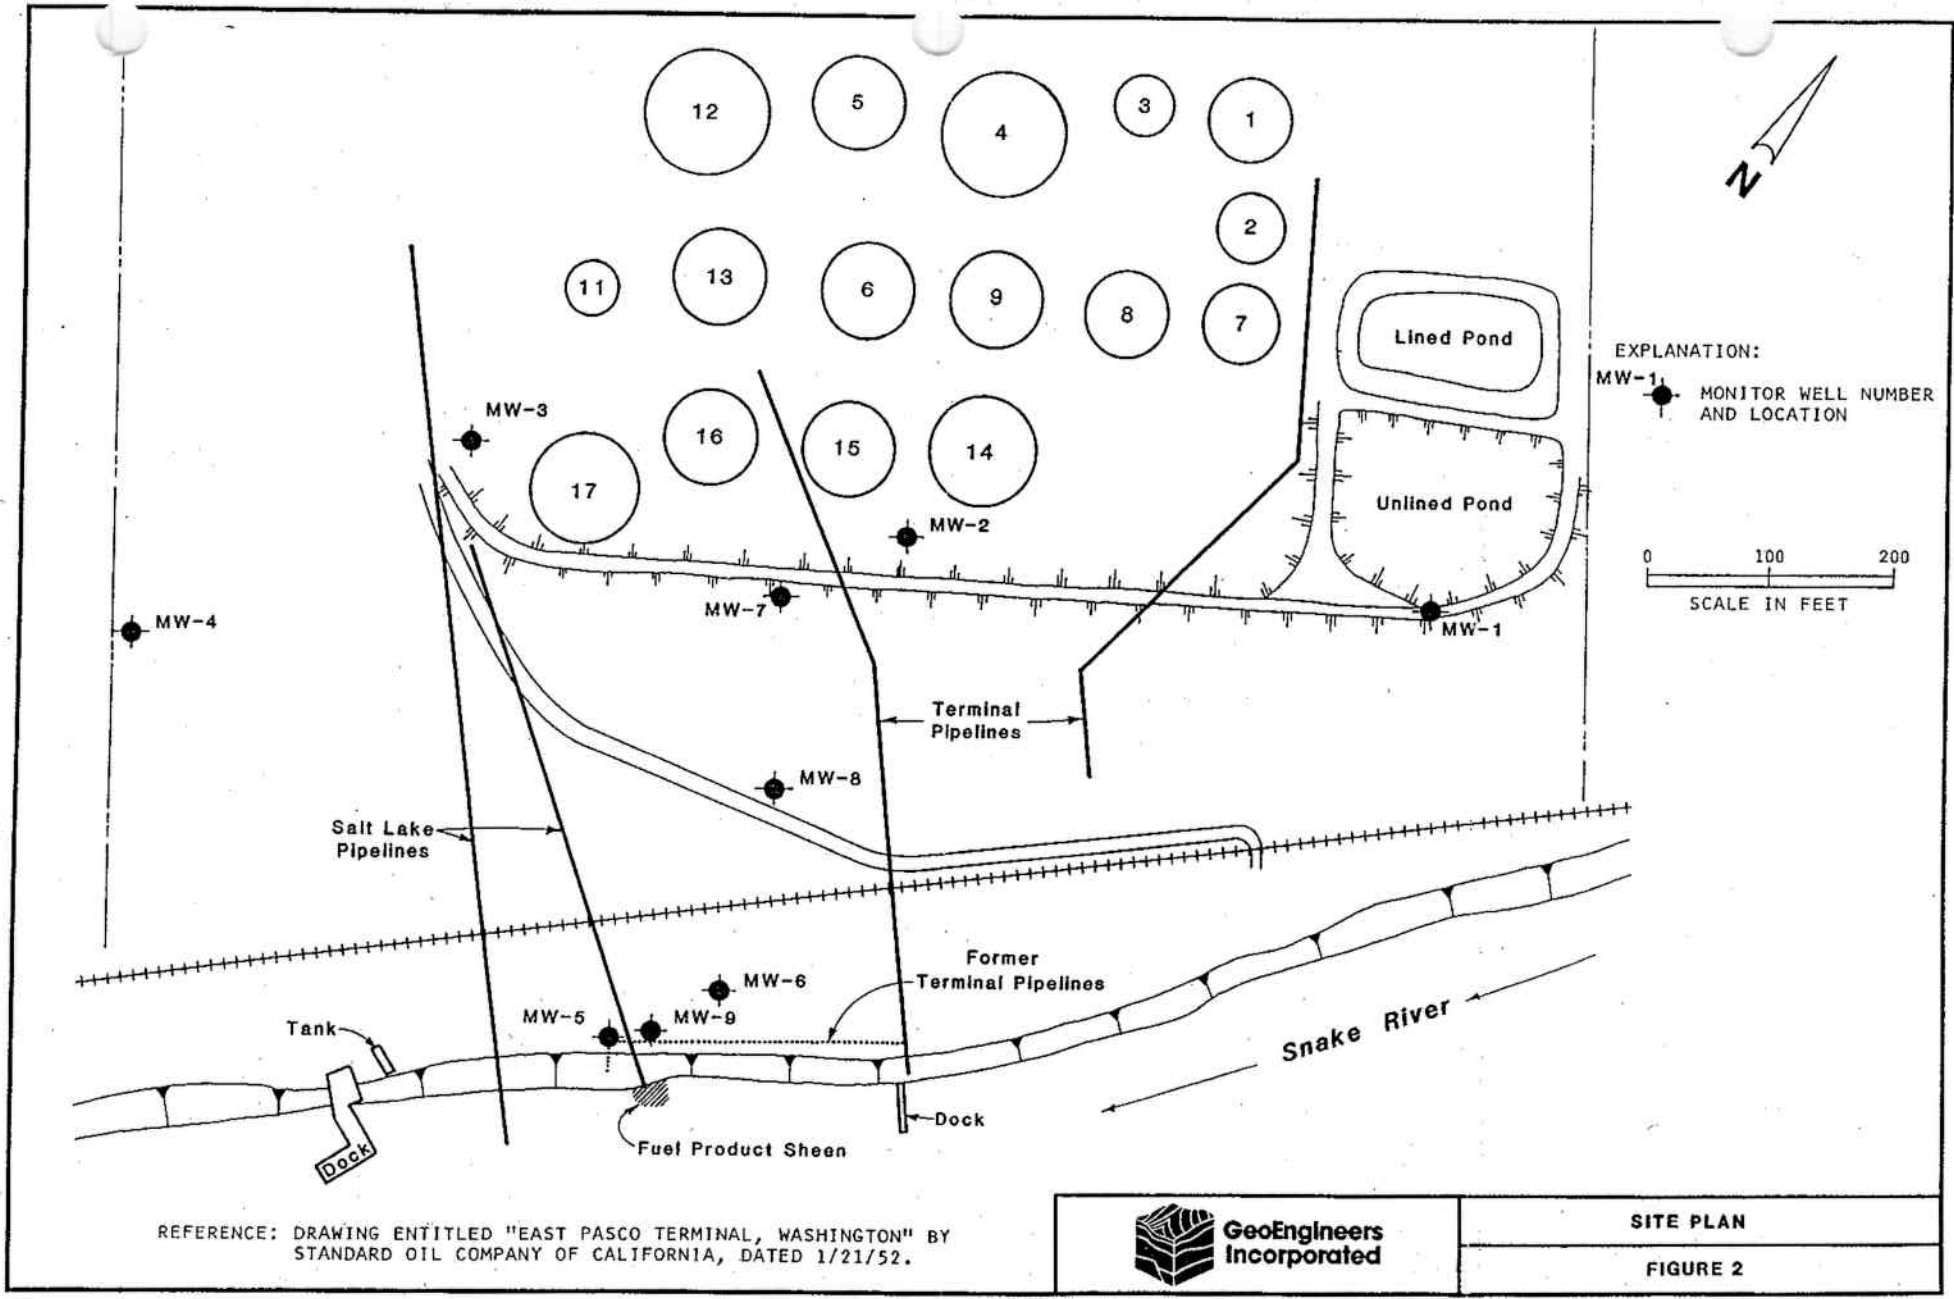
SITE PLAN
FIGURE 2

We understand that free (floating) product was detected in Well MW-2 on July 14, 1986 during a regularly scheduled round of well measurements by Chevron personnel. Chevron personnel also observed a fuel product sheen along the bank of the Snake River and deployed a sea curtain to contain the sheen. The approximate location of the sheen is shown in Figure 2.

Terminal-related pipelines and one of the two Salt Lake pipelines were located near the area of the sheen, as shown in Figure 2. The terminal-related and Salt Lake pipelines were exposed during excavation by Chevron USA during August 1986. A terminal-related pipeline which was dedicated to aviation fuel was found to be leaking and all of the terminal-related pipelines were removed from the subsurface in the area near the sheen. Soil contaminated by fuel products was also removed from the subsurface and replaced with "clean" soil during the pipeline abandonment activity.

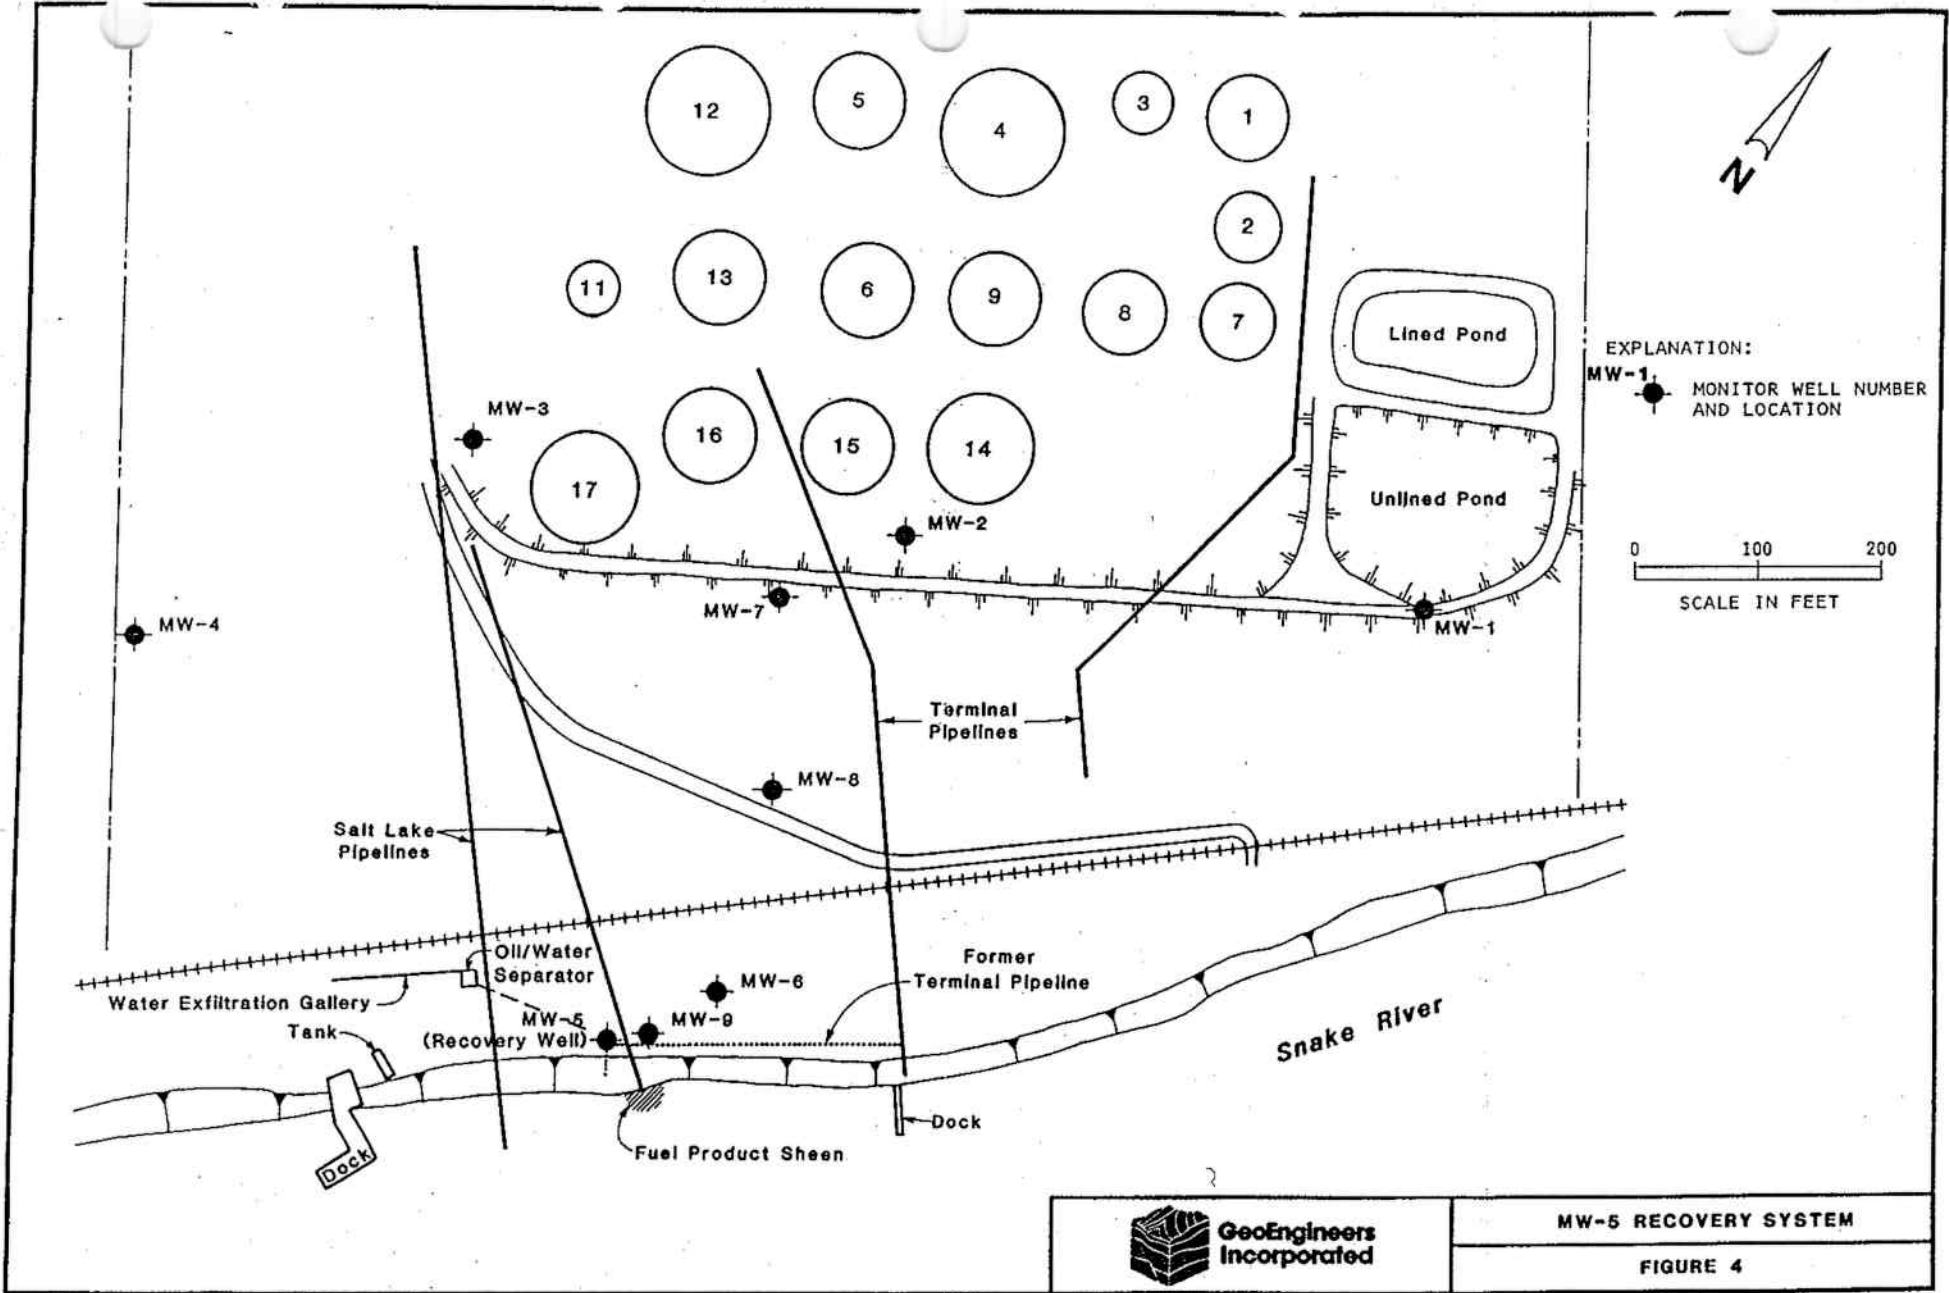
MW-5 RECOVERY SYSTEM
FIGURE 4

Prior to installation of the pumping system, we estimated that a pumping rate of 15 gpm would be necessary to cause ground water to flow to the well instead of the river. Well MW-5 was found to be capable of yielding only 8 gpm during system operation. The cone of depression created in the water table was not large enough to cause an extensive reversal in ground water flow direction. As a result, the sheen persisted during the pumping program. Free product did not accumulate in Well MW-5 during the operation of the pumping system.

Recovery Well: Water was pumped from Well MW-5 in an attempt to produce a cone of depression in the water table and a localized reversal in the direction of ground water flow. The pumping system, an oil/water separator and water exfiltration gallery were installed by Crowley Environmental Services during early January 1987 at the locations shown in Figure 4. The pumping system was operational between January 9, 1987 and April 2, 1987.

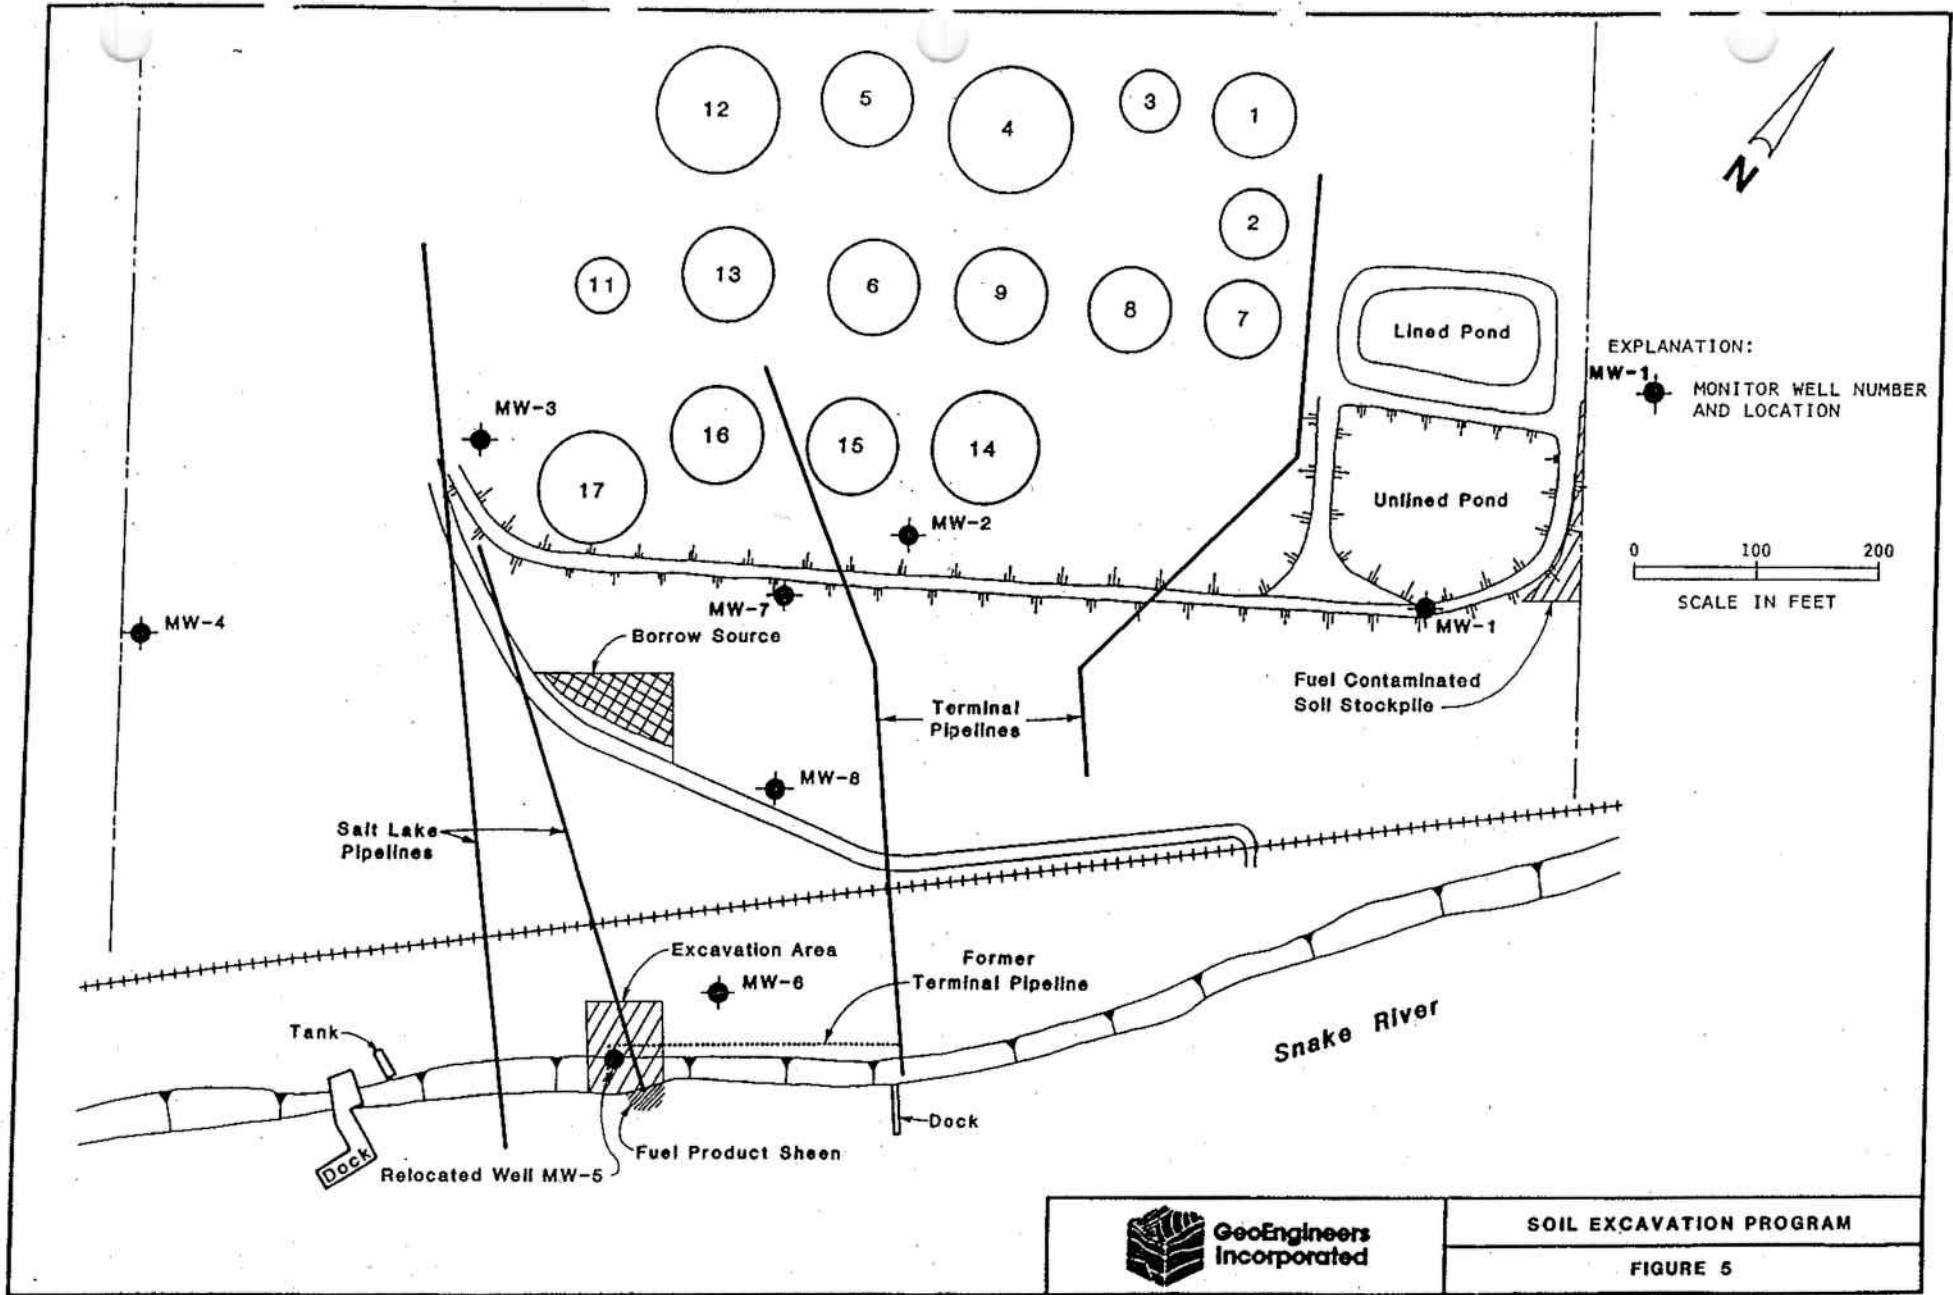
The fuel-contaminated soil consisted of fine to medium sand stained with fuel product. The thickness of the fuel-contaminated layer of soil was as great as 24 inches and the layer of contaminated soil was generally found at the base of the upper sand unit, immediately above the silt unit. The point source of the leak was not located; however, a cone of contaminated soil was noted extending from within 3 feet of existing surface grades downward to the silt. This cone occurred approximately 30 feet west of Well MW-5. The configuration and occurrence of the contamination suggest that this was the source location. The nature of the source of the fuel product is not known.

Summary: Our observations during the soil excavation program suggest that the point source for the fuel product sheen on the Snake River was located about 30 feet west of Well MW-5. The nature of the point source of fuel product is not known.

Removal of Fuel-Contaminated Soil: We recommended that fuel-contaminated soil be removed from along the shoreline based on the persistence of the sheen during the pumping program. Specifications for the soil removal project are presented in our letter dated February 20, 1987. The

location of the excavation, the area used to stockpile the fuel-contaminated soil, and the area used as a borrow source for "clean" fill are shown on Figure 5. Application for construction permits were made to the Franklin County Planner and the U.S. Army Corps of Engineers.

Wells MW-9 and MW-5 were destroyed during excavation. MW-5 was replaced with a 24-inch corrugated metal pipe. The location of the replacement well is shown in Figure 5. Slots were cut in the pipe with an abrasive power saw. Backfill around the pipe consisted of washed pea gravel. The well was developed by withdrawing approximately 8 gpm of water over a period of four hours with a 3-inch diaphragm pump.
