JN 8125-4

Subject: SECOND SEMI-ANNUAL GROUNDWATER MONITORING EVENT Marine Fluid Systems 801 Northwest 42nd Street Seattle (Ballard), Washington

SECOND SEMI-ANNUAL GROUNDWATER MONITORING EVENT

Marine Fluid Systems 801 Northwest 42nd Street Seattle (Ballard), Washington

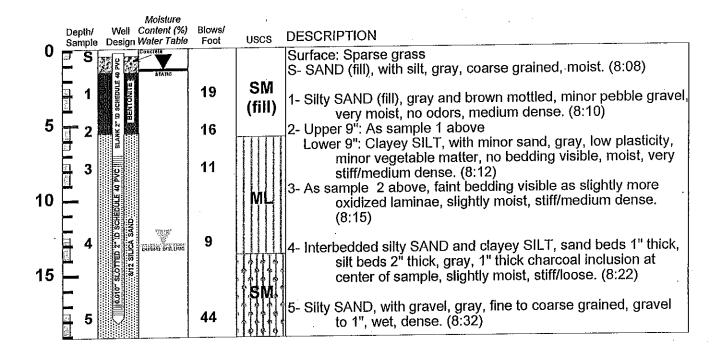
TEST BORING LOG: B-1/MW-1

- Boring/monitoring well located at northeast corner of property, 33.5 feet north of the eastern warehouse, and 41.5 feet east of the northern office/warehouse building.
- * Boring terminated at 19.5 feet on April 1, 1998.
- Monitoring well installed. Depth to groundwater approximately 13 feet at the time of drilling. Depth to groundwater measured at 1.34 feet below top of casing on May 6, 1998. Groundwater sample MW-1 obtained May 6, 1998.
- * No visual or olfactory indications of contamination in soil or groundwater.
- * Numbers in parentheses indicate the time the sample was obtained.

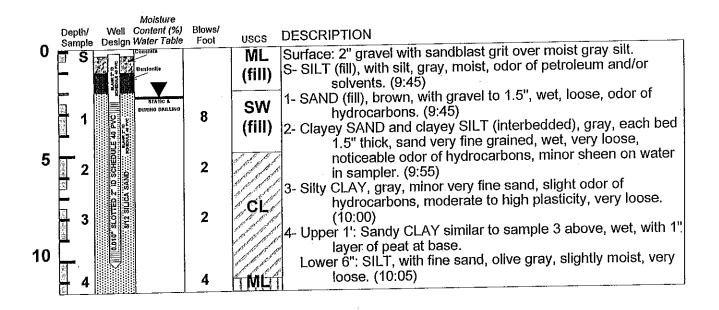
TEST BORING LOG: B-2/MW-2

- Boring/monitoring well located at southeast corner of property, 36 feet east of the steel shop, and 29.5 feet east of the winch.
- * Boring terminated at 11.5 feet on April 1, 1998.
- Monitoring well installed. Depth to groundwater approximately 2.5 feet at the time of drilling. Depth to groundwater measured at 2.28 feet below top of casing on May 6, 1998. Groundwater sample MW-2 obtained May 6, 1998.
- * Odors of solvent/hydrocarbons noted in upper few feet of boring, becoming faint below 9 feet in depth.
- Numbers in parentheses indicate the time the sample was obtained.

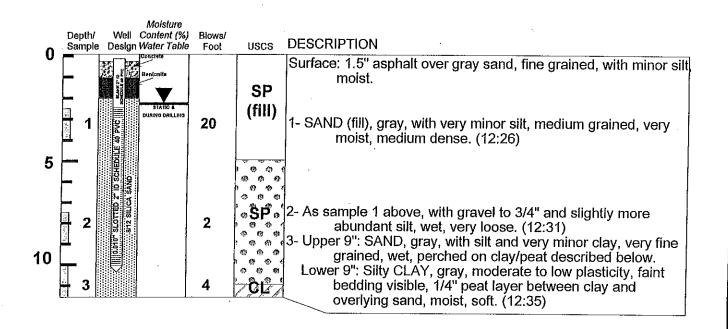
TEST BORING LOG: B-3/MW-3

- * Boring/monitoring well located at northwest corner of property, 48 feet west of northern office/warehouse building, just south of the northern property line.
- * Boring terminated at 11.5 feet on April 1, 1998.
- * Monitoring well installed. Depth to groundwater approximately 4 feet at the time of drilling. Depth to groundwater measured at 3.29 feet below top of casing on May 6, 1998. Groundwater sample MW-3 obtained May 6, 1998.
- * No visual or olfactory indications of contamination in soil or groundwater.
- * Numbers in parentheses indicate the time the sample was obtained.

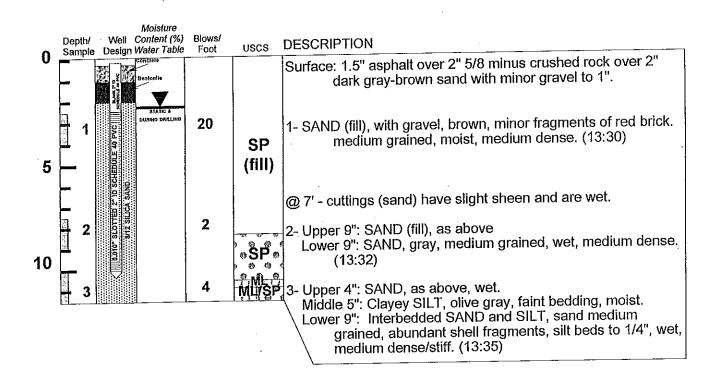
TEST BORING LOG: B-4/MW-4

- * Boring/monitoring well located 27.5 feet south of marine railway, 17 feet east of machine and carpenter shop.
- * Boring terminated at 11.5 feet on April 1, 1998.
- * Monitoring well installed. Depth to groundwater approximately 6 feet at the time of drilling. Depth to groundwater measured at 4.31 feet below top of casing on May 6, 1998. Groundwater sample MW-4 obtained May 6, 1998.
- Visual indications of contamination (slight sheen) noted in soil at approximately 7 feet below ground surface. No visual or olfactory indications of contamination in groundwater.
- * Numbers in parentheses indicate the time the sample was obtained.
