BASALT
environmental

August 24, 2012

Subject: Basalt Project Number 120807-1
Phase I Environmental Site Assessment
Arne's Collision Center
9725 and 9731 Greenwood Avenue North
Seattle, Washington

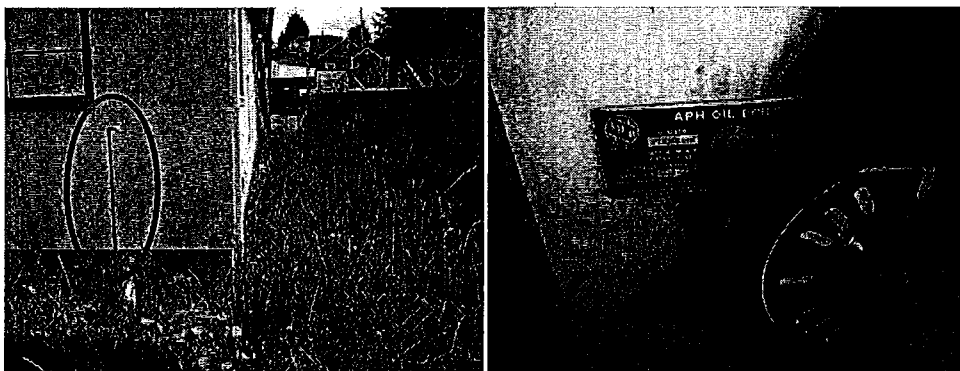
The building apparently was heated by a forced air furnace at one time. The furnace is located in the basement, and originally was oil-fired but was converted to natural gas. A vent line typical of a fuel storage tank was identified on the west side of the building, however a fill port could not be located. Therefore it is likely that fuel oil was stored on site in the past, however it could not be determined if the fuel storage vessel was an underground storage tank (UST) located outside the building, or an above ground storage tank (AST) formerly located inside the basement.

Suspected fuel tank vent line

Former oil burning furnace

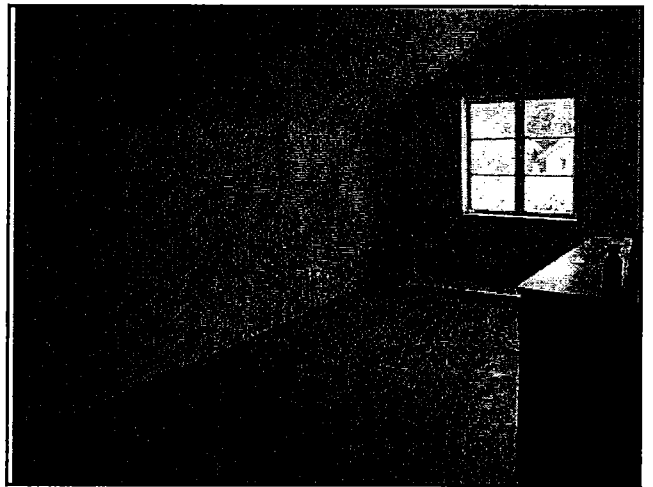
2. Interior, note vinyl flooring.

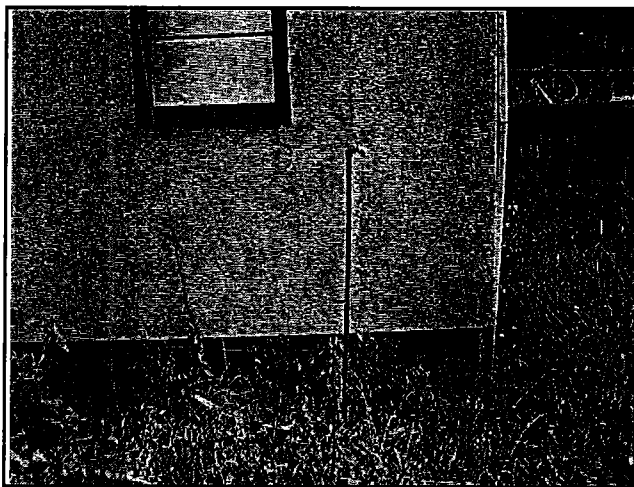
In Basalt's opinion past use and storage of heating oil on the Property is considered a "recognized environmental condition" (as defined by ASTM E 1527-05). Recommendations for further evaluation, if any, will be provided in a separate letter.

5. Suspect fuel tank vent line

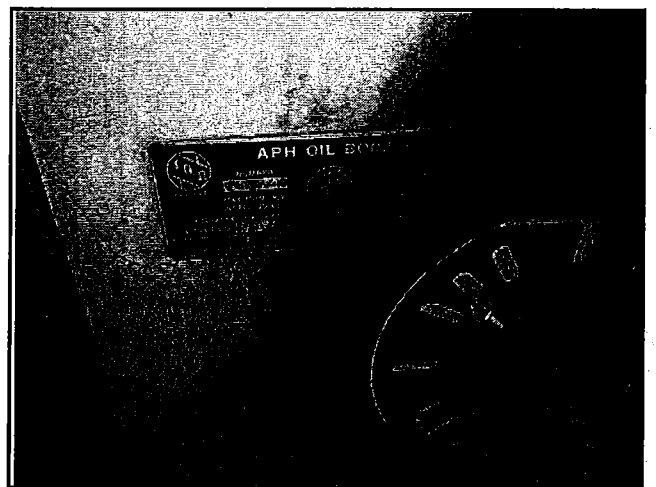
6. Oil burning furnace.

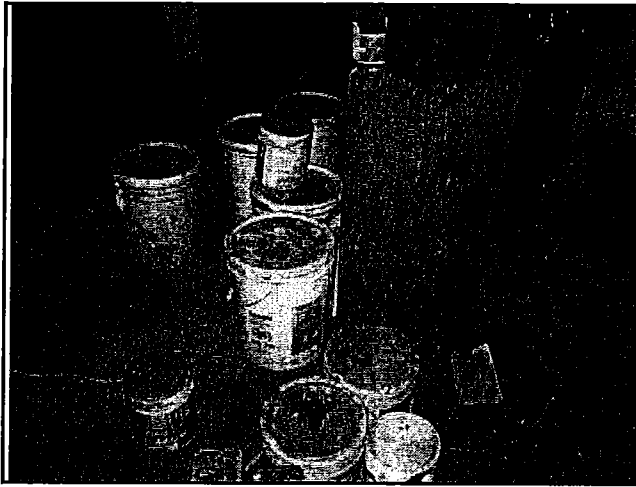
At the time of the site visit, the building was unoccupied and vacant. Portions of the storage yard and parking area were overgrown with dense vegetation and blackberry brambles. Evidence of dumping was noted at various locations across the site. The dumped materials appeared to be household trash, including old tires, furniture, etc. Several five-gallon and smaller containers of paint were observed in the basement.

7. Paint storage in basement.
