## **Environmental Investigation**

Carpenter Road Site  
Lacey, Washington

*for*  
**City of Olympia**

July 3, 2017

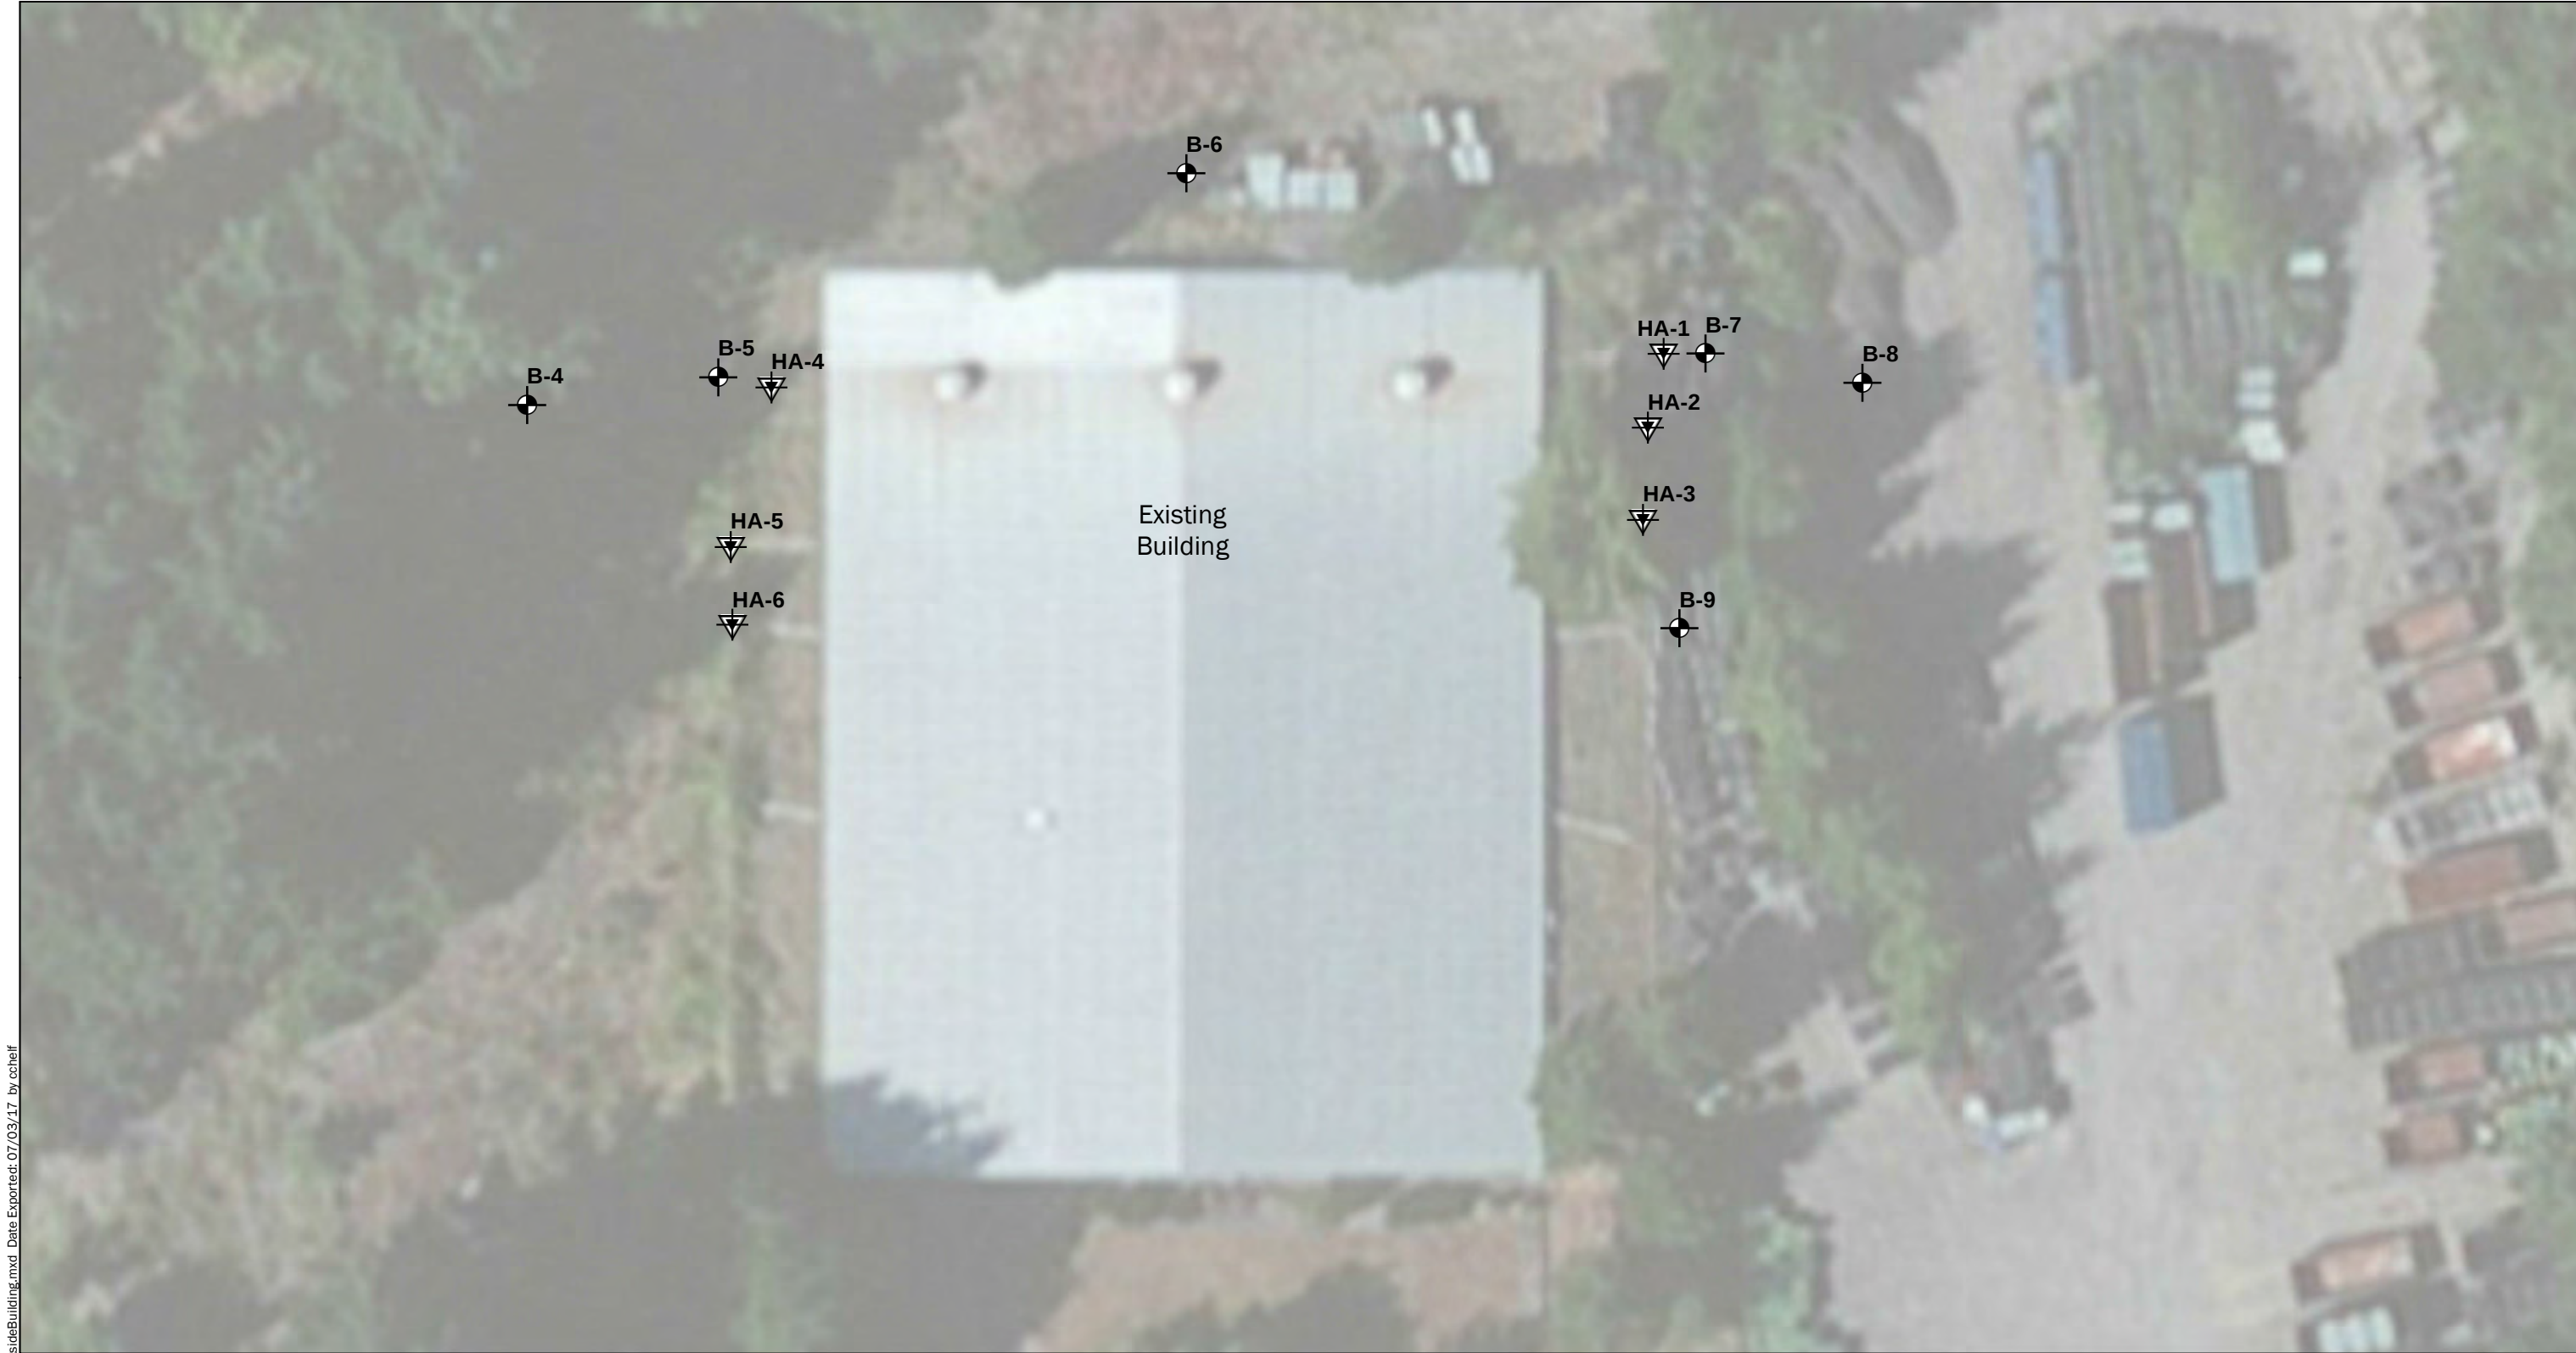
| | <b>Figure 6</b> |

- The lead concentrations in B-8 and B-9 on the east side of the building are less than the MTCA Cleanup Level (Table 4A and 4B).
- The results of TCLP testing of the composite samples Comp A and Comp B had concentrations greater than the toxicity characteristic criteria for lead indicating that the soil will designate as hazardous/dangerous waste and will require treatment and disposal at a Subtitle C landfill (Table 5).

- Soil on the west and east sides of the building have been impacted by firing range activities.
- Remedial actions will be needed to remove soils with lead concentrations greater than the MTCA Cleanup Level.
- Soil that is removed will likely designate as hazardous/dangerous waste and require disposal in a Subtitle C landfill.

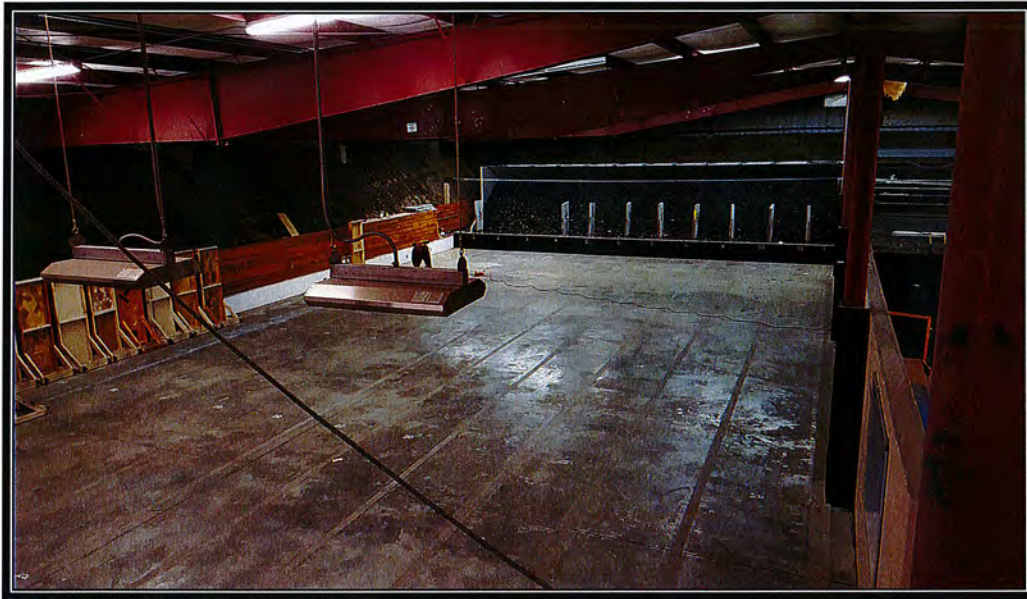
Photo #1 – Range Area Side A

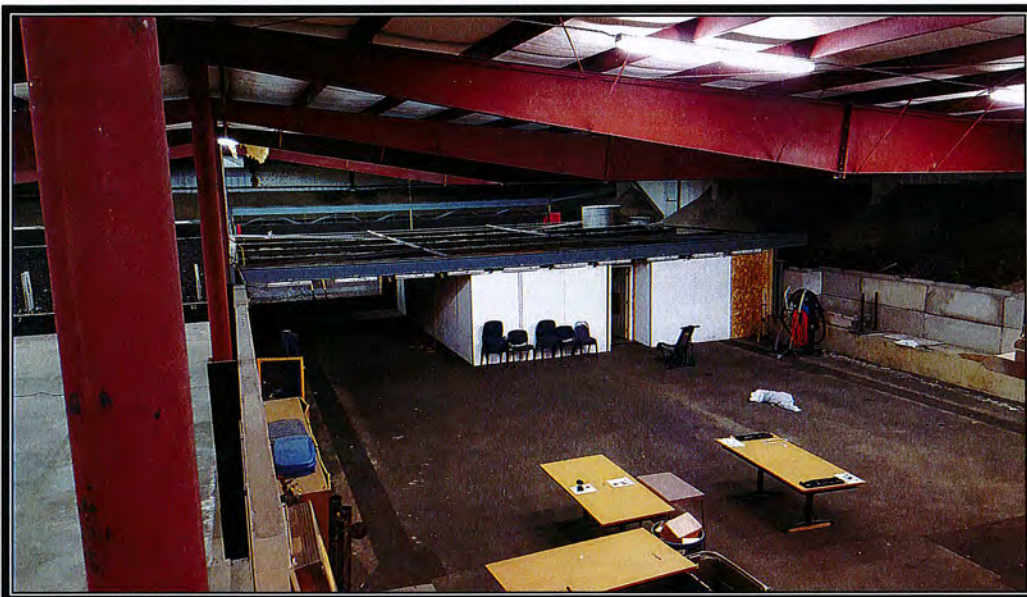
Photo #2 – Range Area Side B

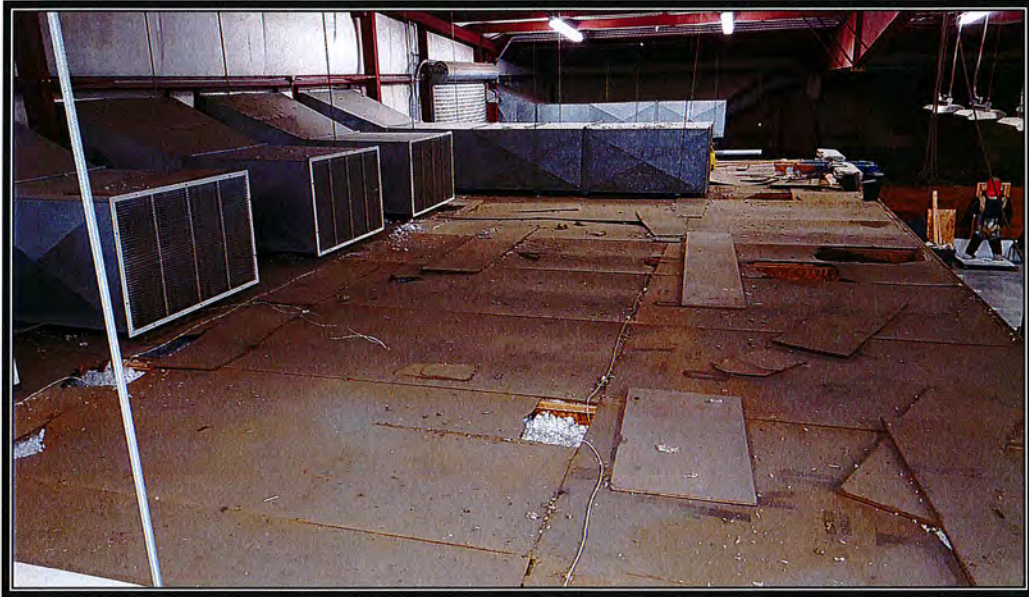
Photo #3 – Settled dust above training room

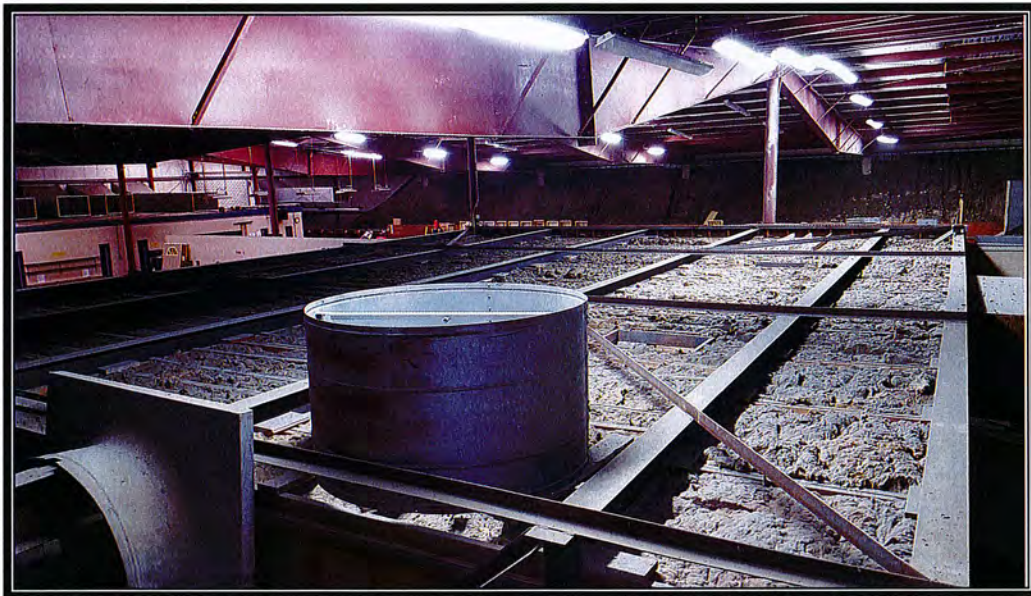
Photo #4 – Settled dust on fiberglass insulation

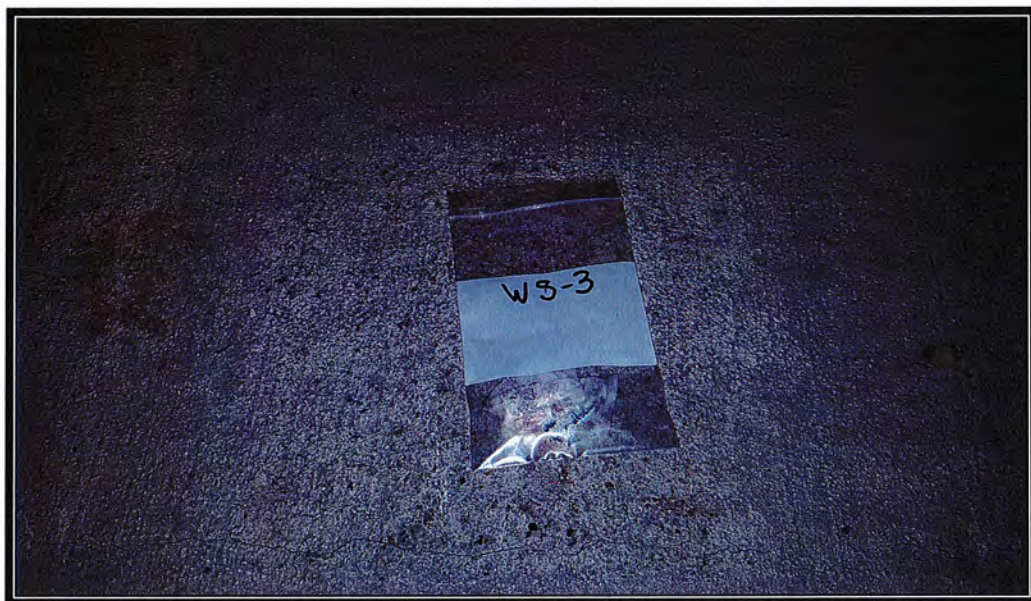
Photo #7 – Dust Sample on Eco Block
