MEMORANDUM

Date: July 3, 2018 **RGI Project Number:** 2012-107M

Subject: 2018 Annual Inspection Summary
Alamo Manhattan Main Street
10505 Main Street
Bellevue, Washington 98004
Ecology VCP No. NW2811

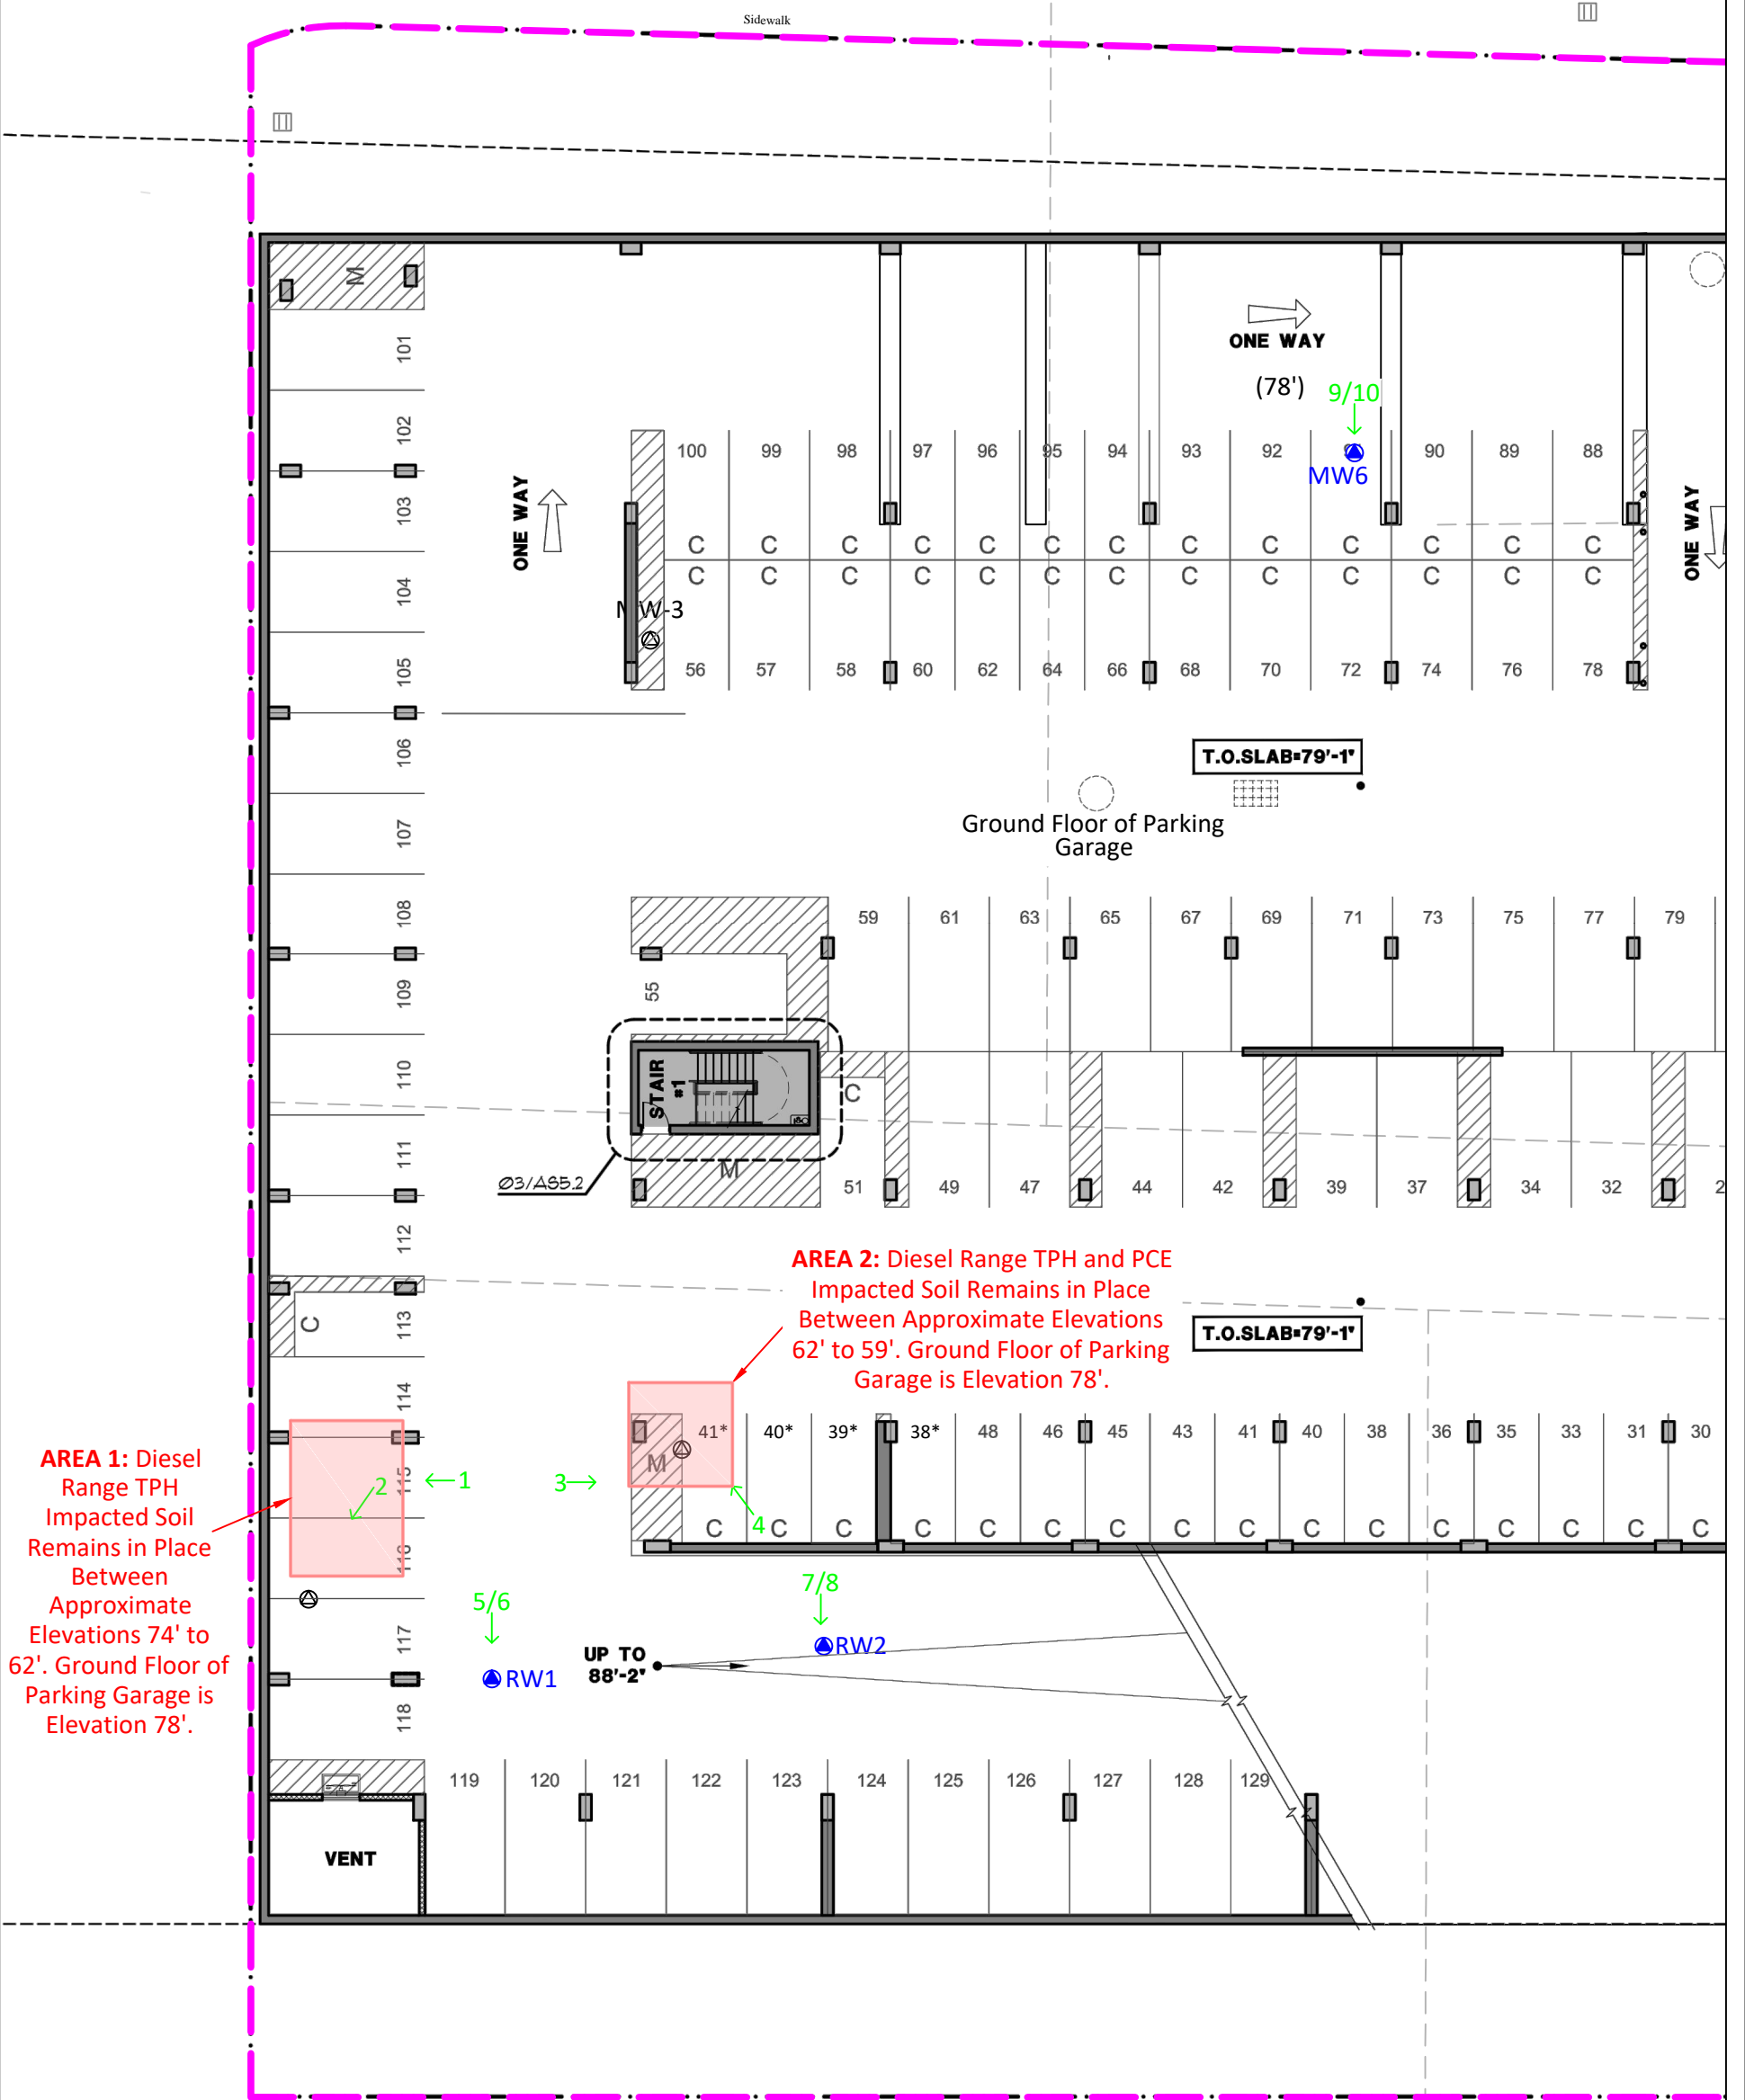
Figure 3

AREA 1: Diesel Range TPH Impacted Soil Remains in Place Between Approximate Elevations 74' to 62'. Ground Floor of Parking Garage is Elevation 78'.

AREA 2: Diesel Range TPH and PCE Impacted Soil Remains in Place Between Approximate Elevations 62' to 59'. Ground Floor of Parking Garage is Elevation 78'.

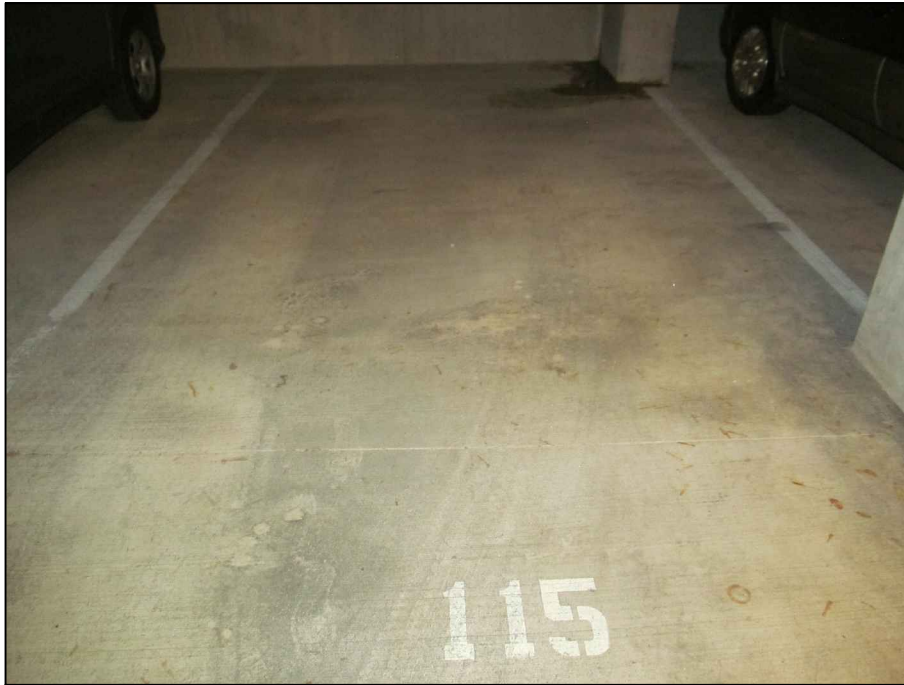
The portions of the concrete garage floor slab situated above Areas 1 and 2 were in good condition and no damage was observed (see Photos 1 through 4). Groundwater monitoring wells RW1, RW2, and MW6 were also in good condition with no damage observed (see Photos 5 through 10).

Photograph 1: View looking west representing the condition of the garage floor slab at the northern portion of Area 1,

No further work is recommended at this time. The next annual inspection is scheduled for June of 2019.

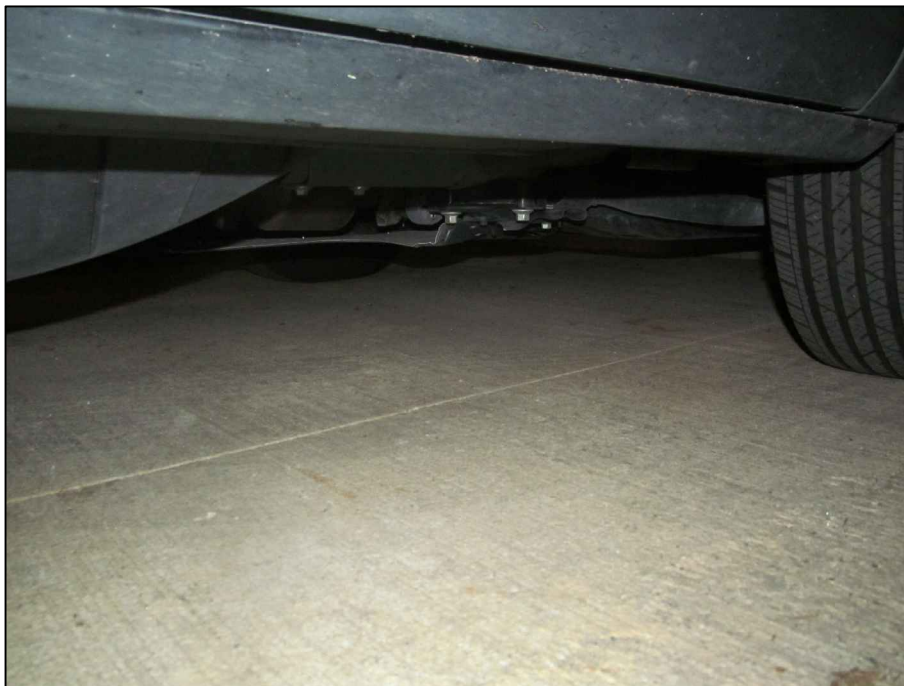
Photograph 2: View looking southwest representing the condition of the garage floor slab at the southern portion of Area 1.

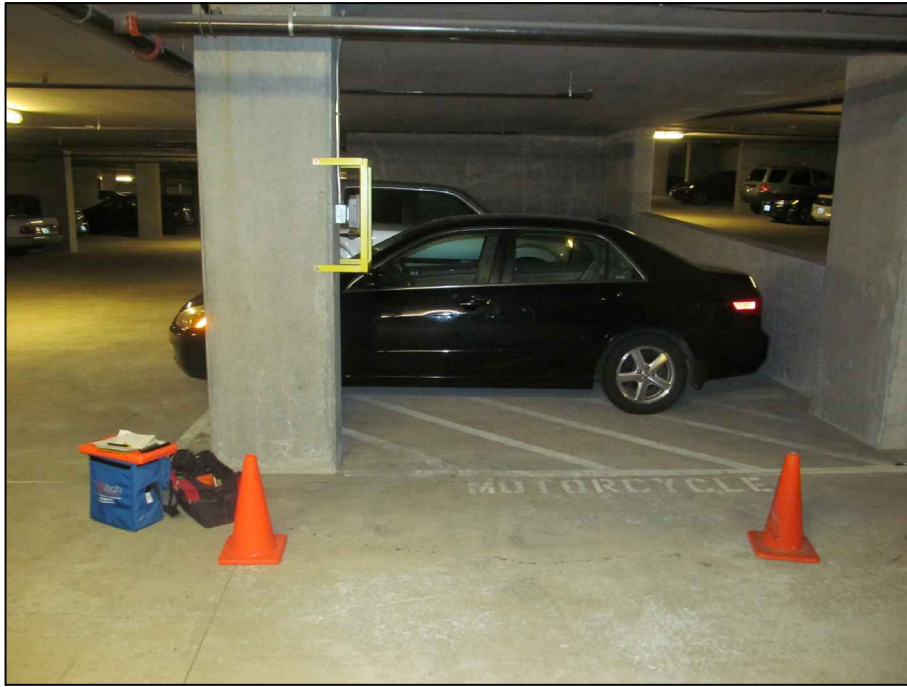
Photograph 3: View looking east representing the condition of the garage floor slab at the western portion of Area 2.

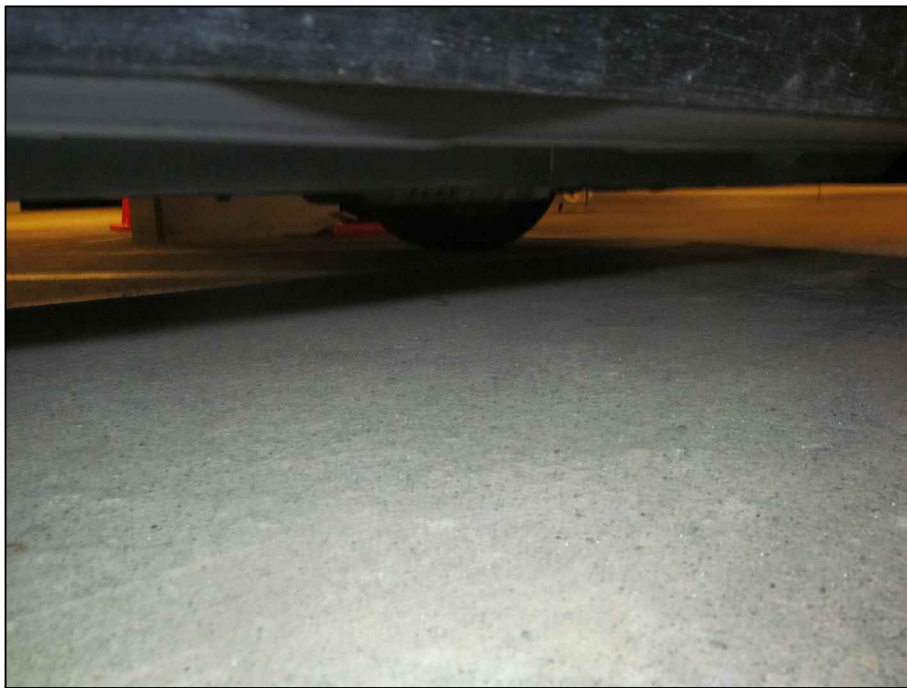
Photograph 4: View looking northwest representing the condition of the garage floor slab at the eastern portion of Area 2.

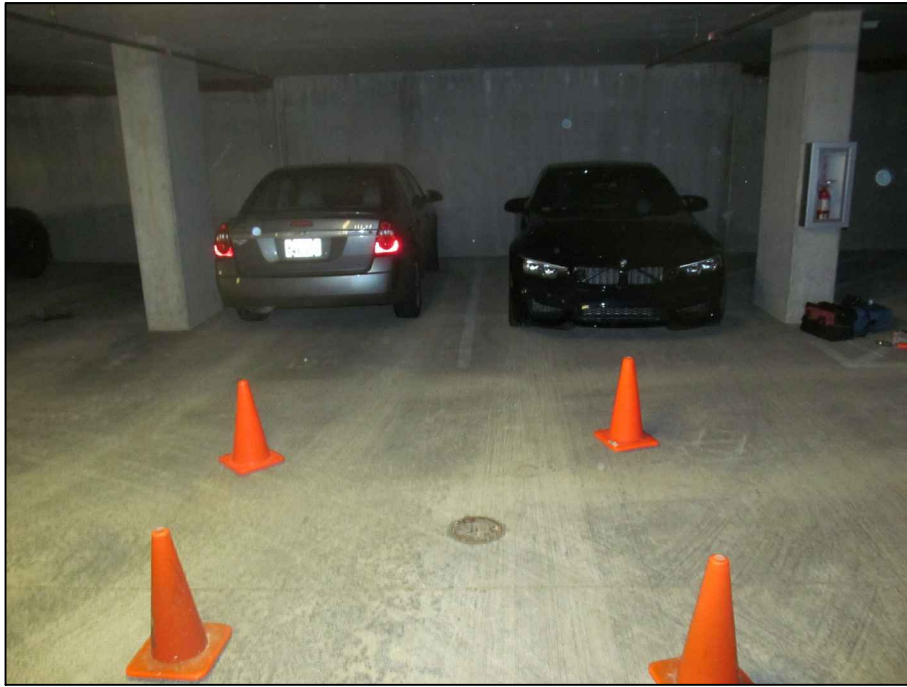
Photograph 5: View looking south at well RW1.

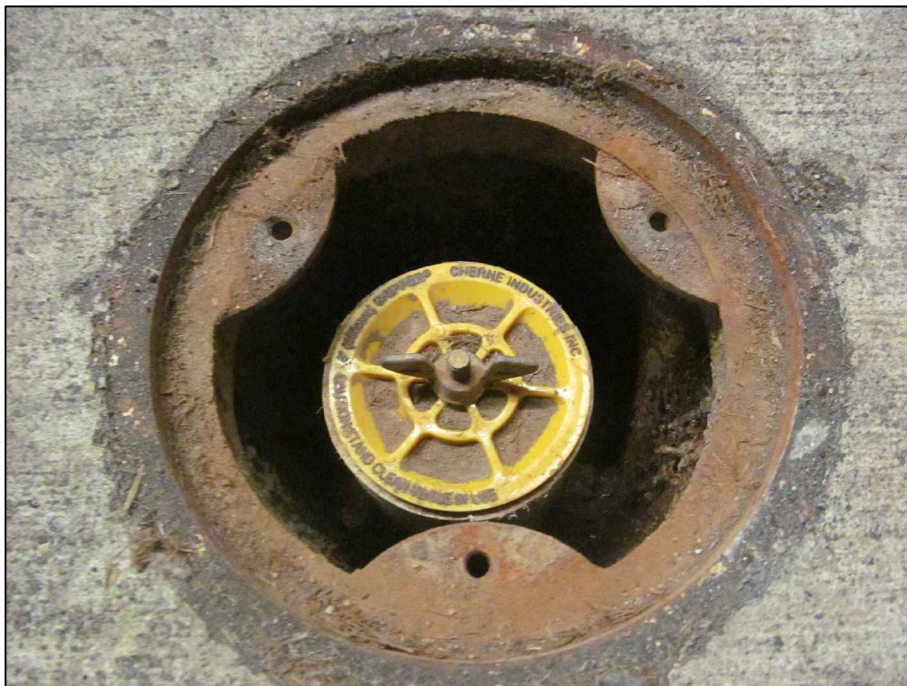
Photograph 6: View of well RW1 without the well cover.

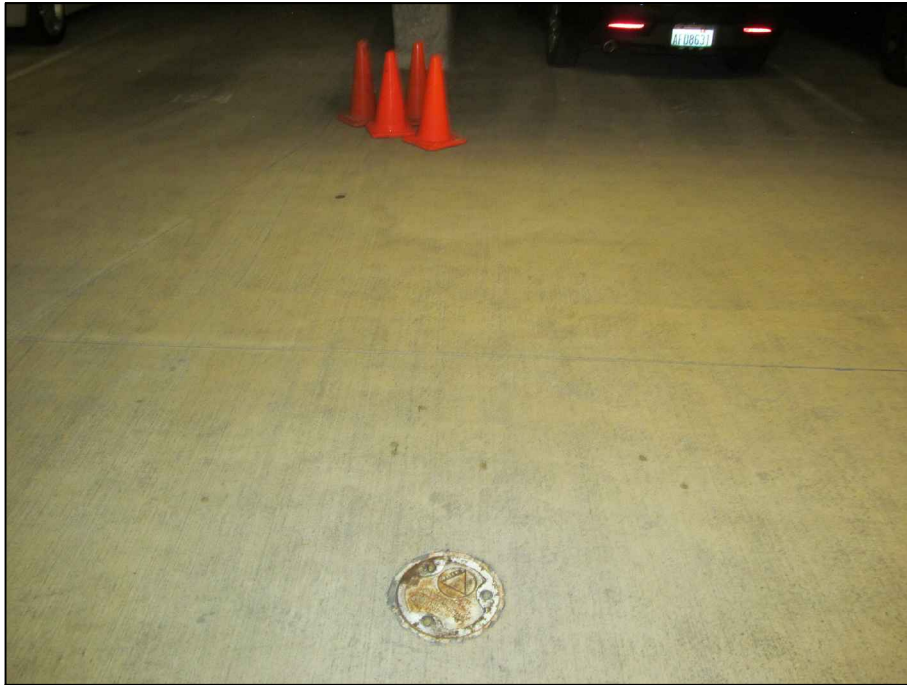
Photograph 7: View looking south at well RW2.

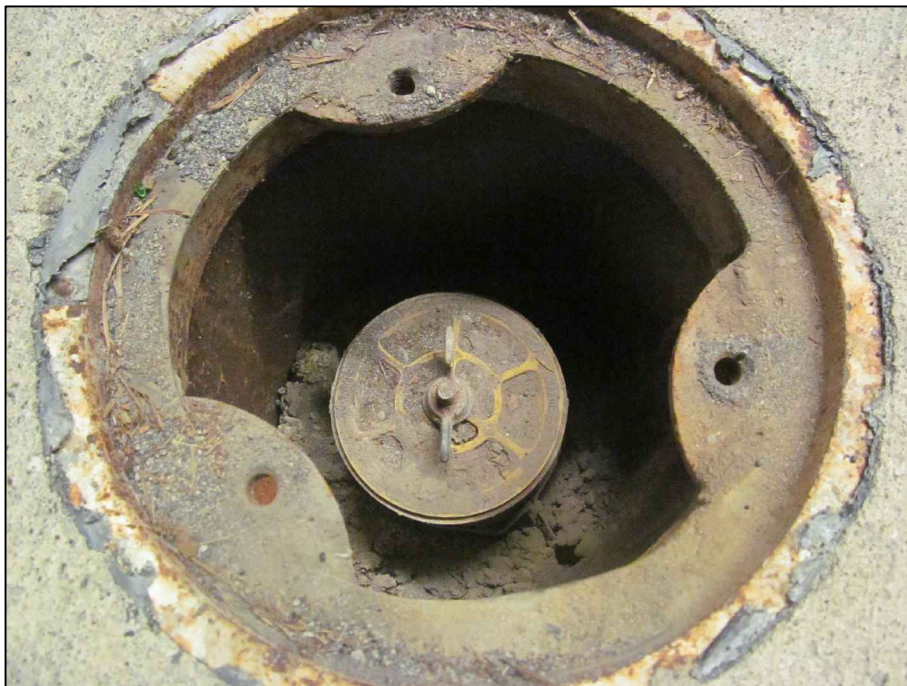
Photograph 8: View of well RW2 without the well cover.

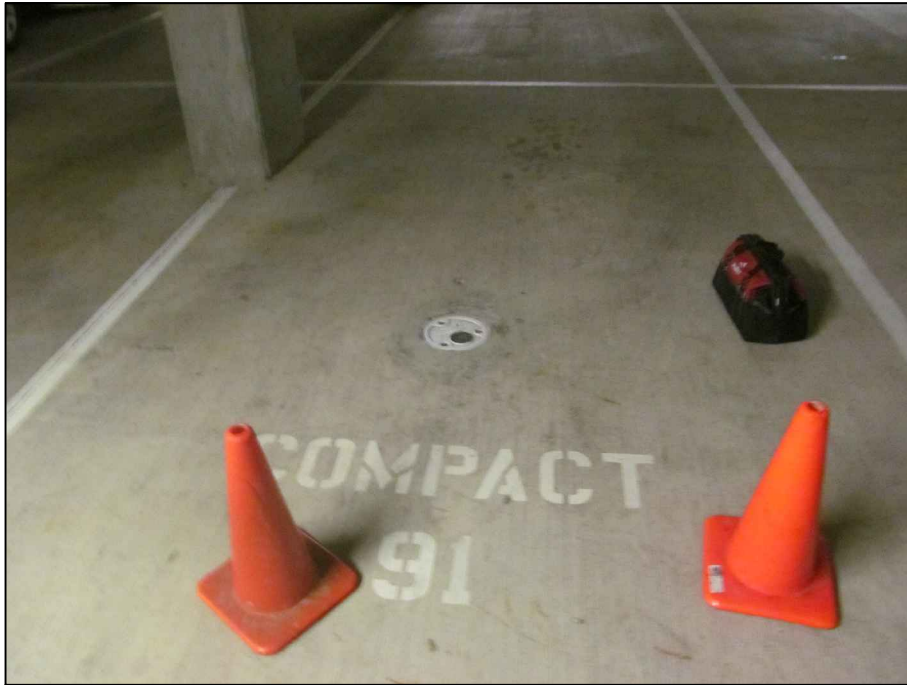
Photograph 9: View looking south at well MW6.

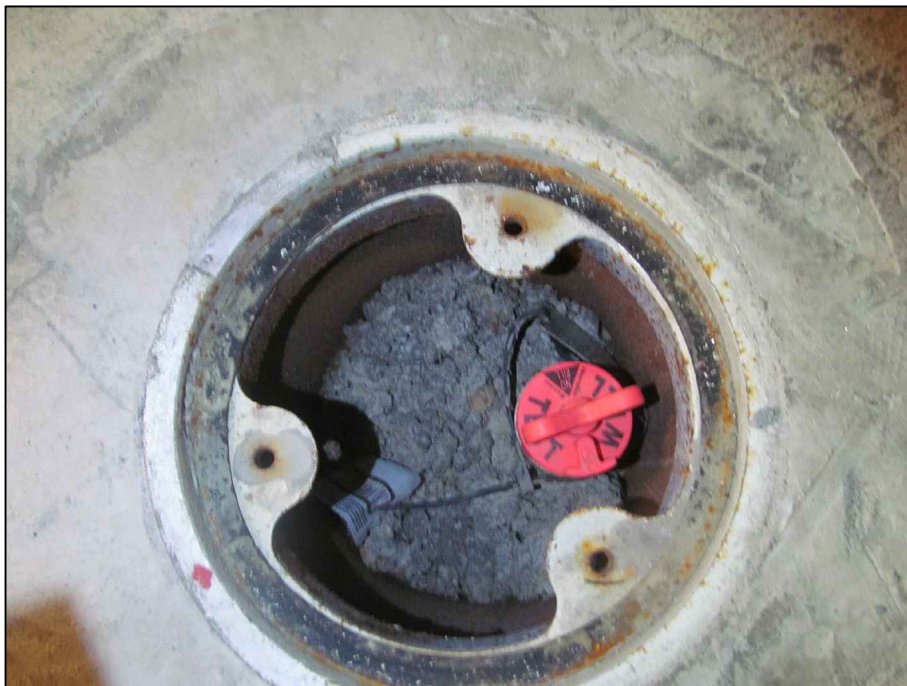
Photograph 10: View of well MW6 without the well cover.
