SITE HAZARD ASSESSMENT Worksheet 1 Summary Score Sheet

Anacortes Former WTP Facility/Site ID: 79423677

SITE HAZARD ASSESSMENT Worksheet 2 Route Documentation

Cleanup Site ID: 13264 Anacortes Former WTP

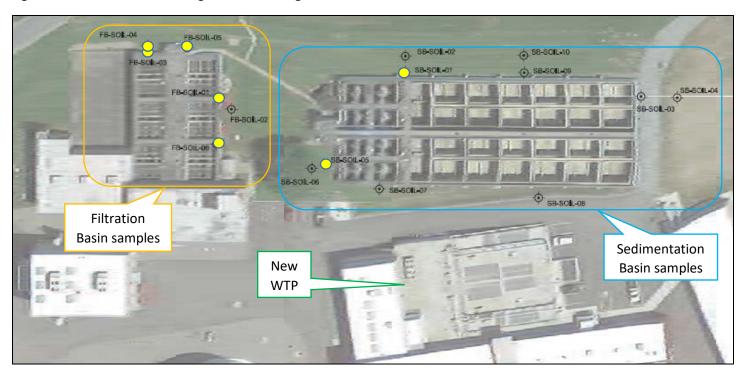
Figure 3: 2017 Remedial Investigation Soil Boring Locations

Sixteen soil samples were collected in May 2016 around the vicinity of the Sedimentation and Filtration Basins (Figure 3). With the exceptions of SB-08 and DG-GW, soil borings were extended to a depth of 30 feet bgs. Soil borings were completed as 14 groundwater monitoring wells. Groundwater was encountered in all locations and ranged in depth from 17.2 to 18.0 feet.

The City of Anacortes is currently working with Ecology to finalize an Agreed Order proposing a remedial action to excavate and remove the PCB-affected soil and collect confirmation soil sampling.

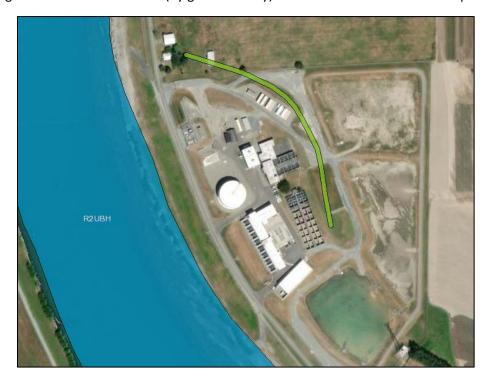
Figure 6: Wetland identified (by green overlay) on the Anacortes Former WTP parcel

Description: Freshwater Emergent Wetland

Distance (ft): <1000 Nearest Sensitive Environment Score: 7
