STATE OF WASHINGTON
DEPARTMENT OF ECOLOGY

Re: Further Action needed at the following site:

- Name: Pit Stop Naches
- Address: 10121 Highway 12, Naches
- Facility/Site No.: 505
- Cleanup Site ID No: 4928
- VCP No.: CE0449

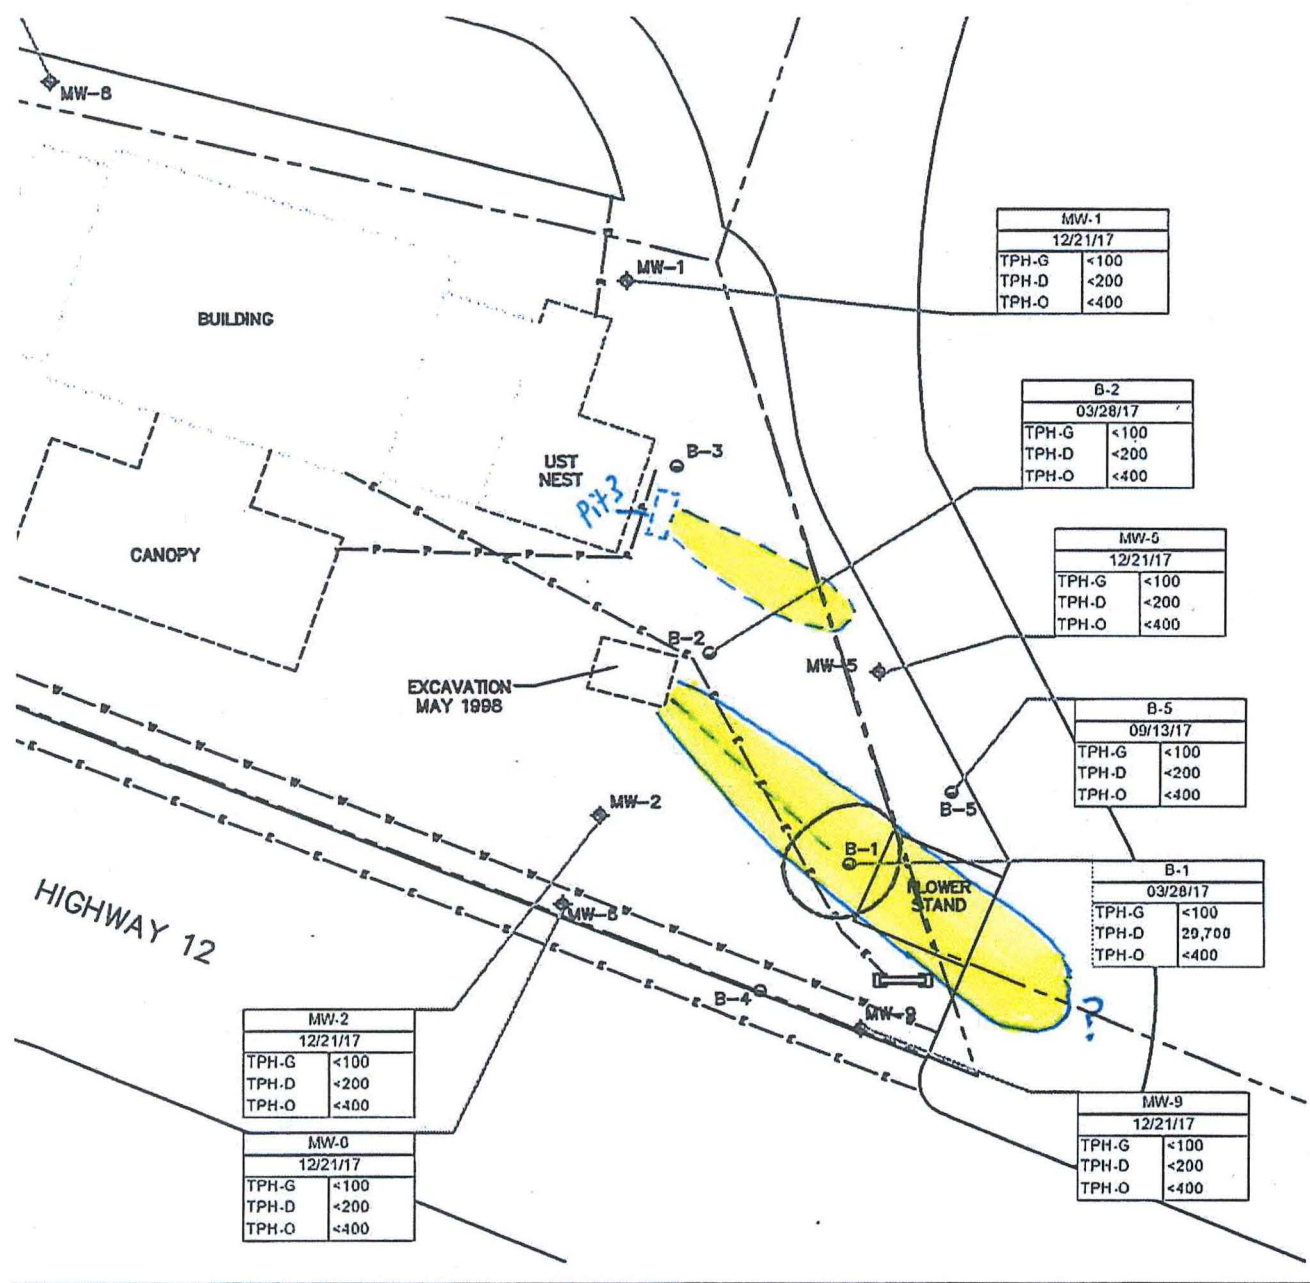
FIGURE 6

- Ecology considers it likely that the area southeast of the May 1998 Excavation area (dispenser release area) and upgradient of B-1, has groundwater contaminant concentrations above cleanup levels. There is currently no data to support limiting the extent of contamination above cleanup levels in this area as shown in Figure 6. A plume map prepared by Ecology is attached.

- Ecology’s plume map also shows a plume adjacent to the Underground Storage Tank (UST) area, based on the location of the Pit 3 centered on the smaller USTs (see Appendix A from the 1991 report). If Pit 3 is actually co-located with B-3, then Ecology concurs with the lack of groundwater contamination in this area (see below comments on the RI Report).

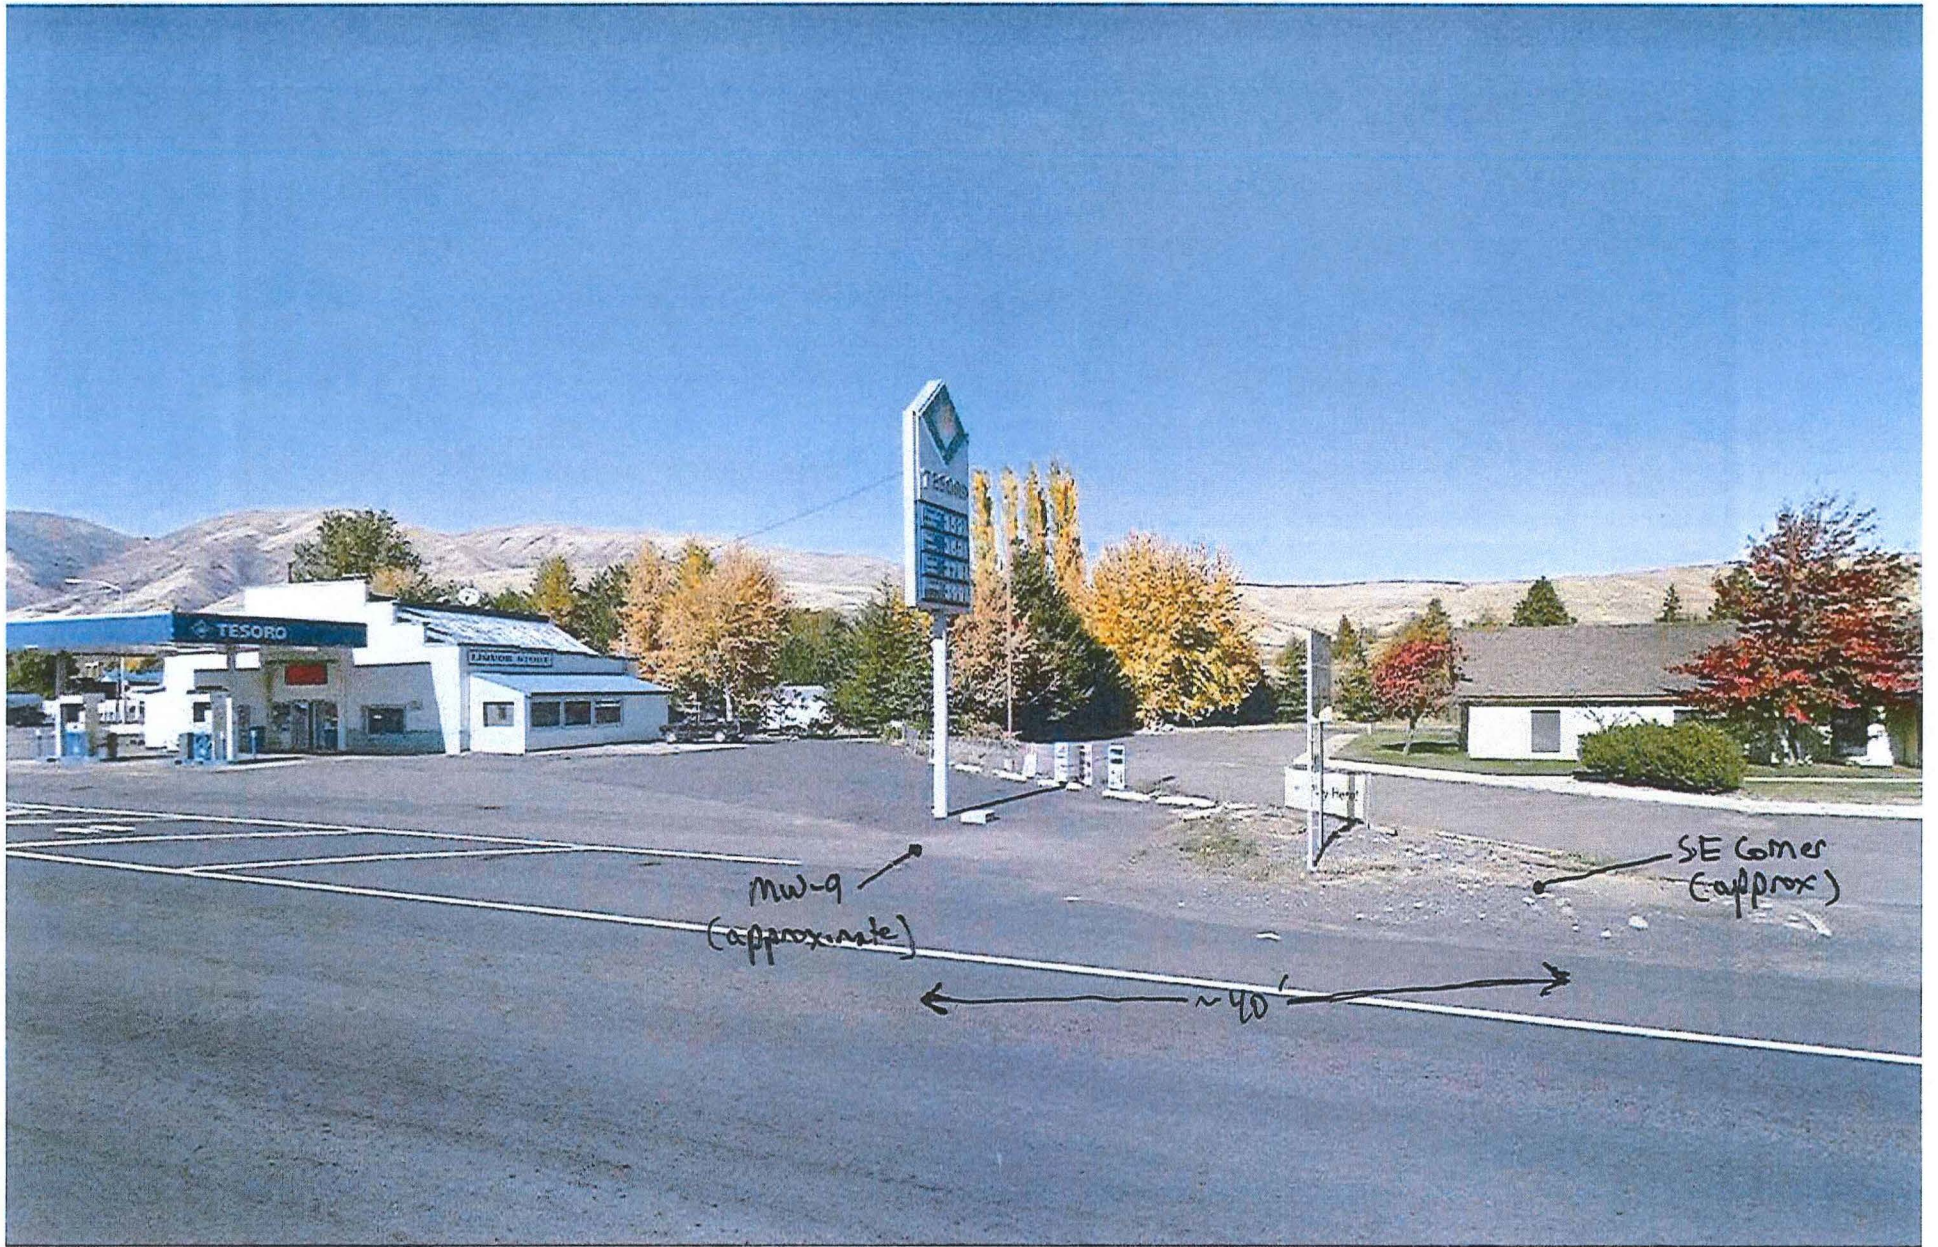
- Section 4.1, fifth bullet states that permanent well MW-9 is located downgradient of B-1. The most recent potentiometric surface maps from March 2018 and March 2017 suggest a groundwater flow direction to the southeast. Note that the groundwater levels at MW-6 were slightly anomalous and it would appear to be appropriate to exclude them in water level contouring. MW-9 is located a few degrees east of south from B-1 and is therefore not located hydraulically downgradient of B-1. AEG had recommended in the May 2017 report the installation of a monitoring well at the southeast property corner. It appears that MW-9 was installed at a distance west of the southeast property corner (see attached Google Street View photo image of this area).

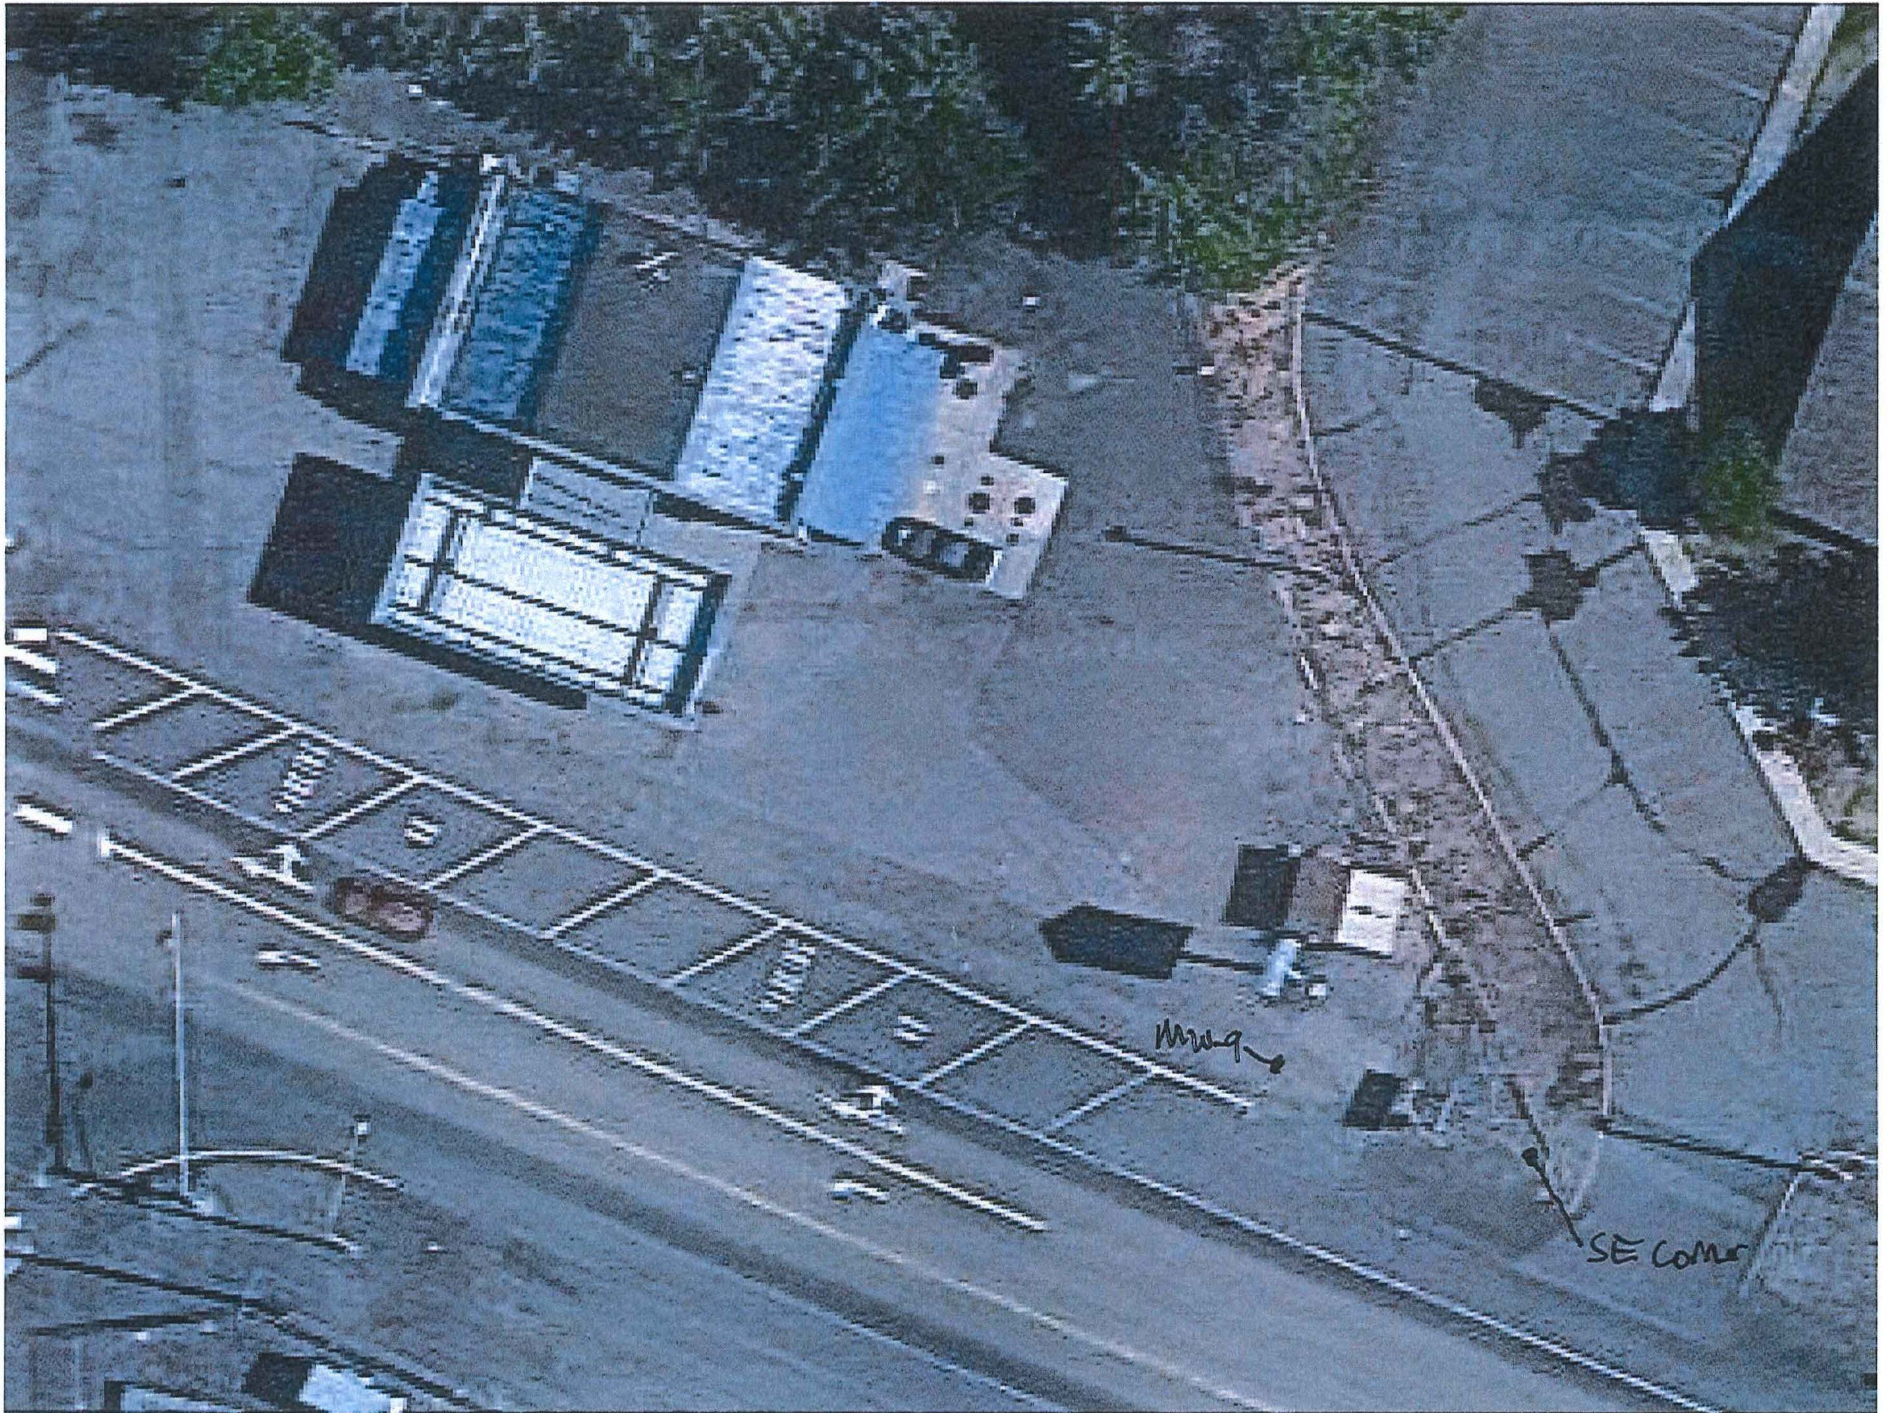
- Ecology has a concern with respect to the accuracy of the base map in the southeast part of the property. Examination of aerial photograph and street view coverage suggest that the features in this area may not be accurately mapped. Please overlay the base map with an aerial photograph to correct it as appropriate. In addition, please add to the base map Pits 1, 2, 3, and 4 from the Exploratory Investigation for Petroleum Contaminants at the Pit Stop, dated July 1991 to the base map, since the test pits had significant soil and groundwater contamination in 1991. Depicting the pits is needed so that the sufficiency of 2017 soil sampling locations can be clearly assessed.
- The historical soil and groundwater results from 1991 should be included within the RI report for comparative purposes.
