Periodic Review

Stevens Pass Ski Resort Vehicle Maintenance Facility
and
Stevens Pass Mini Mart Station
US 2 – Stevens Pass Summit
Skykomish, Washington 98288

Facility/Site ID #s: 19775 and 56
Cleanup Site ID #s: 11420 and 11421

June 2018

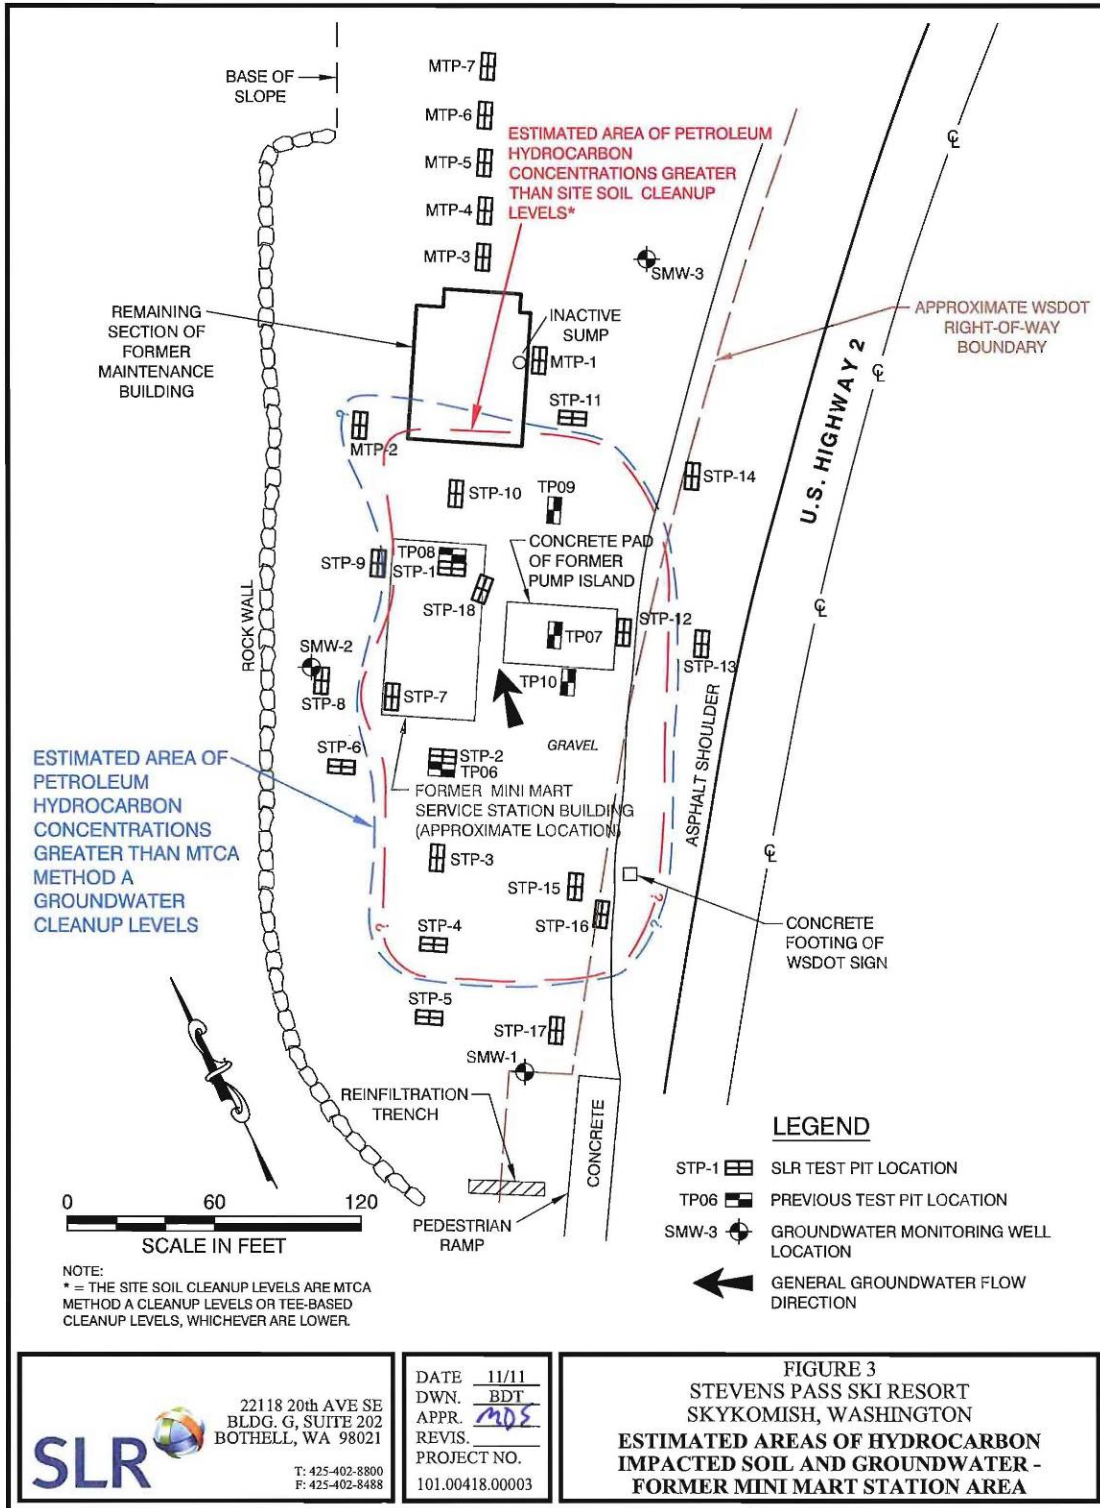
FIGURE 3
 STEVENS PASS SKI RESORT
 SKYKOMISH, WASHINGTON
ESTIMATED AREAS OF HYDROCARBON IMPACTED SOIL AND GROUNDWATER - FORMER MINI MART STATION AREA

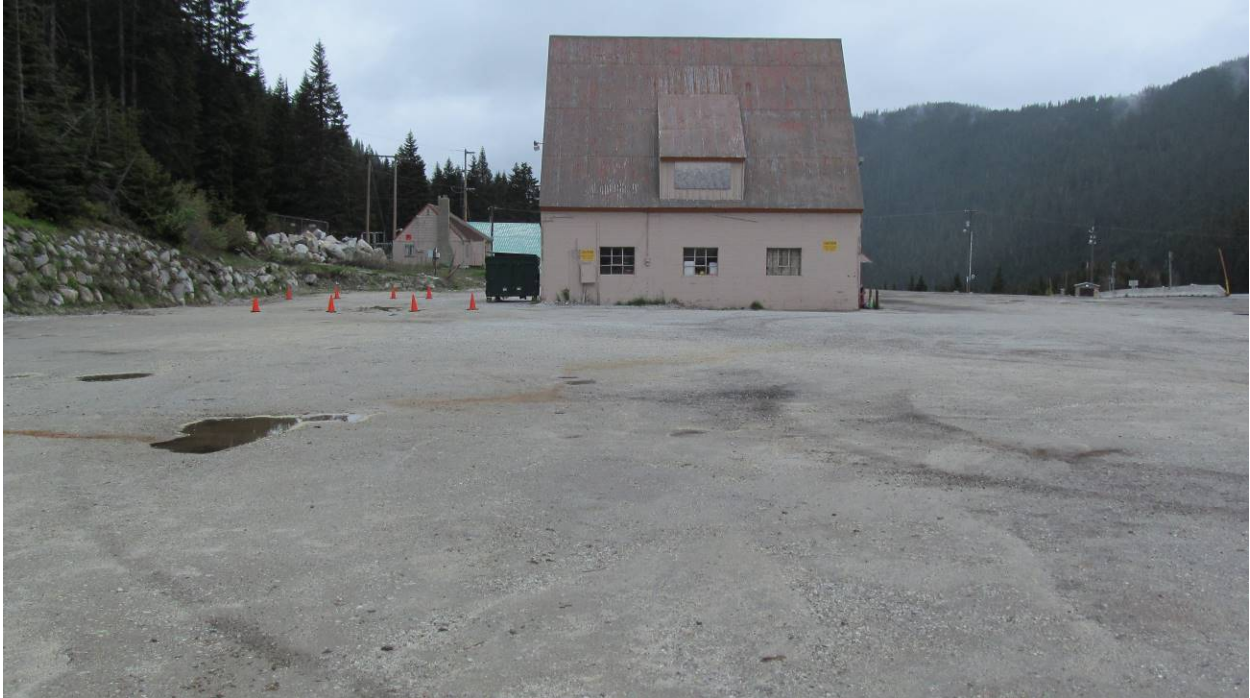
Photo 1: Mini Mart Site – from the west

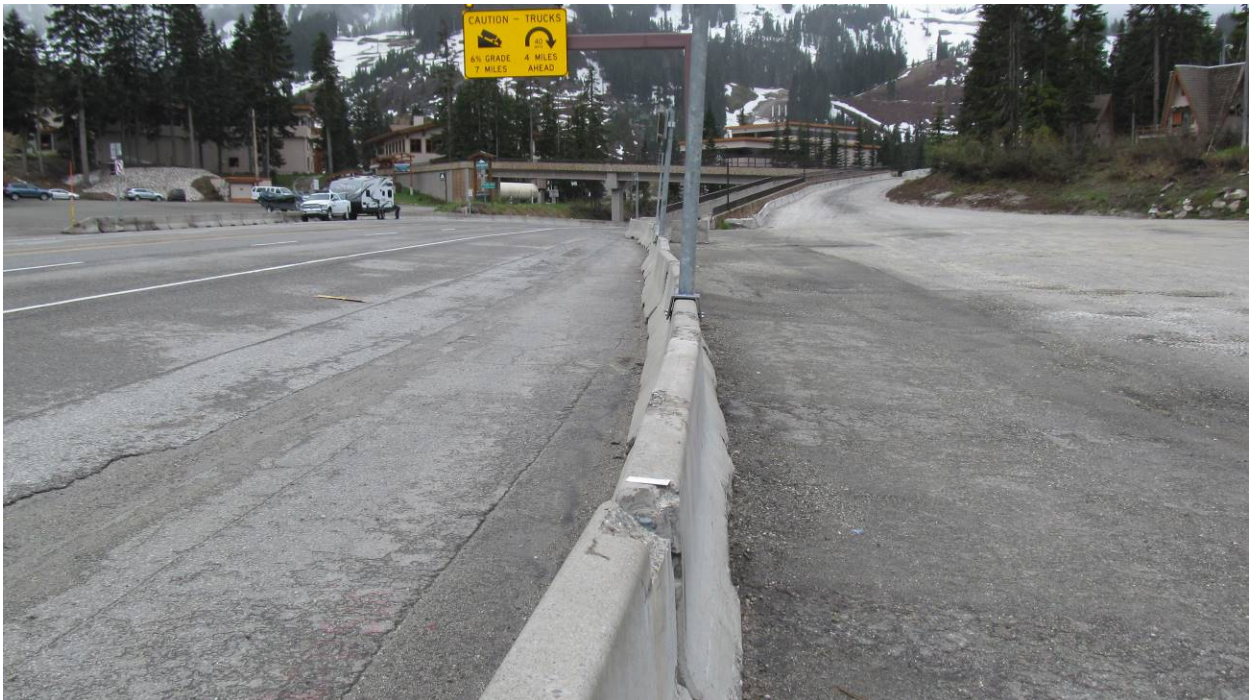
Photo 2: Mini Mart Site and US 2 – from the east

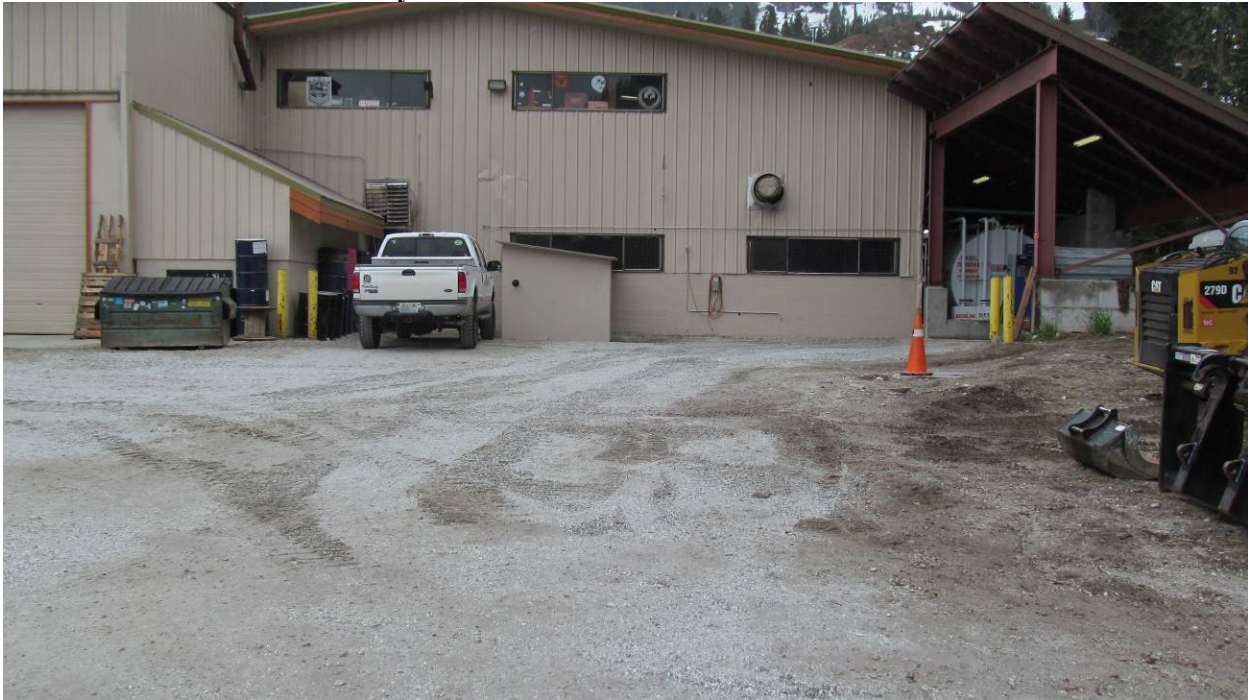
Photo 3: Maintenance Facility Site – from the north

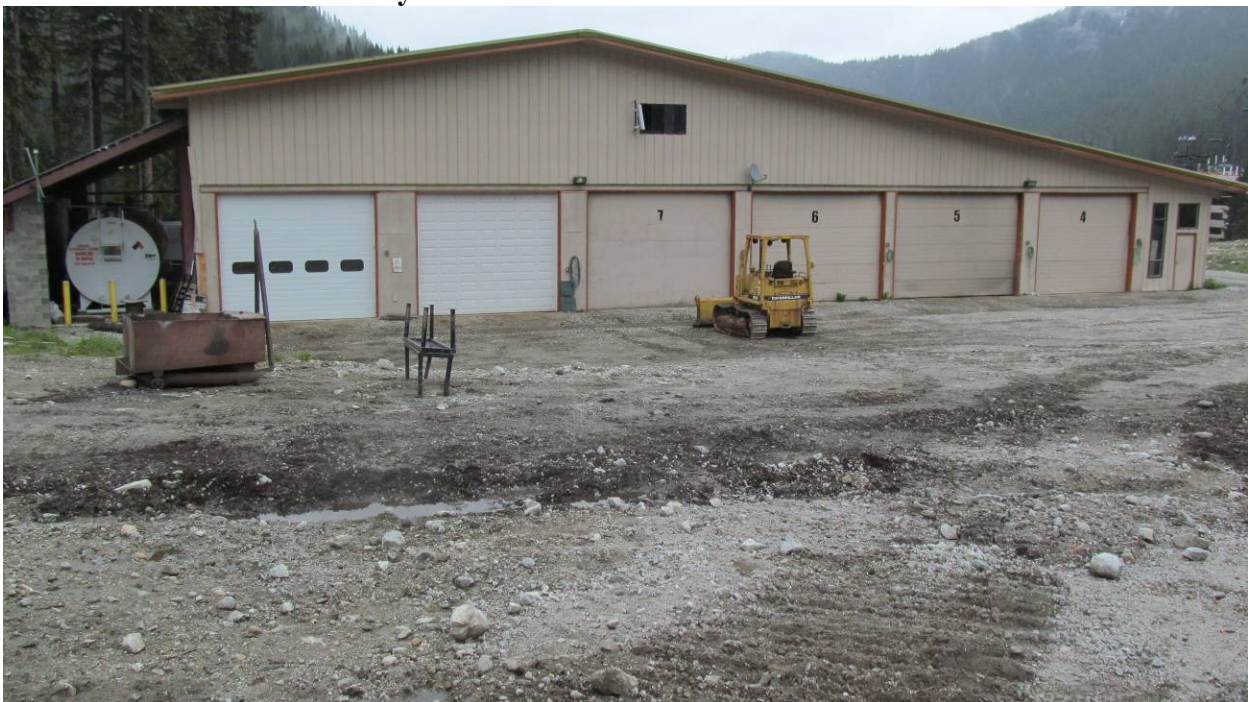
Photo 4: Maintenance Facility Site – from the south
