**Subject:** Second Quarter 2018 Progress Report, Southwest Harbor Project Remediation Areas 1, 2, 3, and 5 Ecology Facility/Site Numbers 2384, 2385, 2127, and 2383

Attachment 3 – Semiannual Inspection of T-5 Ecology- lead Sites: 2018 Mid-Year Inspection – Second  
Quarter 2018

Terminal 5 Ecology-lead remediation areas –  
Locations of observations noted in report

June 2018 inspection

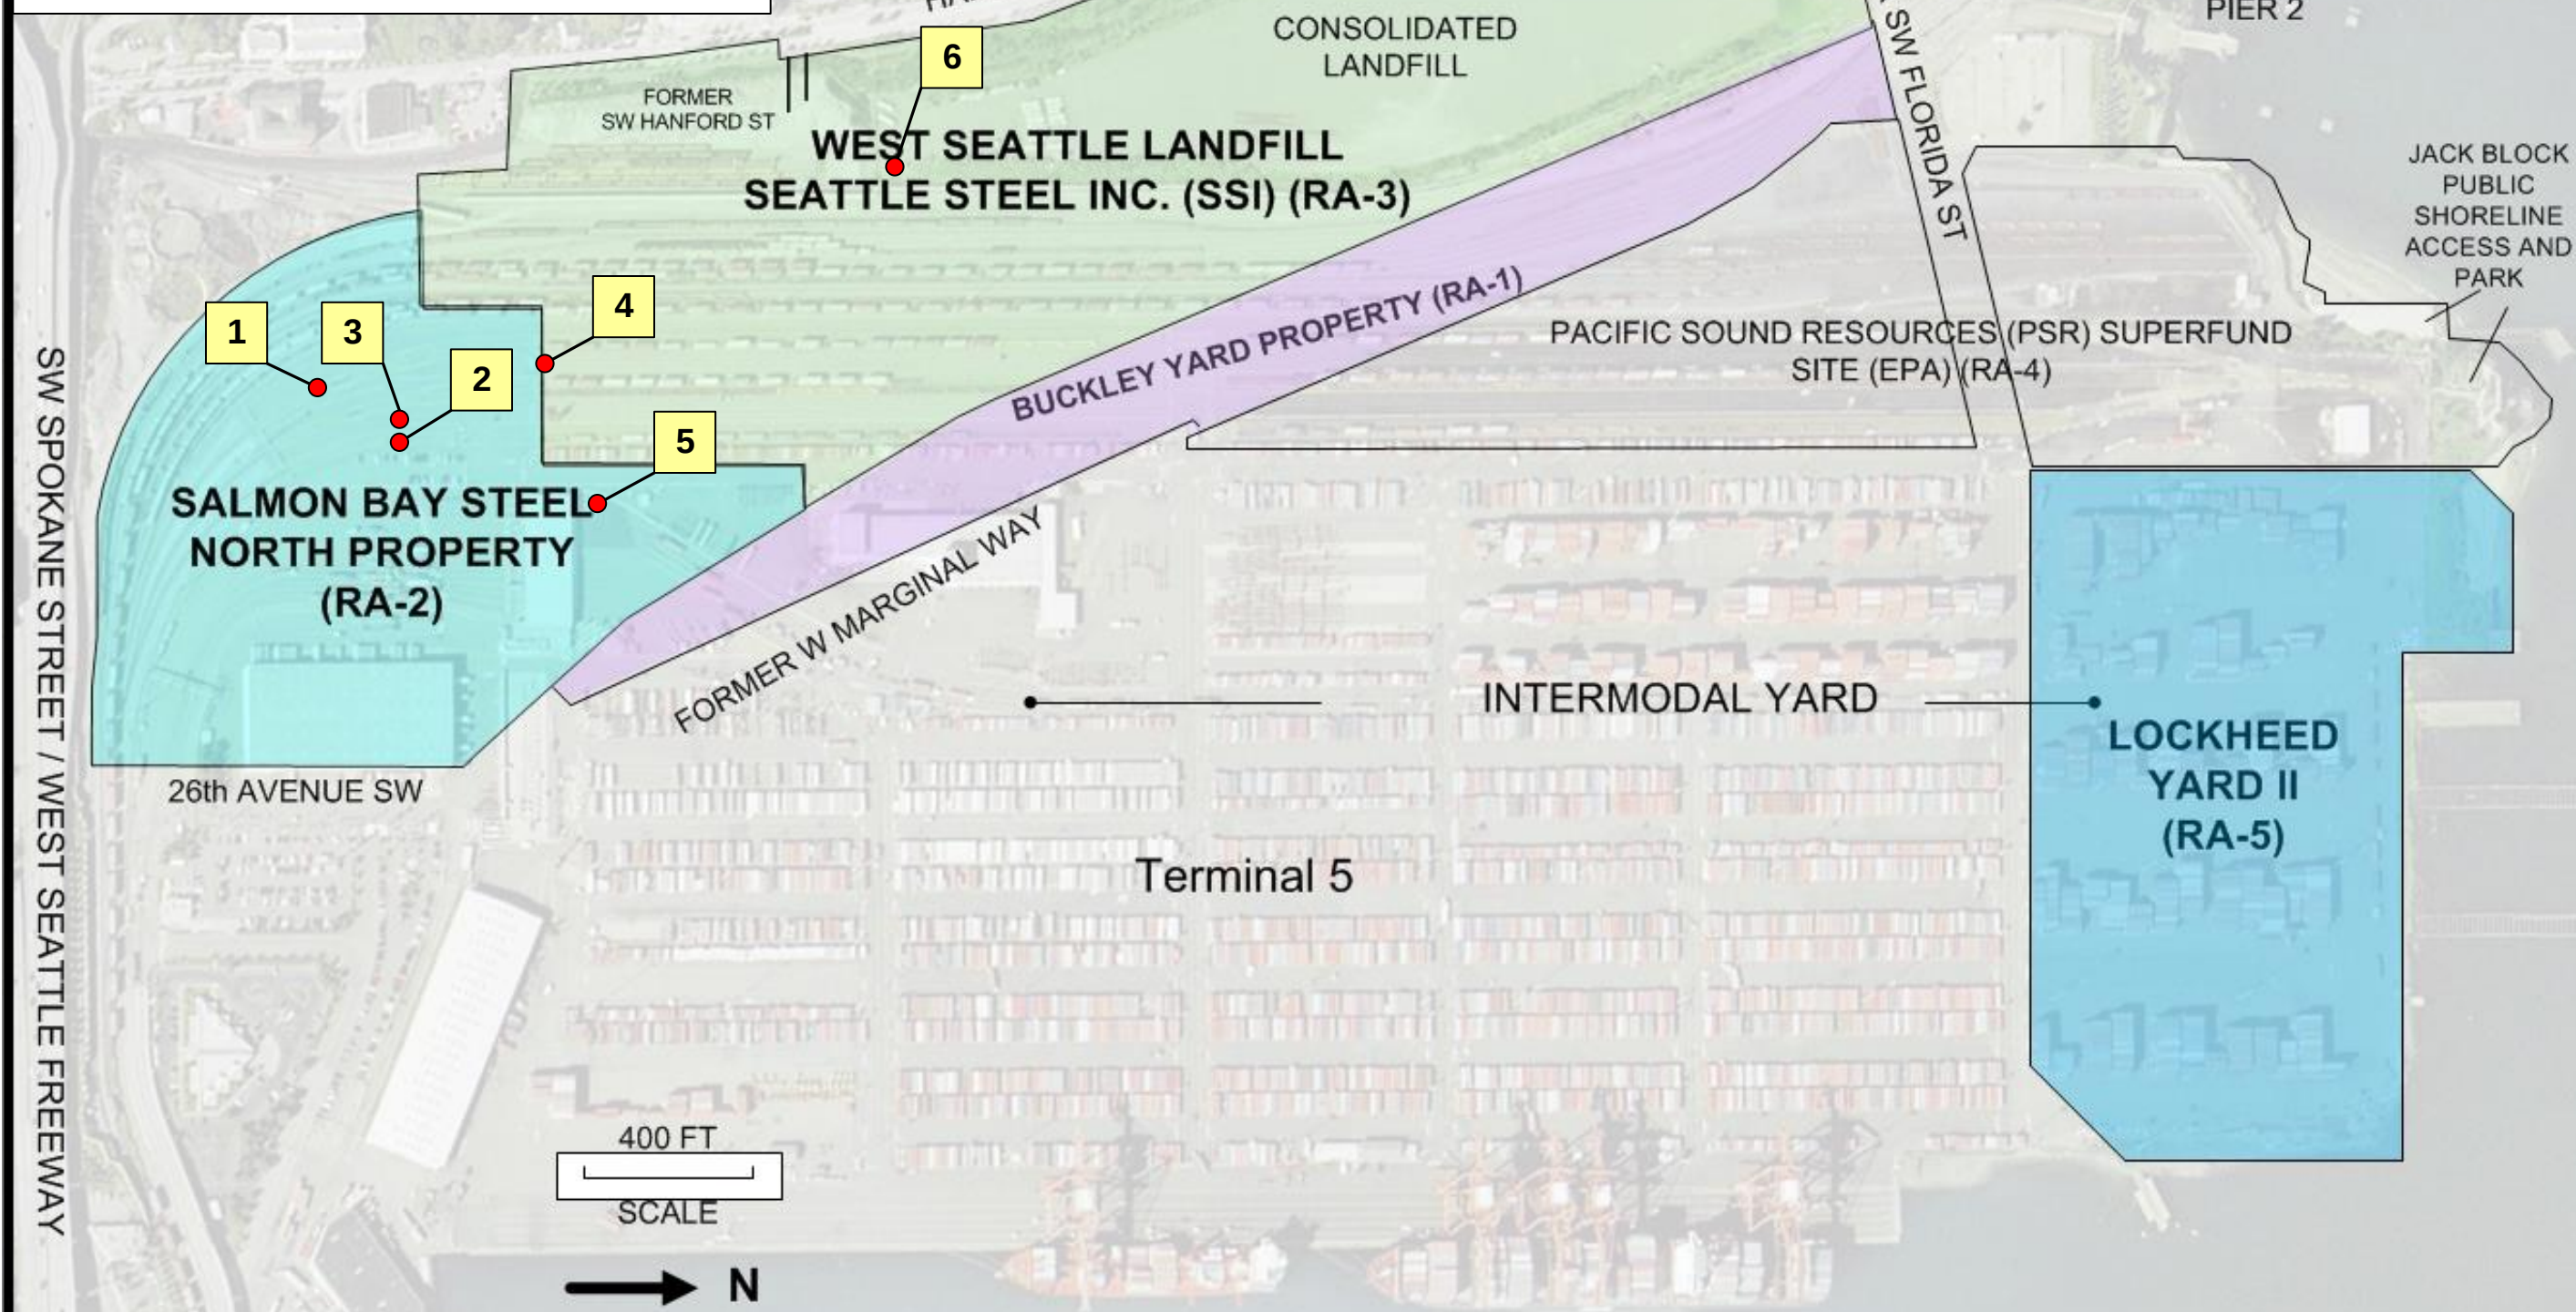
Notes: 1. Vegetation growth near terminal entrance  
2. Pavement mound and cracks (1)  
3. Pavement mound and cracks (2)

4. Pavement mound and cracks (3)  
5. Elongated pavement mound and cracks  
6. Catch basin obstructed by organic debris

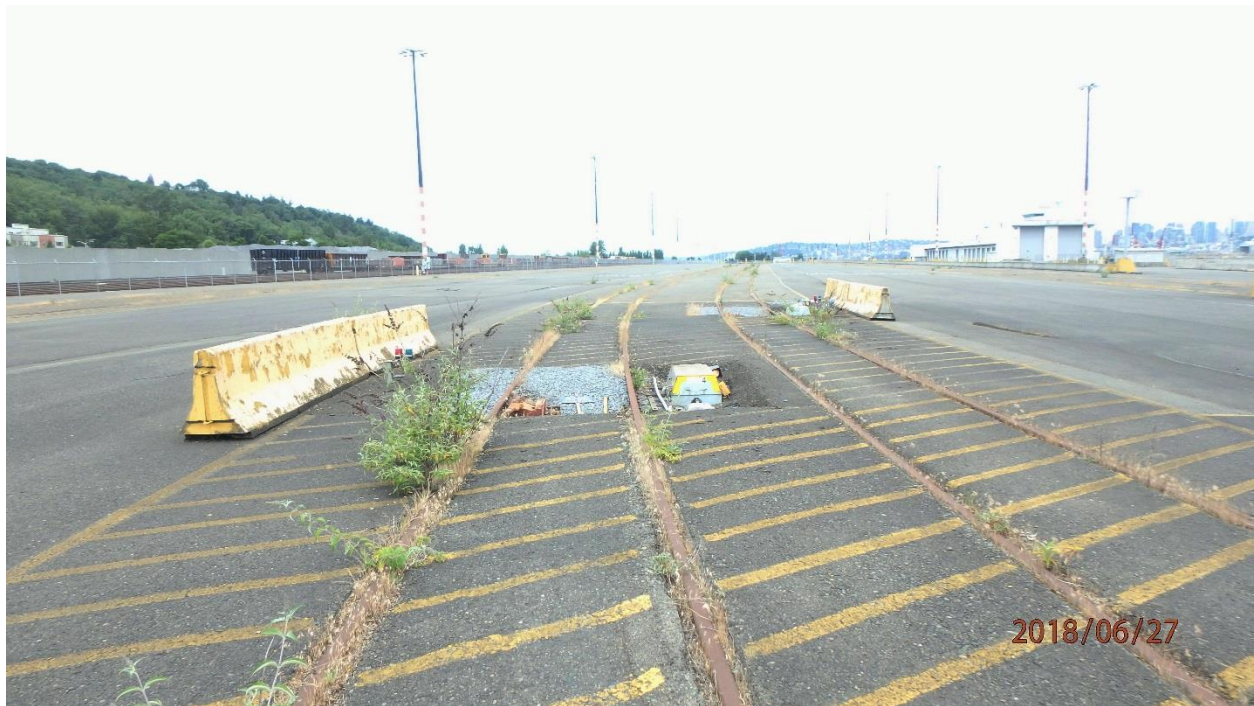
Vegetation—including butterfly bushes (*Buddleia davidii*)—is prevalent near the terminal entrance (RA-2; Attachment 1: map note 1) and throughout the terminal in rail tracks and switch pits (RA-2 and RA-3; Attachment 2: photo 1). Vegetation overgrowth is an issue that requires ongoing maintenance, particularly during the current period of reduced activity at the terminal. It is recommended that the vegetation in RA-2 and RA-3 be removed before it damages the pavement cap system.

**Photo 1. Vegetation growth along rail tracks: RA-2 and RA-3**

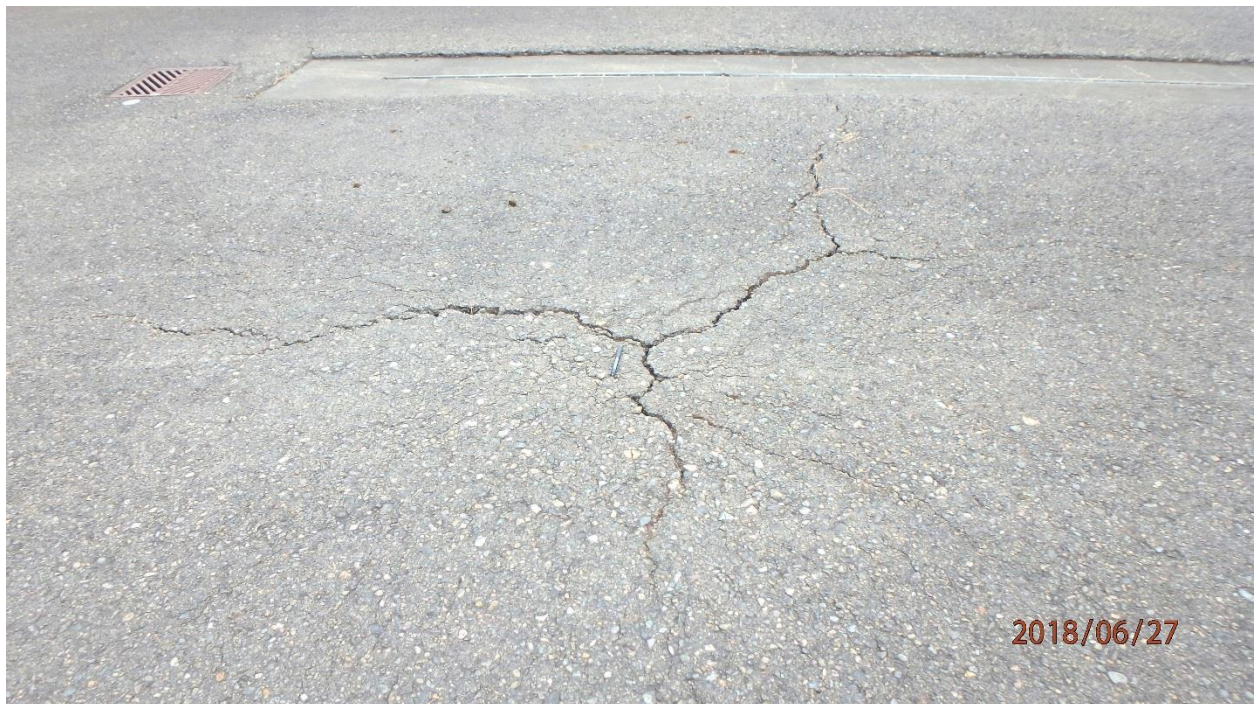
1. Map note 2 (RA-2): The impacted area is approximately 10 × 10 ft (photo 2). The cracks are approximately as wide as 1 in. and as deep as 4 in. (photo 3). This area was originally noted in the 2017 end-of-year inspection and does not appear to have changed since then.
2. Map note 3 (RA-2): This impacted area is approximately 15 × 3 ft and the cracks are approximately as wide as 1 in. and as deep as 4 in. (photos 4 and 5).
3. Map note 4 (RA-3): This area is approximately 5 × 3 ft, with cracks as wide as approximately ½ in. and as deep as approximately 3 in. (photos 6 and 7).
4. Map note 5 (RA-2): The impacted area is approximately 25 × 6 ft (photos 8 and 9). The cracks are approximately as wide as 1 in. and as deep as 5 in. (photo 10).

These conditions are localized and do not compromise the overall cap performance. However, these mounding areas are in traffic areas and will need to be addressed before a new tenant occupies the terminal. The cause of the mounding in the four areas (possibly buried piles) should be determined and, if possible, removed, and the cracked areas should be repaired. Near-term (i.e., temporary) sealing of the cracks should also be done to prevent further deterioration in these four locations.

**Photo 2. Mound in pavement with cracks as wide as 1 in.: RA-2 (map note 2)**

| Condition Noted | Map (Attachment 1) reference | Recommendation |
|---|---|---|
| Pavement mounding with cracks wider than ¼ in., RA-2 | 2 | Evaluate and repair prior to new tenant occupancy. Clean and seal cracks. Check during future inspections. |

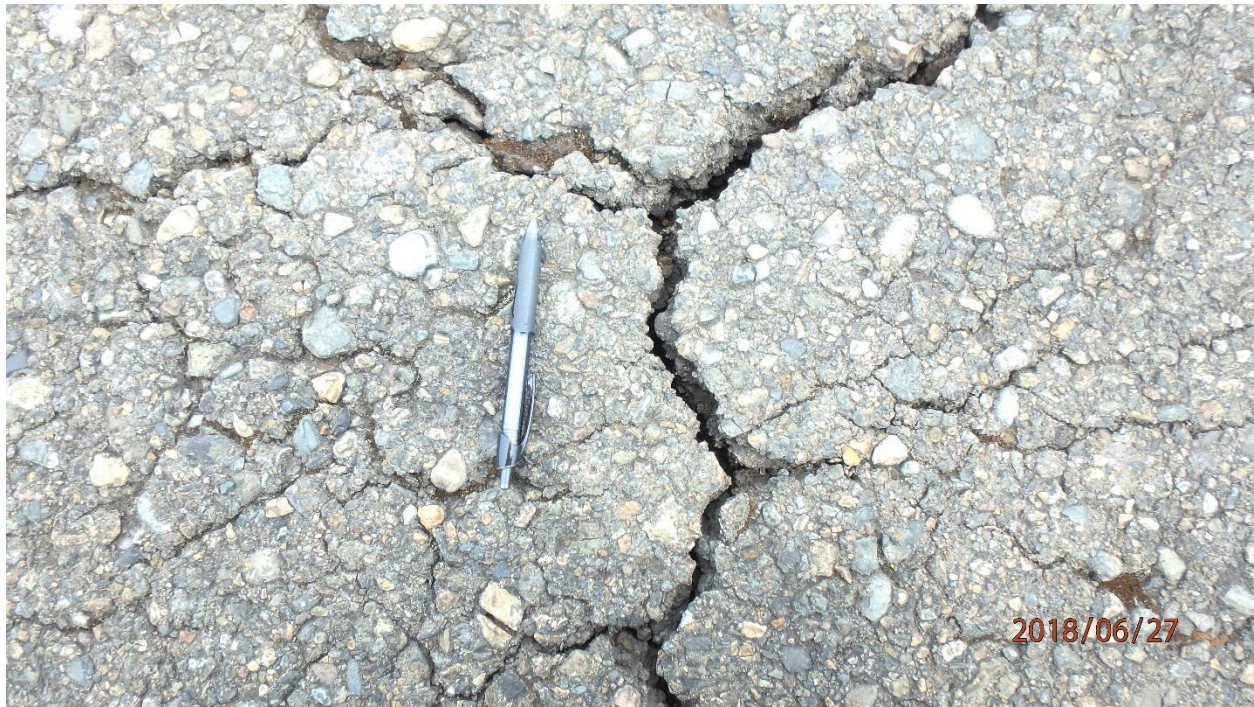
**Photo 3. Close-up of mound in pavement with cracks as wide as 1 in.: RA-2 (map note 2)**

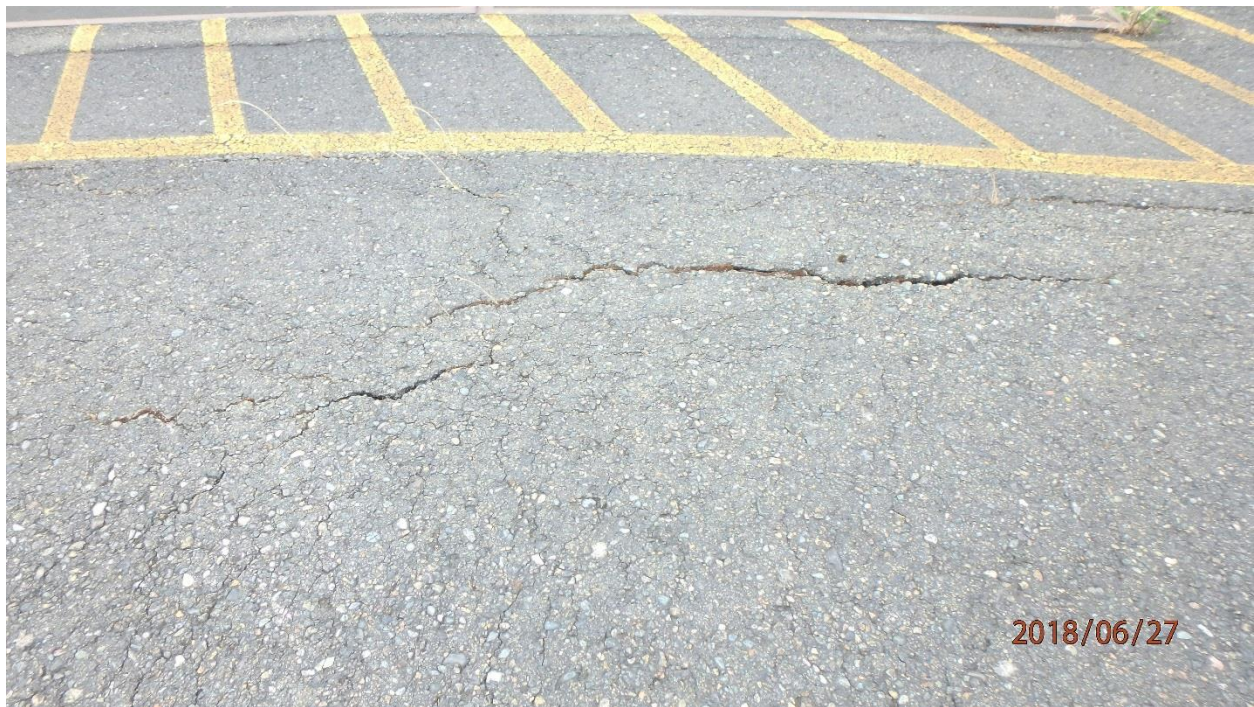
**Photo 4. Mound in pavement with cracks as wide as 1 in.: RA-2 (map note 3)**

| Condition Noted | Map (Attachment 1) reference | Recommendation |
|---|---|---|
| Pavement mounding with cracks wider than ¼ in., RA-2 | 3 | Evaluate and repair prior to new tenant occupancy. Clean and seal cracks. Check during future inspections. |

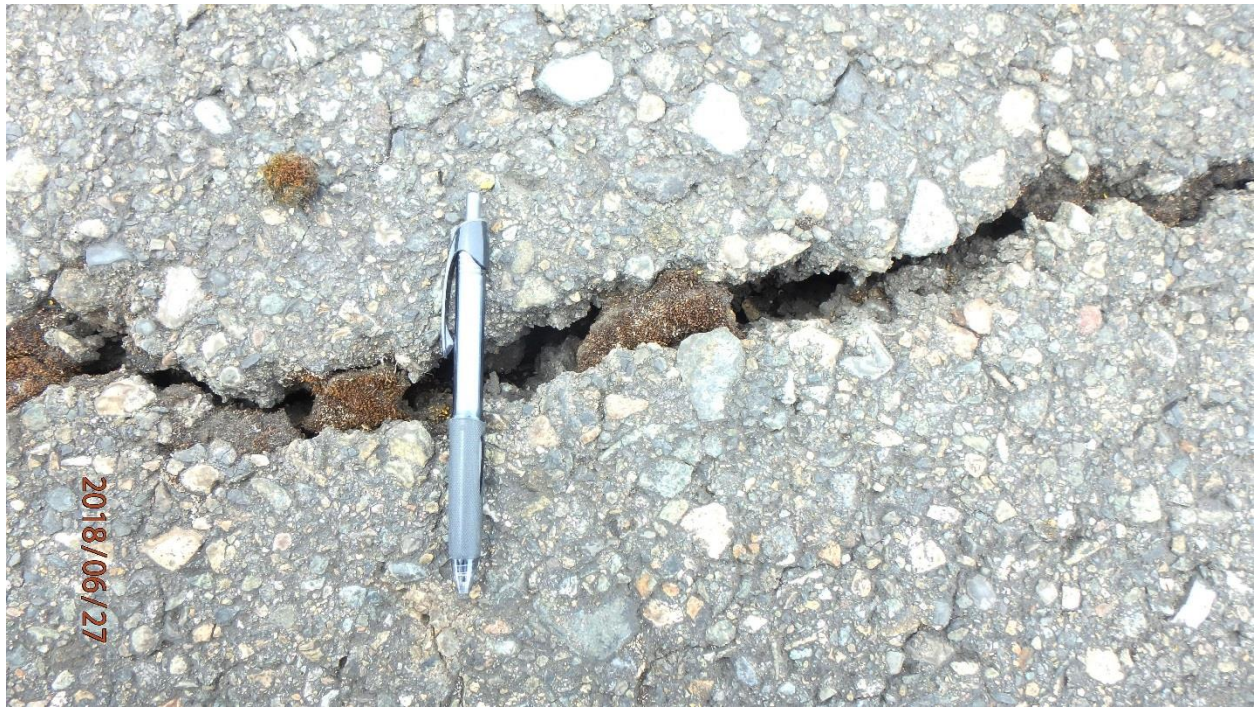
**Photo 5. Close-up of mound in pavement with cracks as wide as 1 in.: RA-2 (map note 3)**

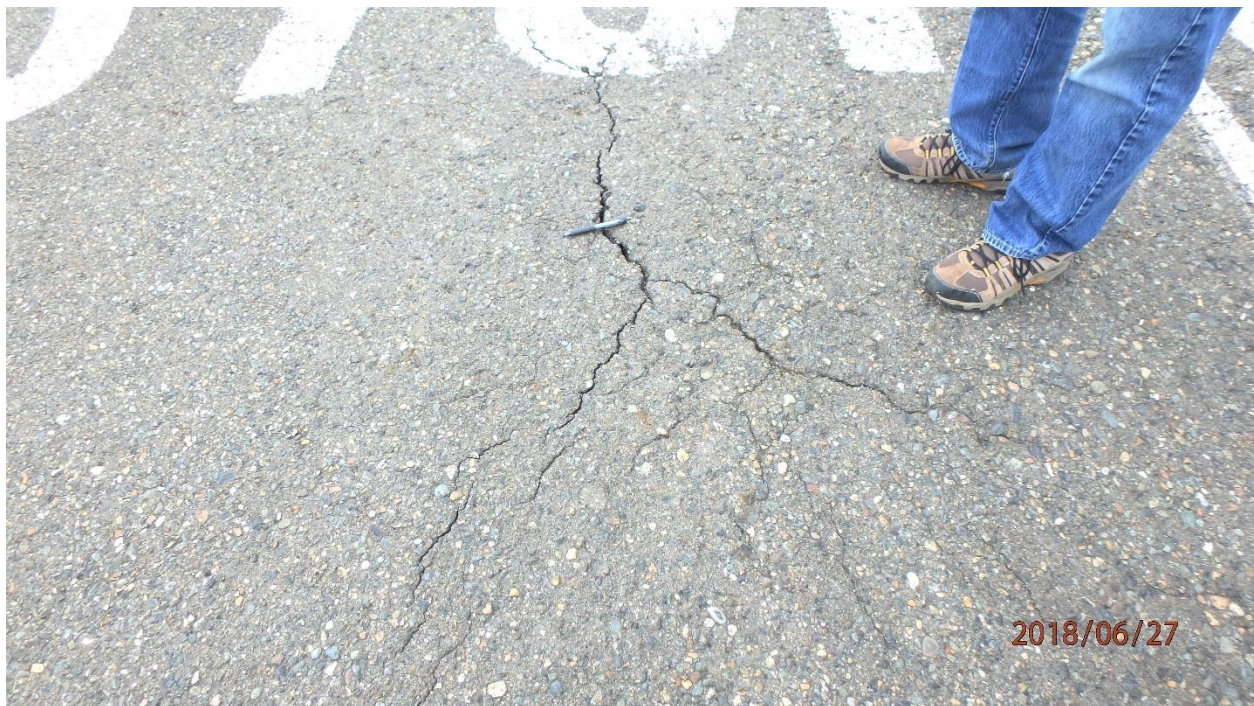
**Photo 6. Mound in pavement with cracks as wide as ½ in.: RA-3 (map note 4)**

| Condition Noted | Map (Attachment 1) reference | Recommendation |
|---|---|---|
| Pavement mounding with cracks wider than ¼ in., RA-3 | 4 | Evaluate and repair prior to new tenant occupancy. Clean and seal cracks. Check during future inspections. |

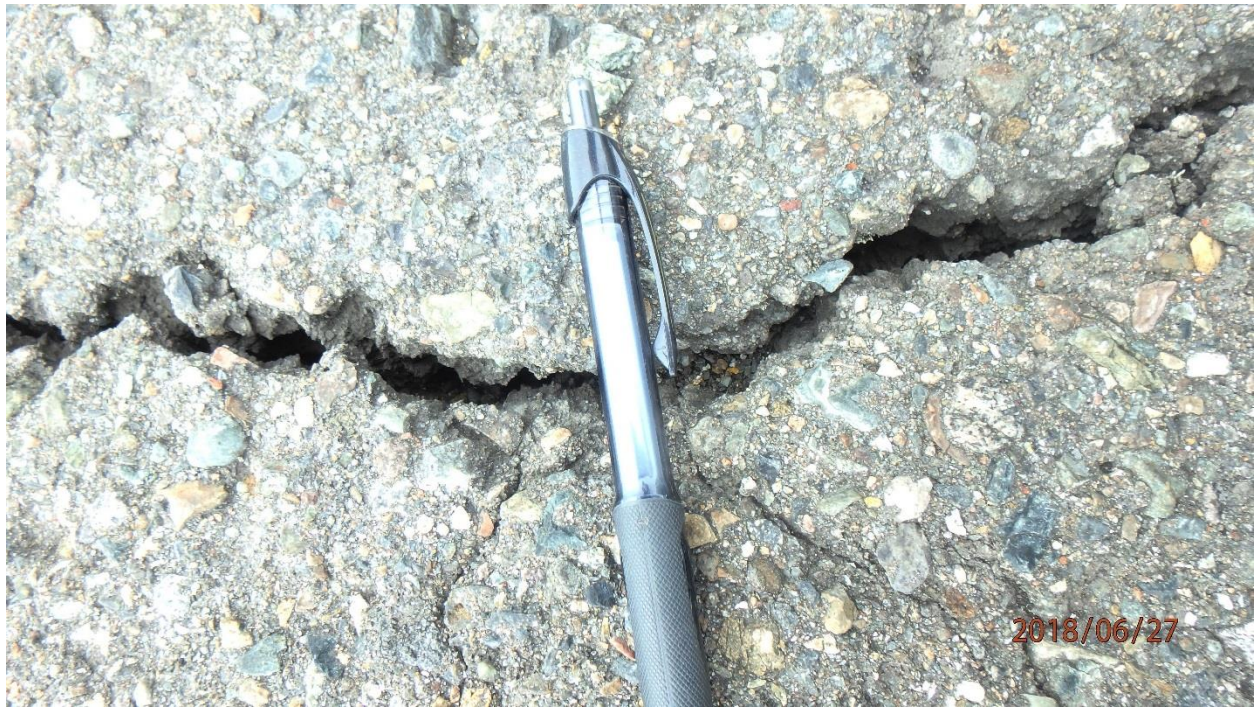
**Photo 7. Mound in pavement with cracks as wide as ½ in.: RA-3 (map note 4)**

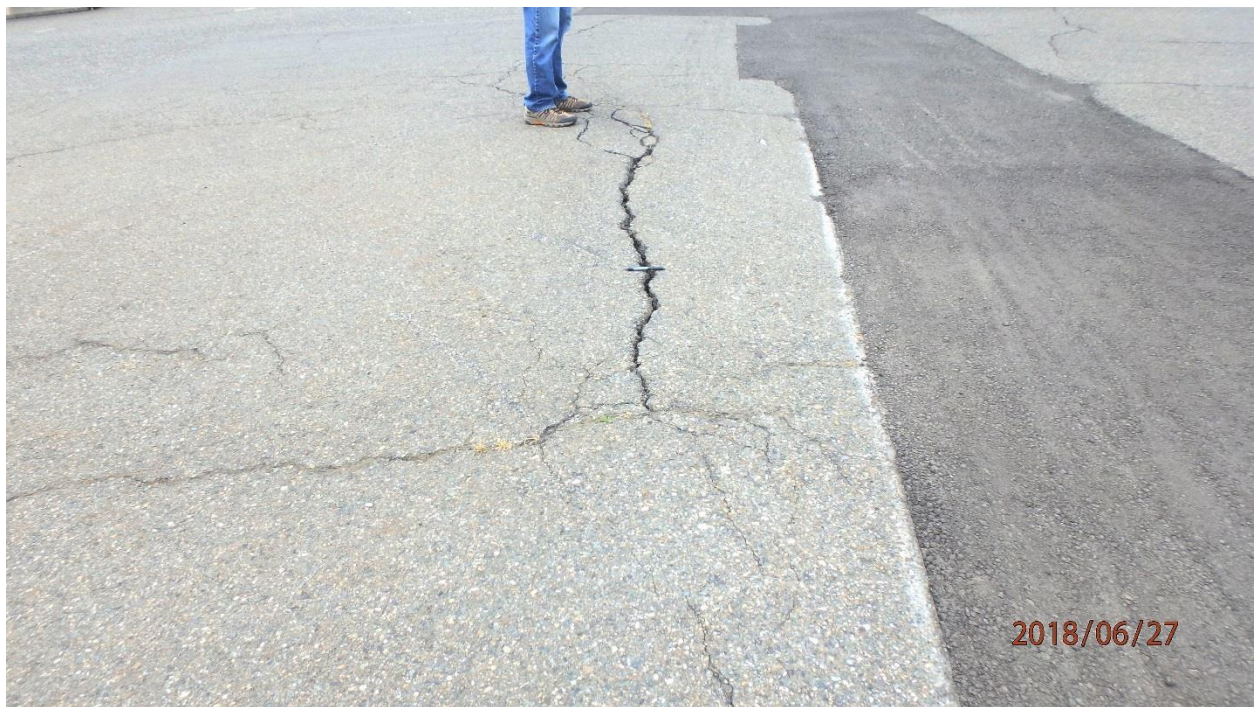
**Photo 8. Elongated mound in pavement with cracks as wide as 1 in.: RA-2 (map note 5)**

| Condition Noted | Map (Attachment 1) reference | Recommendation |
|---|---|---|
| Elongated pavement mounding with cracks wider than ¼ in., RA-2 | 5 | Evaluate and repair prior to new tenant occupancy. Clean and seal cracks. Check during future inspections. |

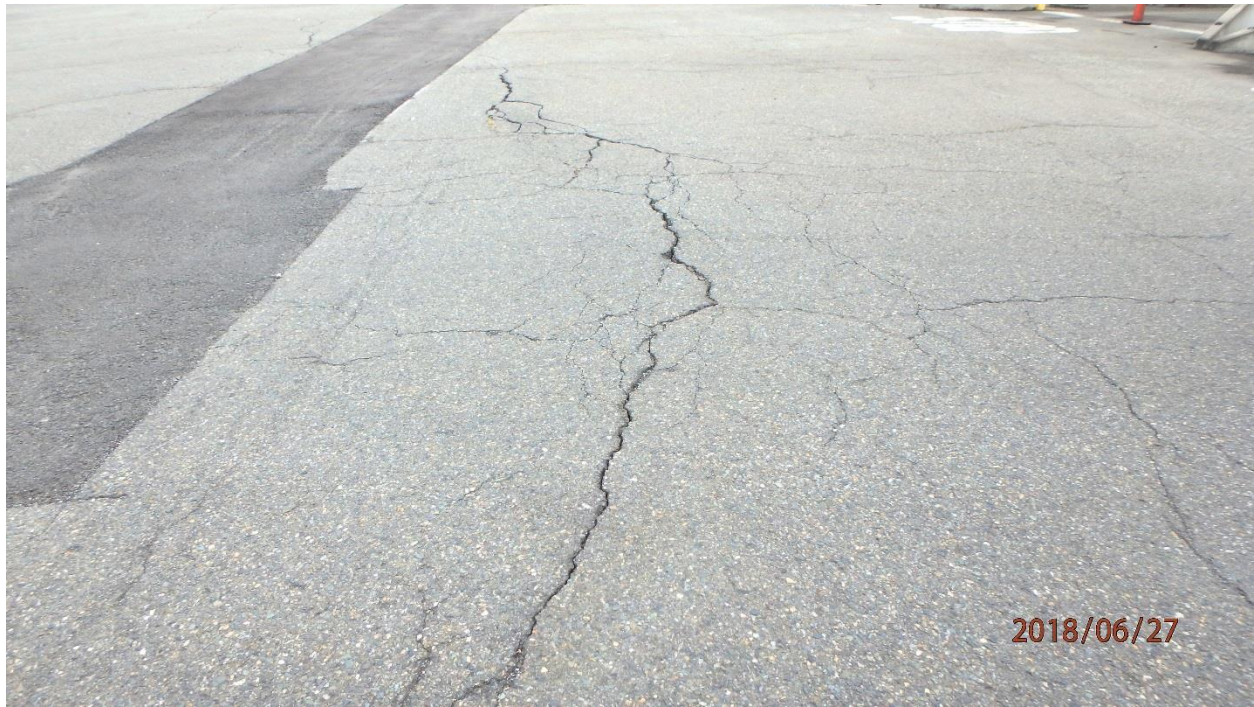
**Photo 9. Another view of elongated mound in pavement with cracks: RA-2 (map note 5)**

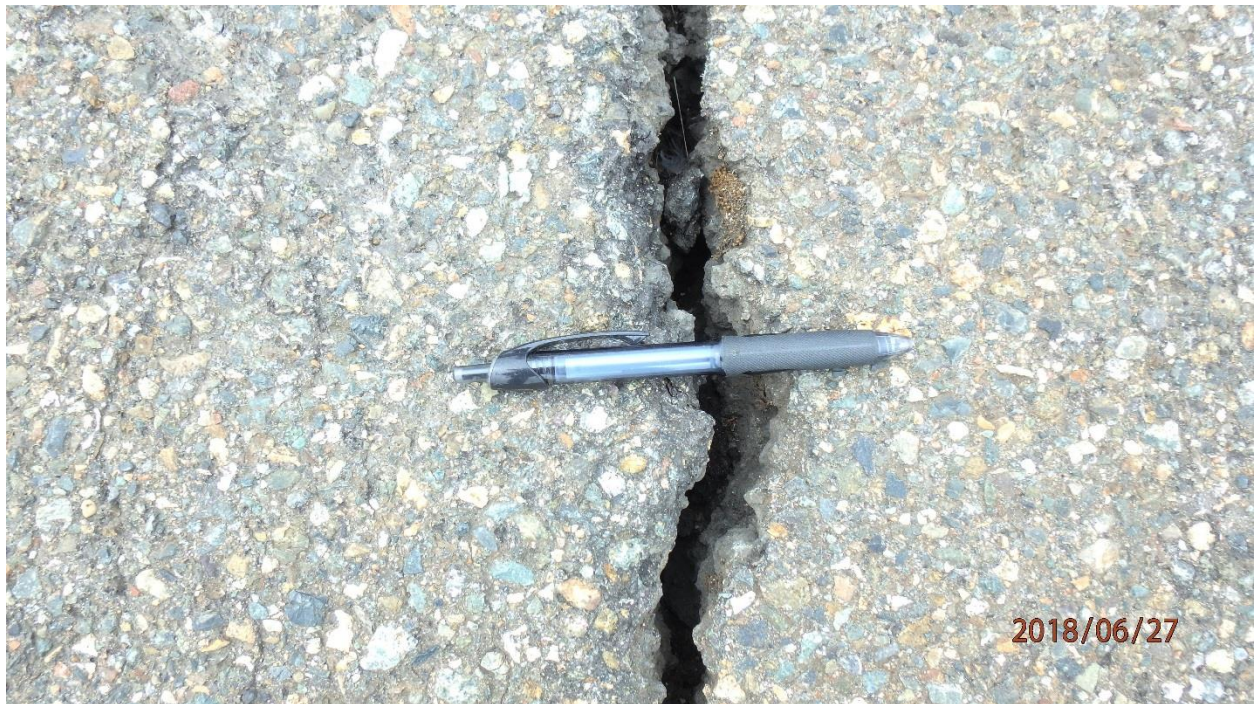
**Photo 10. Close up of elongated mound in pavement with cracks as wide as 1 in.: RA-2 (map note 5)**

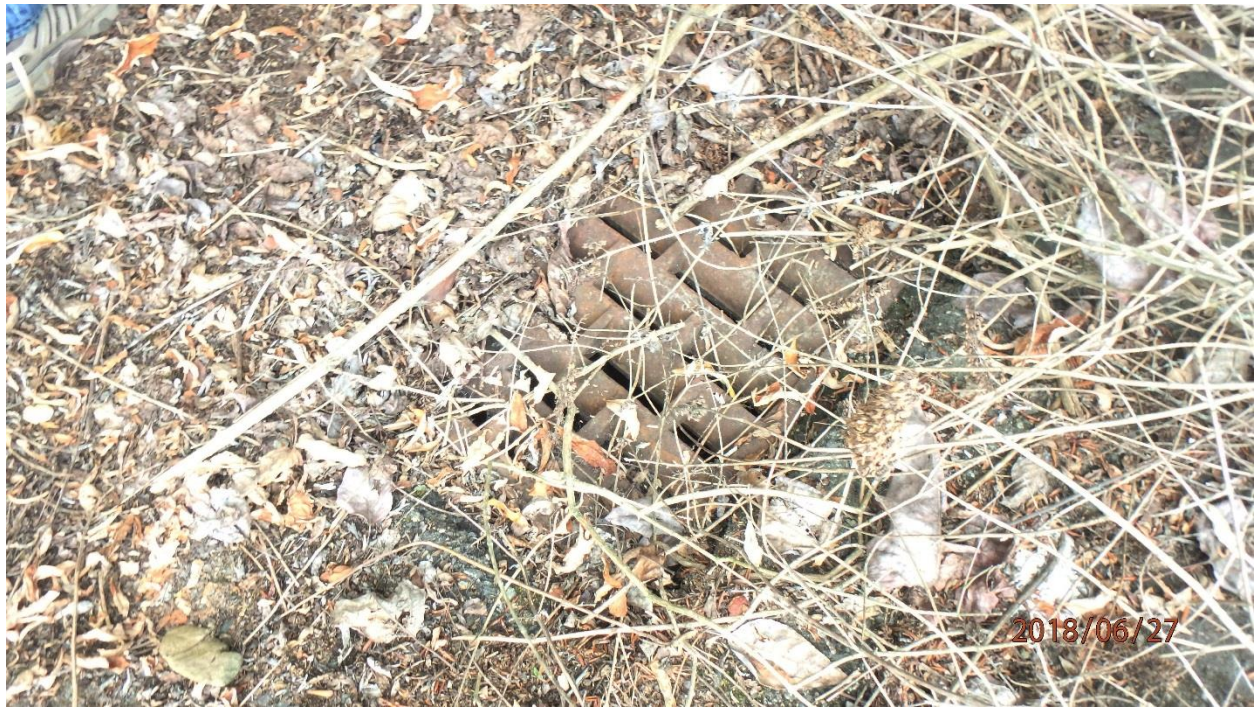
The catch basin located near the southeast corner of the consolidated landfill area is obstructed by organic debris (map note 6 and photo 11). Although no drainage issues were observed during the inspection, this vegetation should be cleared to prevent future drainage issues.

**Photo 11. Organic debris obstructing catch basin near southeast corner of consolidated landfill: RA-3**

Maintenance/Repair Type/Location: See Section 2 for information on a catch basin located in the consolidated landfill area that should be cleared of organic debris.
