MEMORANDUM

SUBJECT: Addendum to Cleanup Action Report
Broadcast Apartments Property
1420 East Madison Street
Seattle, Washington
Voluntary Cleanup Program No. NW1621

FIGURE 1
 REMEDIAL INJECTION LAYOUT
 - CHEMICAL OXIDATION

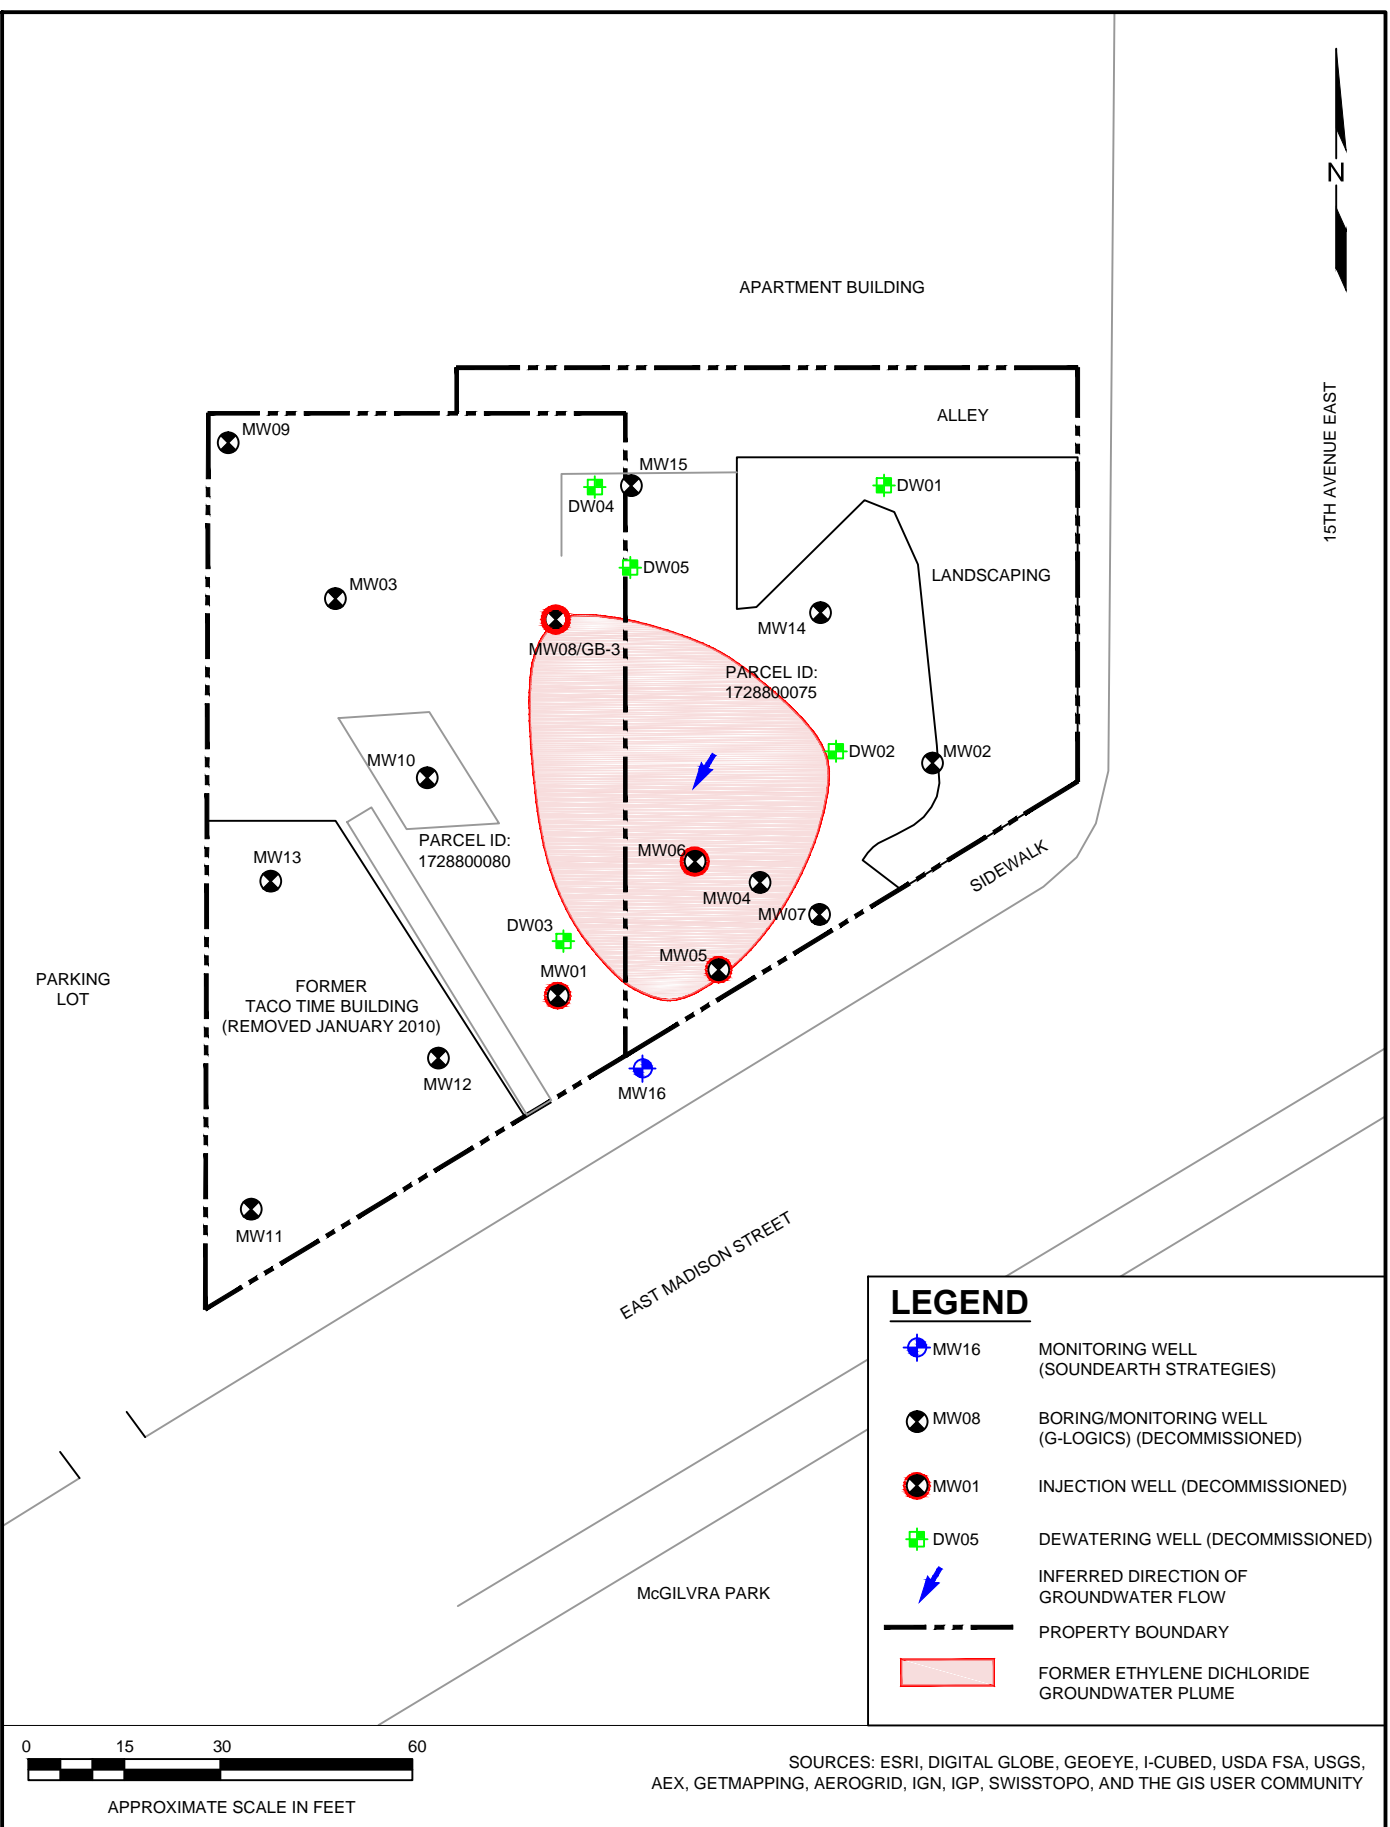
Two injection events were conducted at the Property: one in May and one in September 2014. The locations of monitoring wells and other Property features are shown on Figure 1.

Based on post remedial injection laboratory analytical results for groundwater monitoring from March 2015, the concentration of EDC is below the MTCA Method A cleanup level for the majority of the groundwater treatment zone (Table 2). However, the March 2015 groundwater monitoring event indicated that two monitoring wells, MW05 and MW08, had concentrations of EDC that slightly exceeded the MTCA Method A cleanup level of 5 micrograms per liter (Table 2). In August 2015, 15 monitoring wells within the footprint of the excavation (MW01 through MW15) were decommissioned by a licensed engineer. The remaining monitoring well, MW16, is downgradient of the groundwater treatment zone and was nondetect for EDC in March 2015 (Figure 1; Table 2).
