## TECHNICAL MEMORANDUM

**Project No.** 923-1000-005.100

**FROM** Golder Associates Inc.

### PRE-REMEDIAL ACTION 1,4-DIOXANE DETECTION AT THE LANDSBURG MINE SITE

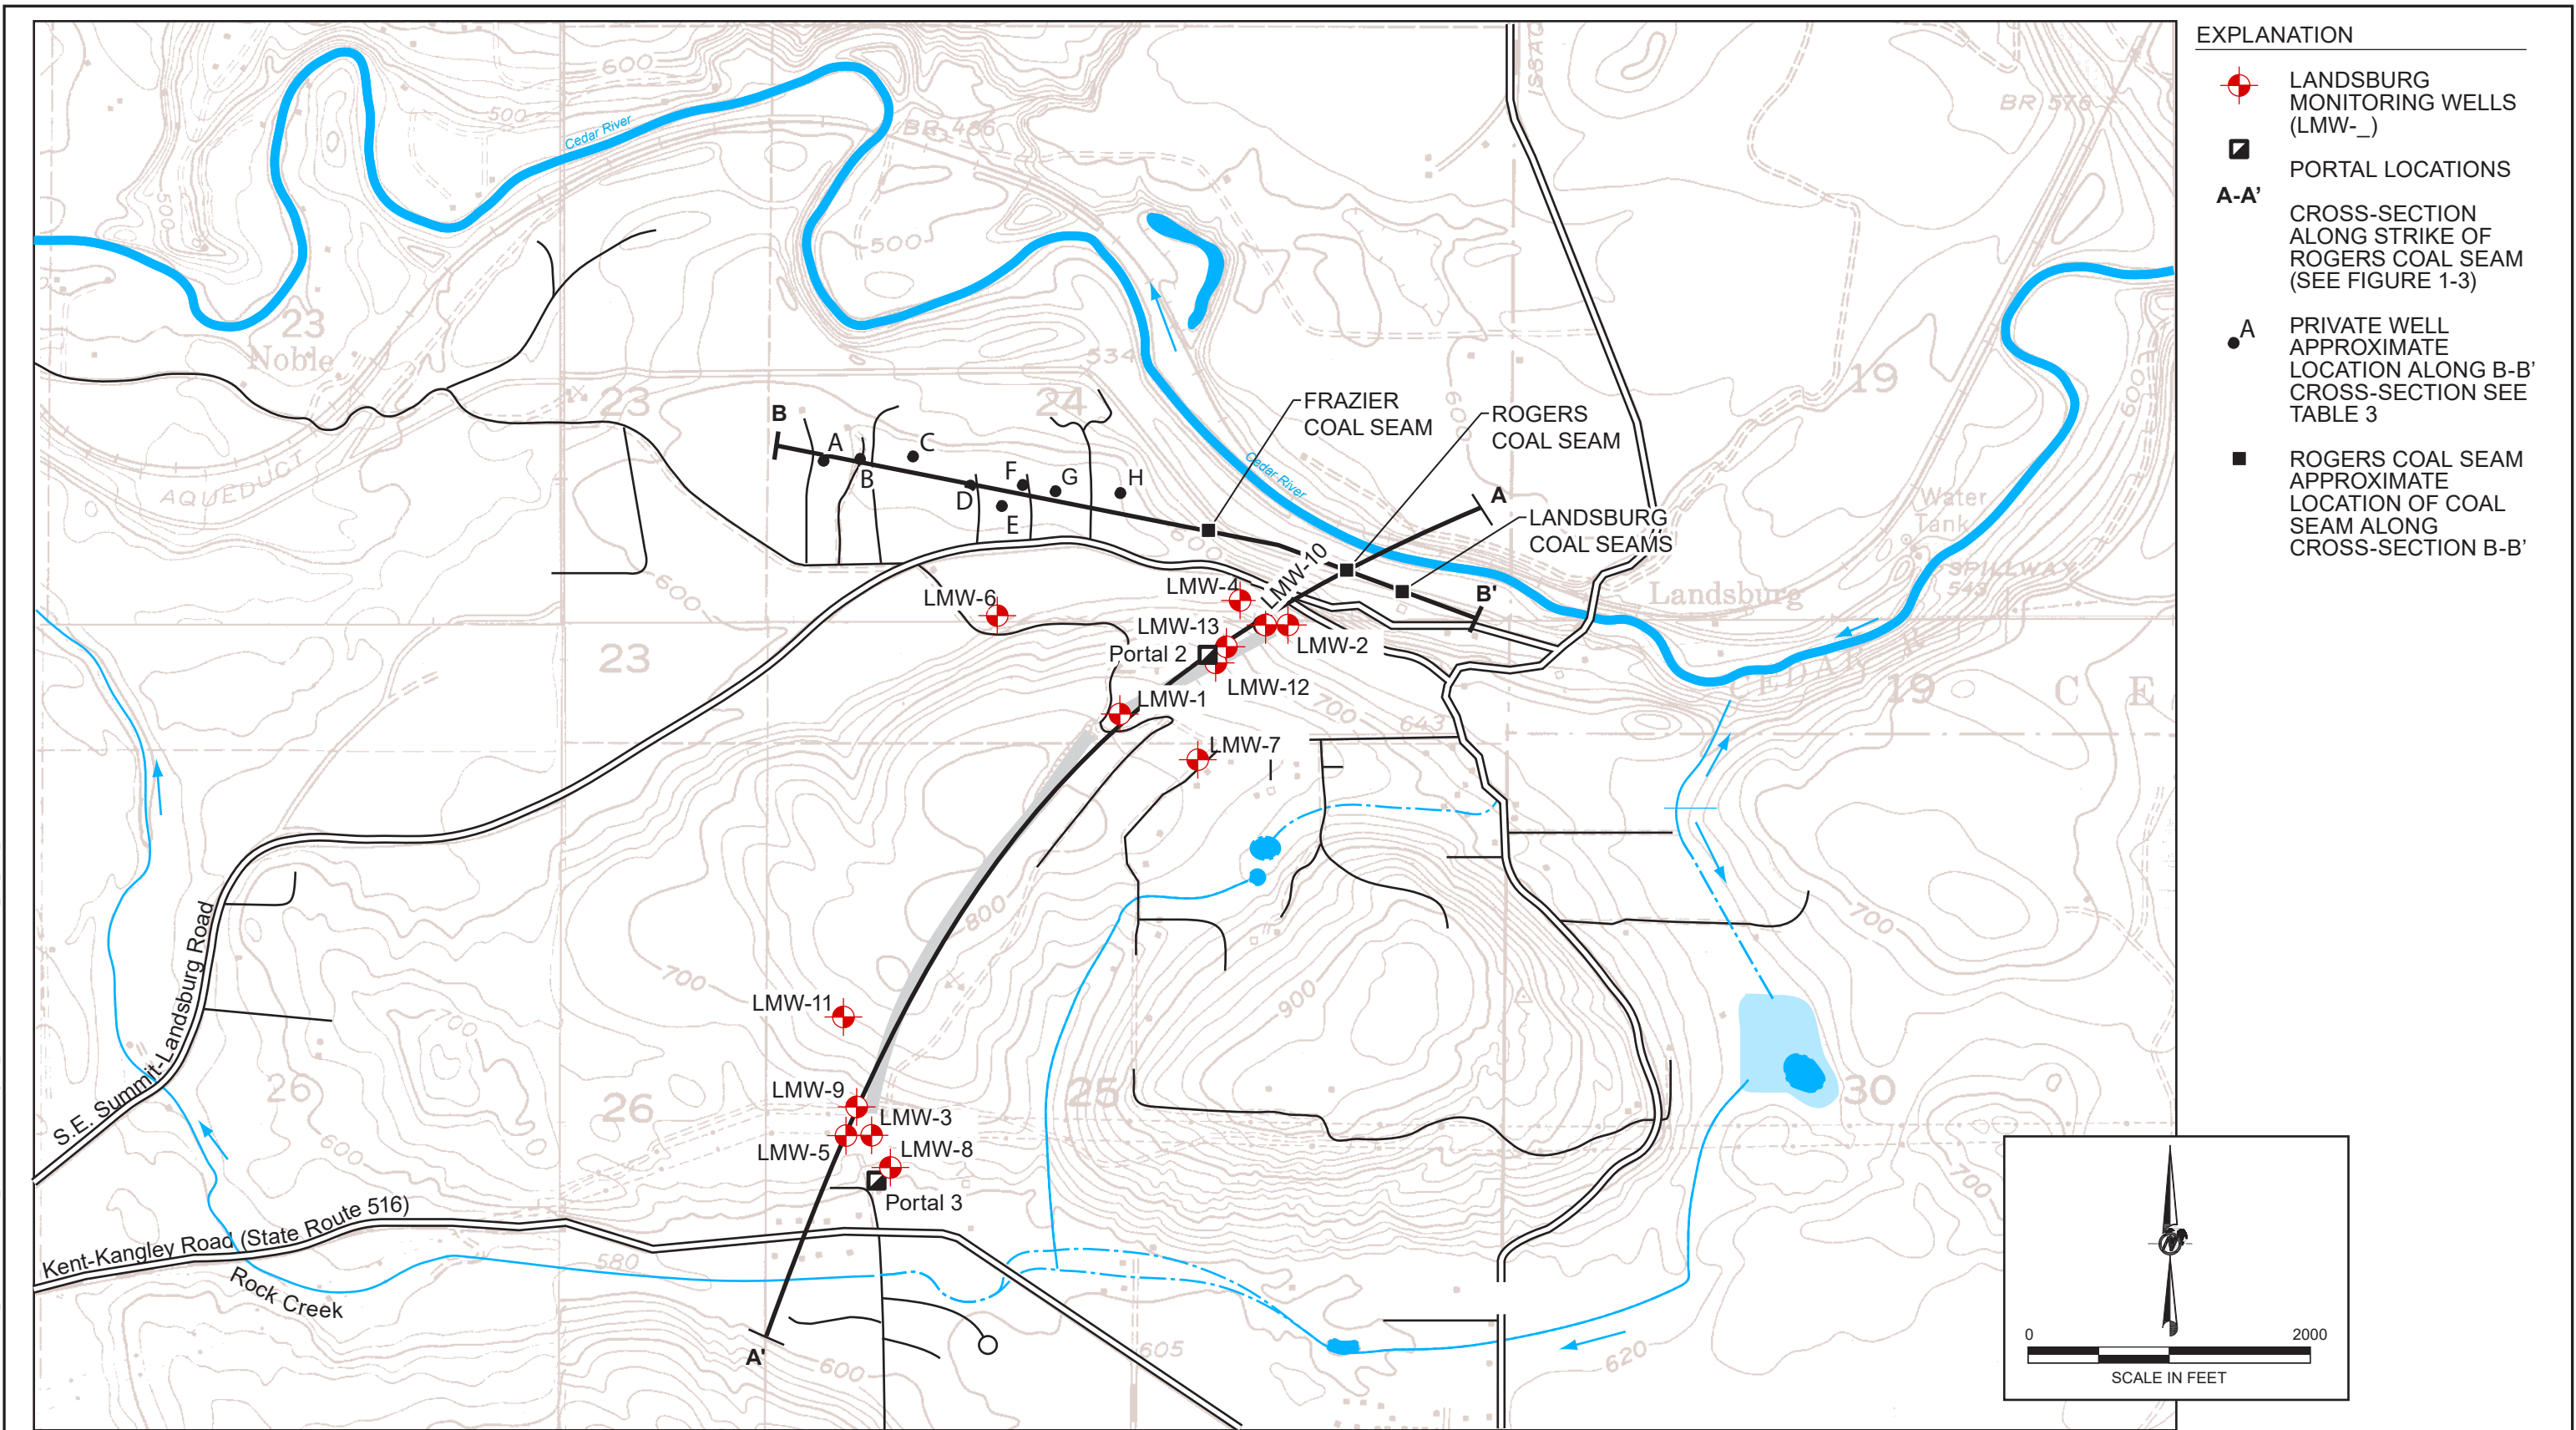
TITLE  
**SITE FEATURES AND MAP VIEW FOR LANDSBURG CROSS-SECTION**

The November 2017 interim groundwater monitoring round included analysis for 1,4-dioxane for the first time. All 10 of the Site groundwater monitoring wells and the north and south Portals were sampled and analyzed for: VOCs; (United States Environmental Protection Agency [EPA] Method 8260C), SVOCs including 1,4-dioxane, (EPA Method 8270D), PCBs (EPA 8082A), pesticides (EPA 8081B), priority pollutant metals (EPA Method 6010C/200.8/7470A Series), and a petroleum hydrocarbon identification scan (NWTPH-HCID). Figure 1 shows the location of the Site groundwater monitoring wells.

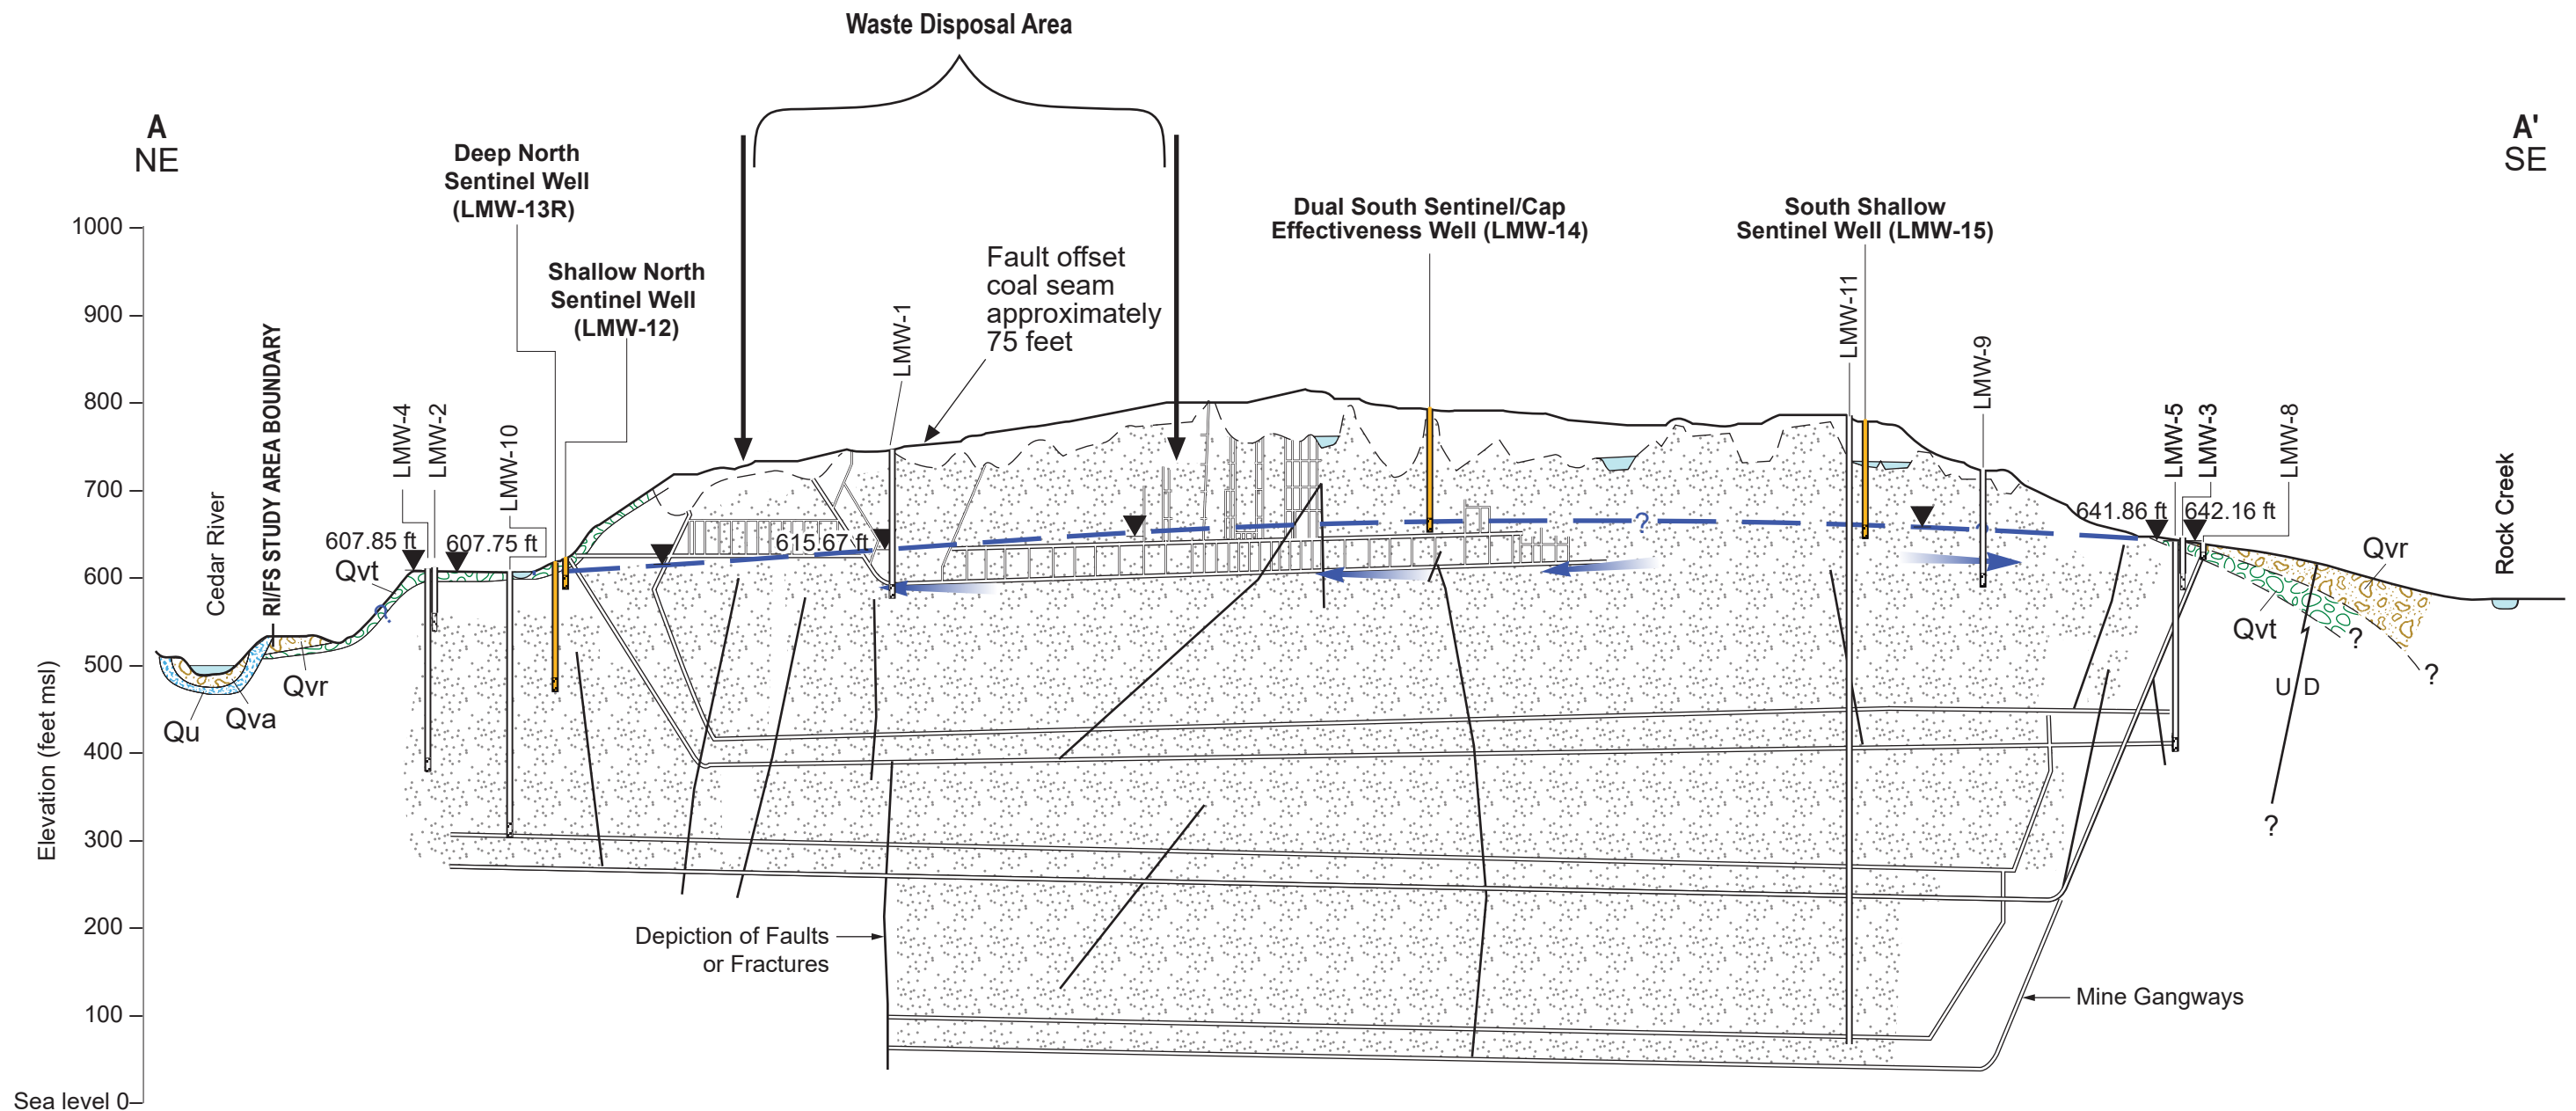
CLIENT		PROJECT	
LANDSBURG MINE SITE PLP GROUP		LANDSBURG MINE SITE	
CONSULTANT	YYYY-MM-DD	2018-08-03	TITLE
	PREPARED	REDMOND	<b>CROSS-SECTION ALONG STRIKE AT COAL SEAM CROSS-SECTION A-A'</b>
	DESIGN		
	REVIEW		
APPROVED			PROJECT No. 923-1000.005
			PHASE 1000

referred to in the CAP as “an alternative source evaluation” (CAP, page 46). As shown on Figure 2, the new shallow north sentinel well (LMW-12) was screened within the former mine workings from a depth of 15.5 to 25.5 feet below ground surface (ft. bgs). The new deeper north sentinel well (LMW-13R) was screened within the former mine workings at a depth of 115 to 140 ft. bgs. Existing north sentinel well LMW-10 is screened near the bottom of the coal seam at a depth of 267 to 287 ft. bgs. The attached Table 1 summarizes the groundwater monitoring well construction details. LMW-10, LMW-12, and LMW-13R are located upgradient of northern compliance wells LMW-2 and LMW-4 and downgradient of the former waste disposal area, as shown on Figure 2. If the 1,4-dioxane detected in LMW-2 and LMW-4 is a mine waste contaminant it would also be expected to be detected in LMW-12 and LMW-13R.

feet north of LMW-2 and LMW-4. Figures 2 and 3 conceptually depict the coal seams, the low permeability Puget Group sandstone and siltstones located on either side of the coal seams, and the recessional outwash sands and gravel deposits beneath the Cedar River.
