JN 23026-2

TECHNICAL OVERVIEW

Mid-Lakes Property

11807, 11811, 11815 Northeast 8th Street

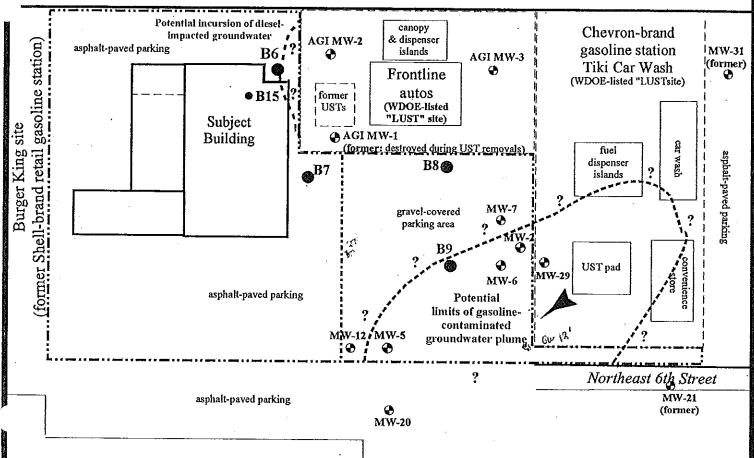
SITE PLAN

We independently reviewed files at the Northwest Regional Office of the WDOE for the Tiki Car Wash site on February 4, 2003. The most recent groundwater sampling data found in the WDOE files was conducted in 1996 (Enviros, 1996). At the time of the May 1996 sampling event, reported concentrations of gasoline-range petroleum hydrocarbons and associated BTEX constituents were well above their applicable MTCA Method A cleanup levels in samples collected from MW-29 (on the Tiki Car Wash site), MW-2, and MW-6 (on the subject site). All of the groundwater samples which were analyzed at that time were reportedly tested by method WTPH-G/BTEX and/or EPA Method 5030/8020. Total gasoline range petroleum hydrocarbon concentrations reported for groundwater samples collected and analyzed from these wells in May 1996 were 6,800 ppb (MW-2), 110,000 ppb (MW-6), and 150,000 ppb, (MW-29). Concentrations of total gasoline-range petroleum hydrocarbons and associated BTEX constituents were reportedly not detected in groundwater samples analyzed from monitoring wells MW-5, MW-7, MW-20, MW-23, and AGI MW-3 (see Plate 2, Site Plan), during the May 1996 sampling event (Enviros, 1996).

As summarized in Table 1, the groundwater sample collected and laboratory tested from boring B9 contained a total gasoline-range petroleum hydrocarbon (TPH-G) concentration of approximately 58,000 parts-per-billion (ppb), and a total diesel- range petroleum hydrocarbon (TPH-D) concentration of approximately 12,000 ppb which are both well above their applicable MTCA Method A cleanup levels of 800 ppb (with benzene present) and 500 ppb, respectively in groundwater. Approximate concentrations of benzene, toluene, ethylbenzene, and total xylenes are all well above their applicable MTCA Method A cleanup levels in the laboratory tested groundwater sample collected from boring B9. No heavy oil-range petroleum hydrocarbons were reportedly detected in the laboratory analyzed groundwater sample collected from boring B9. As mentioned earlier, the location of boring B9 was selected to assist in deducing the possible lateral limits of the potential petroleum hydrocarbon-contaminated groundwater plume which apparently originated from the adjacent Tiki Car Wash site, Plate 2, Site Plan depicts very approximate lateral limits of the potential "Tiki Car Wash" plume.

Acknowledging the elevated concentration of diesel detected in the groundwater at B6, EAI completed a Strataprobe boring (B15) in the northeast corner of the subject property building (Plate 2, Site Plan) on March 11, 2003. The groundwater grab sample retrieved from Boring B15 was tested for diesel range petroleum hydrocarbons. As presented on Table 1, the groundwater sample from B15 contained 190 ppb diesel, which is below the 500 ppb target compliance level.

As depicted on Plate 2, two (2) separate plumes of impacted groundwater appear to have migrated onto the subject property from adjacent sources.

Impacts to the subject property from a petroleum product release that apparently originated off-site at the adjacent "Tiki Car Wash 'Leaking Underground Storage Tank" site were confirmed in tested soil and groundwater samples collected by EAI from boring B9 and in groundwater samples collected and laboratory tested from pre-existing monitoring wells MW-2, MW-5, and MW-9 on the subject site (see Plate 2, Site Plan).

The east adjacent Frontline Auto facility, which was formerly a gasoline station and bulk-heating oil facility, may conceivably be the source of diesel-impacted groundwater in the vicinity of Boring B6. The concentration of diesel at B6 was coincident with the target compliance level of 500 ppb. Acknowledging that the concentration of diesel at B15 is well below the compliance level, it would appear that the encroachment of diesel-impacted groundwater onto the subject property may currently be marginal.
