FINAL CLEANUP ACTION REPORT – SEASON 1 PORT GAMBLE BAY CLEANUP PROJECT

Pope Resources, LP/OPG Properties, LLC

Anchor QEA, LLC

December 2016

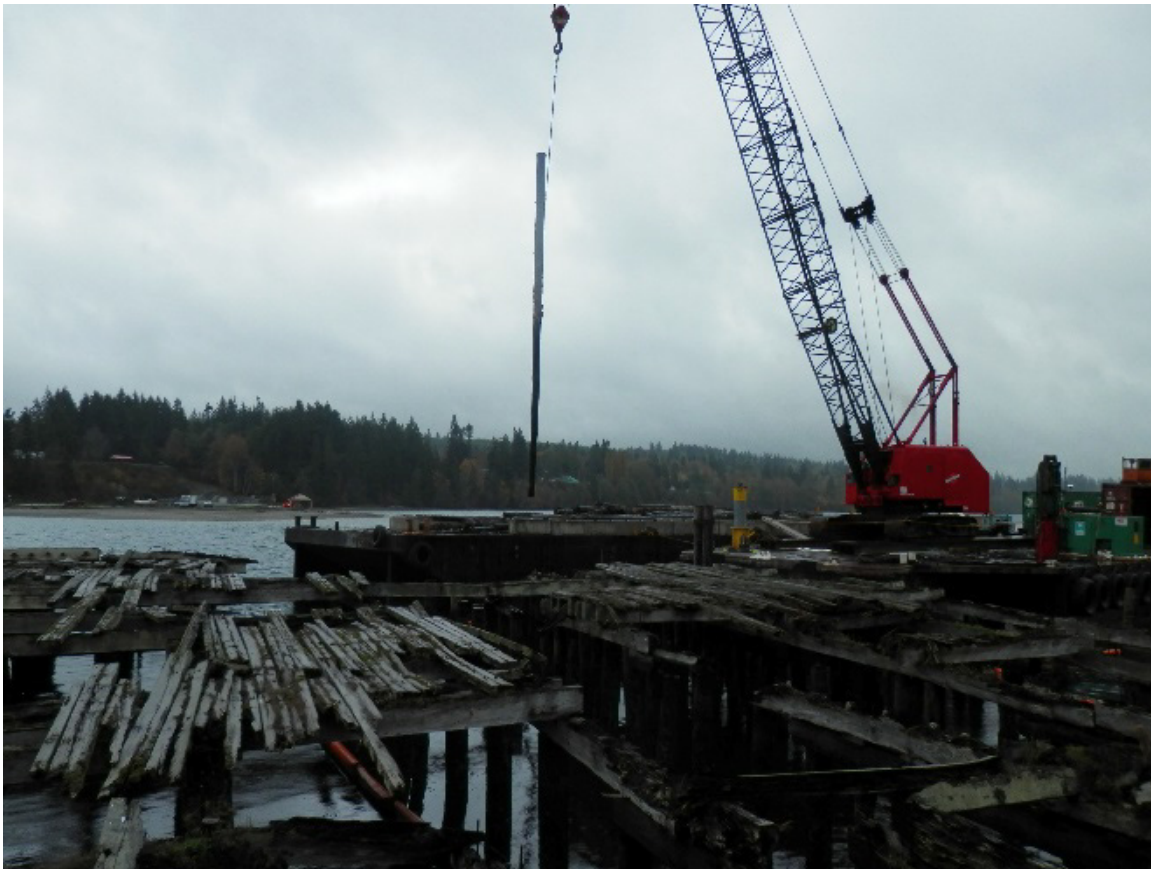
Figure ES-2 – Demolition of Eastern Wharf

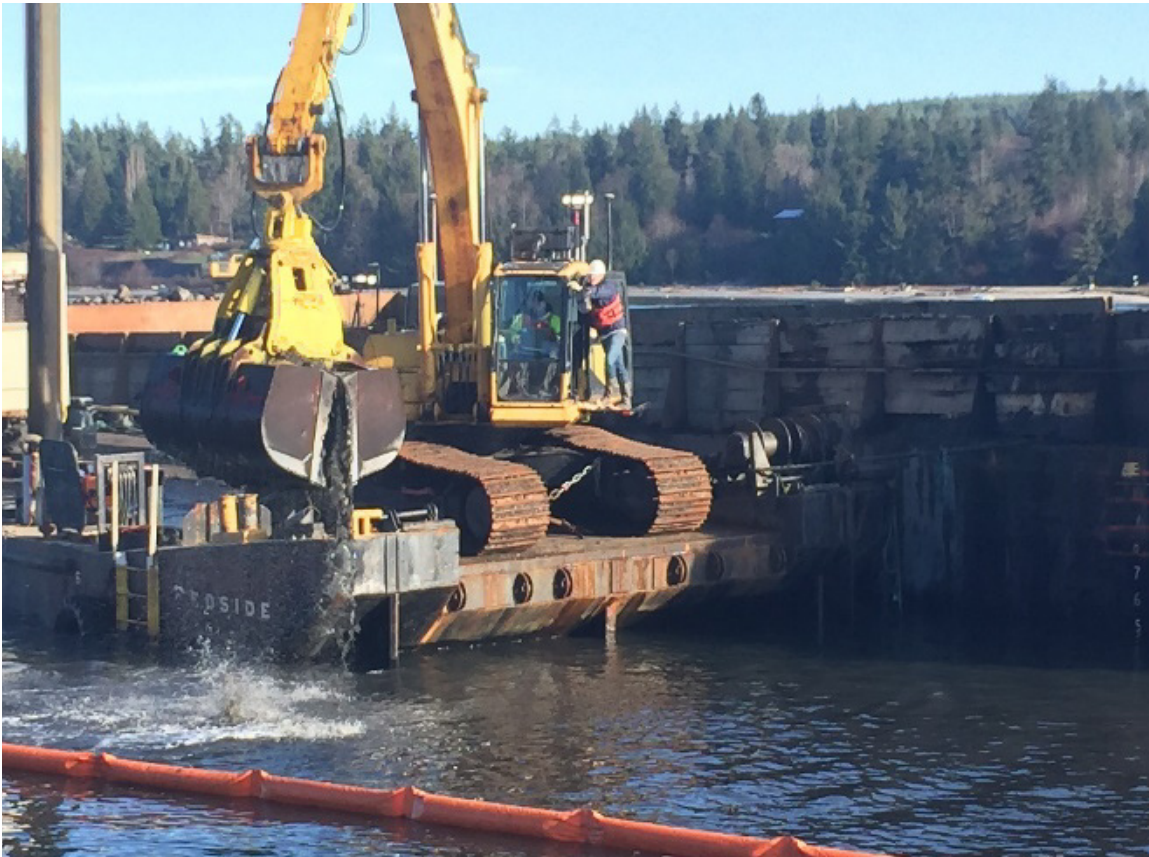
Figure ES-3 – Subtidal Dredging in SMA-2

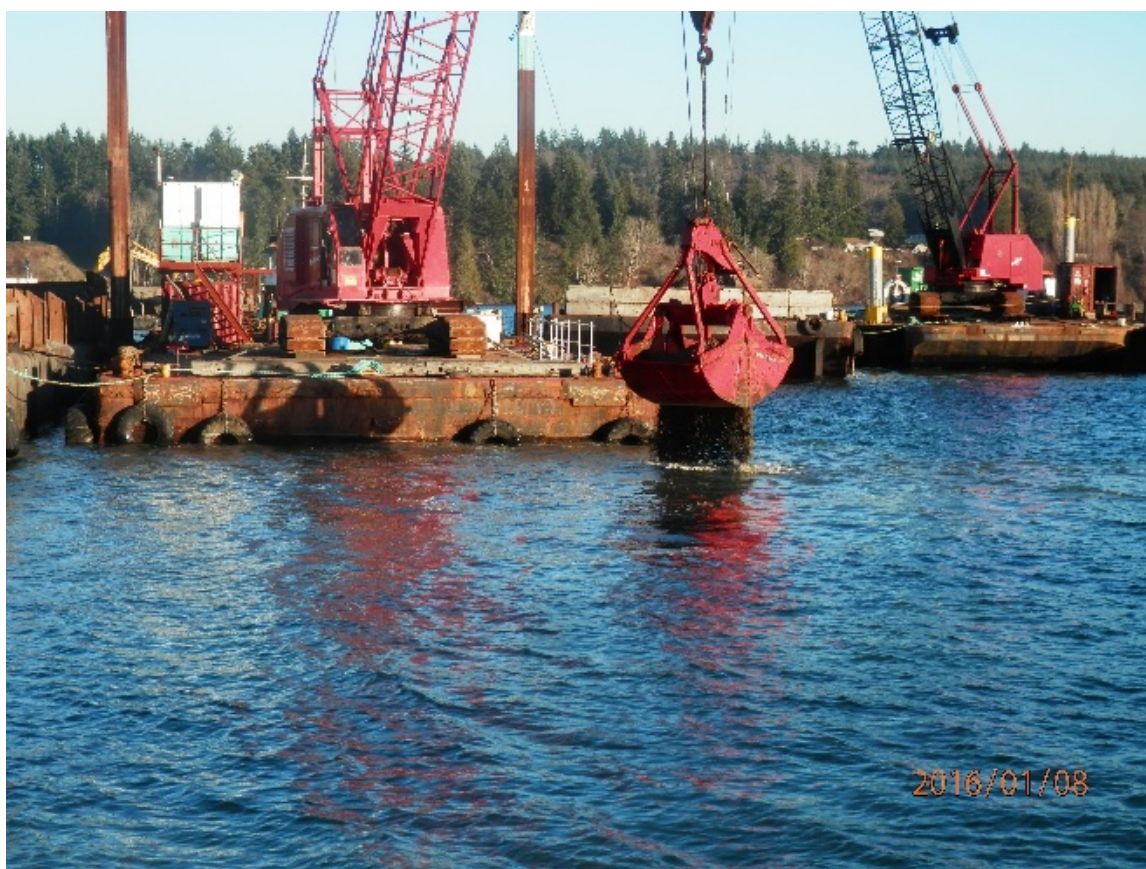
Figure ES-4 – Subtidal EMNR Placement

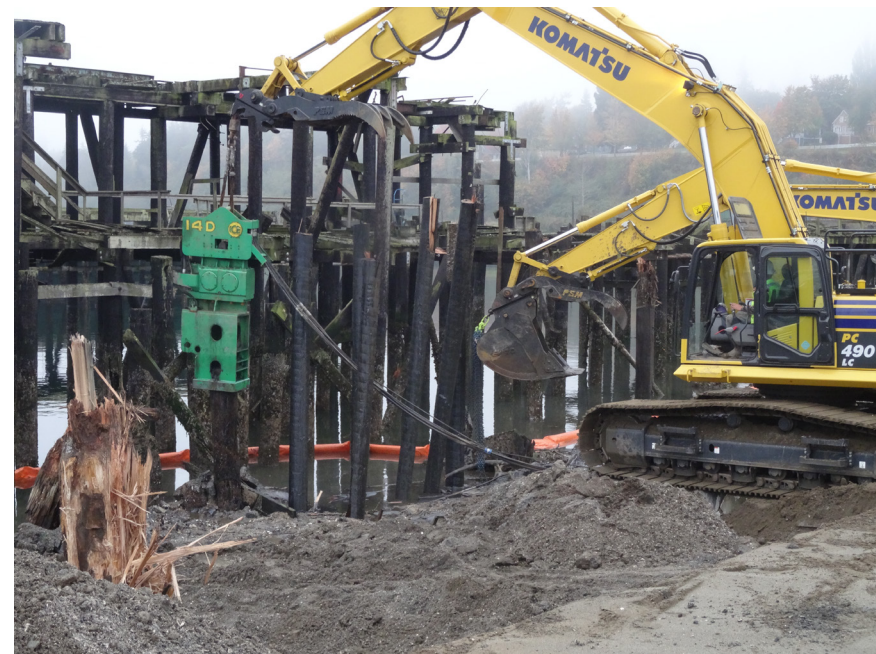
Intertidal pile removal

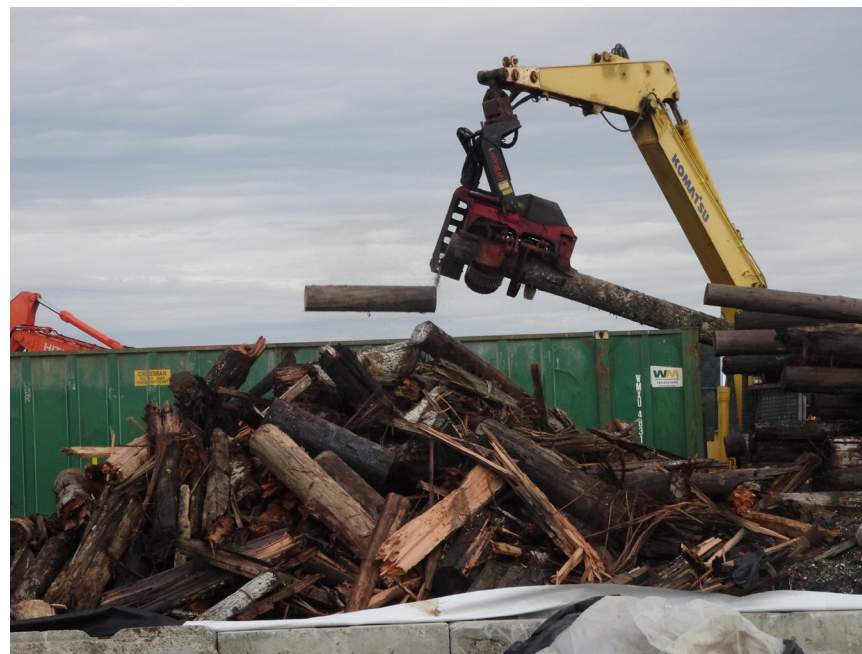
Creosote pile processing

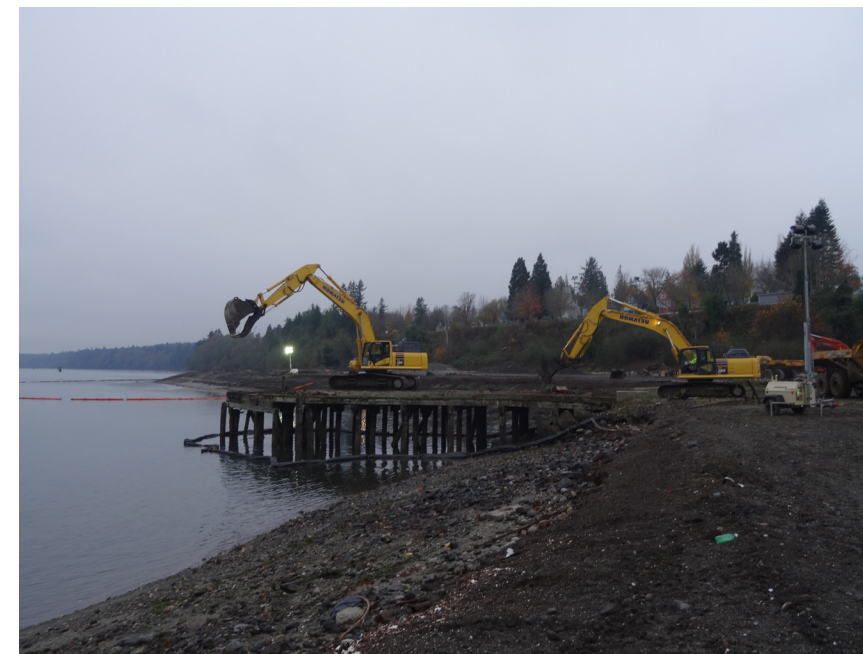
Pier 5 demolition

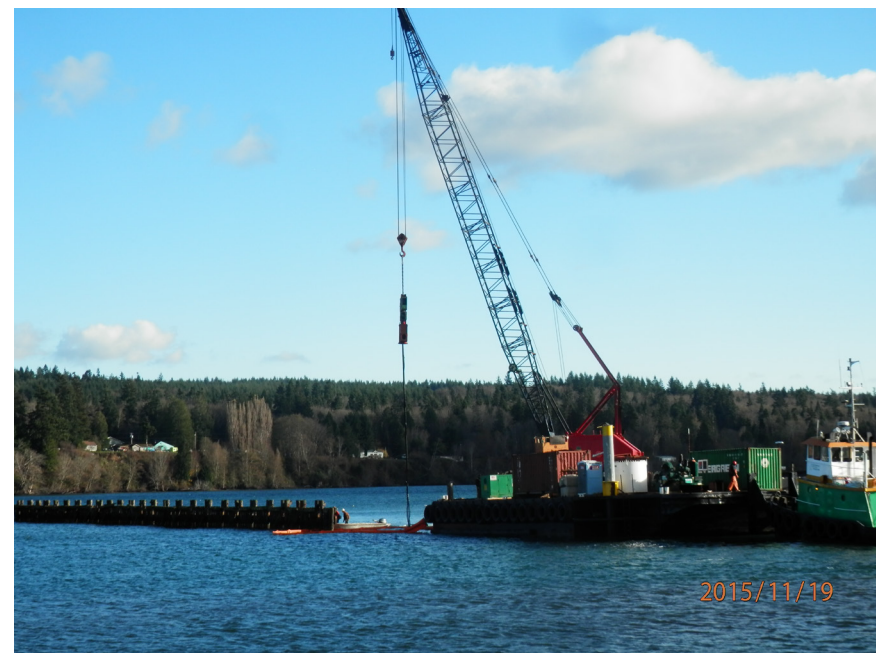
Breakwater demolition

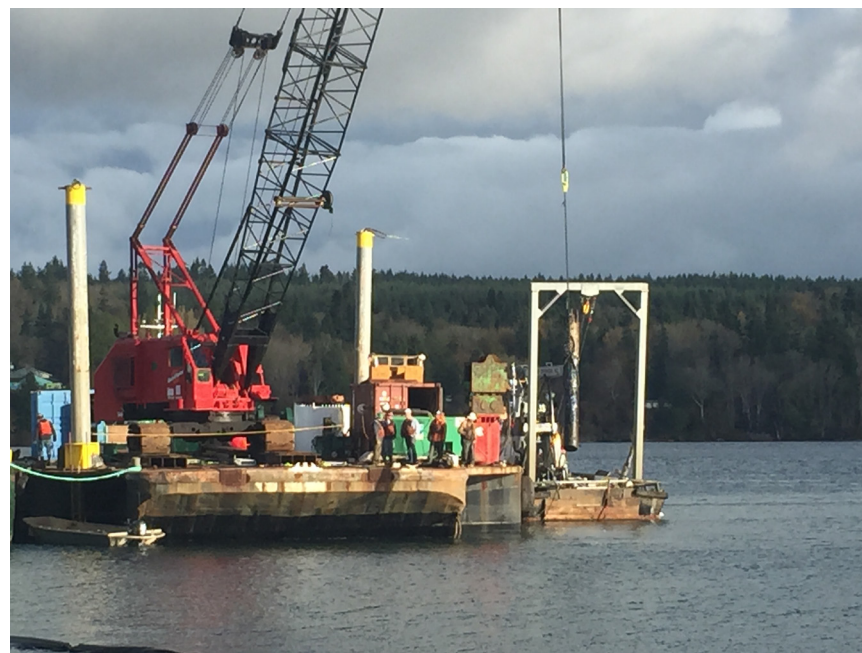
Diver assisted submerged subtidal pile removal

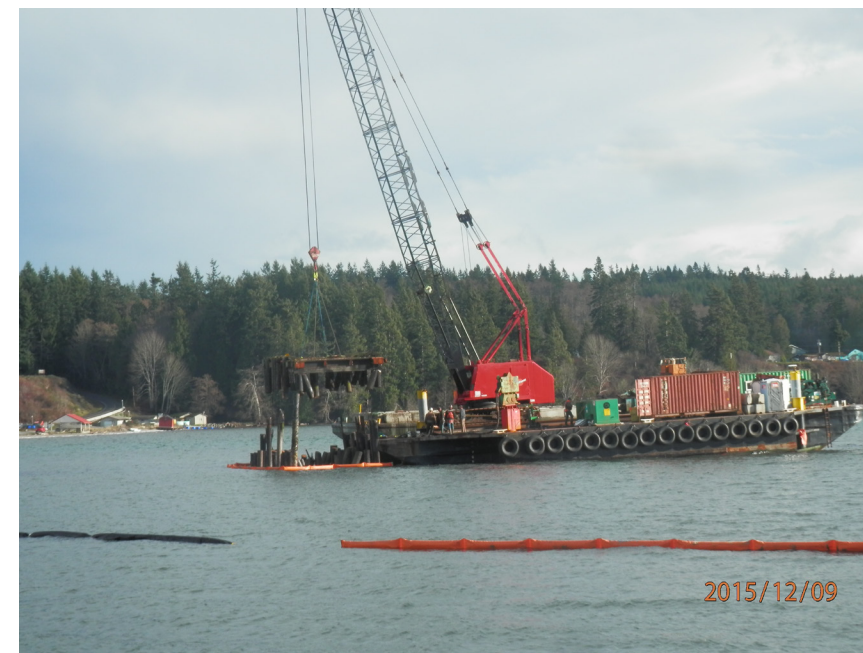
Offshore Alder Chip Pier demolition

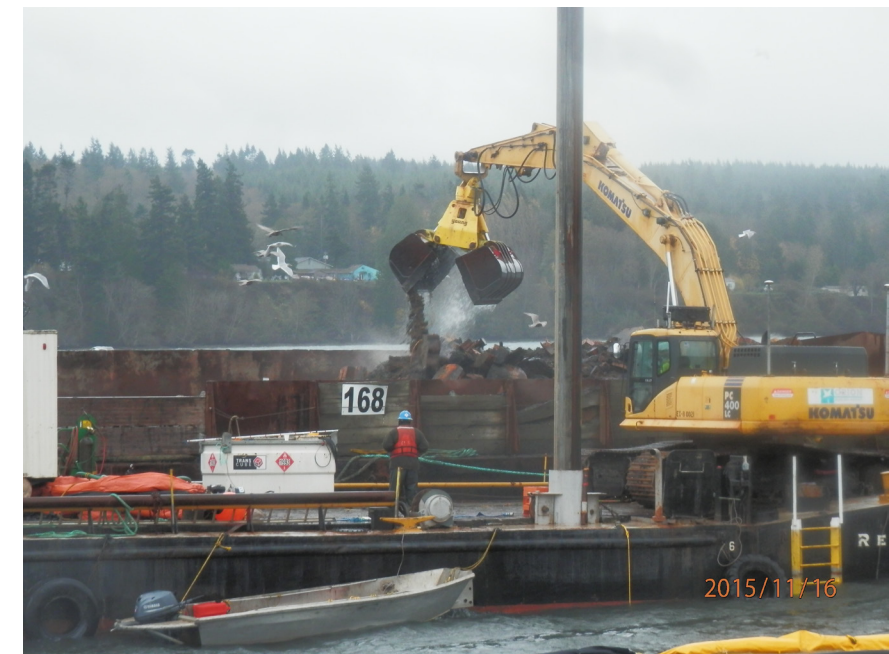
Subtidal dredging	Progress in subtitle dredging was delayed by the presence of debris. Greater consideration should have been given to switching to the clamshell bucket, which is a more effective tool in this circumstance.	Regularly assess progress and ensure adaptive management is responsive to ongoing conditions and schedule. Ecology has requested metrics and reporting requirements to address this issue in Season 2.

Subtidal dredging in area with larger wood debris

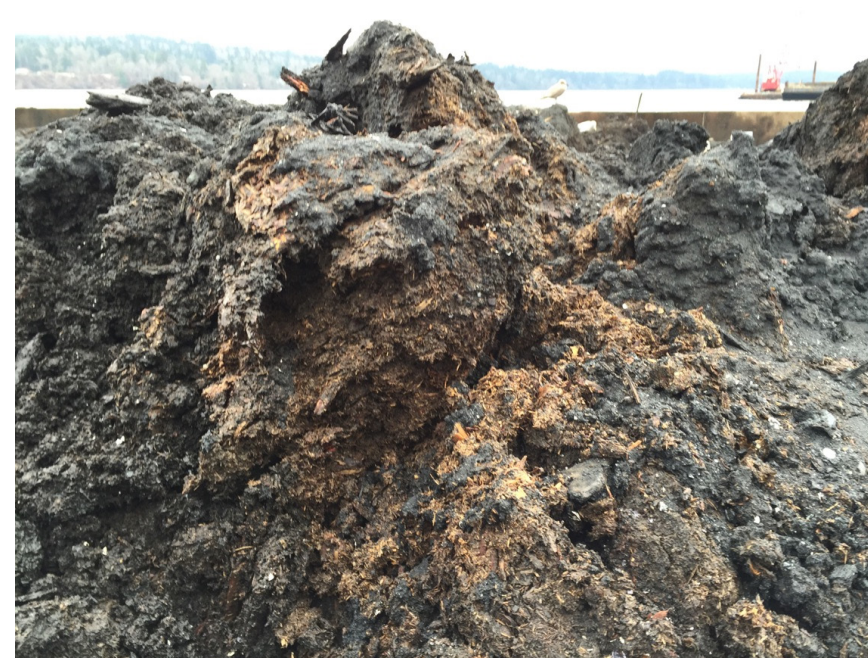
Dredge spoils with wood waste material

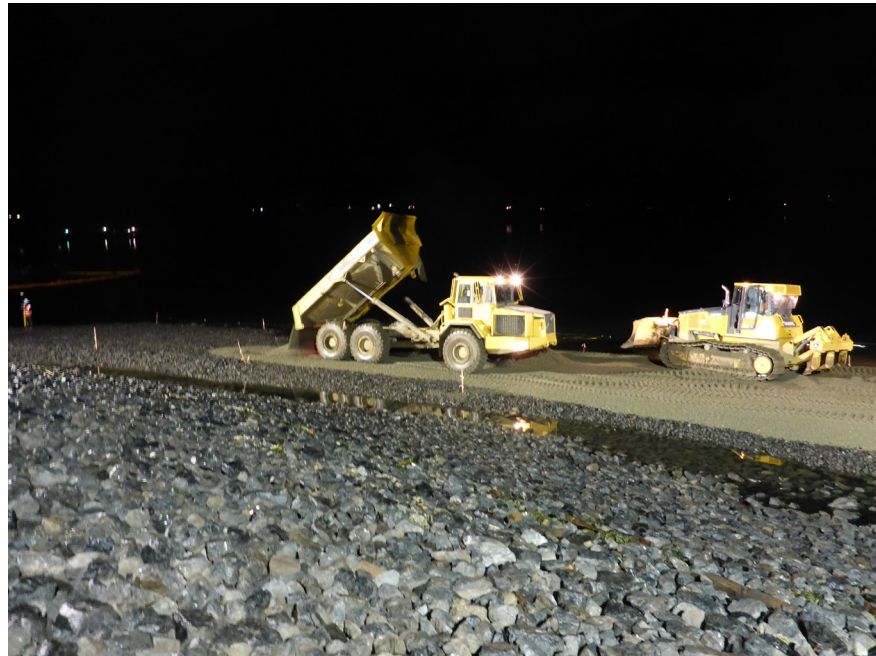
Habitat substrate was placed on the surface of the armored cap along the shoreline, in accordance with the design. Because the grain size of this material is too small to be stable under breaking waves, the design anticipated that habitat substrate material would migrate vertically and laterally within the intertidal zone. This anticipated migration of the rounded habitat material was observed along the intertidal cap slopes that were constructed in Season 1.

immediately after the initial construction. After the second placement, the habitat substrate was observed by Ecology to fill the armor layer interstices. Based on a coastal geologic reconnaissance assessment of the constructed SMA-2 shoreline, habitat substrate material appears to be moving dynamically through this area.

Placing habitat substrate over Type 3 armor

At the request of Ecology, an additional layer of habitat substrate was placed over a test section of cap to infiltrate interstitial spaces in the armor layer due to a storm event

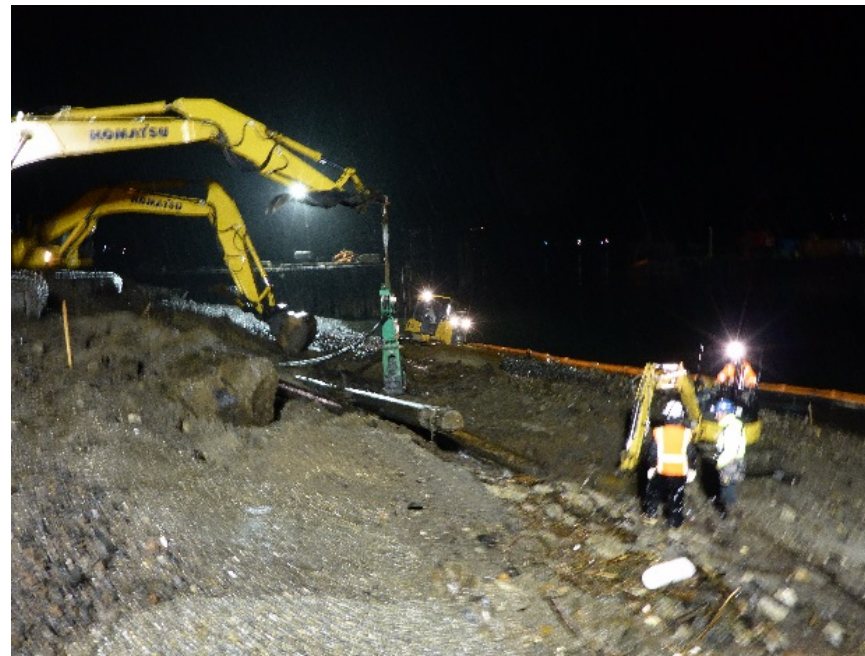
Removal of piles encountered during intertidal excavation

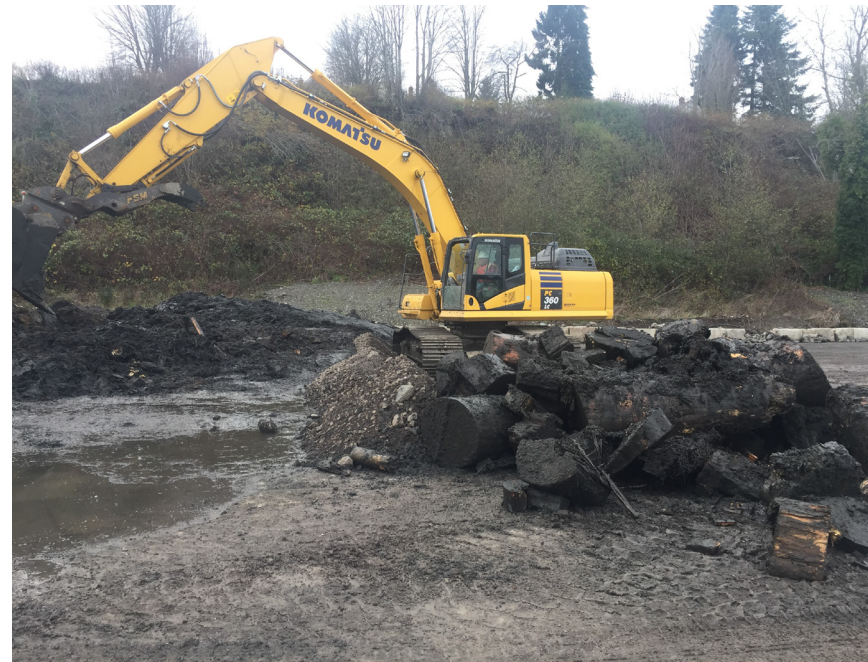
Removing large wood debris from subtidal dredge material stockpiles
