Memorandum

Date: May 30, 2018

Project No: Weyer-Mill E

Re: **Storm Drain Pipe Abandonment Associated with Outfall LLO-07 at the Former Mill E/Koppers Facility**

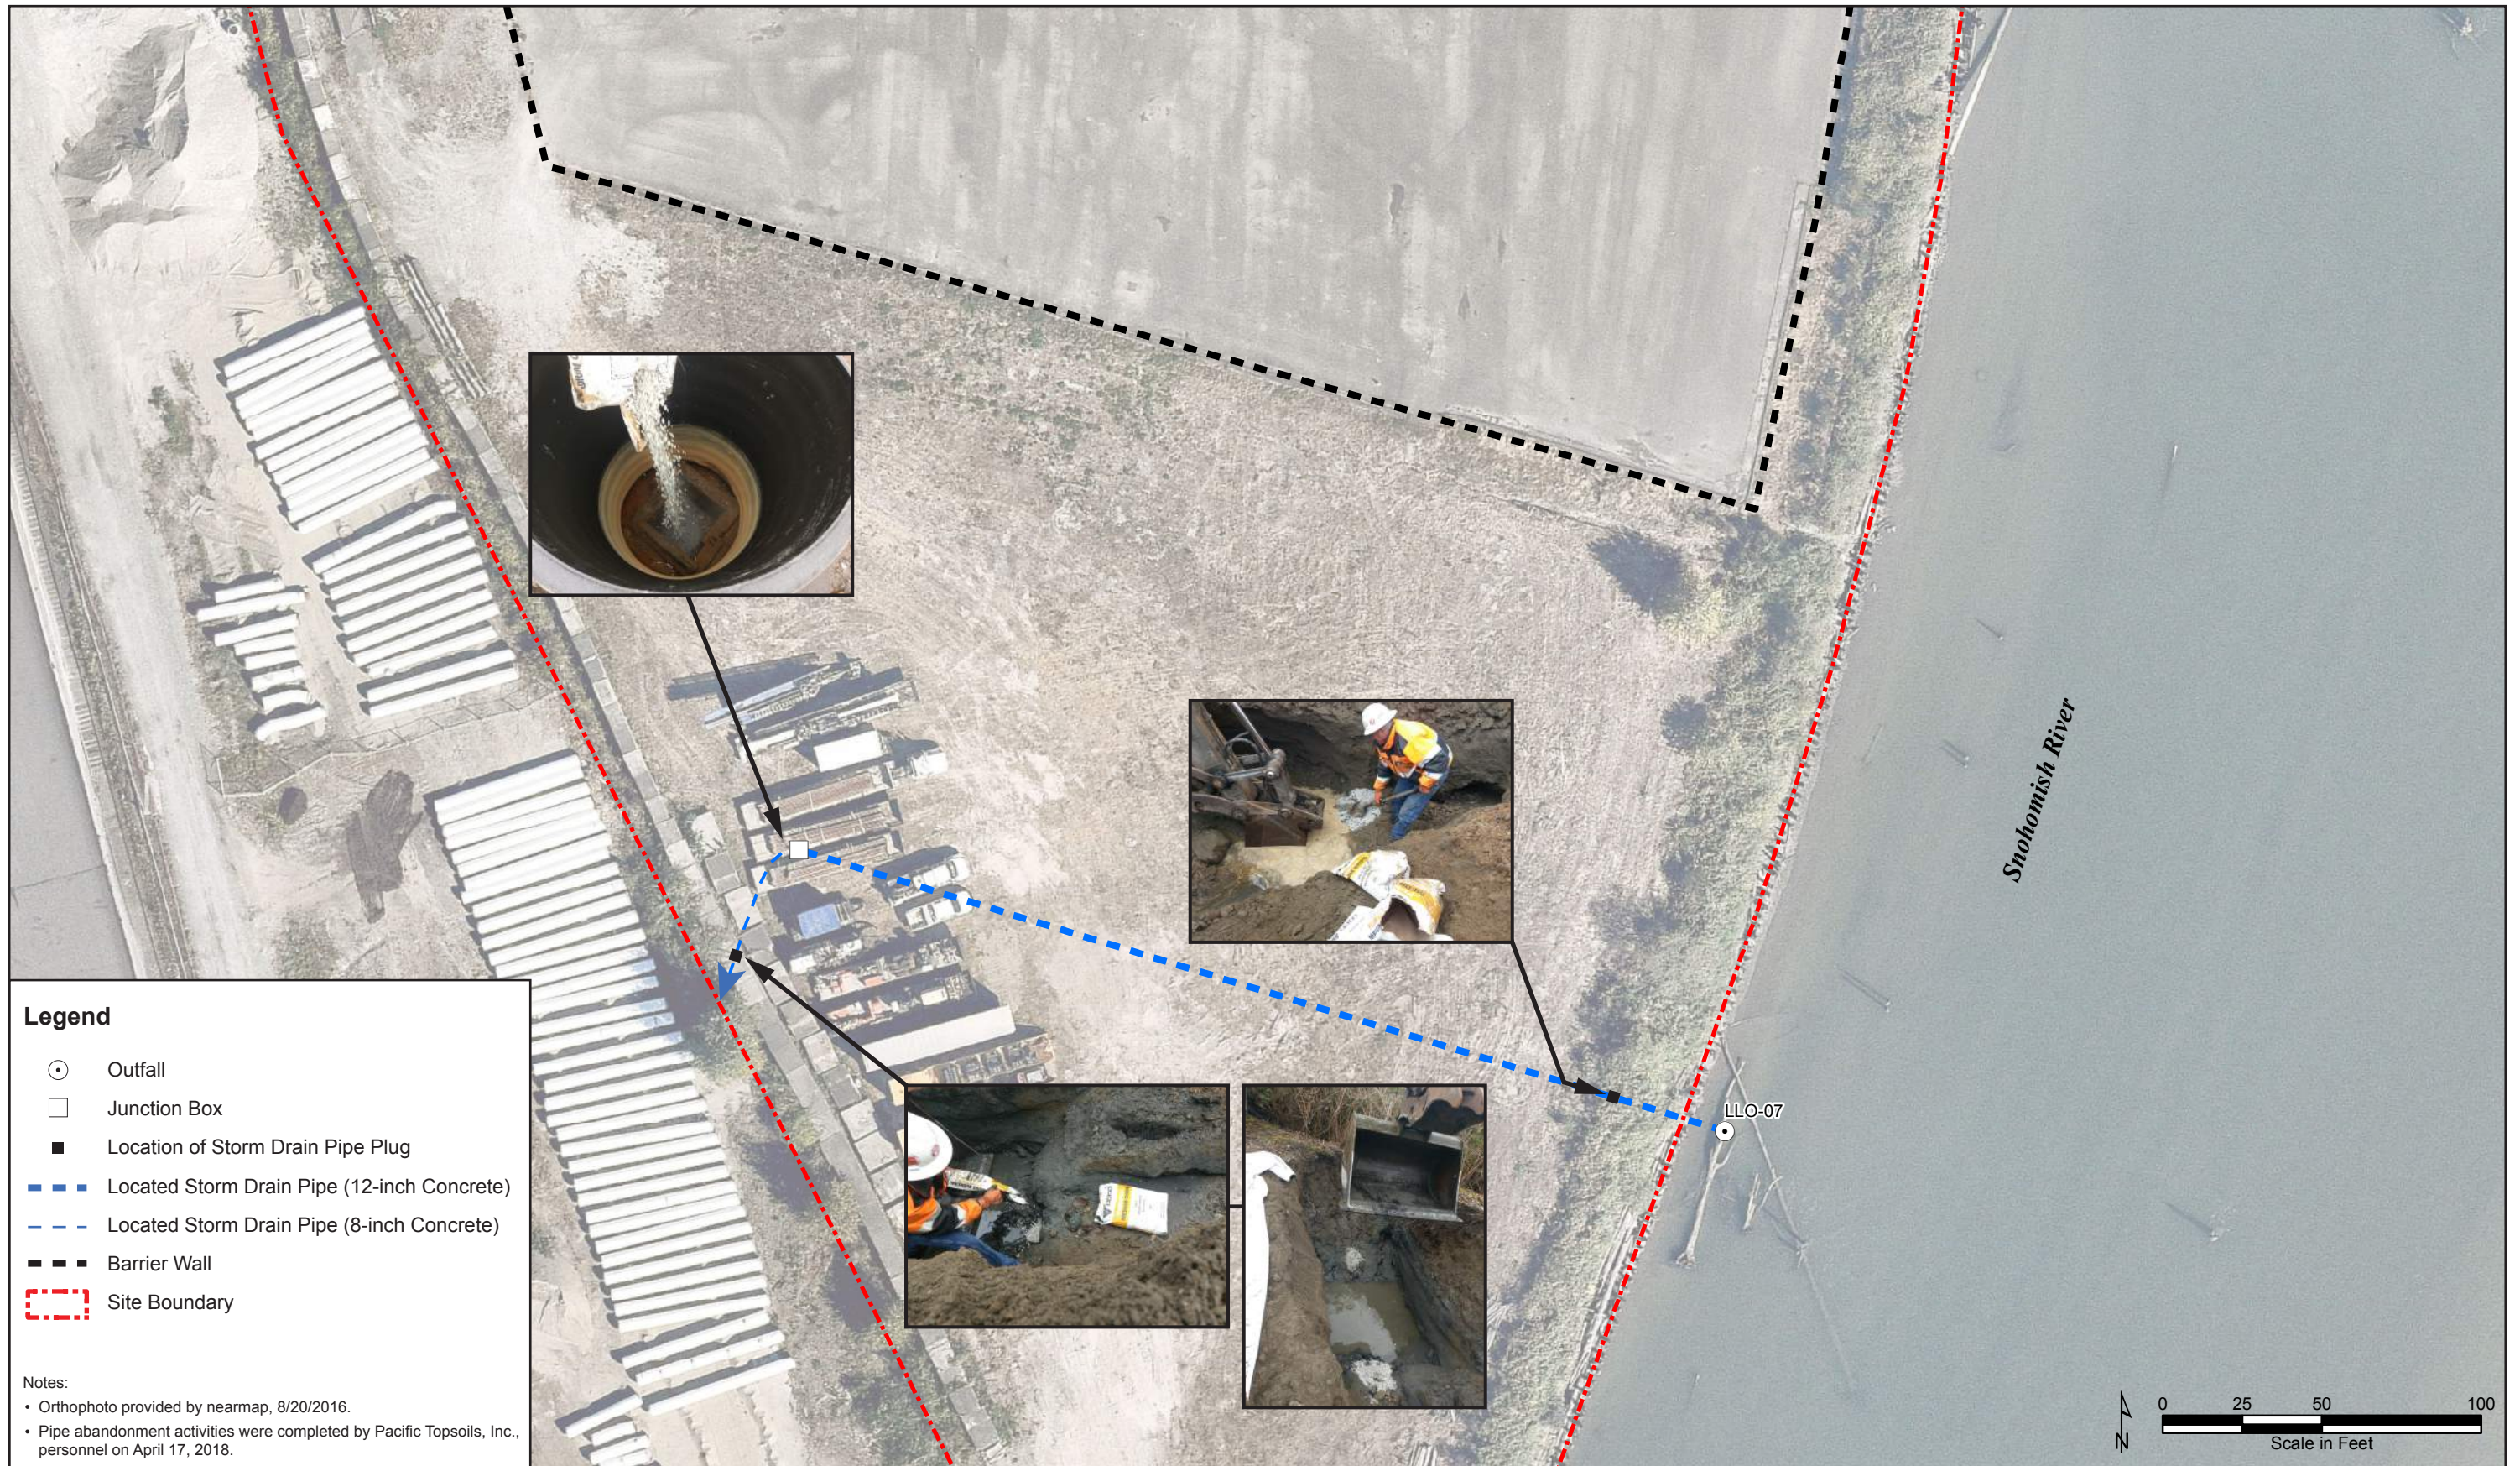
Three locations along the storm drain pipe alignment were selected to be plugged: (1) at the property boundary to eliminate inflow of stormwater onto the Site property, (2) at the junction box, and (3) near Outfall LLO-07 to eliminate discharge. Figure 2 depicts the storm drain pipe alignment and includes photographs of each location where the storm drain pipe was plugged. Work began at the western property boundary using a small excavator to expose the top of the 8-inch diameter concrete drain pipe, which was located at 6 feet below ground surface (bgs). A

small pit was excavated next to the pipe in order to control incoming groundwater and to access the pipe. The pipe was plugged in three spots at the property boundary by breaking the pipe open from the top, clearing away debris and mud from inside the pipe rim, and then pouring in one to two bags of bentonite chips at each location. A shovel was used to push bentonite chips as far into the pipe as possible prior to hydration. A three-foot section of the concrete pipe was also demolished between two of the bentonite plugs. After the bentonite had set, the excavated area was backfilled with the soil that had been removed.

In November 2017, a high-density polyethylene (HDPE) pipe was placed over the junction box for future access. Two bags of bentonite chips were poured inside of the junction box and pressed down with a shovel into the influent and effluent pipes prior to hydration to seal the box and all inlets and outlets to the junction box.

The excavator subsequently moved to the shoreline to expose the 12-inch diameter concrete storm drain pipe approximately 25 feet from Outfall LLO-07 (refer to Figure 2), which was located at 8 feet bgs. A pit was excavated to fully expose the concrete pipe which was then broken open and cleaned out as best as possible using a shovel. Three bags of bentonite chips were poured inside of the pipe and compacted around the outside prior to hydration. After the bentonite was set, the excavated area was backfilled with the soil that had been removed.
