STATE OF WASHINGTON  
DEPARTMENT OF ECOLOGY

December 4, 2018

**Re: Further Action at the following Site:**

- **Site Name:** Conway Feed
- **Site Address:** 2110 Jones Road, Conway, WA 98284
- **Facility/Site No.:** 5135
- **Cleanup Site ID No.:** 2524
- **VCP Project No.:** NW2185

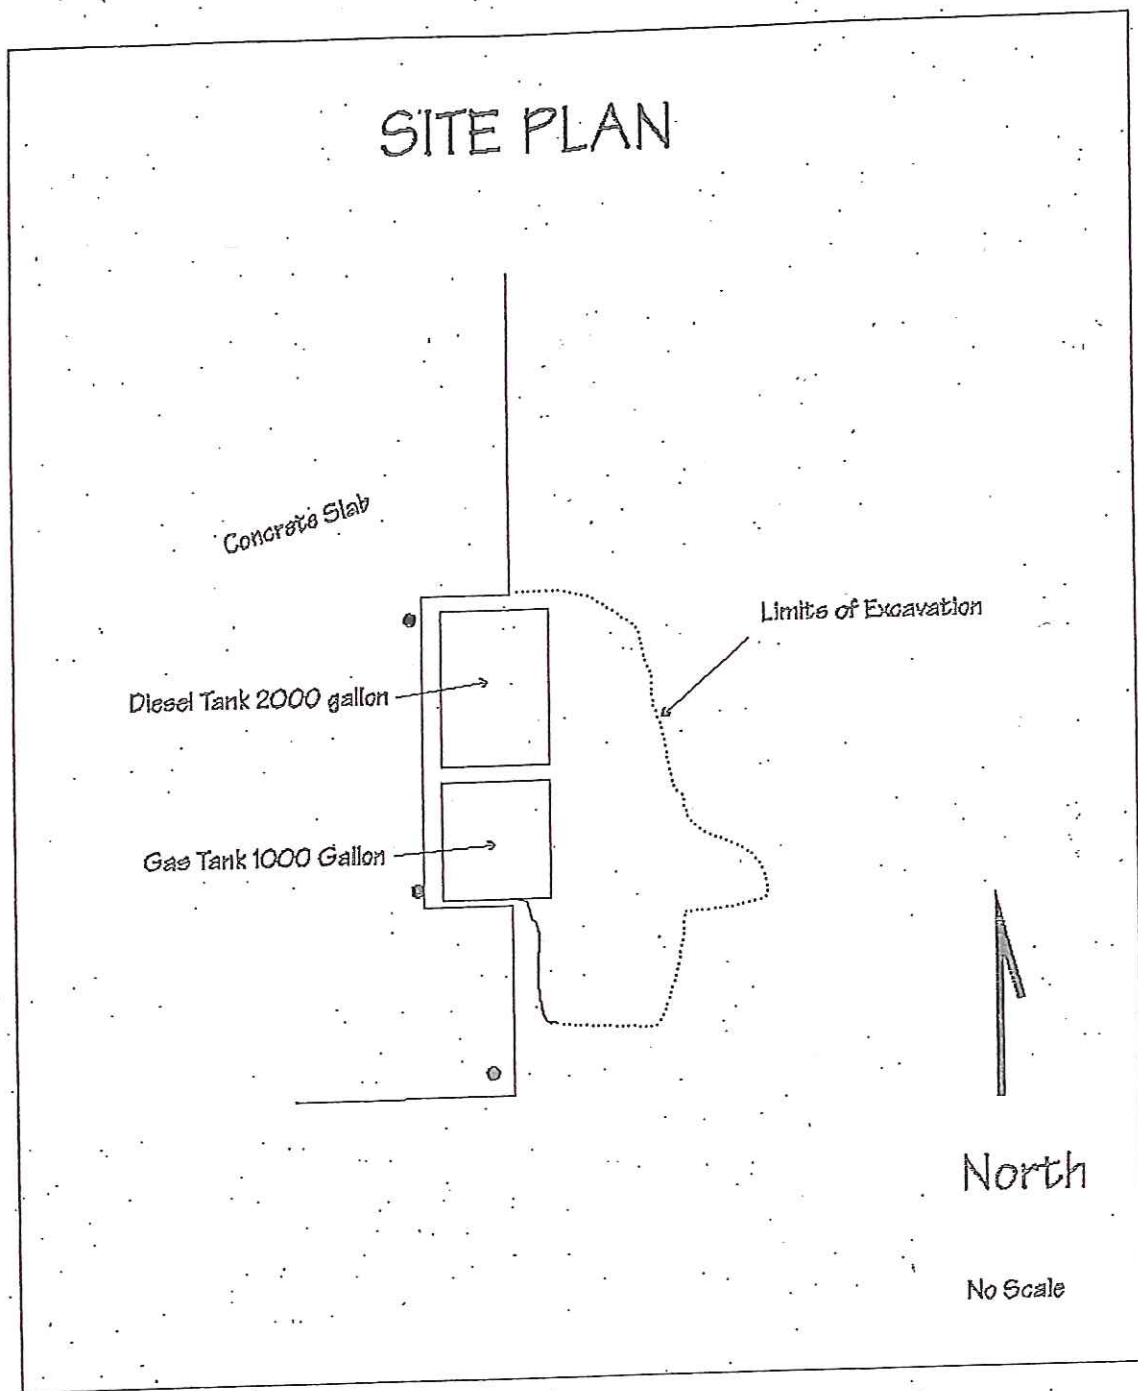
Figure 3

Following the UST removals, soil contamination in the excavation was observed and verified by subsequent soil sampling. Sheen was observed on ground water in the UST excavation at approximately 5 feet below ground surface (bgs). Efforts were made to over-excavate the contaminated soil to the extent defined by Method A cleanup levels for TPH-G, TPH-D, and BTEX applicable in 1991. As determined by field observations and confirmation soil samples, this extent was achieved on the east, south, and north sides, and bottom (approximately 6 feet bgs) of the excavation (Figure 3).

The excavation was not extended to the west because of concrete paving and risk to the structural support of a large steel canopy. Confirmation samples from the west wall of the excavation showed that elevated levels of TPH-G and BTEX (up to 1,646 milligrams per kilogram (mg/kg) TPH-G and 16 mg/kg benzene), in excess of both the 1991 and current Method A cleanup levels, remained in the soil.

Excavation 1992

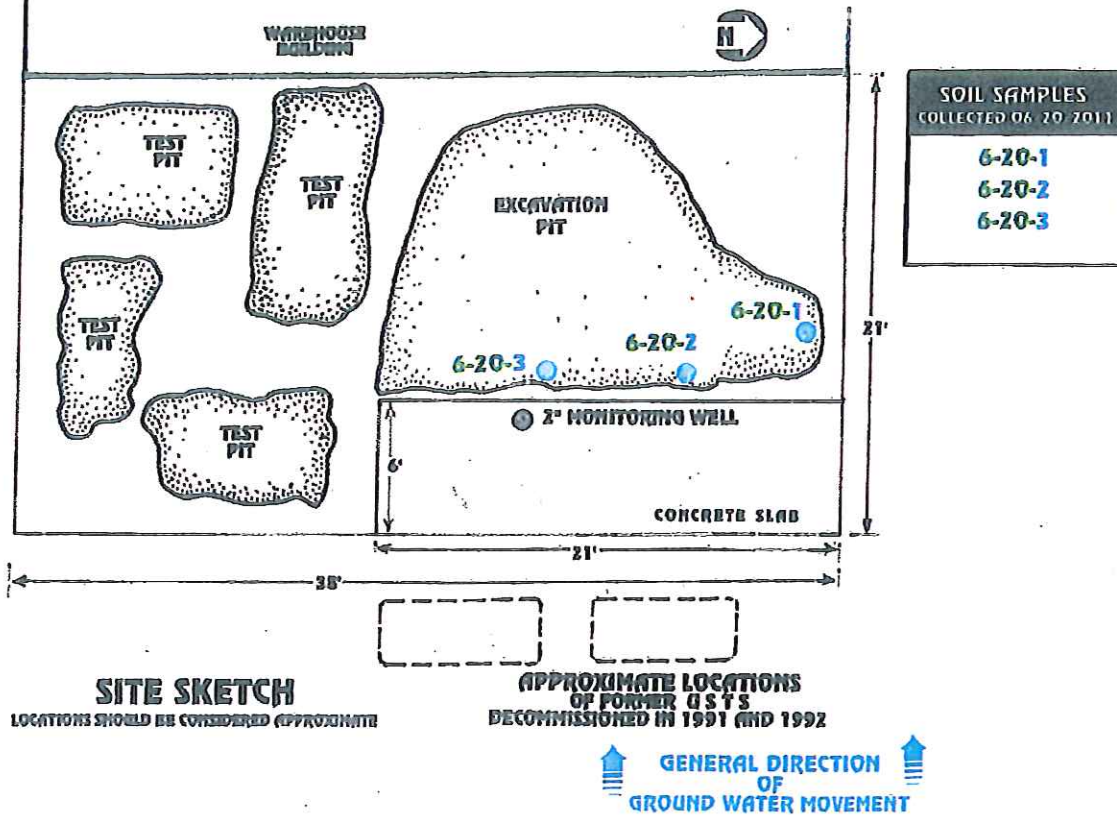
**Figure 4**

During June 2011 a remedial excavation was performed to remove the remaining contaminated soil. The limits of the contaminated soil were determined by field observation (visual and olfactory evidence) and confirmation soil samples referenced to the Method A soil cleanup levels for TPHs, BTEX, and lead. The remedial excavation encompassed the locations of two of the exploratory test pits (Figure 4).

Three confirmation samples were acquired at 6 to 7 feet bgs - two along the east wall of the remedial excavation (adjacent to the previous 1991 excavation) and one on the north side of the excavation. Sample results were non-detectable concentrations except for three low detections of lead, and one of toluene. A confirmation soil sample was not acquired at that time to indicate that the western extent of the contaminated soil was reached. However, a soil sample later acquired during March 2018 immediately west of the former excavation and inside the warehouse, demonstrated that the extent of the contamination had been reached.

**SITE SKETCH DEPICTS AREA IN FRONT OF WAREHOUSE BUILDING THAT WAS NEAREST THE FORMER USTs AND WHICH WAS EXCAVATED FOR THE INVESTIGATION**

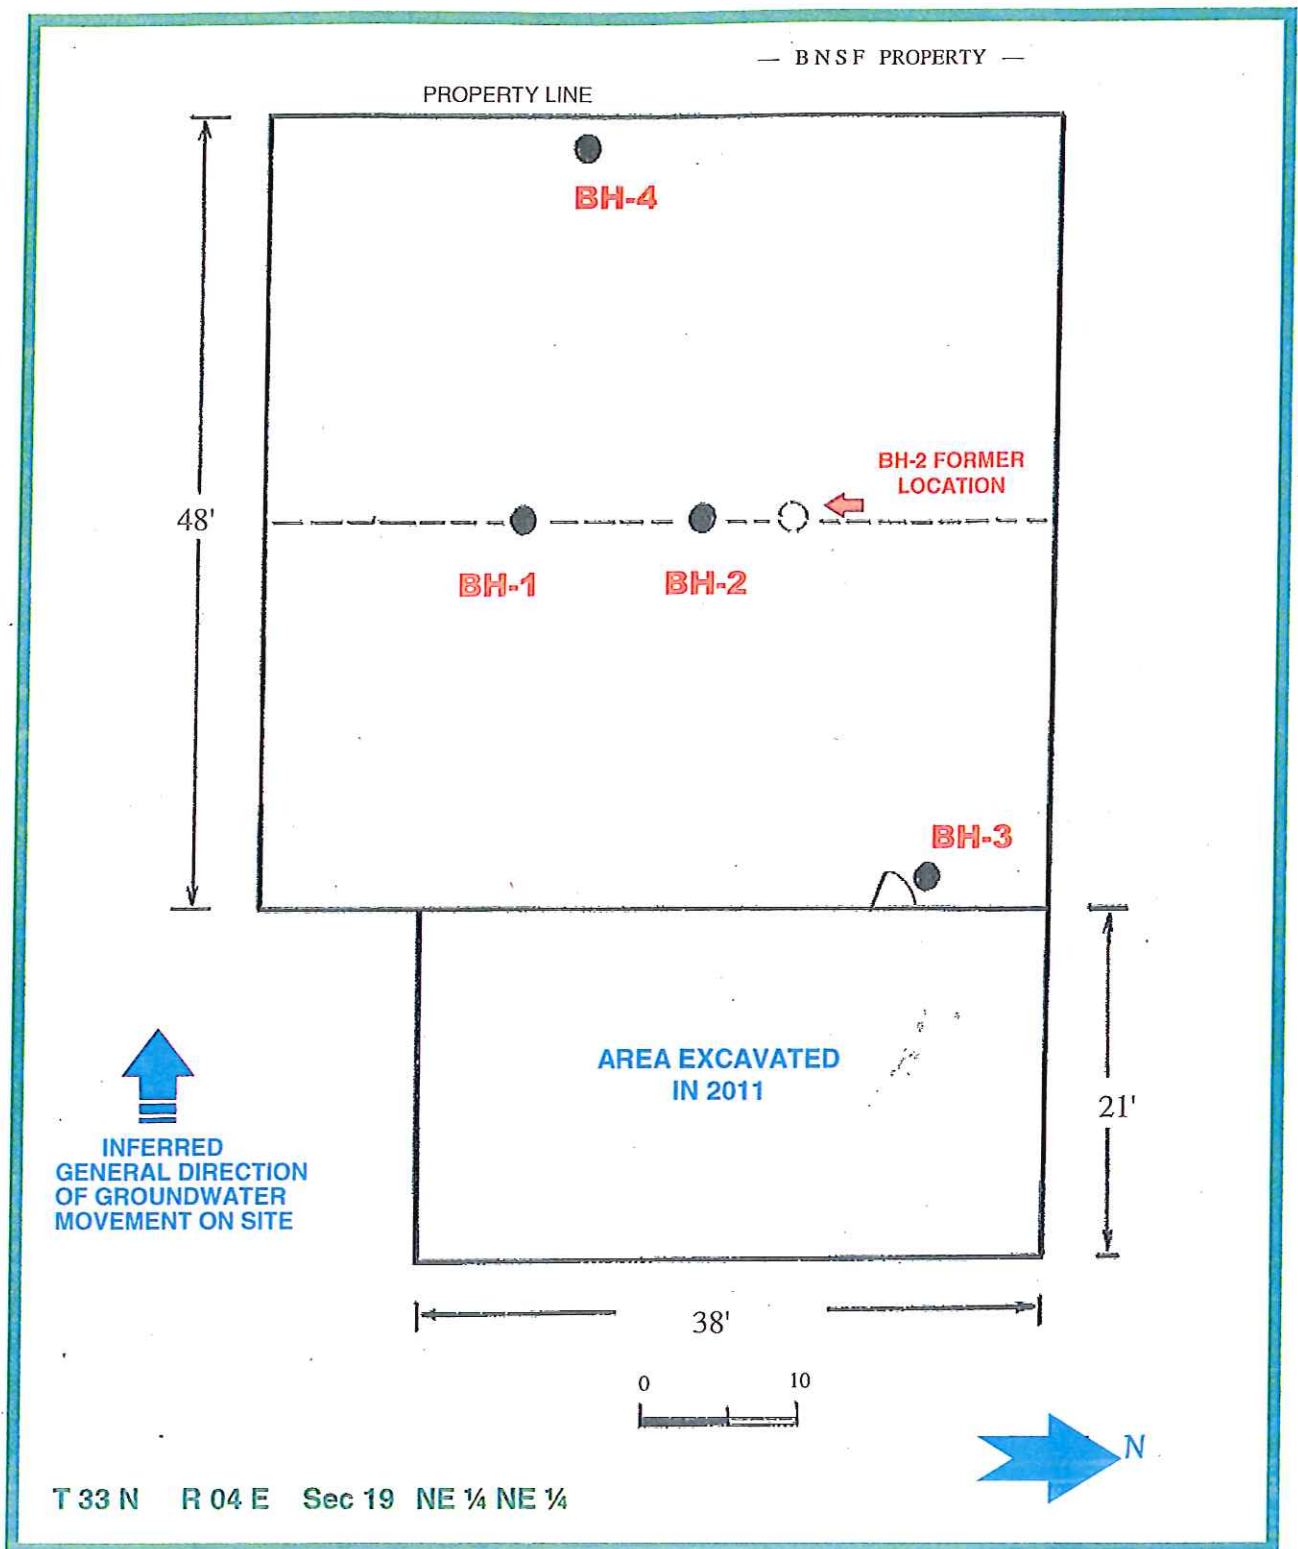
**Figure 5**

In March 2018, four borings (BH-1 through BH-4) were placed inside the warehouse to the west of and adjacent to the remedial excavation completed in June 2011 (Figure 5). The purpose of the borings was primarily to evaluate ground water conditions down-gradient of the excavated areas. The ground water flow direction was reasonably

The soil sample results were non-detectable for all compounds except lead, which was detected at concentrations well below its Method A soil cleanup level (250 mg/kg) in all borings. The ground water samples were non-detectable for all compounds except lead, TPH-D and TPH-O. Lead was detected at concentrations well below its Method A ground water cleanup level (15  $\mu\text{g/L}$ ) in three borings, but exceeded its Method A ground water cleanup level in boring BH-1.

The sum of TPH-D and TPH-O exceeded the Method A ground water cleanup level of 500  $\mu\text{g/L}$  in all borings except BH-2. The highest concentrations of lead (44  $\mu\text{g/L}$ ) and TPH-D+O concentrations (2,420  $\mu\text{g/L}$ ) in ground water were found in BH-1, along with an odor of hydrogen sulfide.

The characterization of the soil within the Property associated with the releases from the USTs appears to be complete via the remedial excavation work described above. The cause of the elevated lead and TPH contamination remaining in ground water has yet to be determined, however, and additional characterization is required.

- The contaminant levels in ground water found inside the warehouse should be determined by analyzing representative samples acquired over time from properly constructed and developed monitoring wells installed by a licensed well driller. The current ground water samples are one-time "grab" samples acquired from hand-auger borings, which unavoidably can contain some sediment particles that may cause sample results to be biased on the high side. Grab ground water samples are appropriate for reconnaissance sampling, but not for determining compliance with cleanup levels. More accurate samples from monitoring wells could demonstrate that the ground water is actually in compliance. The lack of consistency borehole to borehole may suggest this.

- Perhaps a reasonable initial course of action would be to install one monitoring well near BH-1 and monitor quarterly for a year, using low-flow ground water sampling procedures, and passing the portion of the sample destined for lead analysis through a 0.45 micron filter in the field prior to filling the sample bottle that contains acid as a preservative. This will provide a dissolved lead result that is representative of ground water quality.
