SOIL REMEDIATION REPORT

Bank of the Pacific Butler Street Property Cathlamet, Washington

Prepared for: The Bank of the Pacific

Project No. 010120-002-01 • April 21, 2004

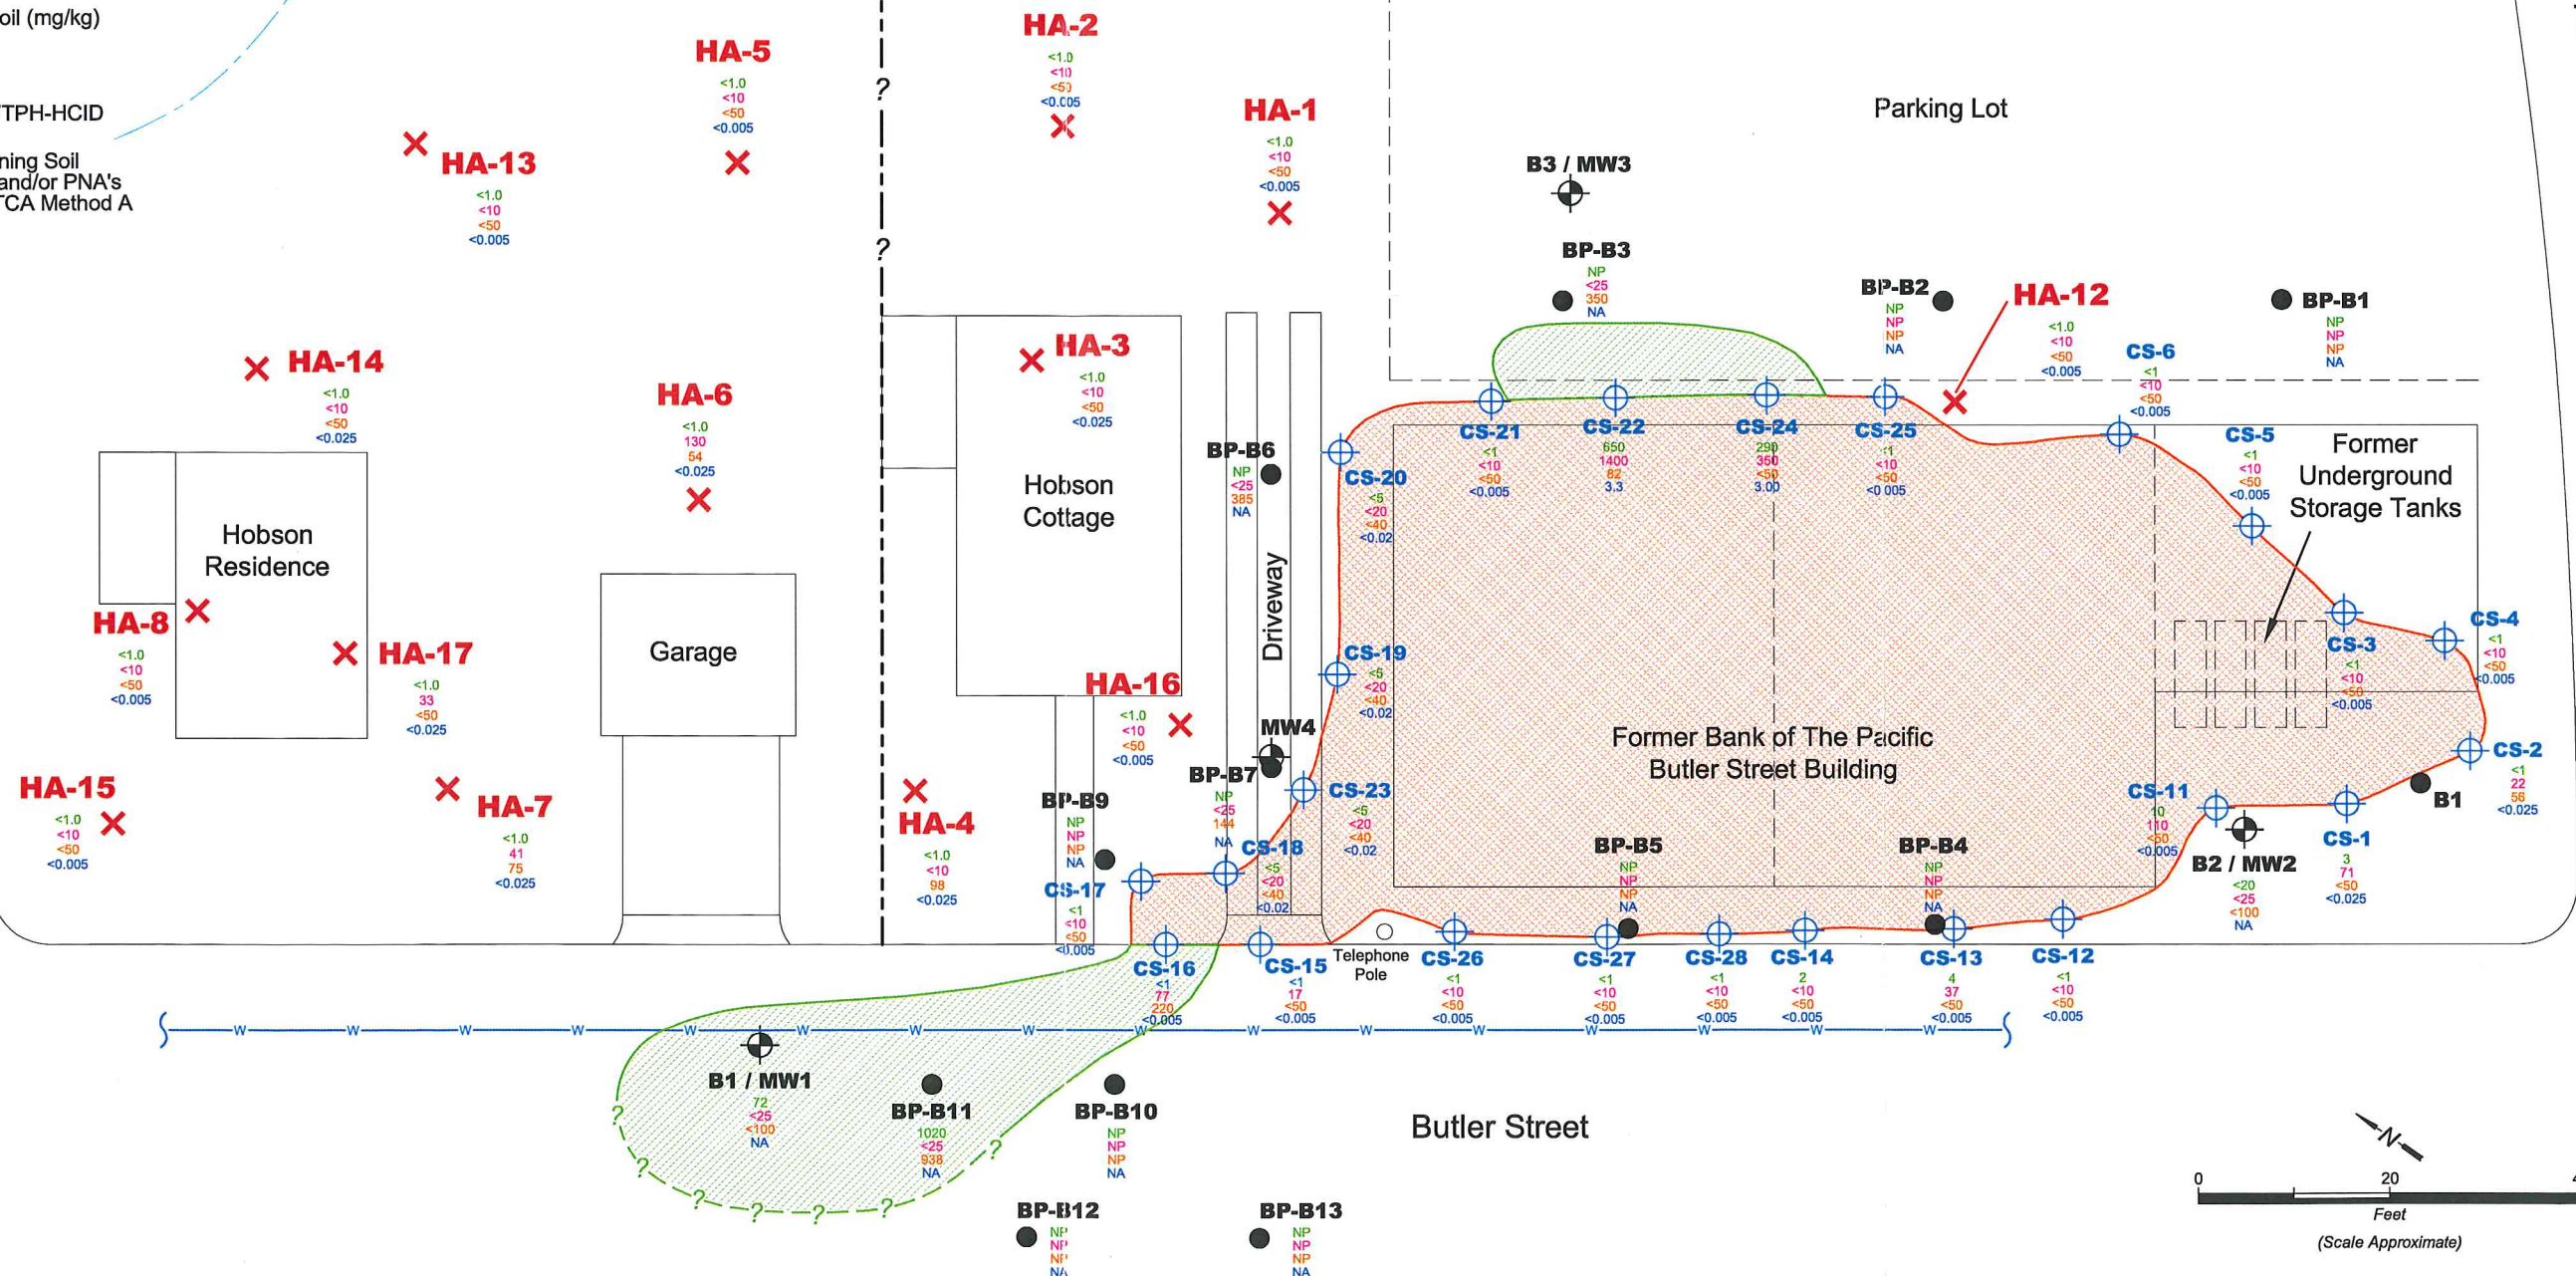
Site Plan
Bank of the Pacific Property
20 Butler Street, Cathlamet, Washington

Additional on- and off-site soil investigations were conducted by PNEC in September 1999 and August 2000, and by Aspect Consulting in May 2002 (Aspect Consulting, 2002). The results of these sampling efforts confirmed the presence of impacted soil above basalt bedrock beneath the foundation of the Bank's building, on the southwest portion of the immediately adjacent "Hobson Cottage" property, and beneath portions of Butler Street. No TPHs exceeding applicable Model Toxics Control Act (MTCA) cleanup levels were detected on the main "Hobson Residence" property located north of the "Hobson Cottage" property. A complete summary of historical soil sampling results are included in Table 1. Historic soil sampling locations are shown on Figure 2.

In August 2000, PNEC installed three monitoring wells (MW-1, MW-2 and MW-3) at the locations shown on Figure 2. Shallow groundwater was encountered beneath the Site in fractured basalt, with general groundwater flow inferred to be to the north, towards Birnie Creek. Sampling of the monitoring wells (PNEC, 1999a and 2000; Robert D. Miller Consulting, 2001) indicated the presence of only marginal exceedences of the MTCA cleanup level for TPHs as oil in groundwater in wells MW-1 and MW-2. No exceedences of MTCA cleanup levels for TPHs as gasoline were recorded in these wells. Benzene was only detected in well MW-3, and at concentrations below the MTCA Method A groundwater cleanup level of 5 micrograms/liter ($\mu\text{g/L}$) for benzene.

Results of the initial confirmation samples (24 total) indicated that additional excavation was required in several areas. Four additional confirmation samples were collected from these areas after the additional excavation was completed. The outline of the completed excavation and locations of the final 24 confirmation sidewall samples are shown on Figure 2.

gasoline and BTEX above respective MTCA Method A unrestricted cleanup levels remains beneath the parking lot to the east of the former building (see Figure 2). Based on confirmation sample results and historic soil samples data from surrounding borings, the estimated volume of impacted soil in this area does not likely exceed 30 cubic yards.

An additional area of soil impacted by TPHs as gasoline and PNAs above MTCA Method A cleanup levels is present beneath Butler Street to the west of the "Hobson Cottage" property (see Figure 2). The southward extent of TPHs as gasoline in this area is constrained by borings BP-B10 and BP-B12, but the northwestward extent beneath Butler Street is unknown. PNAs exceeding MTCA Method A cleanup levels were detected only in sample BP-CS-16, from immediately beneath the edge of the sidewalk along Myrtle Street. The source of the PNAs in this sample are unknown, as are the potential extent of PNAs in soil to the northwest beneath Myrtle Street.

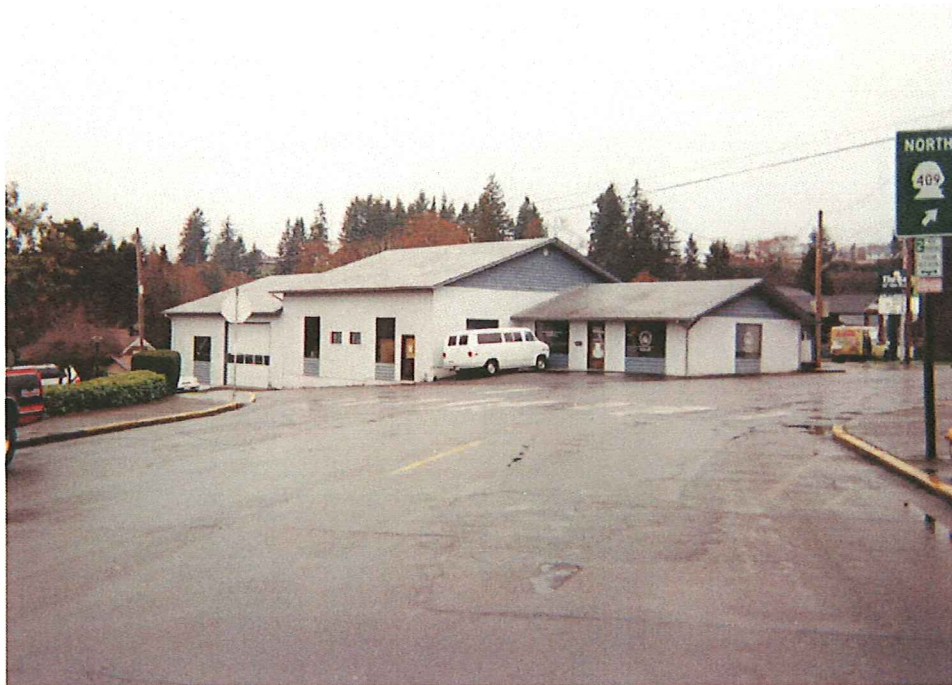
Photo #1: View of Site looking North from Main Street

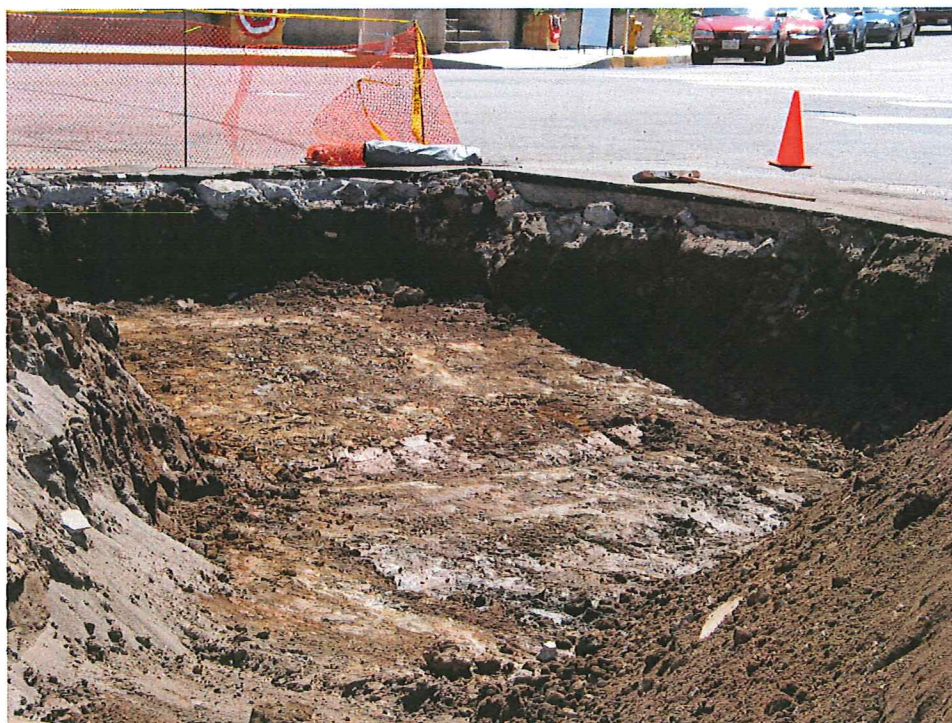
Photo #2: Former UST area SW corner of the Site

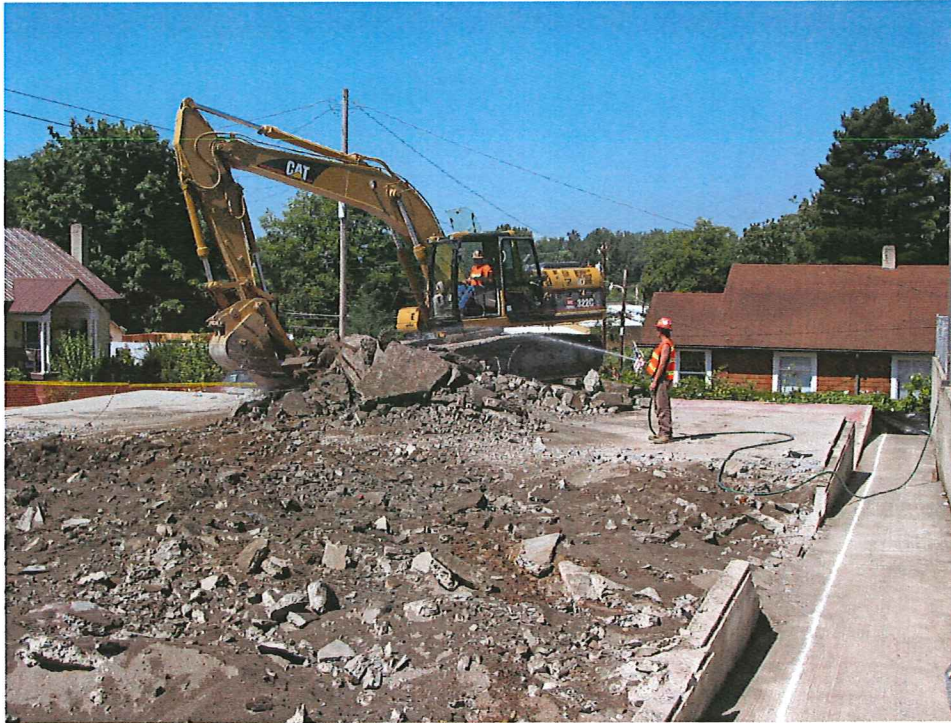
Photo #3: Slab demolition

Clearcreek mobilized to the Site on August 14, 2003 and completed demolition of the building slab on August 15, 2003. Waste concrete was transported to the Burns quarry on Elochman Valley Road in Cathlamet for disposal.

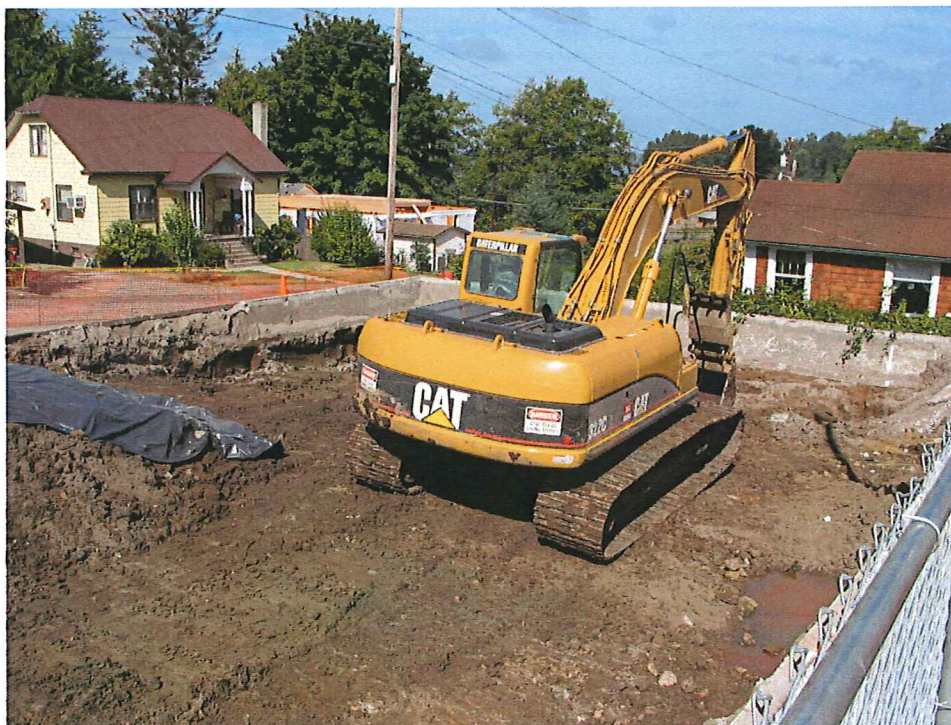
Photo #4: Excavation within former foundation looking NW

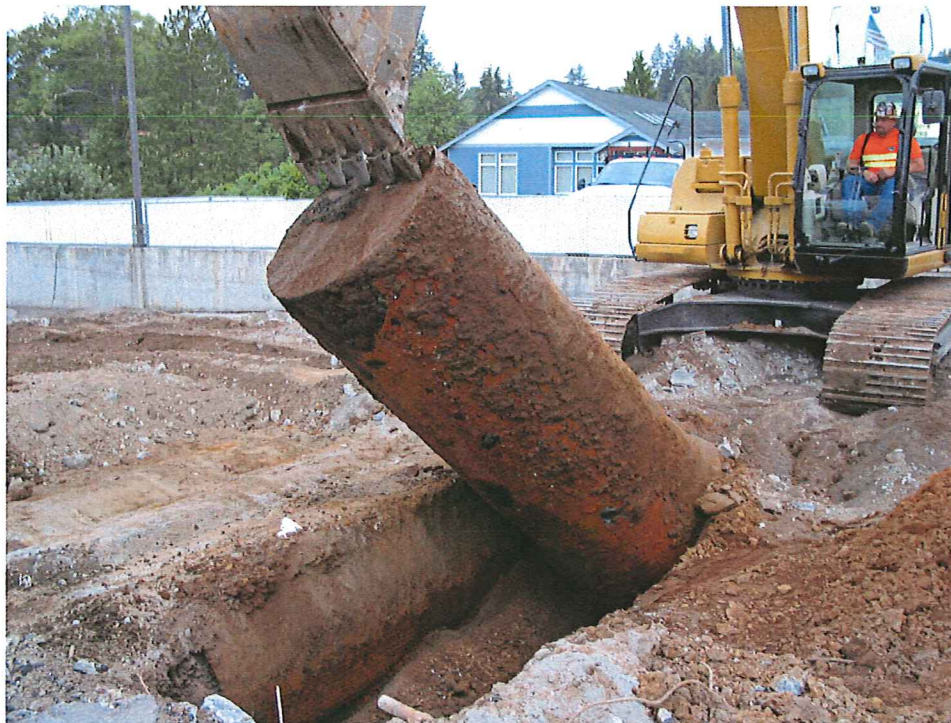
Photo #5: UST removal

The closed-in-placed USTs were excavated and cut open on August 15, 2003. The sand fill emplaced during UST closure was removed and stockpiled for subsequent disposal with the impacted soils. The empty USTs were then transported to Metro Metals Northwest in Kelso for recycling.

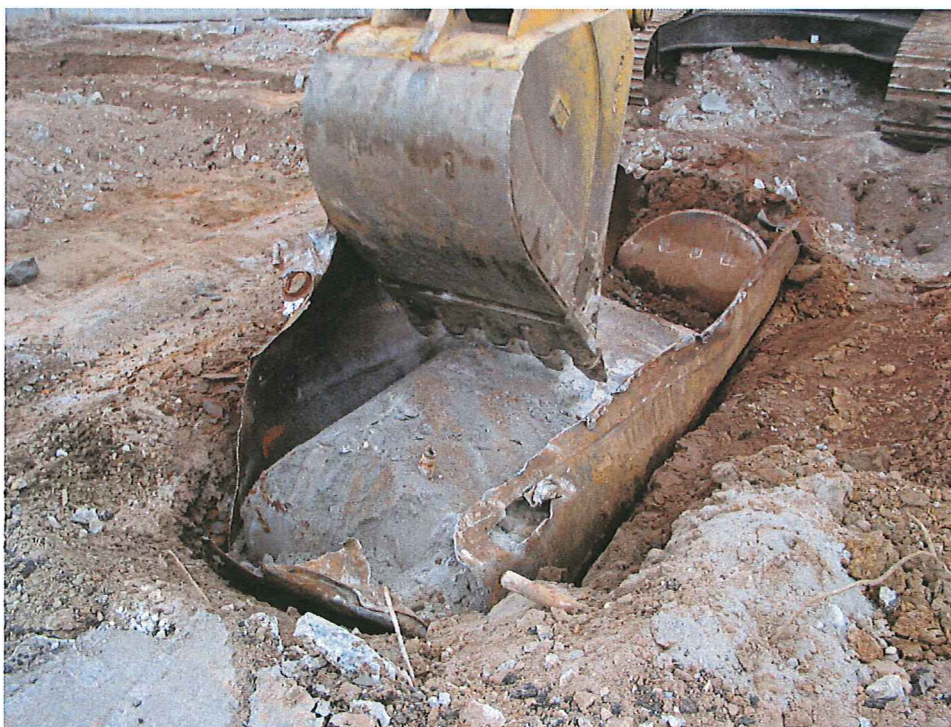
Photo #6: Removing contents of UST from former abandonment

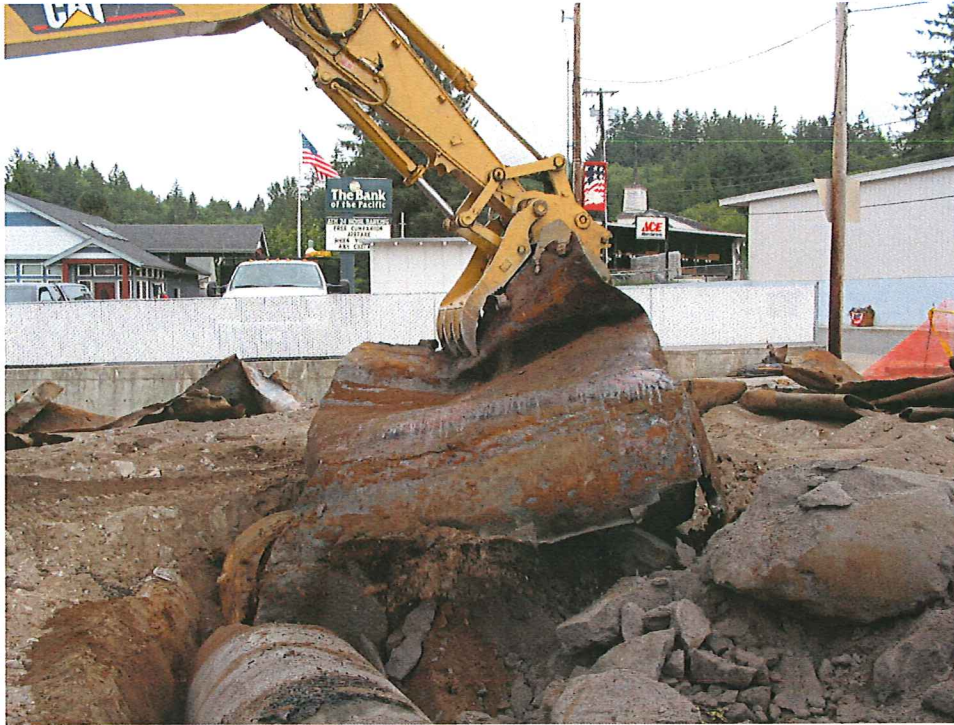
Photo #7: UST removal

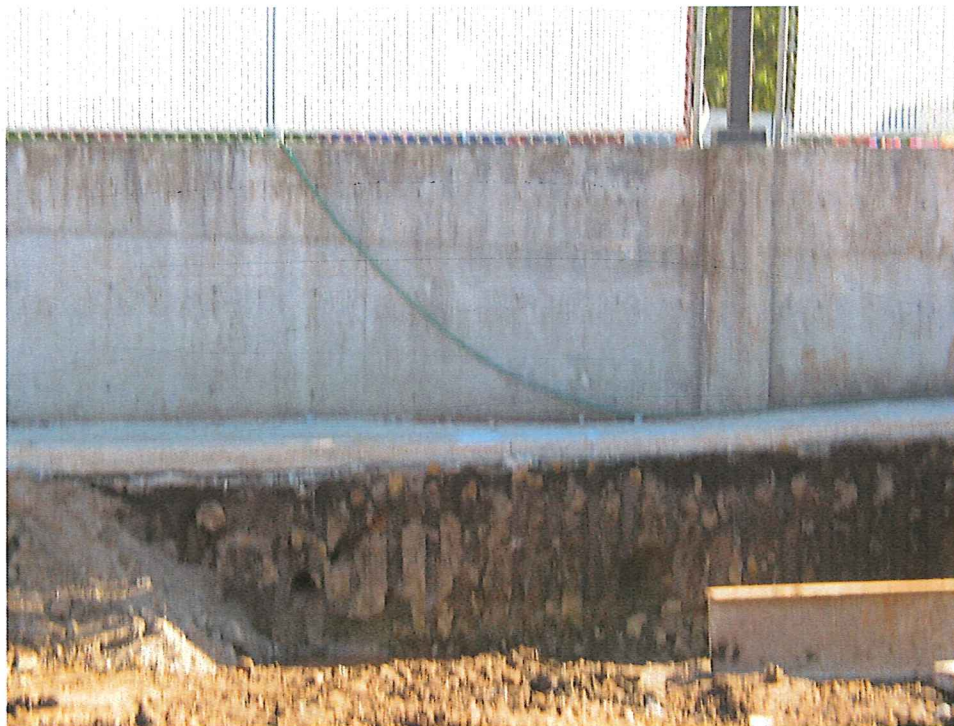
Photo #8: Excavation East wall below Bank parking lot

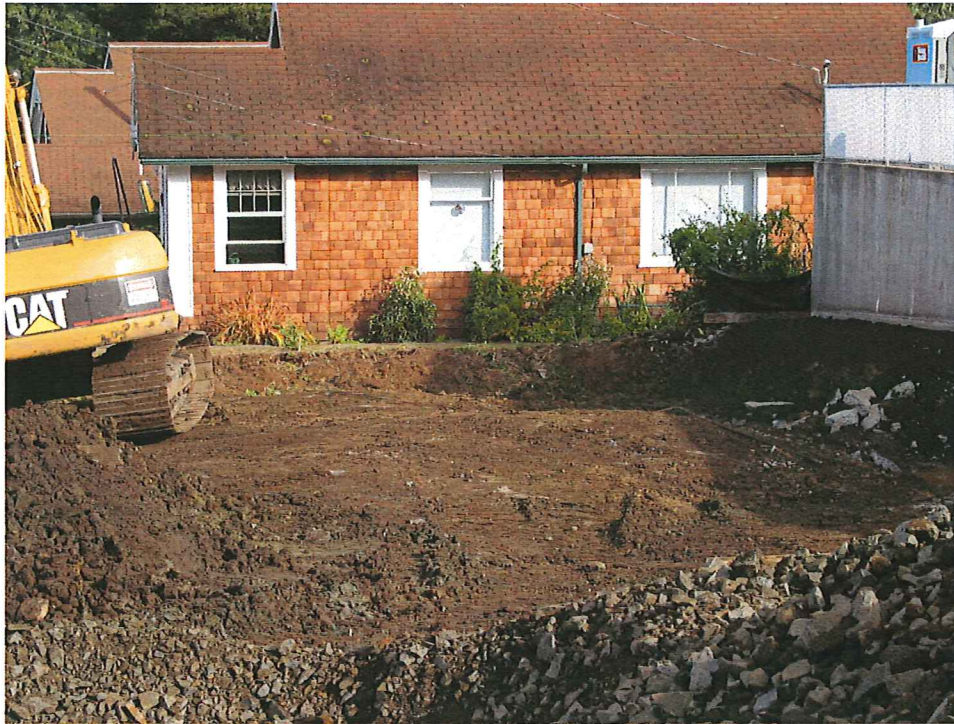
Photo #9: Excavation looking north towards Hobson Cottage

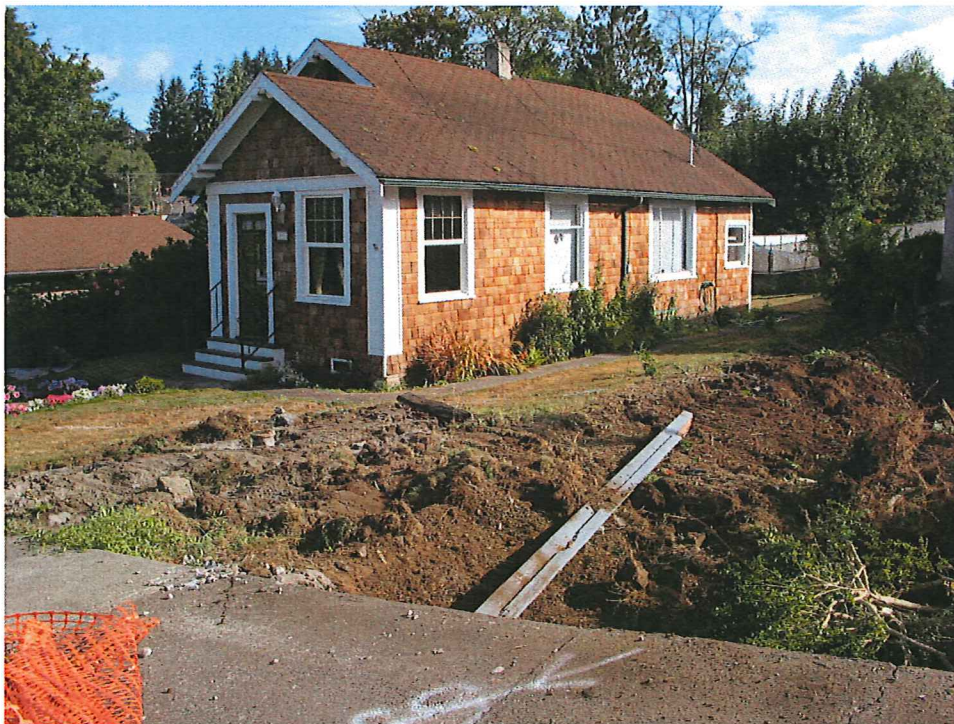
Photo #10: Excavation in Hobson Cottage yard

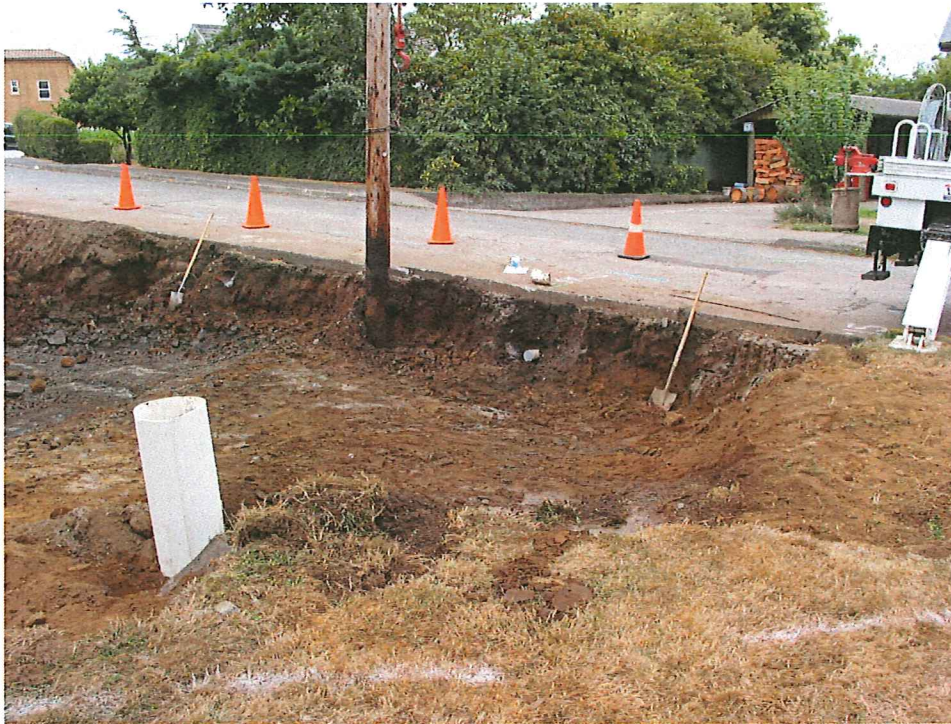
Photo #11: Excavation in Hobson yard looking SW towards Butler Street

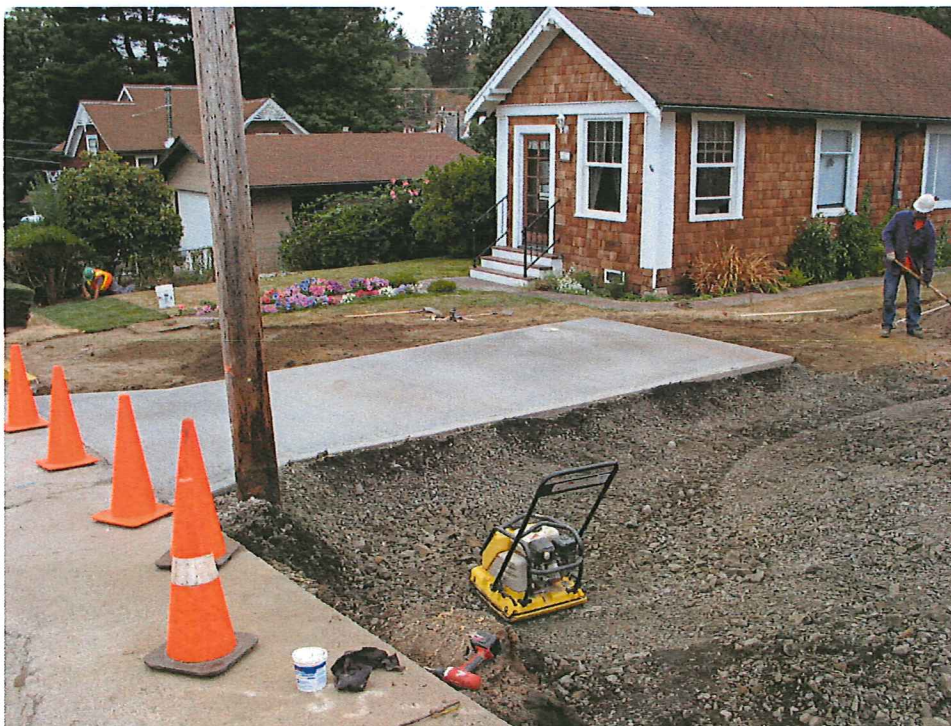
Photo #12: Site restoration Hobson Cottage and north end of site.

Excavation backfilling was completed between August 25 and August 29, 2003. Excavation backfill included 4-inch minus gravel subgrade and 1-1/4-inch gravel surface. Compaction was accomplished using a vibratory sled compactor, trackhoe-mounted plate compactor and a vibratory rolling compactor. The "Hobson Cottage" driveway was restored with a 4-inch concrete slab. A standard concrete curb was completed from the intersection of Main and Butler to the "Hobson Cottage" driveway. The excavated portion of the "Hobson Cottage" lawn was backfilled with topsoil and laid with sod.

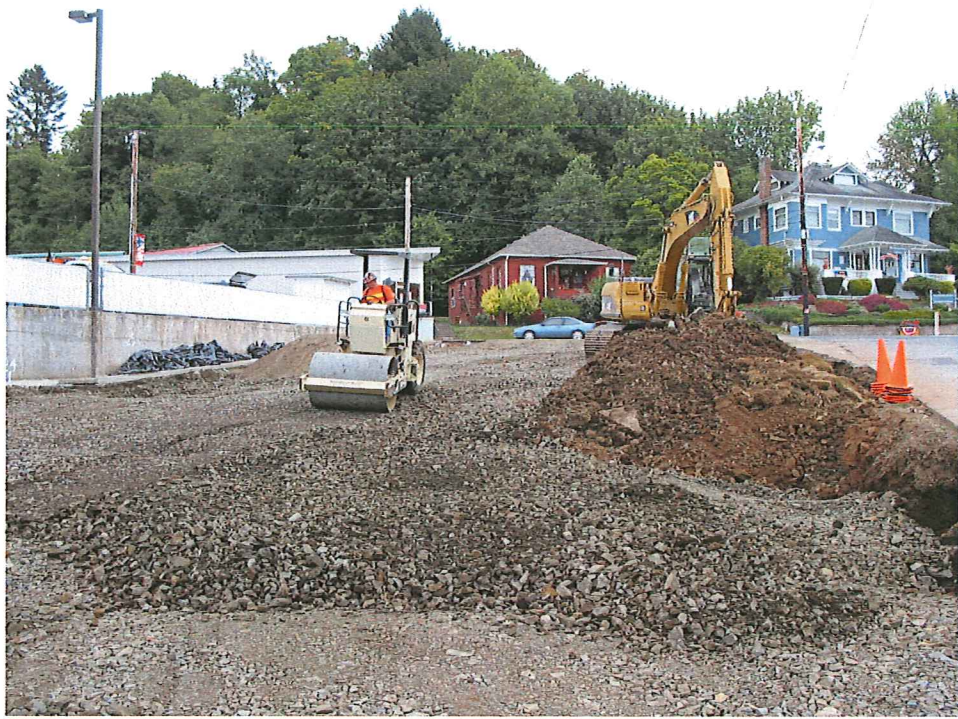
Photo #13: Site restoration (looking south)
