STATE OF WASHINGTON
DEPARTMENT OF ECOLOGY
1250 W Alder St • Union Gap, WA 98903-0009 • (509) 575-2490

Re: No Further Action at the following Site –Groundwater Model Remedy #5:

Site Name: Grandview Market Petrosun 1070
Site Address: 100 E Wine Country Road, Grandview
Facility Site No.: 91458995
Cleanup Site No.: 6845
VCP Project No.: CE0442

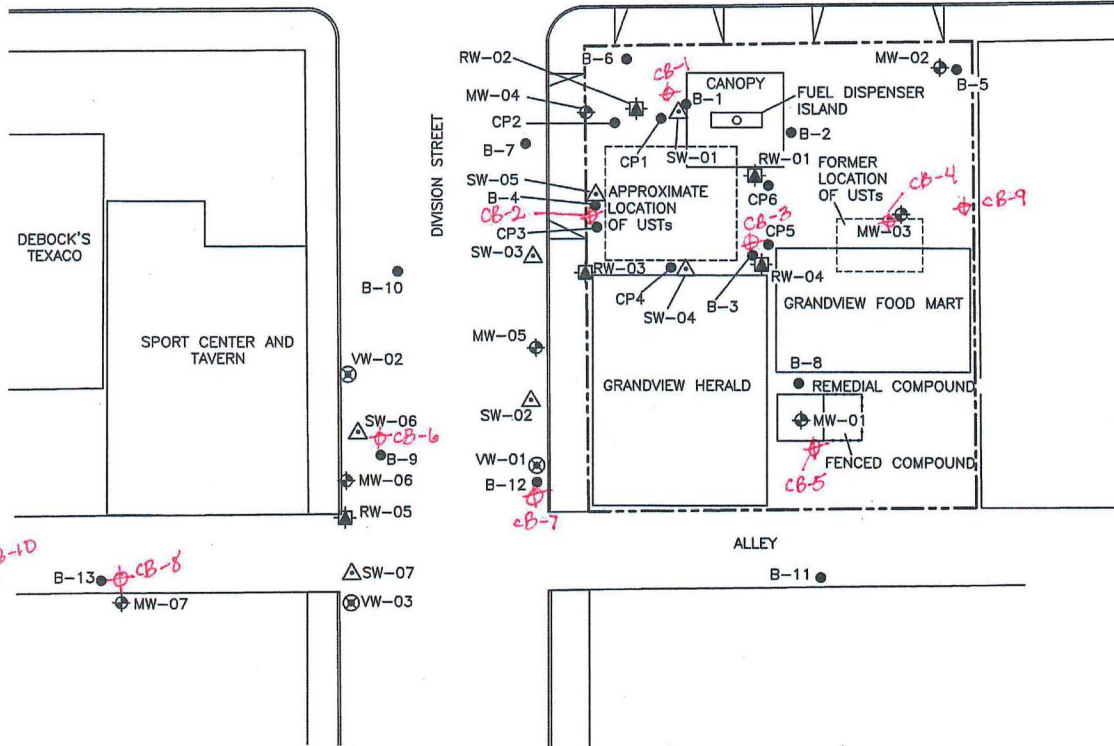
<p>ES ENGINEERING SERVICES <small>1 Park Plaza Suite 1000 Irvine CA 92614 949.261.0500 949.950.0524</small></p>	<p>FIGURE 2 SITE PLAN</p>	<p>DATE DRAWN 01/25/2018</p>
	<p>Site No. 0700 100 E. Wine Country Road Grandview, Washington</p>	<p>PROJECT NO. 123243</p>
		<p>FILE NO. 123243F2-SP</p>

Confirmational soil sampling performed in December 2016 found detectible concentrations of GRPH present at 17 ft bgs in soil borings CB-3 & CB-10; and at 17 & 22 ft bgs in CB-4. However, the reported concentrations (max. 400 mg/kg) were significantly lower than the established CUL (1,500 mg/kg).

CB-3 and CB-4 are located near the source of the petroleum release at the Site. CB-10 is located down-gradient of monitoring well MW-7; a sentinel well used to characterize the lateral extent of groundwater contamination.

Based on the following, it appears the GRPH present in soil at CB-10 at 17 ft bgs is associated with a release from an adjacent cleanup Site to the west (Debocks Main Street Texaco (CSID: 6910)):

- Soil samples collected at CB-8, located closer to the release source and adjacent to MW-7, had no COC detections.
