Project No. 923-1000-005.5000

LANDSBURG MINE SITE – REMEDIAL ACTION PROGRESS REPORT FOR NOVEMBER 2018

November 2018 Photo Log

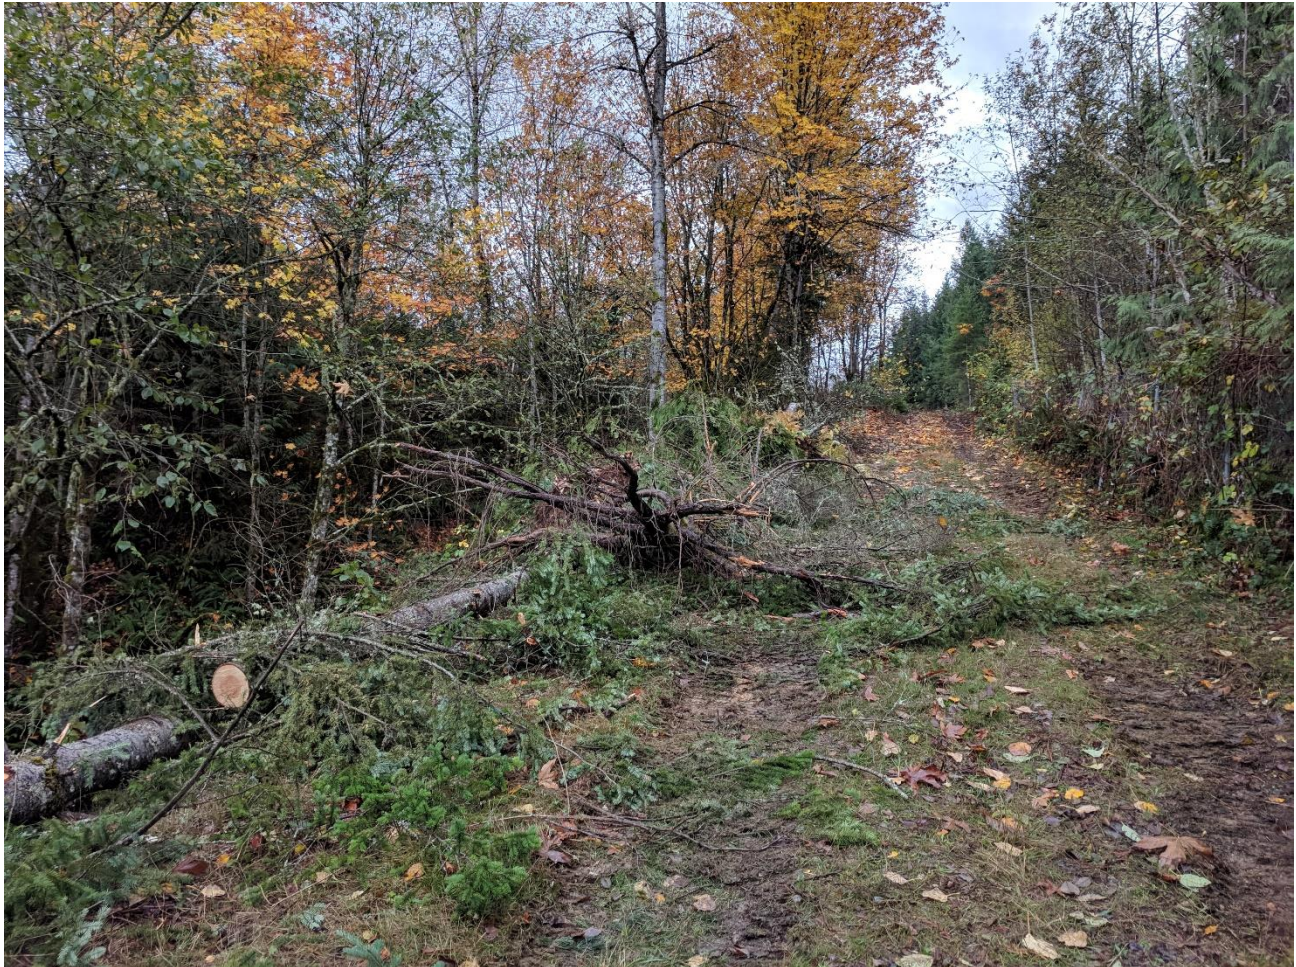
Photo 1 – View at start of tree removal along the top of the west edge of the trench.

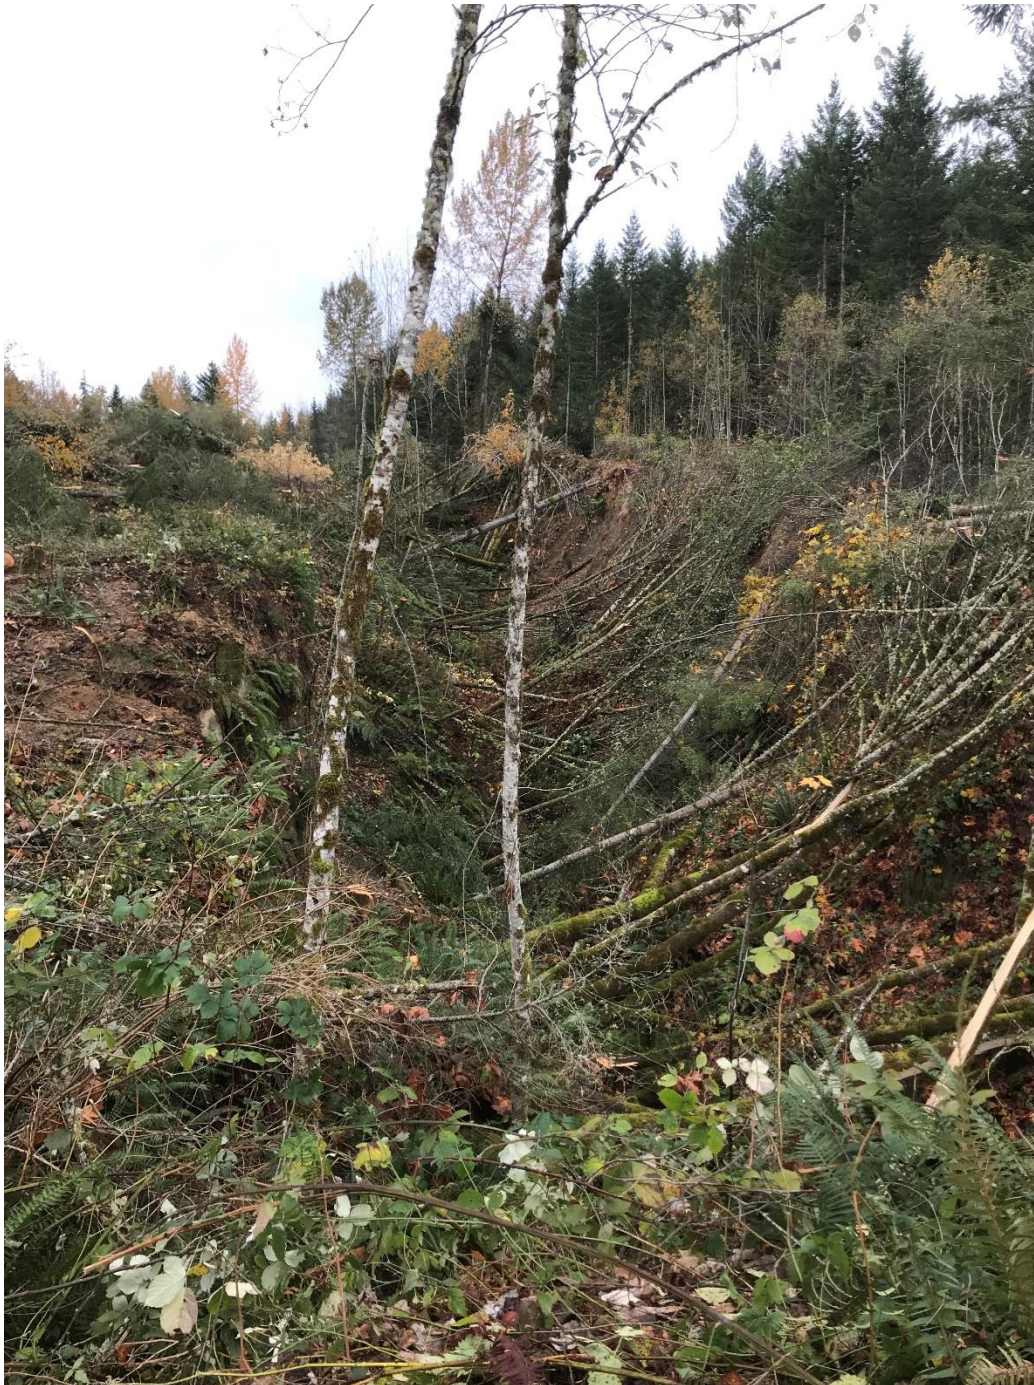
Photo 2 – Cut trees within trench, felled to lie against trench side-walls to allow removal with tree picker.

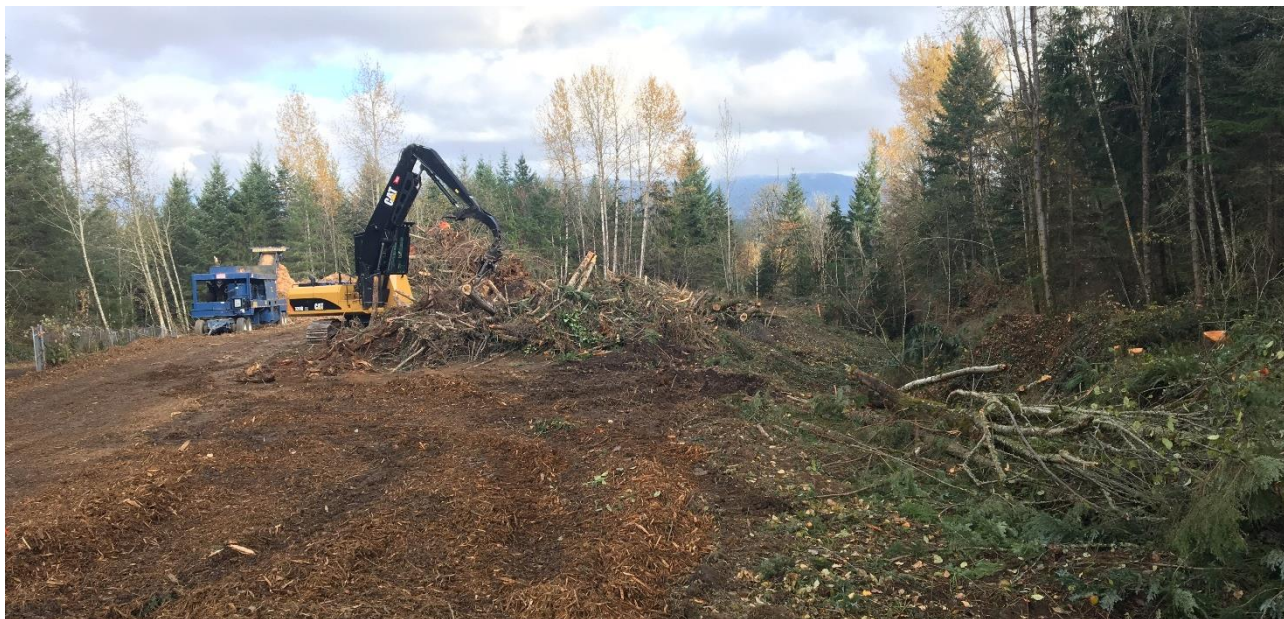
Photo 3 – View of Area 9 looking north from the southern tip. Wood chipping and wood stockpile area is on the left side.

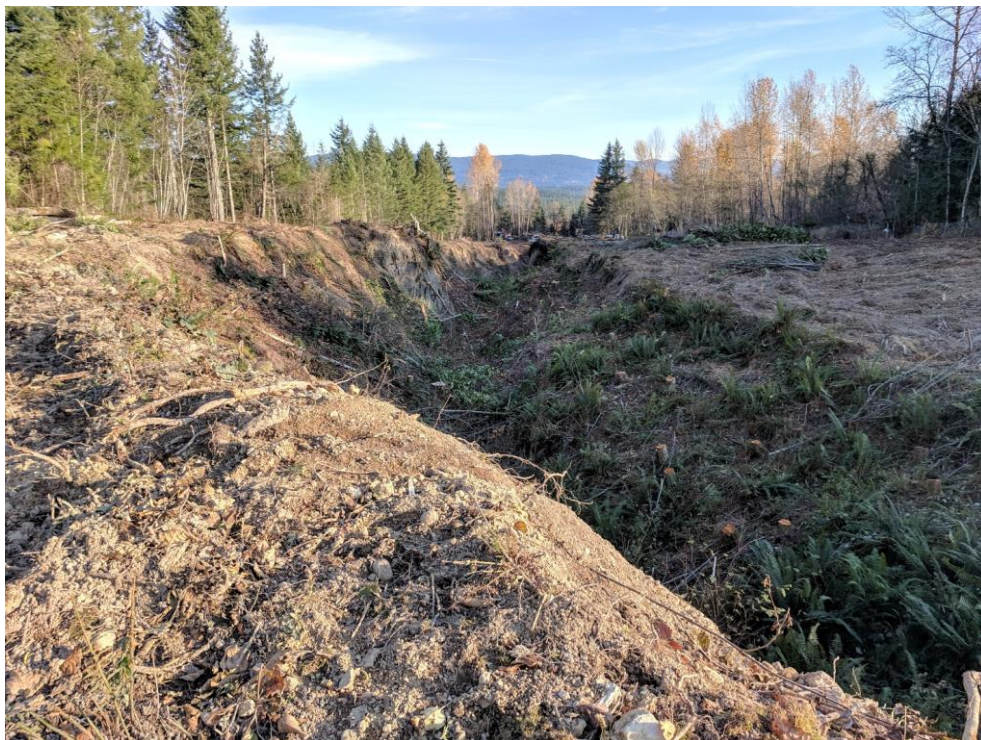
Photo 4 – View of Area 8 looking north from the middle of the west side, after tree removal.

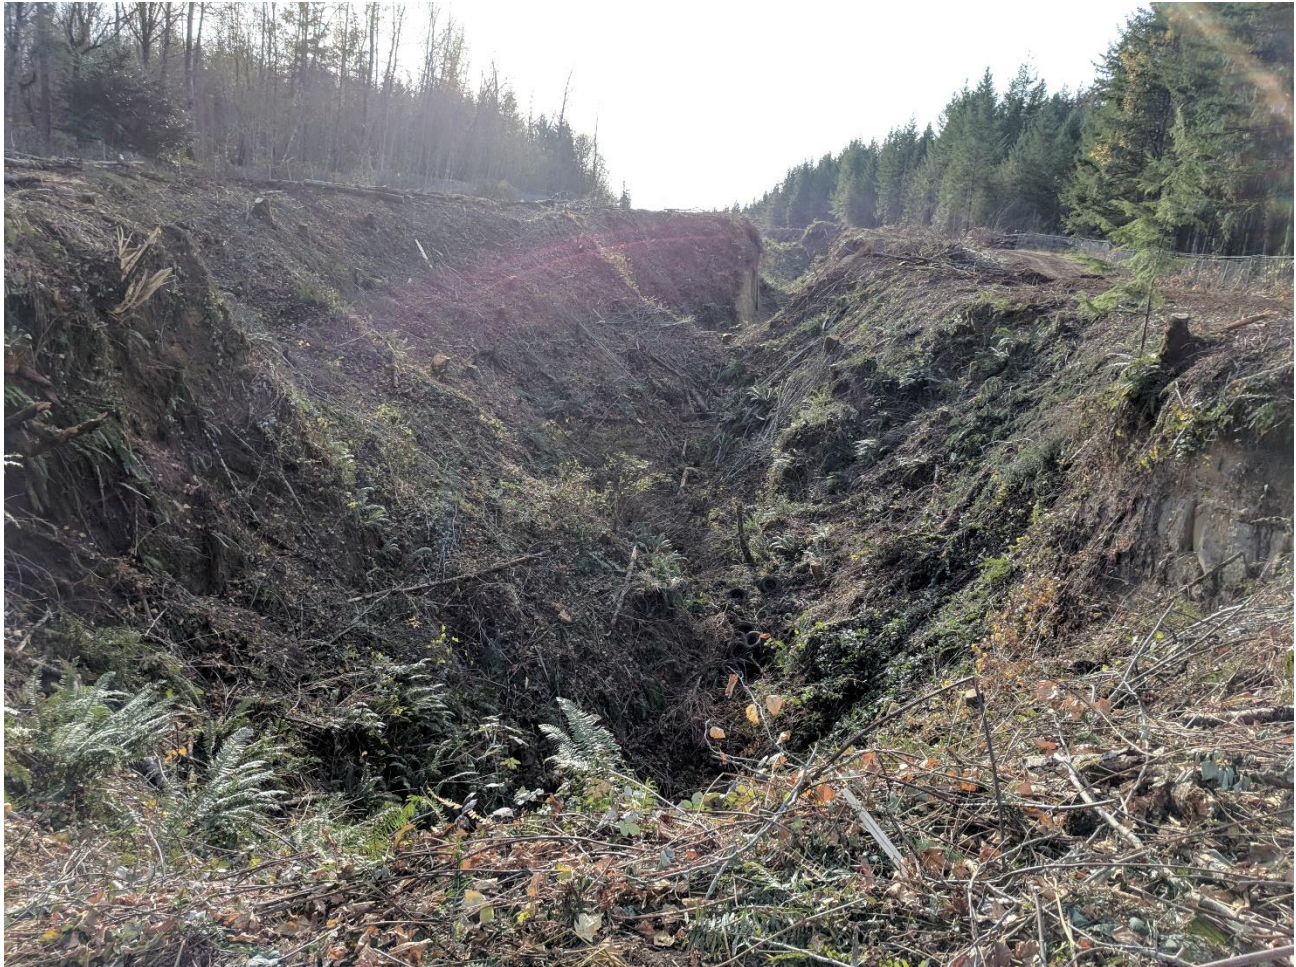
Photo 5 – View of Area 8 looking south from the north tip, after tree removal.

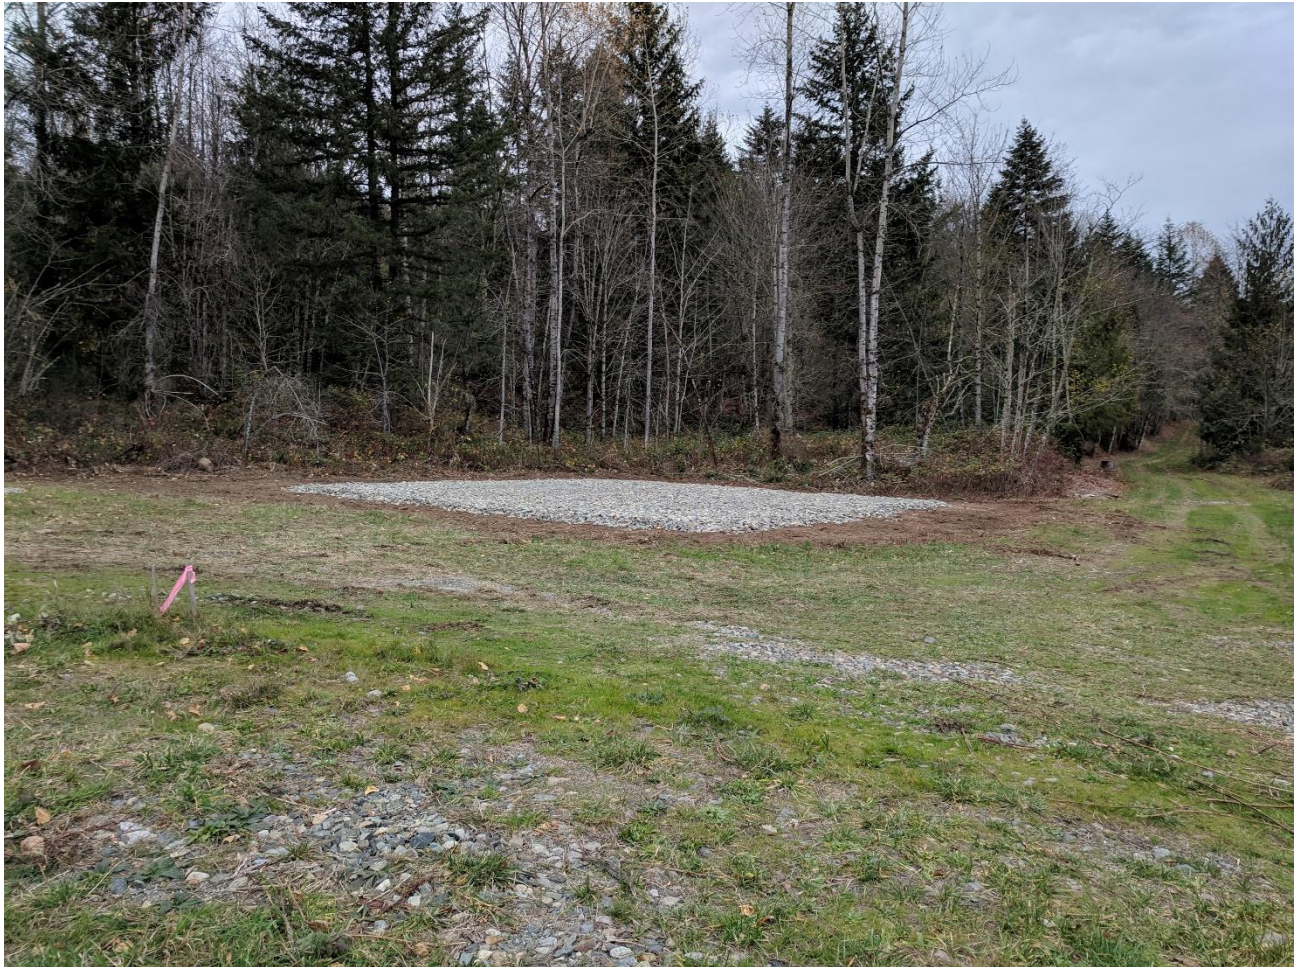
Photo 6 – View of south contingency treatment area that was cleared and rock pad placed.
