February 2018
Port Gamble Bay and Mill Site Cleanup Project

Final Cleanup Action Report – Season 2

Prepared for Pope Resources, LP/OPG Properties, LLC

Prepared by
Anchor QEA, LLC
720 Olive Way, Suite 1900
Seattle, Washington 98101

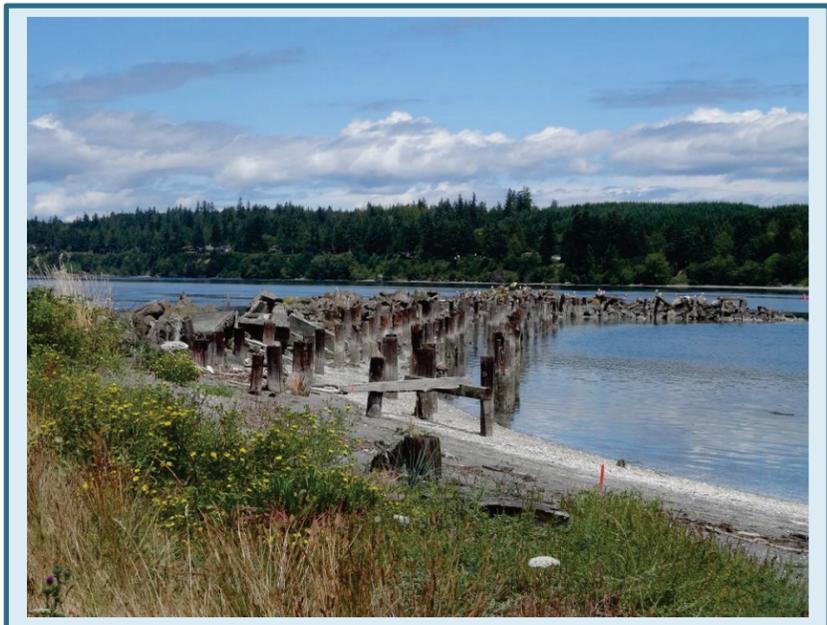
During Season 2 site inspections, several large pieces of concrete debris and additional creosote-treated piles were identified in the jetty, located south of the crest. Ecology provided direction on the removal of these pilings and pieces of concrete. To maintain the function of the jetty and remove the large concrete debris, it was agreed that on-site stockpiled riprap would be re-used to replace the concrete removed from the jetty and maintain the overall average elevation of the existing jetty crest. This work occurred during in August 2016 (Table 3) using land-based equipment (Section 3.1.1). Several untreated piles in the jetty south of the crest and below OHW were also removed.

SMA-1 Jetty – Prior to Piling Removal and Capping

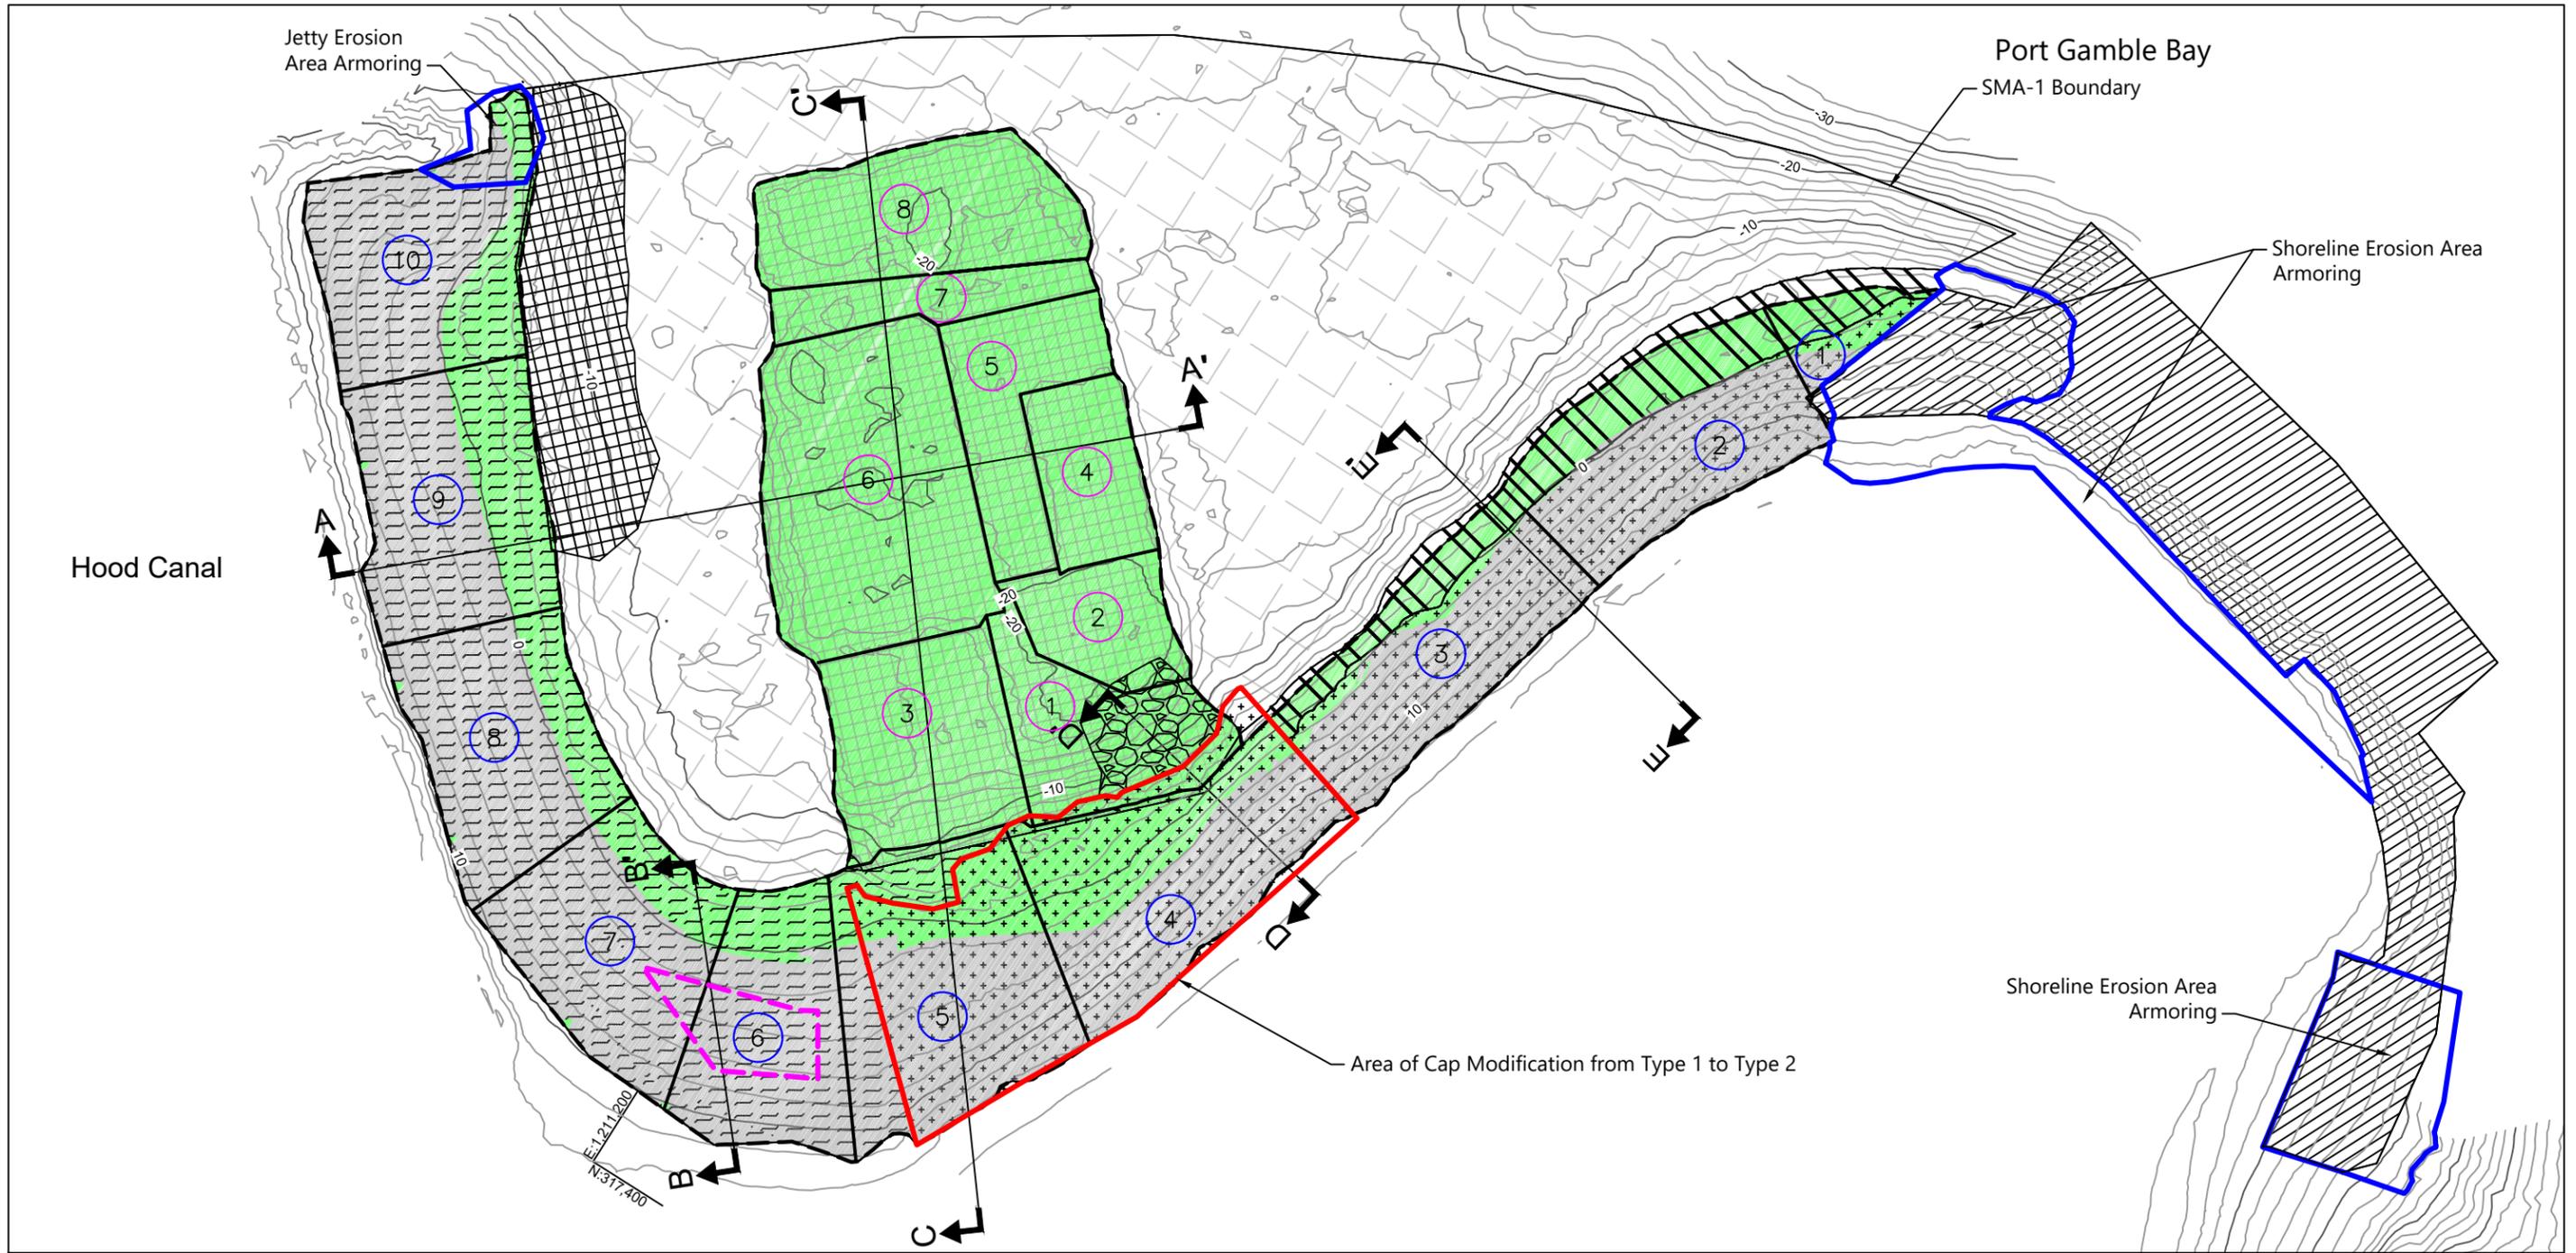
Figure 4a
SMA-1 Dredge and Material Placement Plan

A small, localized area of erosion within the previously installed Type 1 intertidal cap was identified at the end of the SMA-1 jetty. The cap modification and repair of this area was completed during the nighttime low tide on January 13, 2017, as discussed in Section 2.4.5.2. SMA-1 capping activities are discussed further in Section 3.3.2. The location of this repair is shown on Figure 4a.

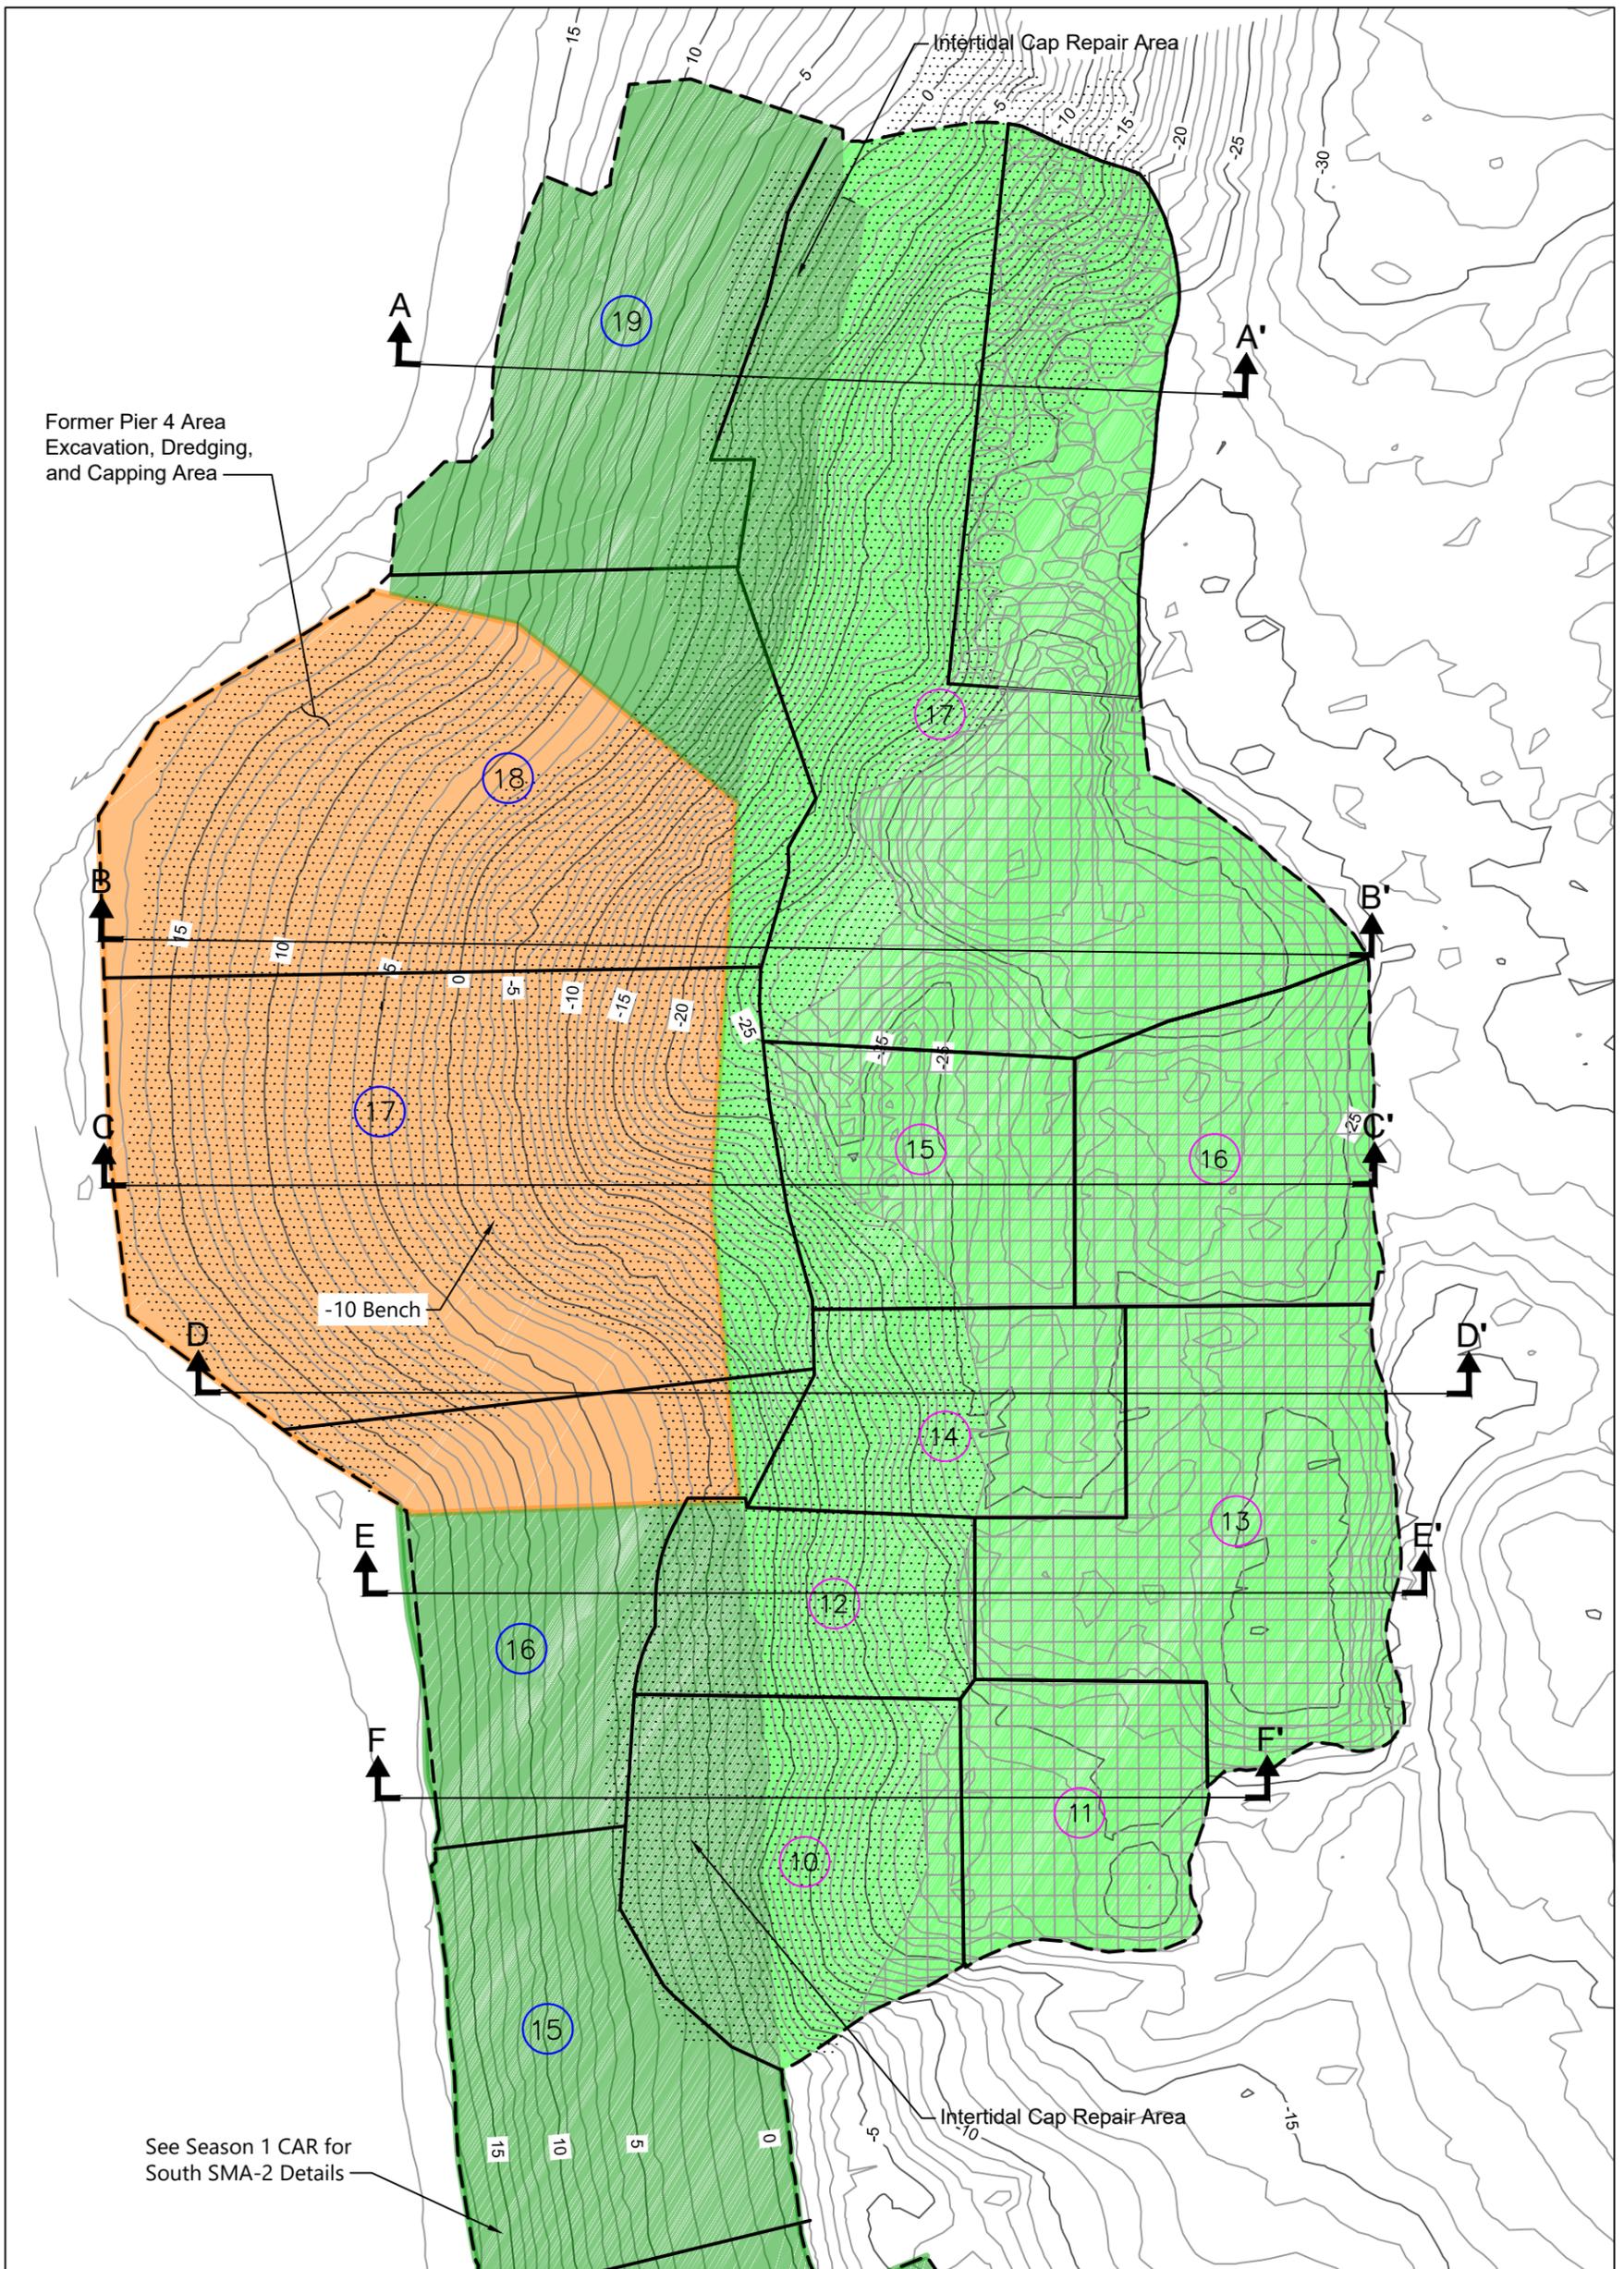
Figure 5a
SMA-2 Dredge and Material Placement Plan

As work progressed in SMA-2, OMCI encountered areas where wood waste deposits extended deeper than the (revised) SMA-2 dredge prism design elevations. A discussion of the design revisions implemented to address this condition during construction is included Section 2.4.3.

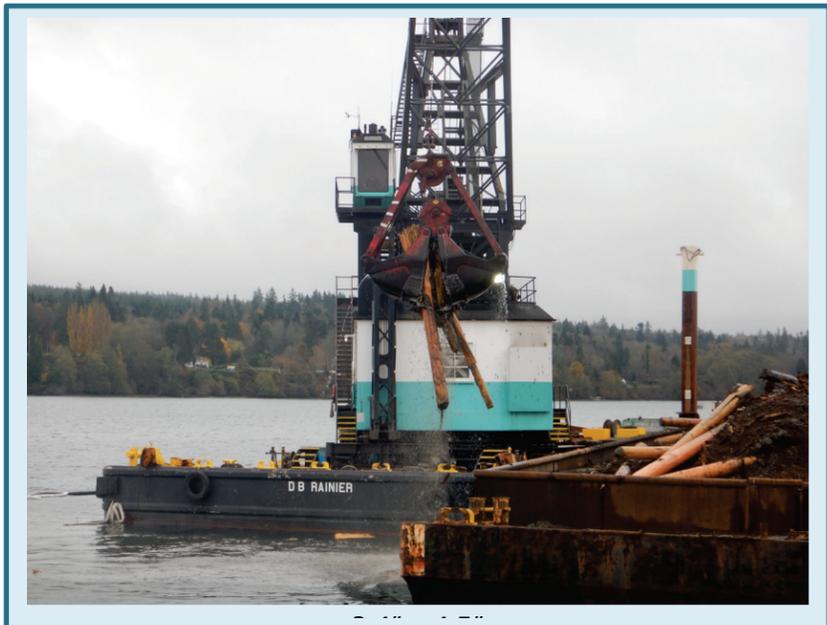
DB Rainier Dredging Area with Numerous Buried Pilings in SMA-2

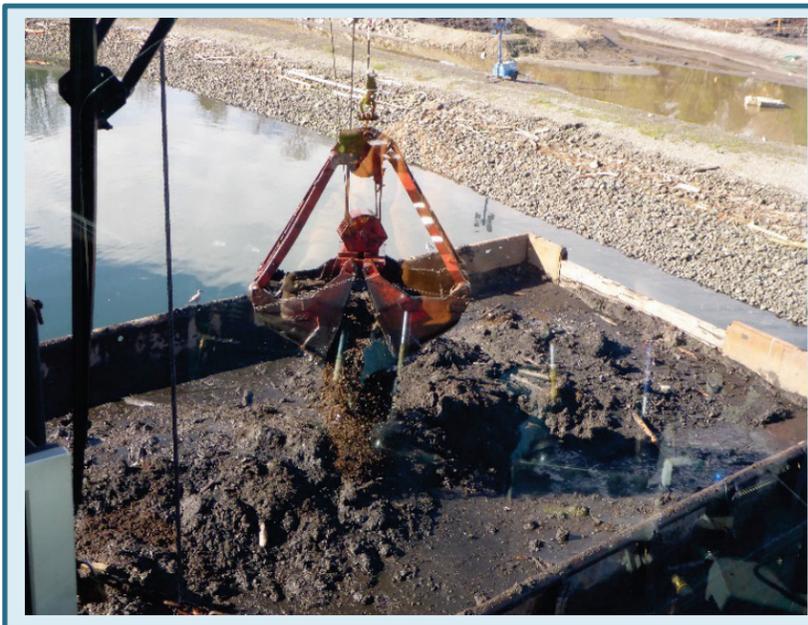
DB Rainier Dredging Wood Waste in Former Pier 4 Area

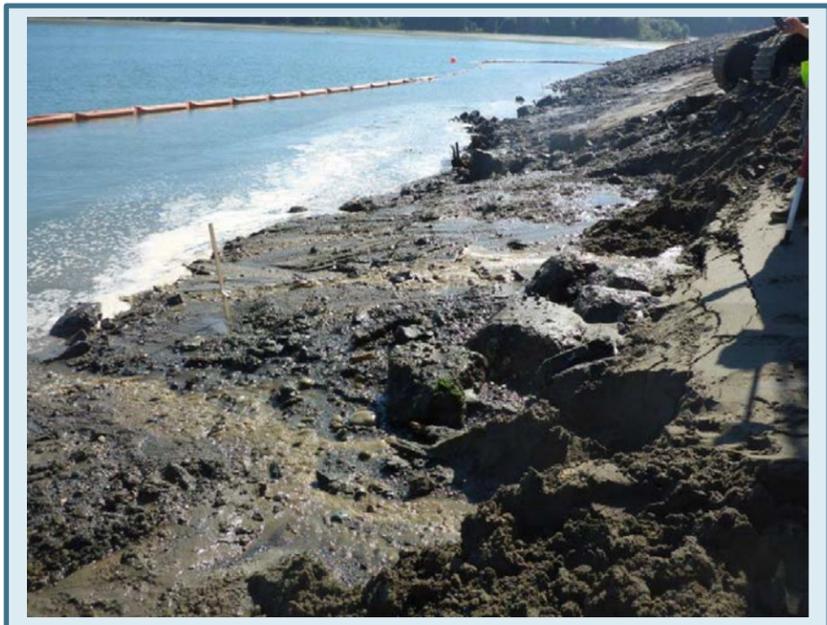
On December 16, 2016, erosion of the previously constructed SMA-1 intertidal cap was identified in the area of the seep that was observed during intertidal excavation. As discussed in Section 2.4.5.1, Anchor QEA proposed a cap design modification in this area to ensure this area remained protective. The cap modification included backfilling over-steepened sections of the intertidal slope with large salvage rock, substituting the Type 1 armor throughout this area with larger Type 2, and placing angular gravel backfill buttress material on the lower portion of the subtidal slope.

Seep Area Encountered During SMA-1 Intertidal Excavation

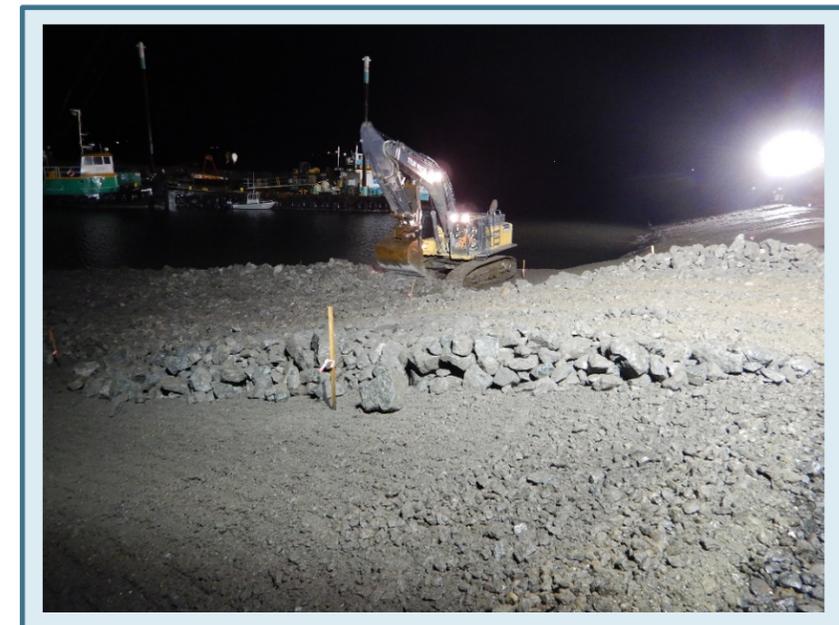
Cap repairs were performed within a portion of the SMA-1 Type 1 armor and filter layers that were damaged during construction (potentially by propeller wash and/or localized groundwater seepage), resulting in undermining of the toe of the 3H:1V constructed cap and exposing portions of the underlying filter material. The damaged cap areas were initially backfilled with larger salvaged armor rock to restore the 3H:1V slope, creating a buttress to provide additional stability. Wave modeling (Appendix C) was also performed to address the potential for wave induced scour associated with changes to the jetty breakwater. The wave modeling evaluation concluded that within the area of cap erosion (approximately 2,500 square yards [sy]), replacement of the original Type 1 armor with Type 2 armor would provide appropriate additional protection for this areas of SMA-1.

Placement of Type 2 Armor in SMA-1 Intertidal Cap Repair Area

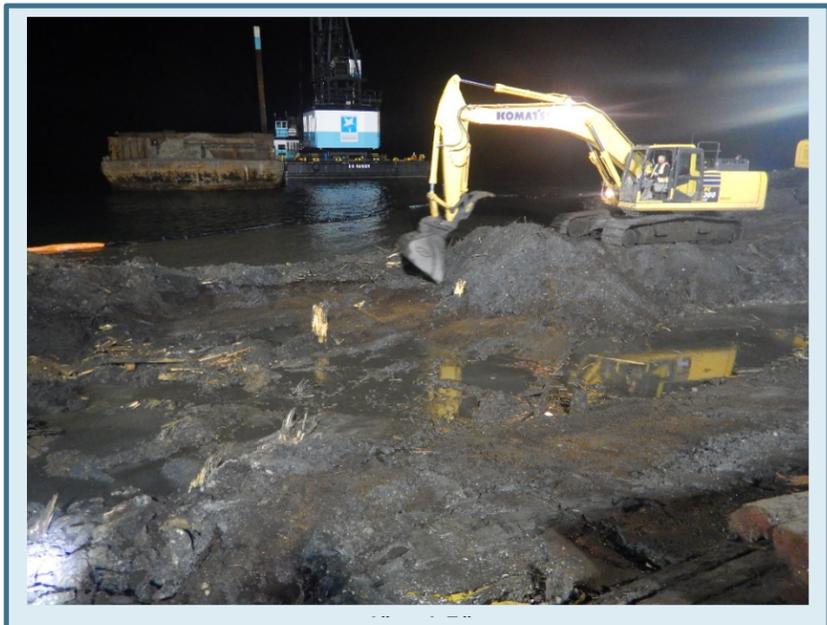
Former Pier 4 Area Additional Wood Waste Removal Above +0 MLLW

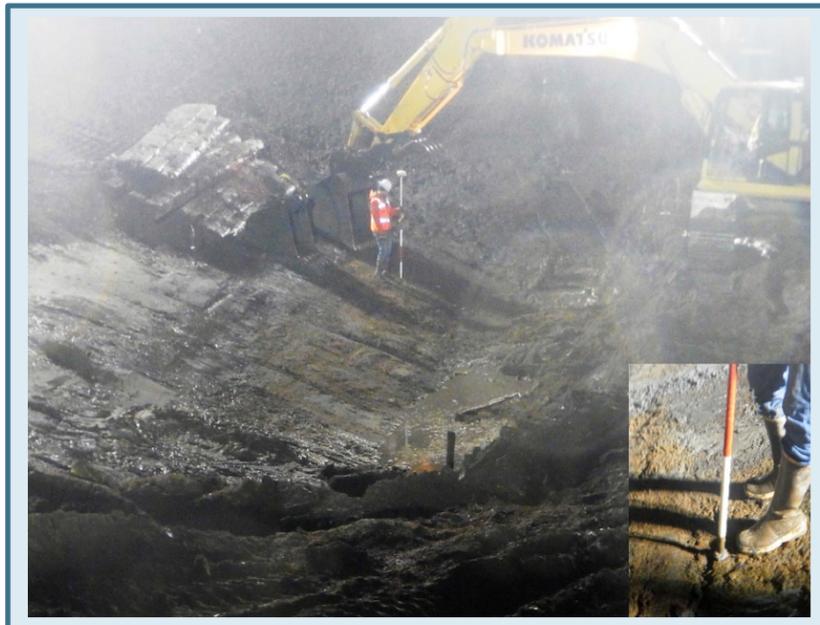
During the Season 2 dredging in SMA-2, a wood waste deposit was encountered within the bank and nearshore slope adjacent to the former Pier 4 area. The specific measures taken to remove this material are discussed in Section 3.2.7. A discussion of the design revisions implemented to address this condition during construction is provided below.

Wood Waste Deposit in Pier 4 Excavation at +2 MLLW
