STATE OF WASHINGTON
DEPARTMENT OF ECOLOGY

December 20, 2018

Re: Further Action at the following Site:

- **Site Name:** Provisioners Express Inc
- **Site Address:** 2102 West Valley Highway N, Auburn, WA 98001
- **Facility/Site No.:** 91612121
- **VCP Project No.:** NW3206
- **Cleanup Site ID:** 6847

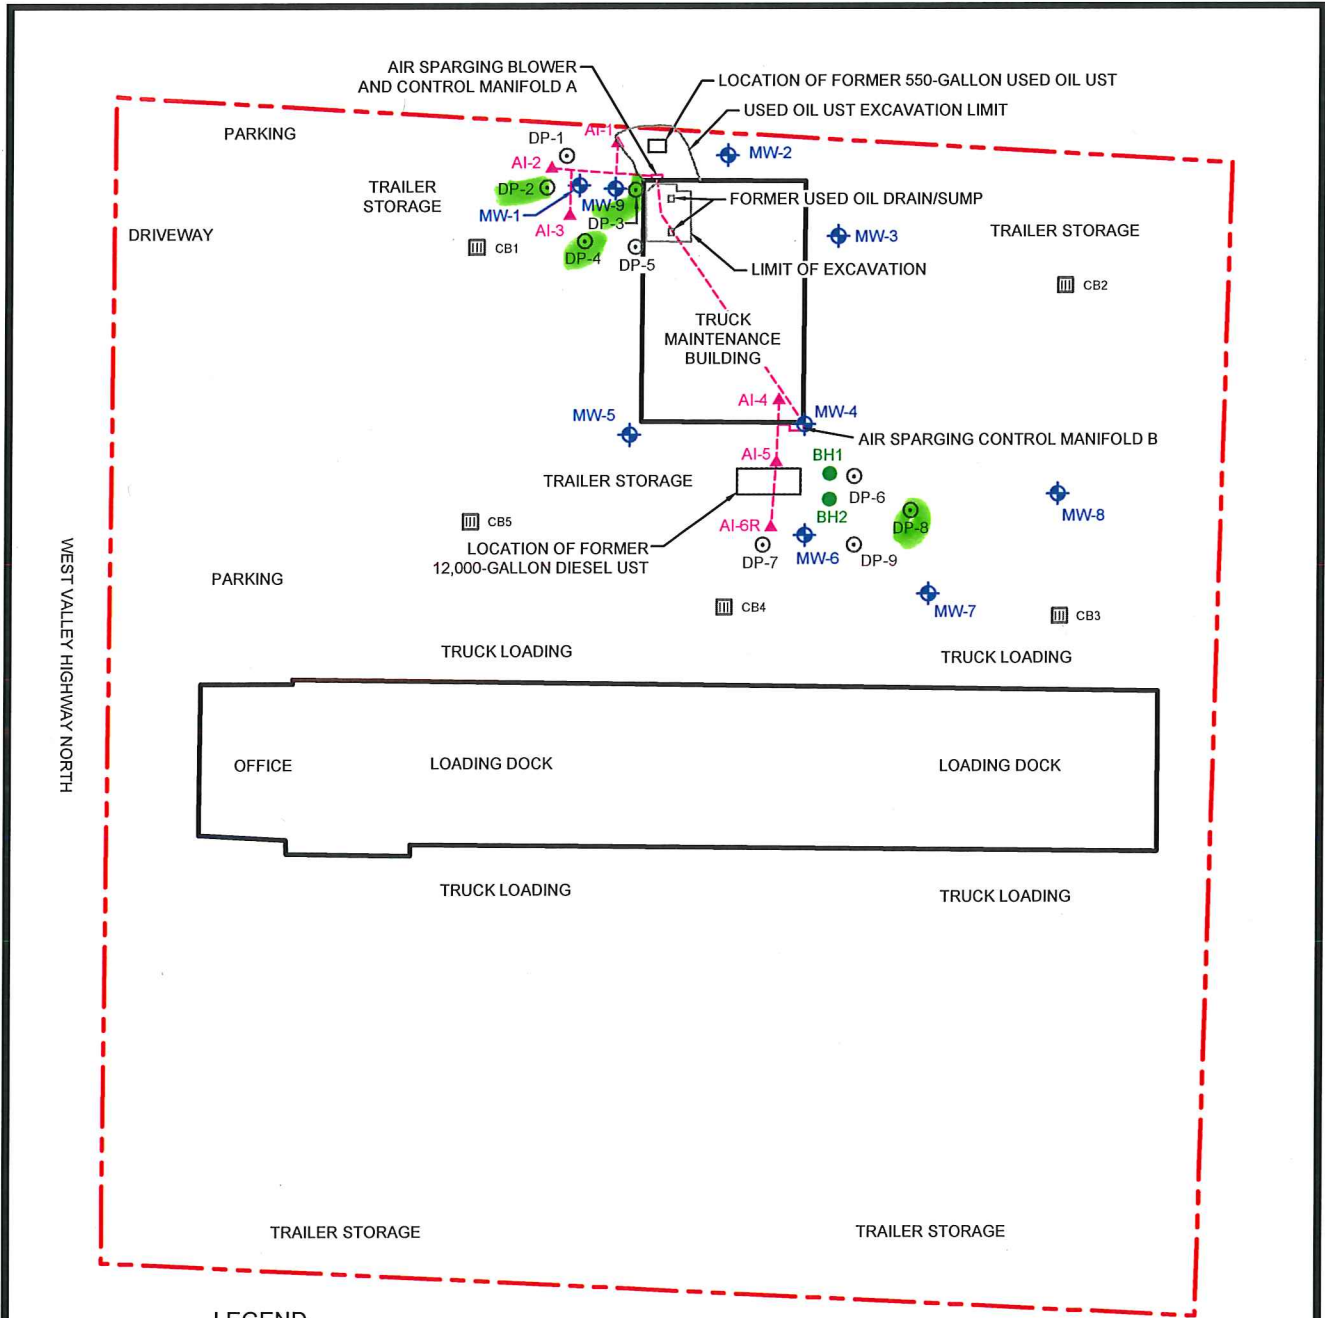
Enclosure A: Figure 2

One oil-water separator is located south of the vehicle maintenance building. Several above ground storage tanks (ASTs) were present on the Property for at least a period of time around 1998, including three oil ASTs located inside the western portion of the vehicle maintenance building, one waste oil AST connected to a waste oil burning heater inside the southeastern portion of the vehicle maintenance building, and a propane gas AST located immediately north of the vehicle maintenance building. Two floor drains and sumps were formerly located inside the northwestern portion of the vehicle maintenance building. The locations of the former USTs and floor drains/sumps are depicted on **Figure 2**.

Nine ground water monitoring wells (MW-1 through MW-9) are present at the Site (**Figure 2**). These monitoring wells were installed between 1998 and 2017, and completed to total depths ranging between 13 and 15 feet bgs. Screens were installed from 5 to 15 feet bgs for monitoring wells MW-1 through MW-6, from 4 to 14 feet bgs for monitoring wells MW-7 and MW-8, and from 3 to 13 feet bgs for monitoring well MW-9.
