WEEKLY SUMMARY REPORT

PROJECT NO.: 130388-01.02

REPORT NO.: 045

PROJECT NAME/LOCATION: Port Gamble Bay Cleanup

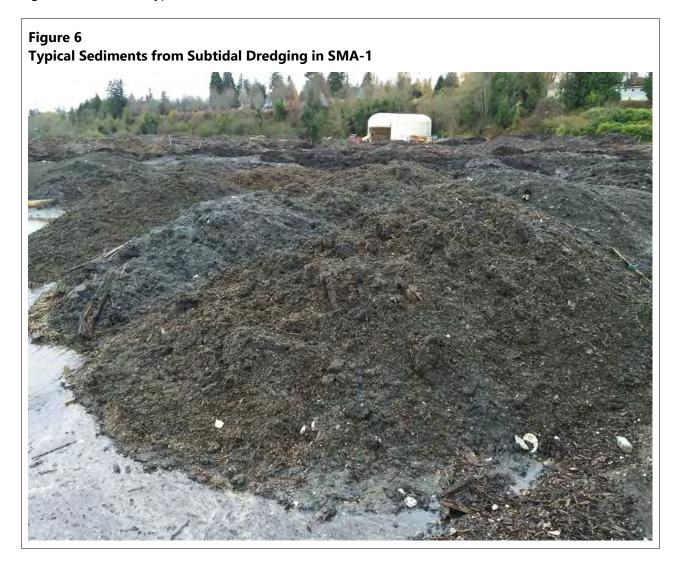
Subtidal sediments from dredging in SMA-1 were observed as they were stockpiled on the mill site, because it was not possible to observe directly from the dredging barge due to health and safety considerations. Observed sediments were of two types: subtidal silty sand with fragments of modern shell, and wood waste mixed with sandy silt. The latter was notable for the degree to which wood chips appeared intact, with a landscaping mulch-like appearance. Both types of sediments contained sparse evidence of historic activity such as metal cable, PVC pipe, glass, fabric, and metal fragments. Figure 6 shows both types of sediments.
