Phase II Evaluation (April 28, 1994) – 2759 First Avenue South

E-5370-3

**Subject: Phase II Evaluation
Sears Auto Center
Seattle, Washington**

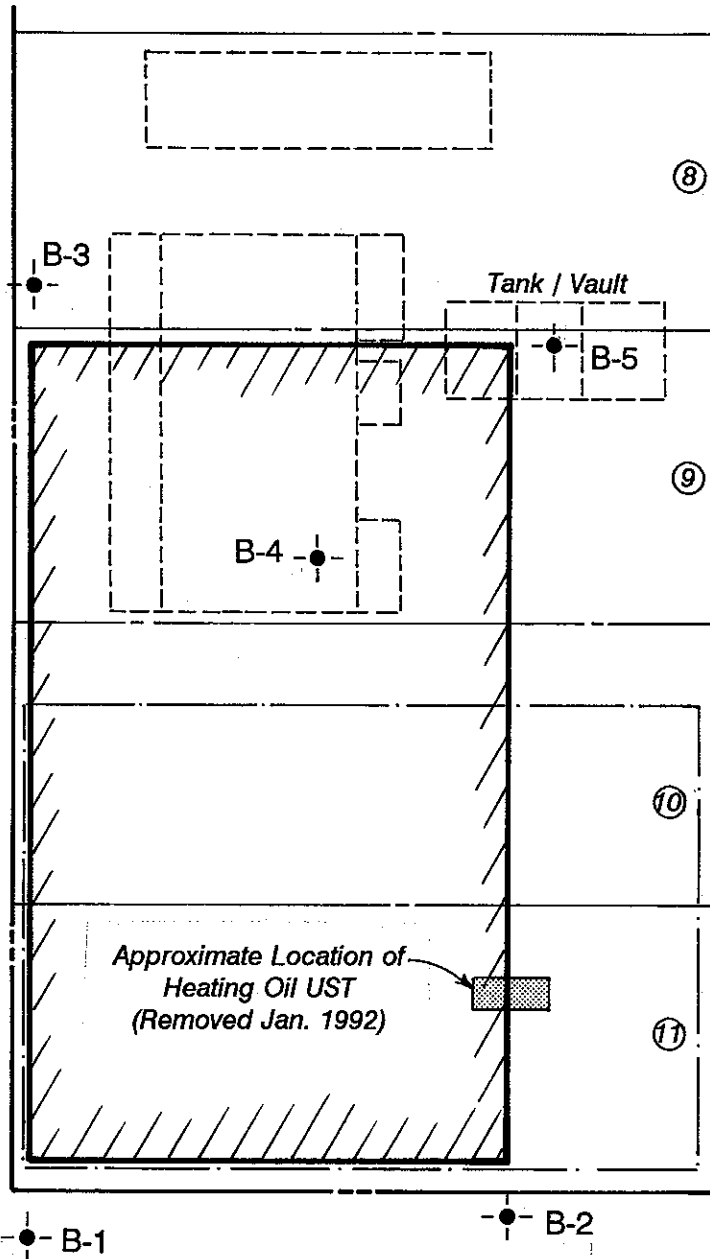
Plate 1

A review has been completed of associated reports (1, 2, 3, 4) and historical maps (5, 6) for the subject area. An attached figure (Plate 1), overlays the position of the existing building structure on historical structure locations. The positions of soil borings performed by Earth Consultants, Inc. under project number E-5730 in August of 1991 (1) are also indicated.

- The northeast corner of the current structure for the Sears Auto Center is located over what would have been the western end of the subject vault. During construction of the current building, the existing building perimeter was overexcavated to four and one-half feet below grade and extending at least four feet beyond the perimeter (3). If a vault or tank was present, it would have been encountered at that time. No structure was encountered.

Approximate Location of Heating Oil UST (Removed Jan. 1992)

Based upon the review of referenced documents and records, ECI believes that the three-celled structure no longer exists and has not existed for a considerable time. Per conversation between Joe Nessel, of Earth Consultants, Inc. and Doug Knowlton, of the Washington State Department of Ecology, Underground Storage Tank Section, April 20, 1994, it appears that the structure was closed in accordance with the regulatory requirements of the time, there has been no release of contaminants and no release is to be expected; and in the absence of the structure and any release, UST issues are not involved and no further action is required with respect to the three-celled tank.
