June 9, 1991 55-1884-02

RE: Plum Street Site Investigation

Figure 1.
Diagram of Trench Layout
and Approximate Sample
Locations at the Plum Street Site

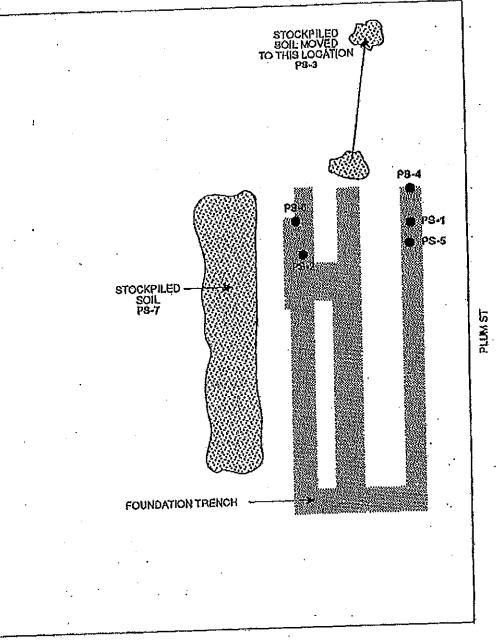
Two water samples were collected from the trenches by filling the bottles beneath the water surface. Water sample PS-1 was collected in from the northeast corner of the trench in the area that the oil sheen had first been detected. Water sample PS-2 was collected in the northwest corner of the trench.

Three soil samples were collected from the sidewall of the trench in areas that were visibly stained or showed a sheen. These soil samples were collected with stainless steel spoons. Sample PS-4 was collected in the northeast end of the trench at the interface between the silt and sand layers at a depth that ranged from 1-2.5-feet. Sample PS-5 was collected from the bottom of the trench approximately 15-feet south of sample PS-4. This was at the area

where the oil sheen had been observed in the water. This sample was collected at a depth of approximately 3.5 feet in a mixture of sand, peat and organic material. Sample PS-6 was collected from the west sidewall of the northwest corner of the trench. The sample was collected at a depth of 2.5-feet in a layer of sand that had a slight diesel-odor.

During the site visit an area of excavated material near the northwest corner of the trench had a slight diesel odor. Approximately 10 cubic yards of this material was moved onto a layer of visqueen at the northeast corner of the site. A composite sample (PS-3) of this material was collected. Mr. Valdez indicated that this material would be covered with visqueen by the end of the day to keep the material protected from rain.

A composite sample (PS-7) was also collected from a lift of excavated material that was deposited west of the trench during excavation. The quantity of stockpiled material in this was later estimated to be approximately 60 cubic yards by Mr. Ron Valdez.

A copy of the results of the soil and water analysis is enclosed. One water sample PS-2 was found to contain 1 part per million (PPM) of TPH as indicated by Method 418.1. This is the current action level set by the Washington State Department of Ecology (DOE). Three soil samples were found to contain TPH (as indicated by method 8015) in excess of the current action level of 200 PPM TPH (other than gasoline). All hydrocarbons detected with Method 8015 appeared to be similar to # 1 diesel fuel. Two of the samples (PS-3&7) in excess of the cleanup standard (3,720 PPM TPH and 731 PPM TPH respectively) were from excavated material and the third sample (PS-6 at 1,236 PPM TPH) was from the sidewall of the trench.

Several old treated pilings and timbers were noted in the northeast corner of the trench. The oil sheen observed in this section of the trench may be the result of leaching from treated wood. The sand layer in the northwest corner of the trench had a slight diesel odor

and a sheen was observed leaching into the water in this area during the site visit after the water level in the trench had been lowered by pumping.

All of the excavated material that was sampled (2 samples) showed levels of TPH contamination in excess of the cleanup standard. The water samples collected in the trench following the removal of water by the vacuum truck did not contain TPH in excess of the current DQE action levels.

Based on the new information discovered during the current construction activities, we recommend that additional sampling and analysis of soil and groundwater be conducted to assess the site's subsurface conditions specifically in the area of current construction and other areas of the site that have not been previously evaluated. If you have any questions regarding this information please contact me, Mr. Clyde Moore, or Ms. Julie Wukelic at Parametrix.
