AS-BUILT REPORT FOR RAU-WIDE CAPPING
Pulp and Tissue Mill Remedial Action Unit
Georgia-Pacific West Site
Bellingham, Washington
Volume 2: RAU-Wide Capping

Prepared for: Port of Bellingham

Project No. 140298-001-15 • February 28, 2017 Final

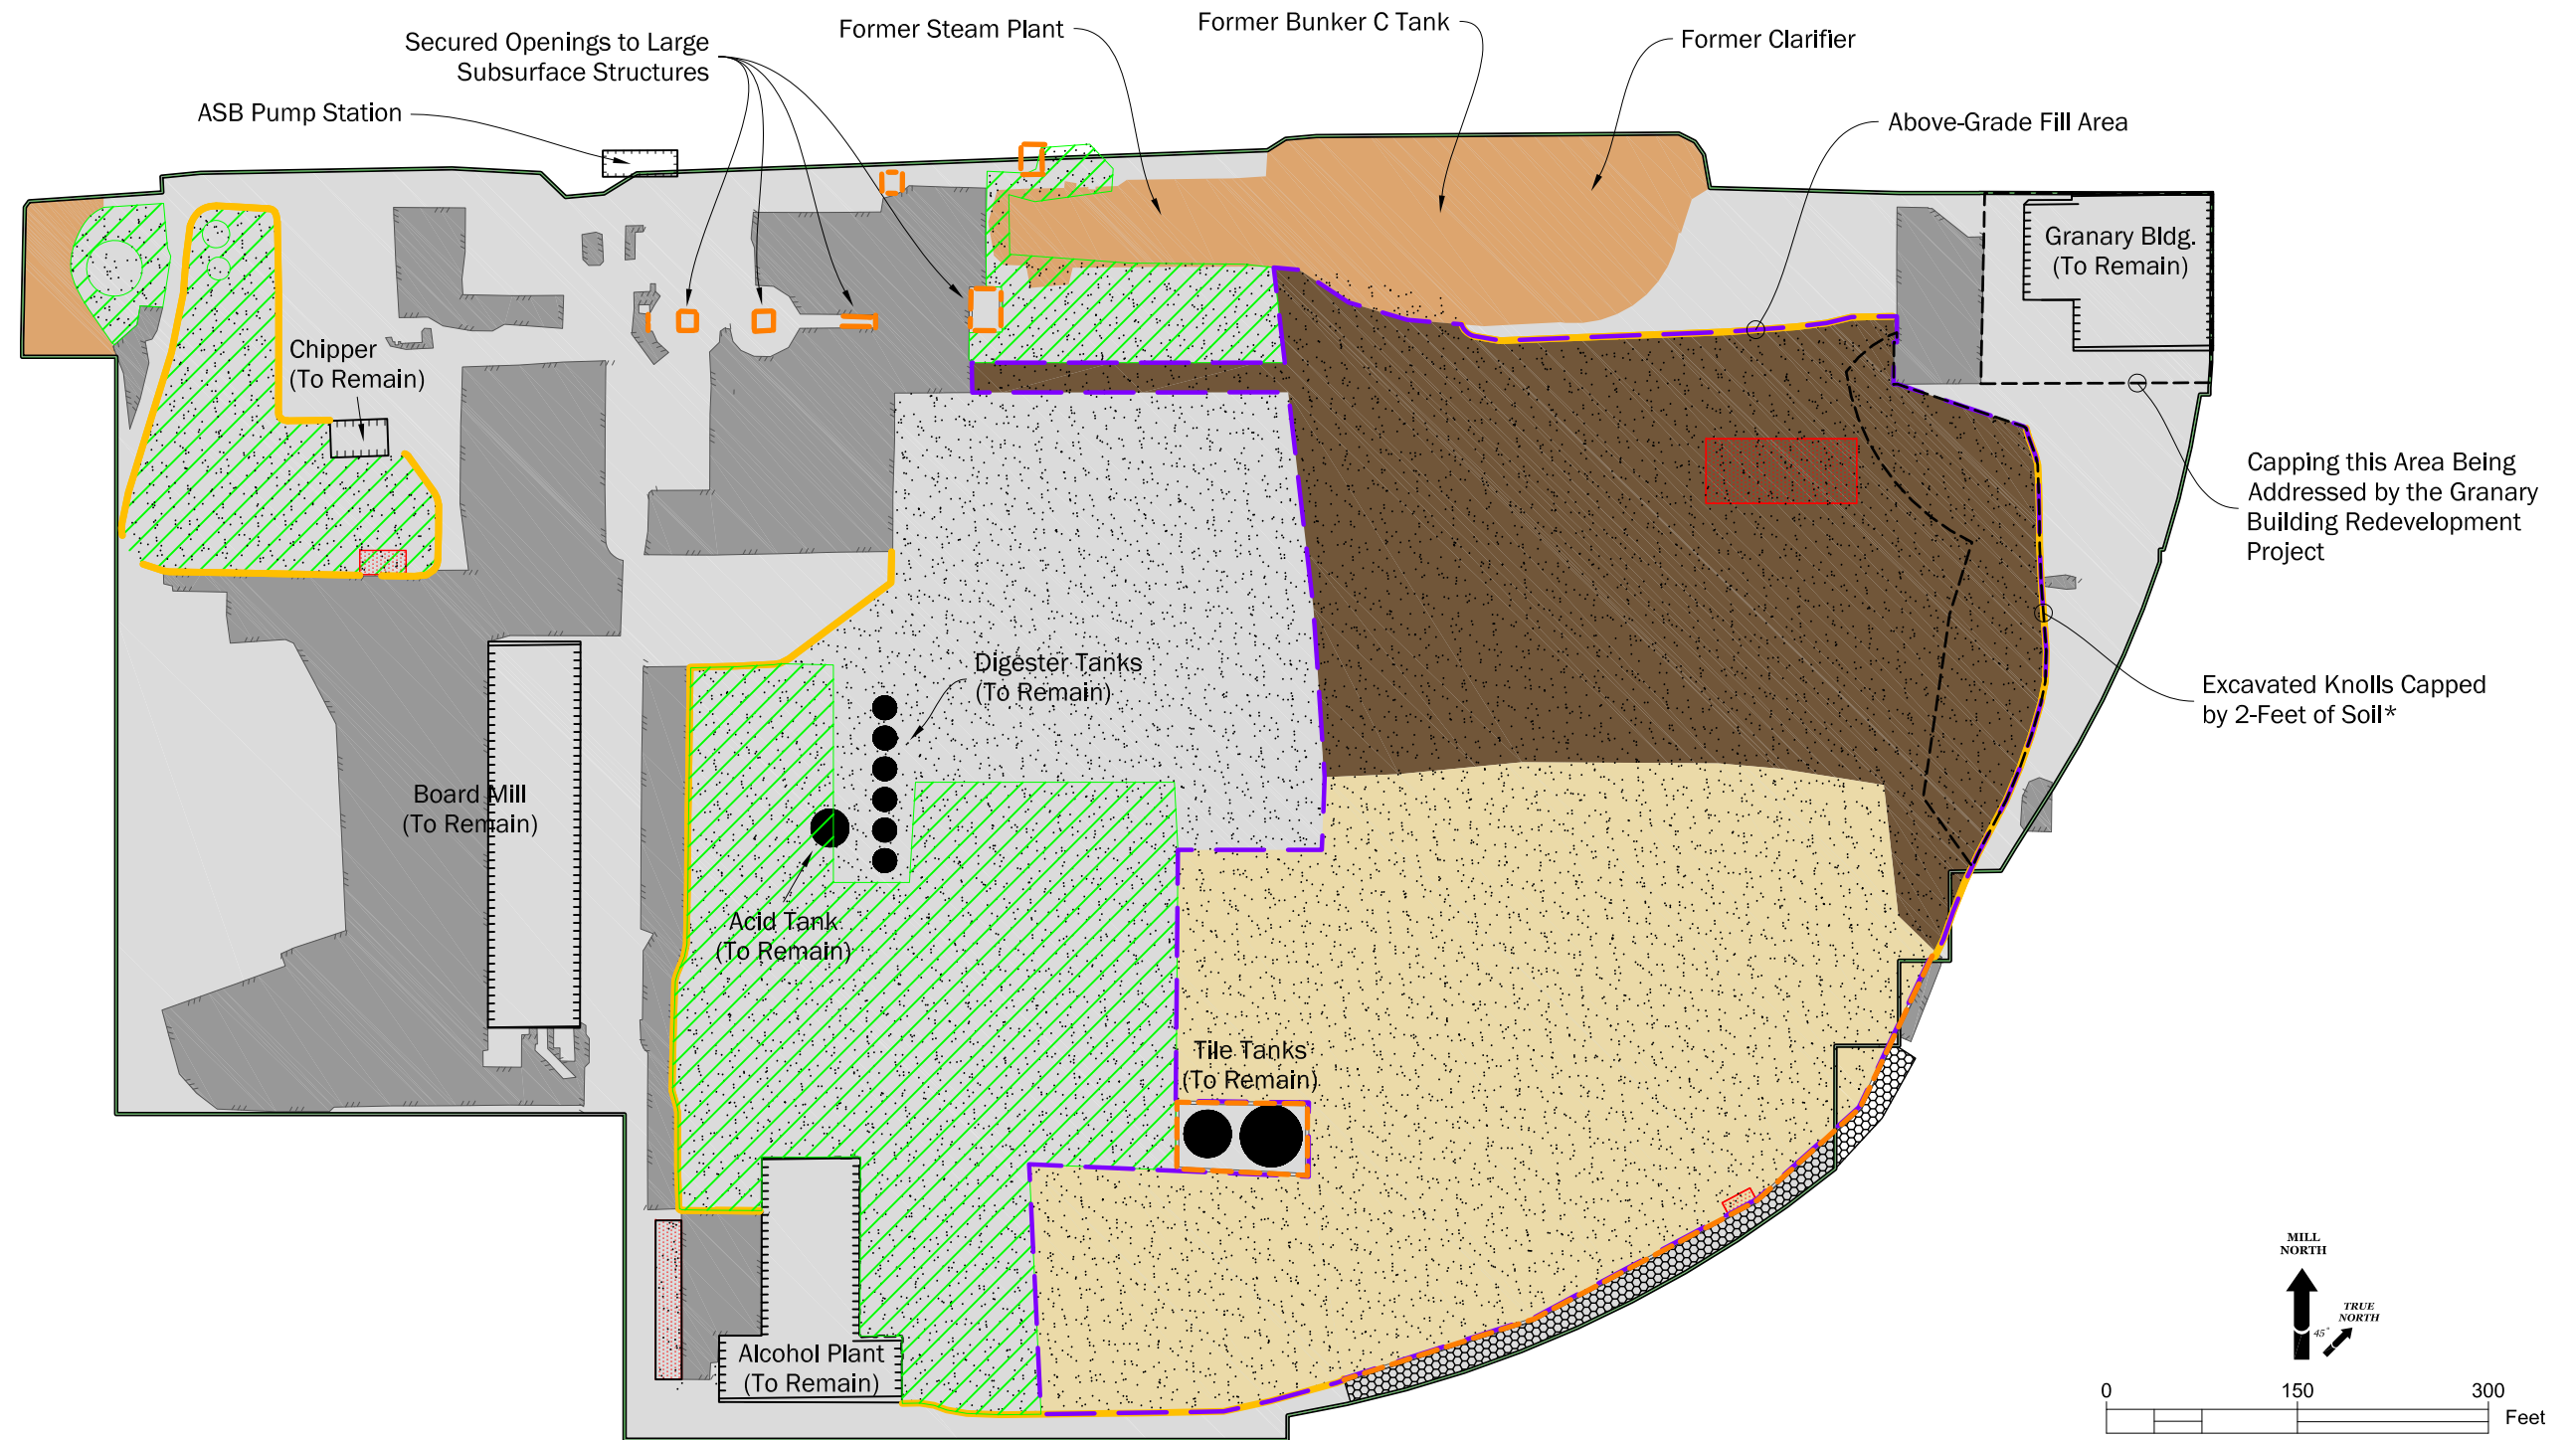
<p>As-Built Capped Condition for the Pulp and Tissue Mill RAU PTM RAU Site-Wide Capping As-Built Report Port of Bellingham Bellingham, Washington</p>		
	Jan-2017 <small>PROJECT NO.</small> 140298 - 015	<small>BY:</small> MAV/ASC <small>REVISED BY:</small> SCC/RAP
		<small>FIGURE NO.</small> 2

During the capping project, major regrading occurred only in the eastern portion of the RAU, where topographically higher knolls composed of soil were excavated to lower their elevation. Immediately west of that, that excavated contaminated soil and other soil and select debris generated by the project were placed as fill to raise grade. The area where fill was placed was termed the “above-grade fill area” for purposes of the project (Figure 2).

During the capping project, excavation to lower grade was generally limited to the areas of the two knolls on the east end of the RAU, southwest of the Granary Building (that approximate cut area is depicted on Figure 2). Several full-sized conifer trees and other vegetation was growing on the knolls, and the Contractor removed the vegetation as part of clearing and grubbing to allow excavation. When excavating to achieve the designed subgrade (elevation 14.75 feet MLLW) within the knolls area, the Contractor encountered and removed portions of below-grade utility structures and building foundation elements of various sizes and materials. Minor excavation was also conducted for cap grading purposes along the eastern edge of the Laurel Street right-of-way.

As stated in Section 2, the RAU-wide cap includes a combination of hard caps, composed of a minimum 3 inches of competent concrete pavement, asphalt pavement, or building foundations, and soil caps composed of a minimum 2 feet of imported soil or crushed rock. Figure 2 depicts the as-built RAU-wide cap, denoting the pre-existing and newly constructed surfaces constituting the cap. Areas of crushed concrete/brick that were covered by 6 inches of crushed rock are also denoted.

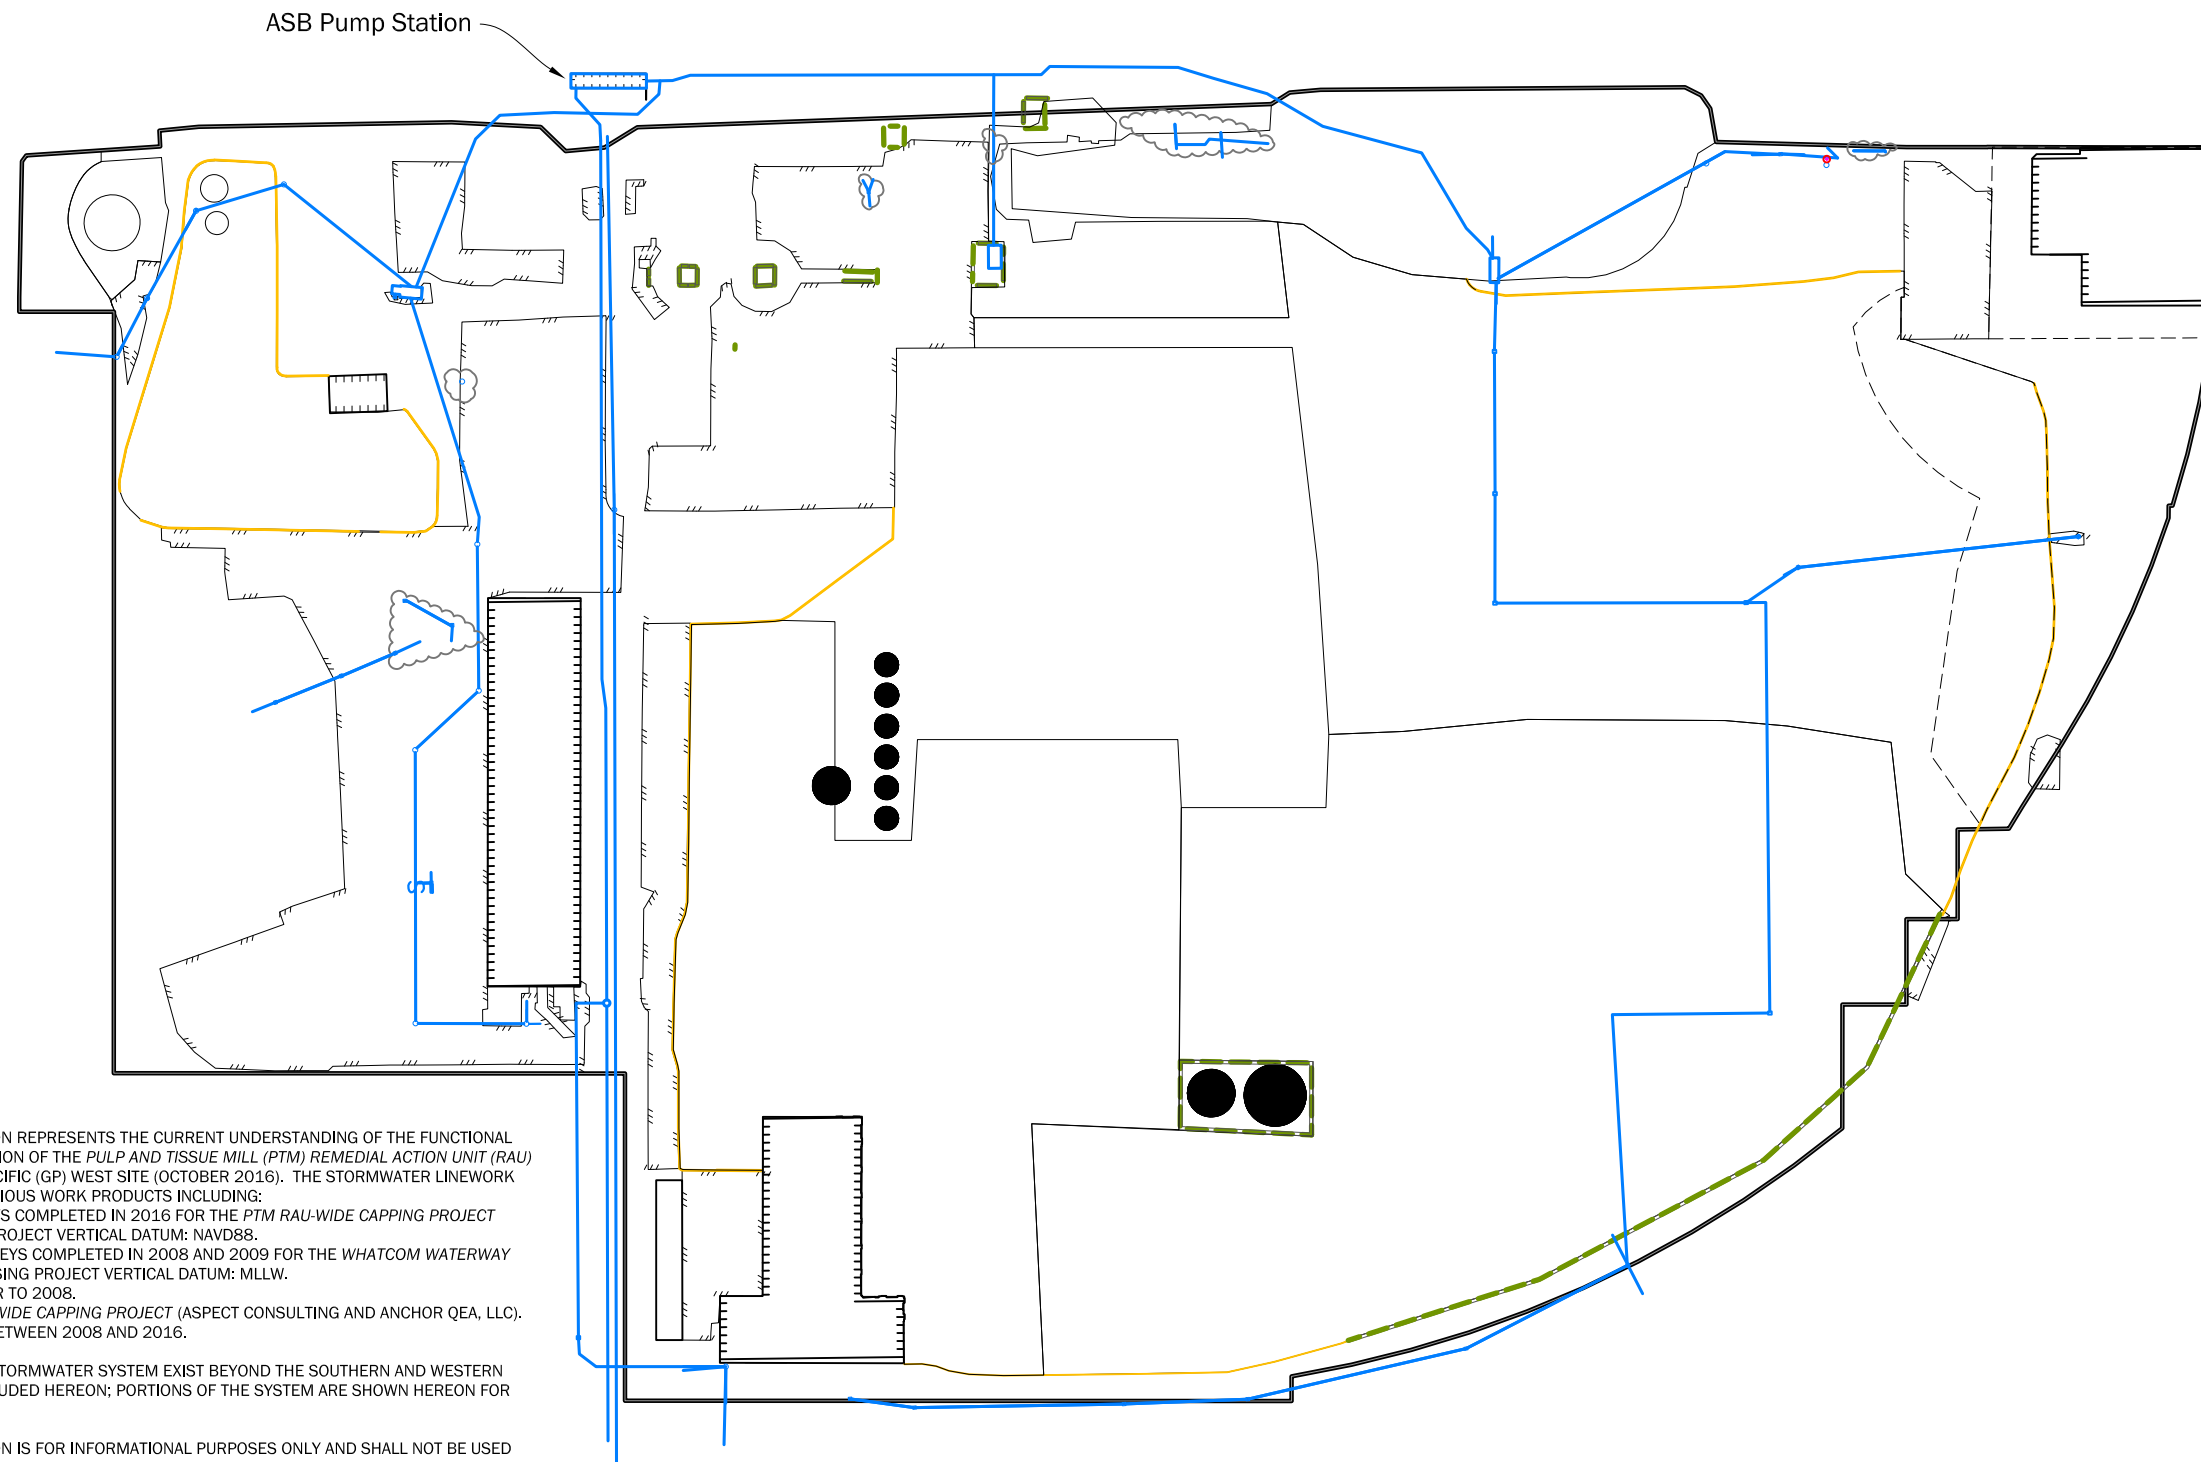
Functional Stormwater System for the Pulp and Tissue Mill RAU
 PTM RAU Site-Wide Capping As-Built Report
 Port of Bellingham
 Bellingham, Washington

As described in previous sections, the post-cap condition at the RAU simplified the functional stormwater system, which was generally oversized and outmoded following closure of the mill. A number of activities during the course of the Project simplified the stormwater system, including, but not limited to: grading, promoting onsite infiltration, decommissioning of portions of the stormwater system that were no longer functional, constructing asphalt-paved cap areas that reduce ponding, and replacement of select portions of the stormwater system.

Following completion of capping construction in late September 2016, the cap and RAU have been observed during and after a few intense or prolonged rainfall events. In general, there is an overall reduction of onsite ponding compared to what occurred prior to the cap

- The north end of Laurel Street, where there are currently no functional catch basins. The City's planned Laurel Street and Granary Avenue improvements project will address drainage in this area.
- Northwest of the Board Mill, west of Laurel Street. The paving was perforated here to facilitate infiltration before RCA and ballast were placed, but the ponding persists.
- North of the Chipper. The new asphalt pavement placed in this area was successfully graded to reduce the ponding size, but limited ponding persists.
- The southeast corner of the RAU at a topographically low point. The paving below the cap here was perforated to facilitate infiltration, and ponding in this area has been observed to be temporary following heavy rainfall events.

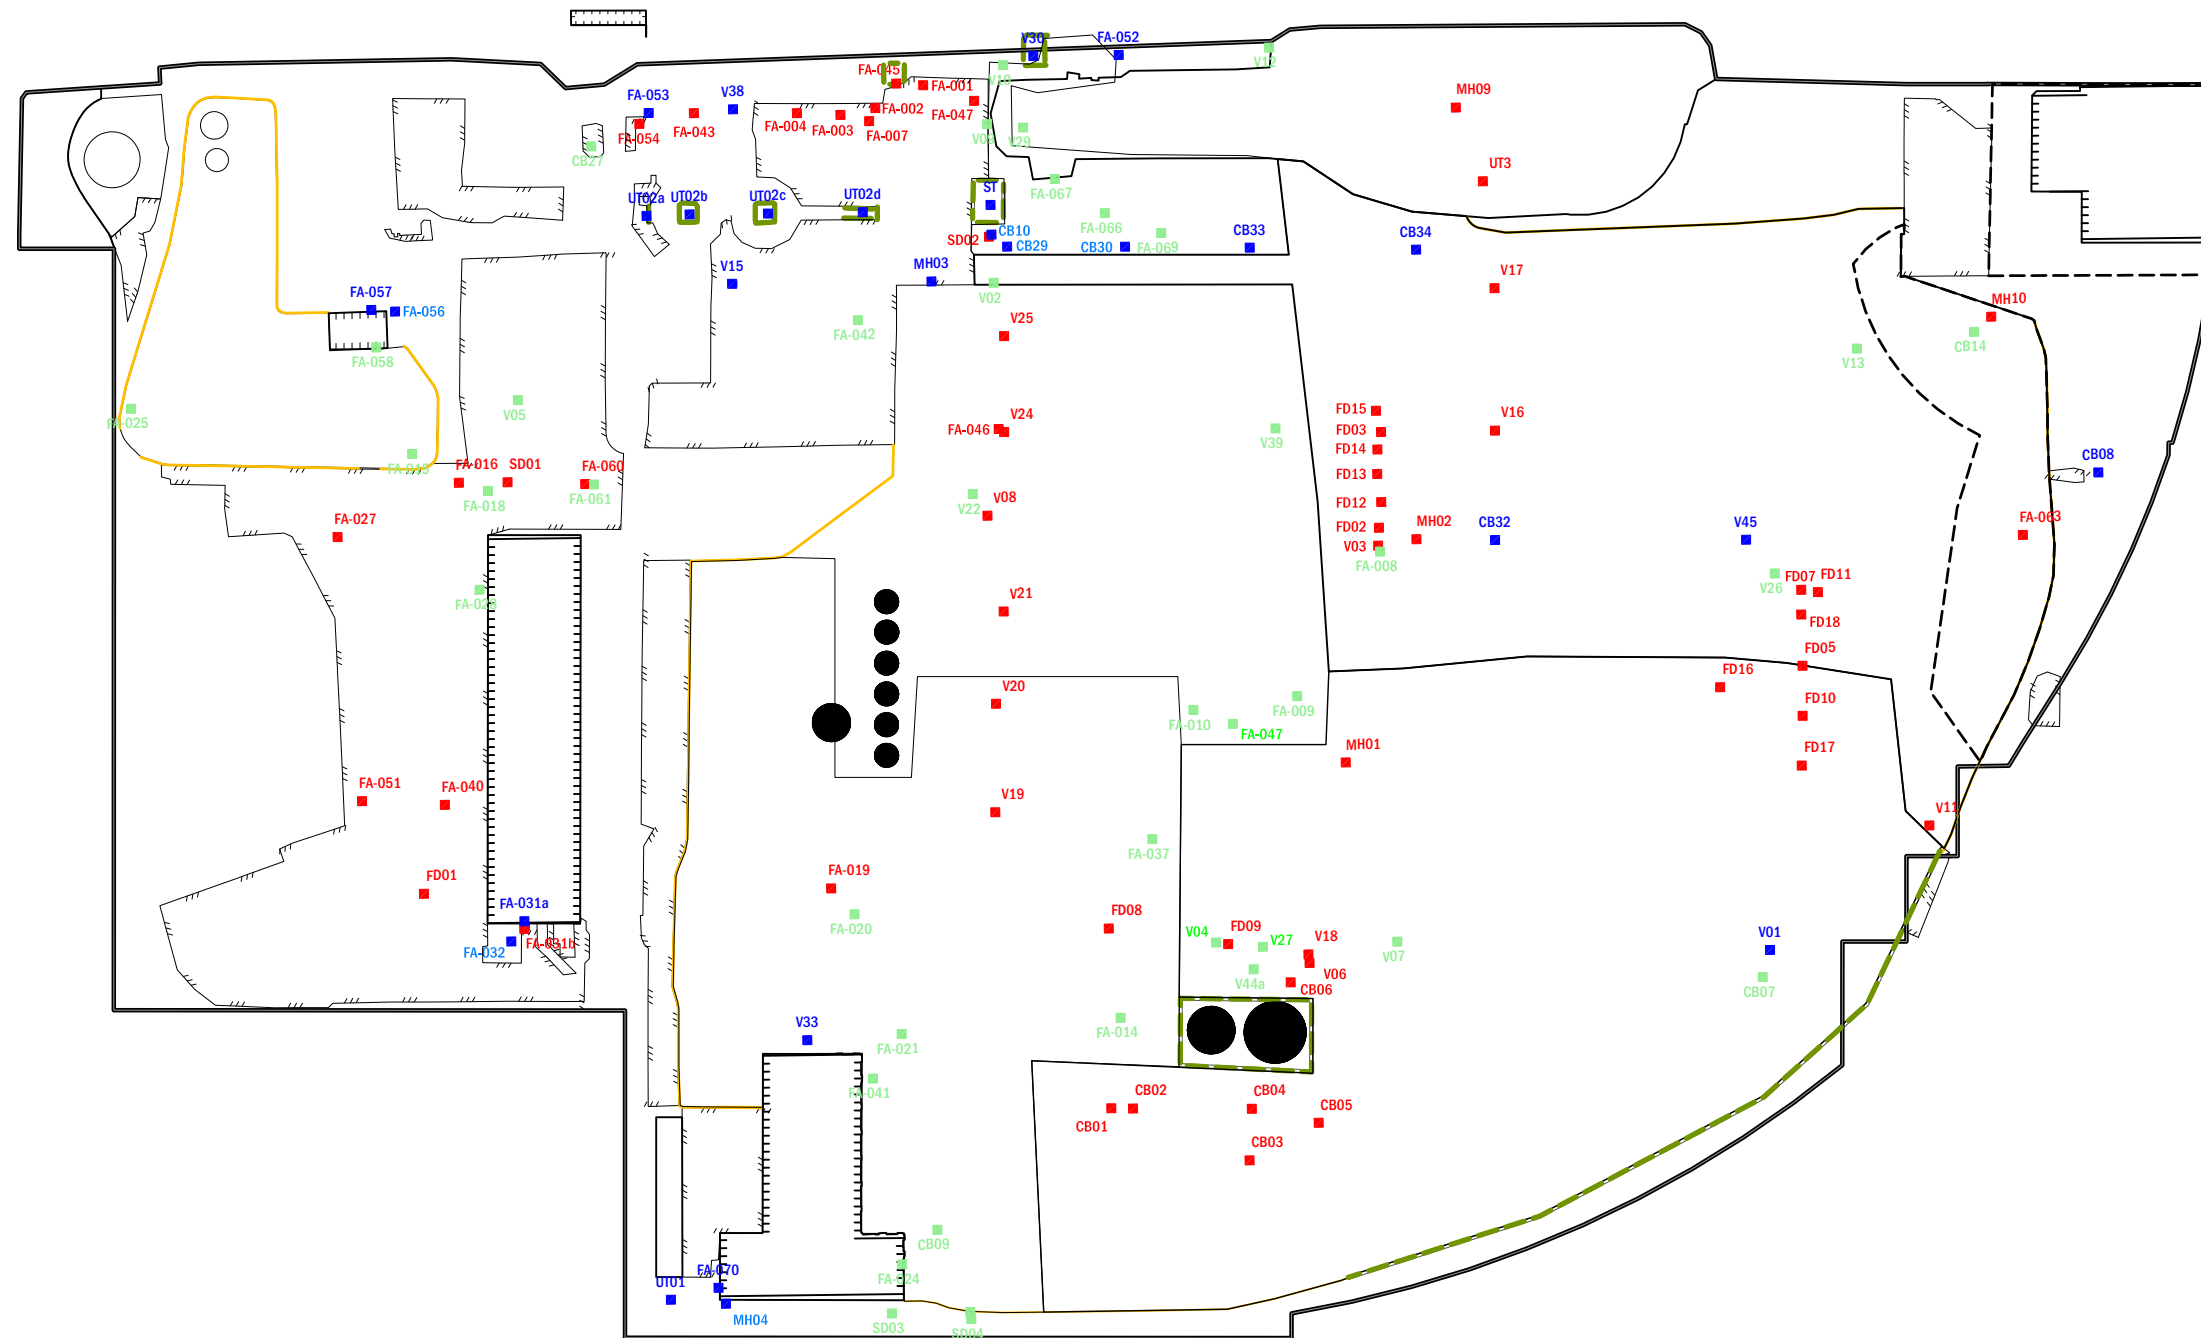
**As-Built Subsurface Structure Status
for the Pulp and Tissue Mill RAU**
PTM RAU Site-Wide Capping As-Built Report
Port of Bellingham
Bellingham, Washington

Approximately 120 subsurface vaults, utilidors, drainage structures, conduit banks, and other similar subgrade structures were identified in the CPS as potential physical hazards (pose risks of cap settlement or risks to physical safety) or potential uncontrolled conduits for stormwater, to be mitigated. However, during the course of the cap construction, numerous additional such structures and other subsurface voids were identified and mitigated. In total, about 175 subsurface structures and voids were addressed during this capping project using a variety of solutions such as structure removal, backfilling, plugging pipes or conduits, and securing covers on structures.

As required by the CPS and directed by the Engineer, the Contractor filled the structures with clean, permeable import soil where the Engineer determined that stormwater infiltration is possible and desirable, or with controlled density fill (CDF) where the Engineer determined stormwater infiltration is not practical or desirable.

The Contractor secured the tops on select structures necessary to maintain stormwater drainage functionality where the cap was constructed above the structure and raising the structure to the finished grade of the cap was not feasible. Similarly, select structure tops were secured in areas beyond the cap to mitigate safety hazards or where backfilling the structure was not feasible or cost-effective. Table 1 tabulates and Figure 4 illustrates the pertinent information regarding each of the subsurface structures addressed during the project as potential physical hazard or uncontrolled stormwater conduit.

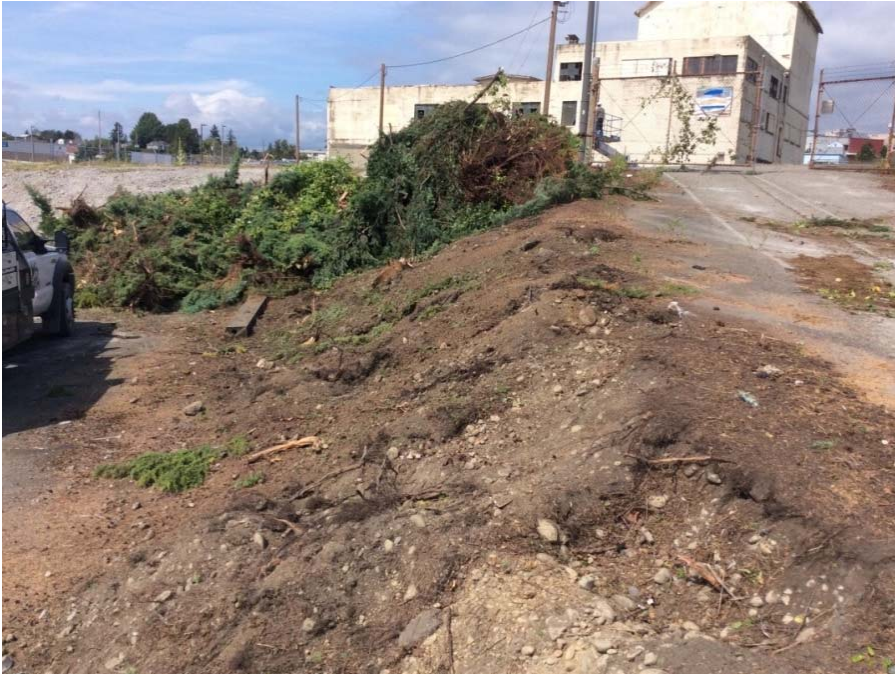
Photo 1. Clearing and grubbing before excavation of knolls.

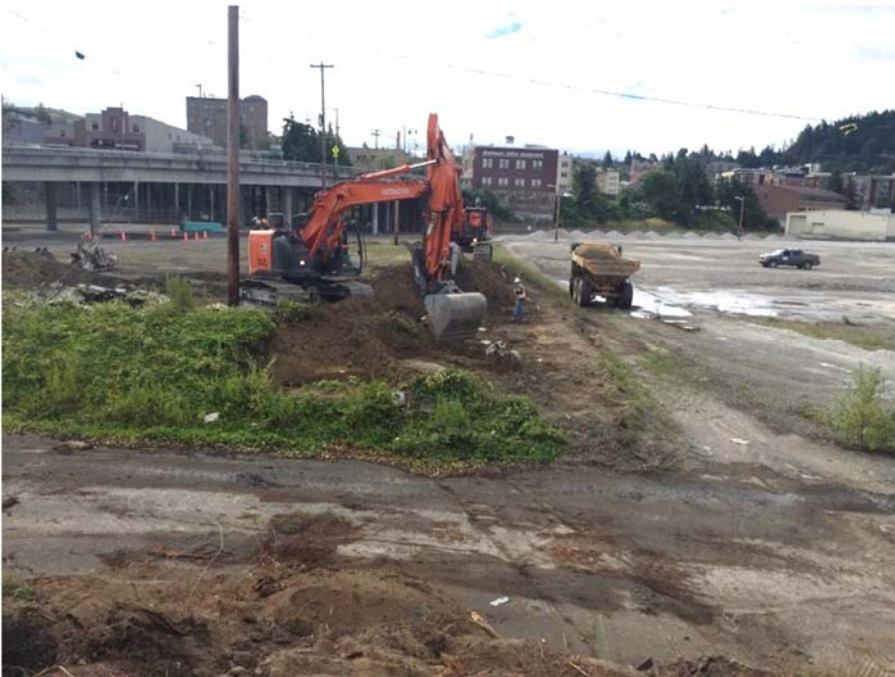
Photo 2. Excavation of knolls.

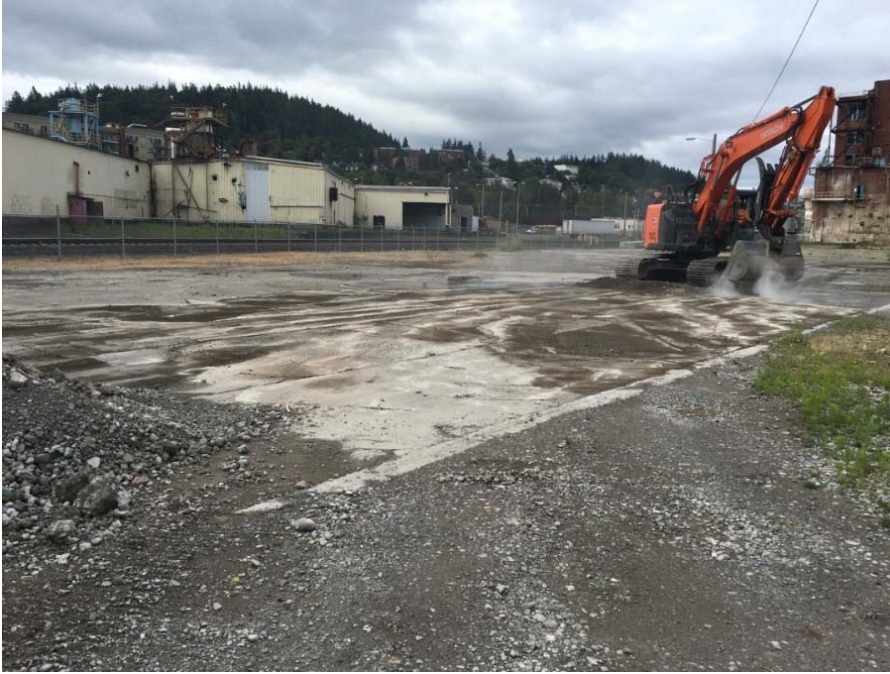
Photo 3. Veneer removal.

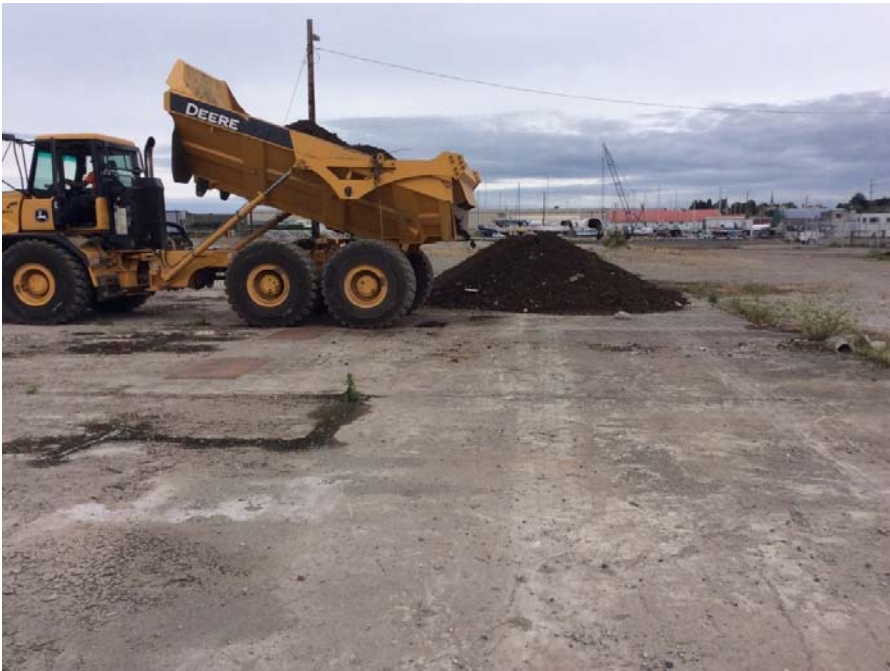
Photo 4. Placing removed veneer in above-grade fill area.

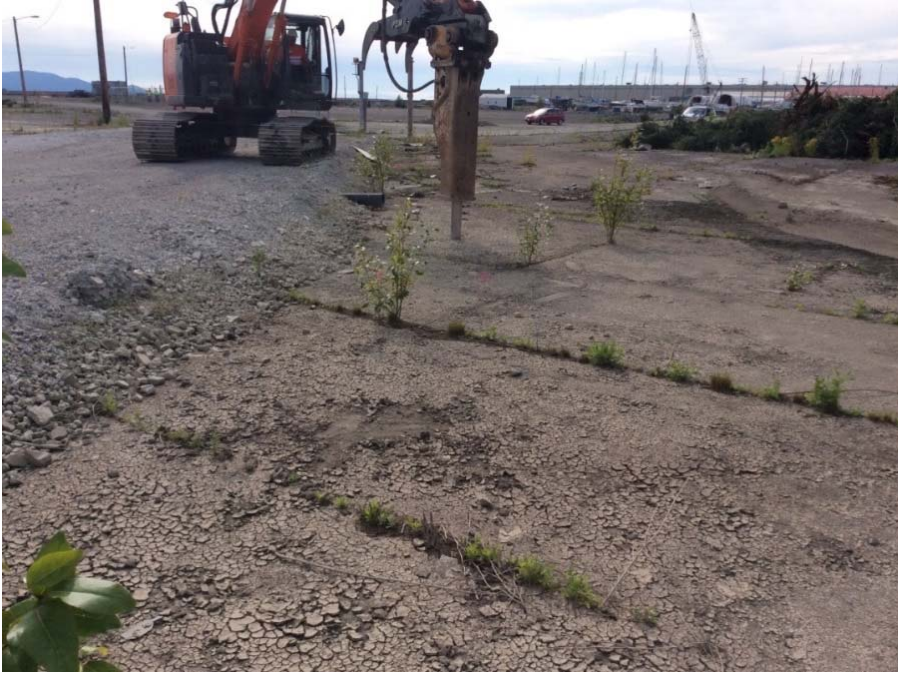
Onsite infiltration was promoted by perforating or breaking up some impervious existing surfaces prior to their capping with import soil. The CPS identified an area of a few hundred square yards where the soil cap would cover an asphalt-paved surface that was in disrepair. This area was also observed to be topographically low and impervious to infiltration, and thus stormwater runoff ponded there in the pre-construction condition. To mitigate this condition, the Engineer directed the Contractor to perforate pavement in this area to promote infiltration and to minimize accumulation of water that could potentially reduce the geotechnical stability of the cap. Pavement perforation was also conducted at Engineer direction in several smaller areas where localized ponding was observed, which are depicted on Figure 2. The perforation involved breaking existing paved surfaces into pieces of less than 12 inches in any dimension and leaving the broken material in place as a subgrade for the cap.

Photo 5. Perforating degraded pavement to facilitate infiltration.

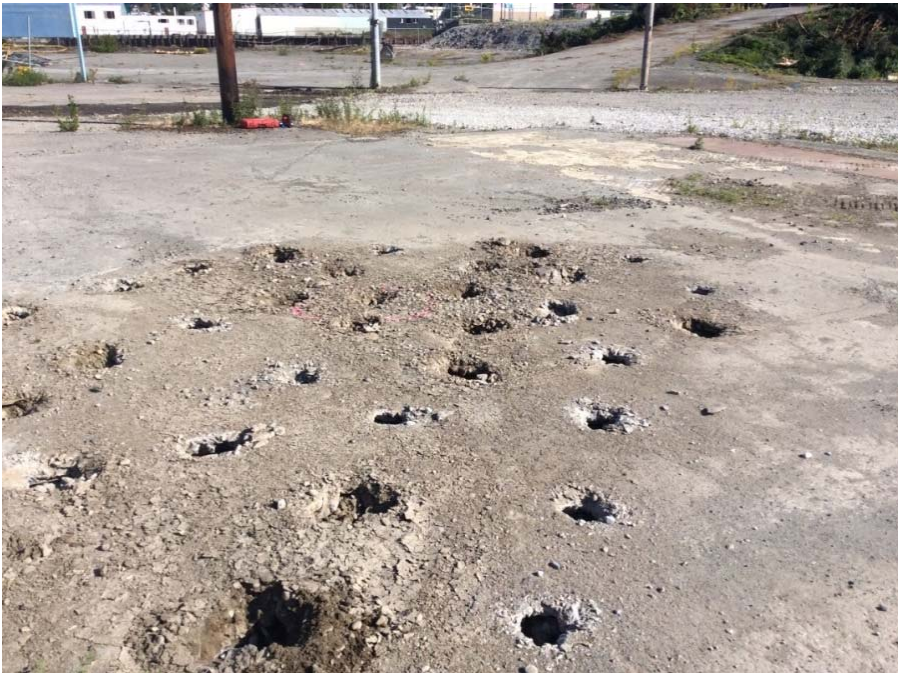
Photo 6. Perforated pavement.

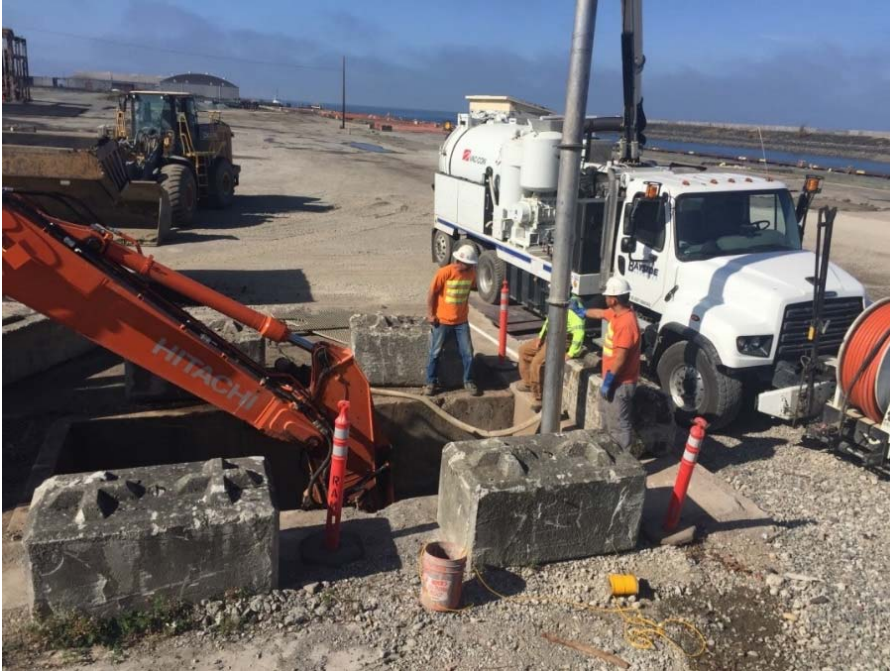
During the process of stormwater and sewer system utility modifications (see Section 4.3) and securing subsurface physical hazards (see Section 4.4), the Contractor removed debris and soil from some subsurface structures as necessary to maintain stormwater functionality and to ensure that structures requiring backfill did not contain voids that could affect the performance of the cap. As required by the CPS, the Contractor managed the soil and debris removed as stormwater solids, which were stockpiled, characterized and profiled for disposal, and hauled offsite to an approved Subtitle D landfill.

Photo 7. Cleaning out subsurface structures.

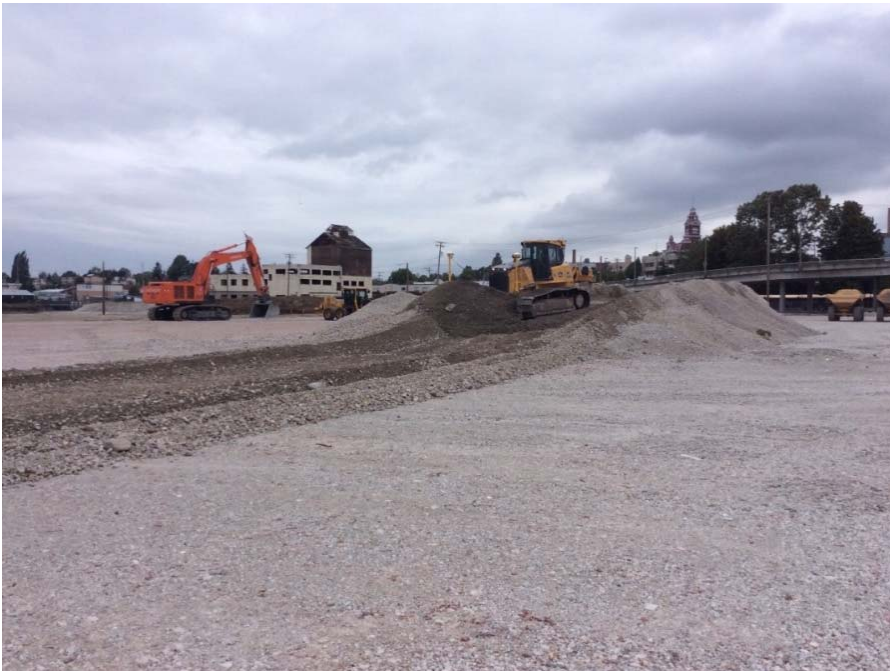
Photo 8. Re-grading Recycled Concrete Aggregate.

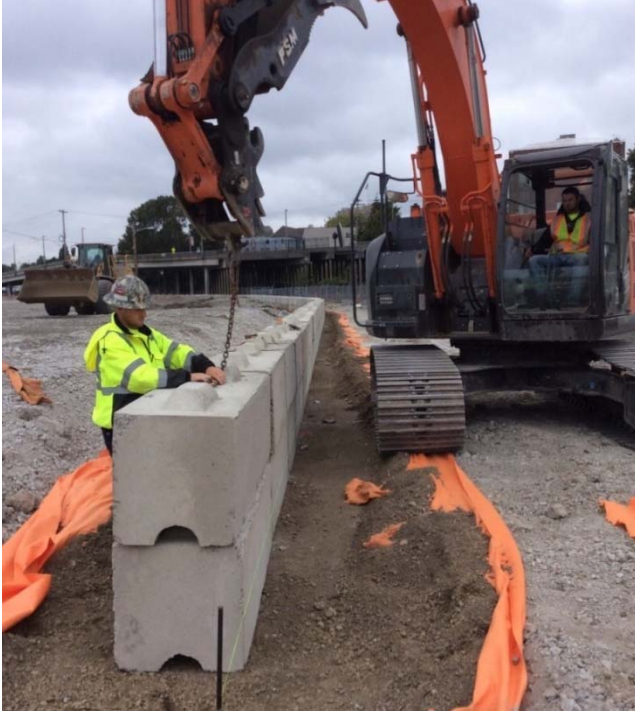
Photo 9. Constructing gravity block wall along southeast edge of above-grade fill area.

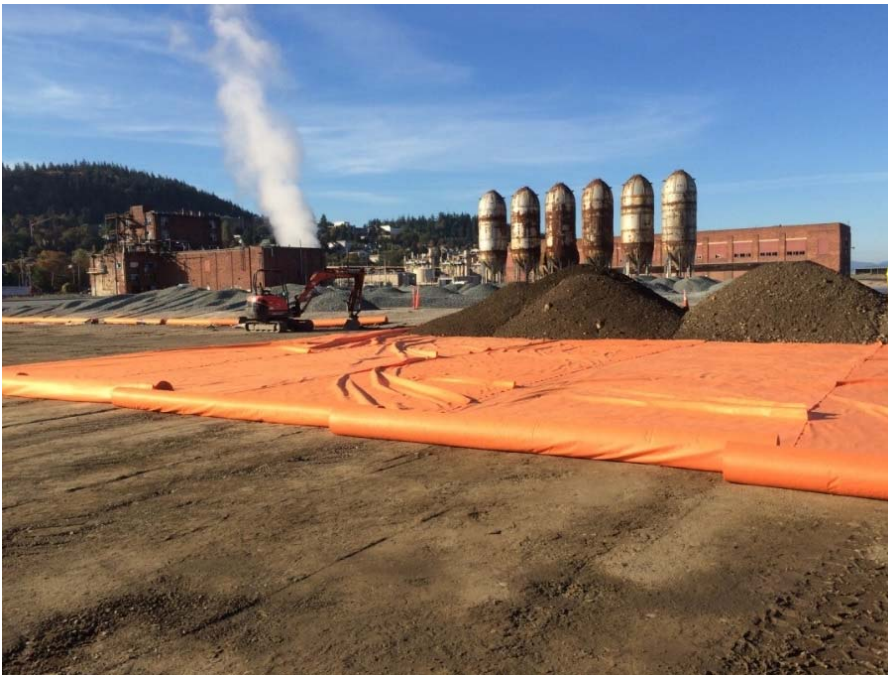
Photo 10. Separation geotextile placed over graded and compacted soil/veneer site-derived fill. Gravel borrow to be placed over geotextile.

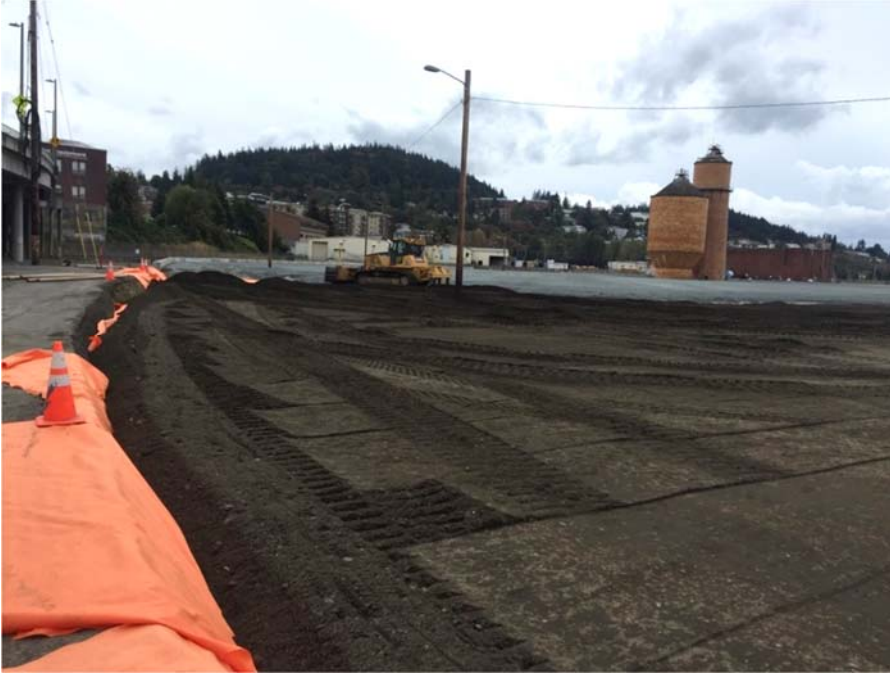
Photo 11. Grading of gravel borrow over separation geotextile.

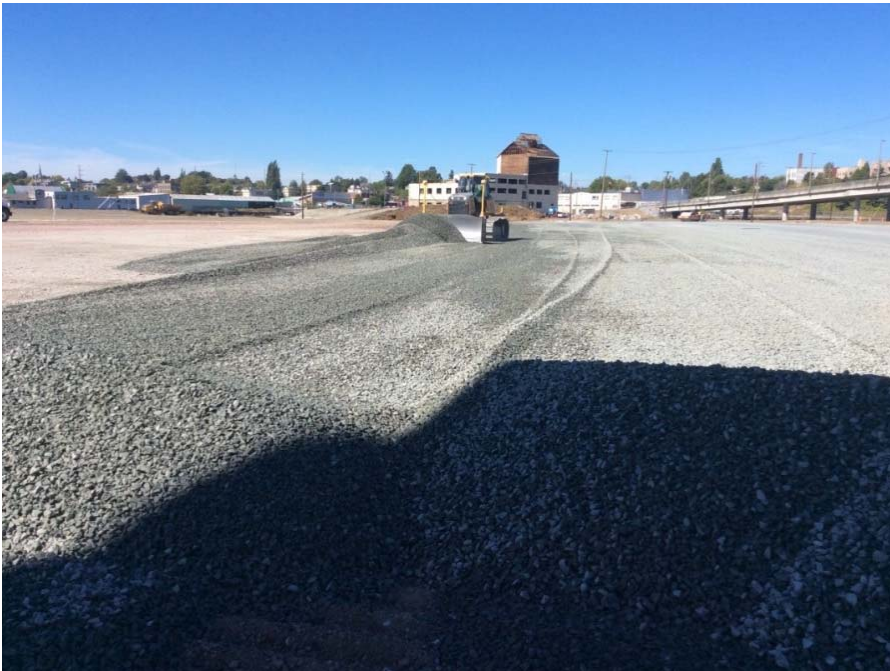
Photo 12. Placing permeable ballast.

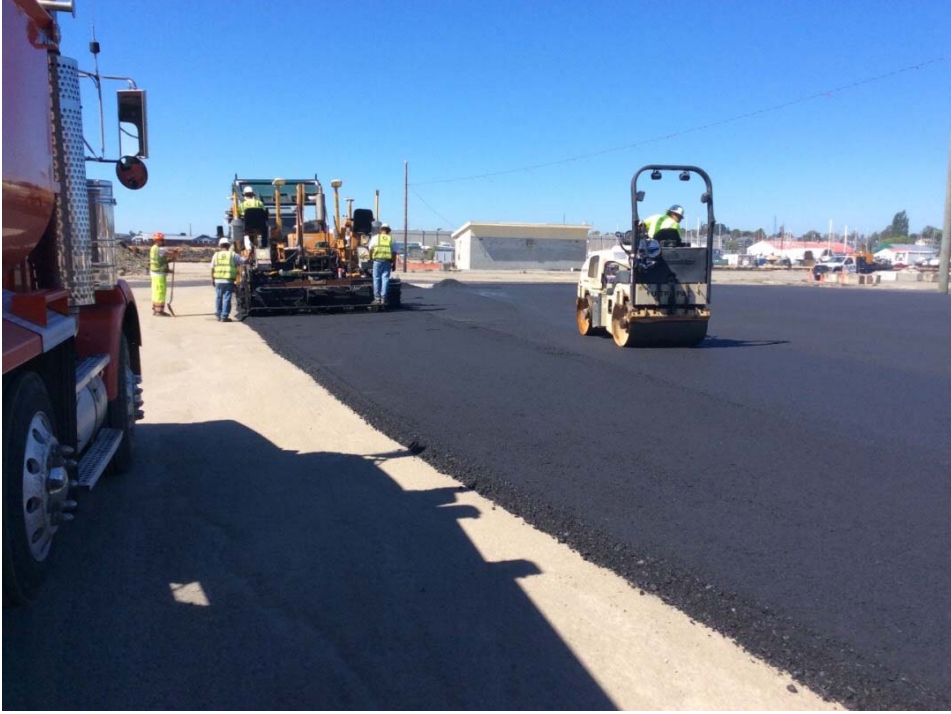
The Contractor prepared and paved those areas of the RAU where the Engineer directed that the capping material will be asphalt pavement rather than import soil. Subject to determination that the existing pavement could accommodate an asphalt overlay pavement, a 3-inch asphalt overlay was on top of the existing pavement to meet CAP requirements. Where the existing surface was too degraded or uneven to accommodate an asphalt overlay, the Contractor placed and compacted a base course of imported crushed rock for leveling,

Photo 13. Constructing asphalt pavement hard cap.

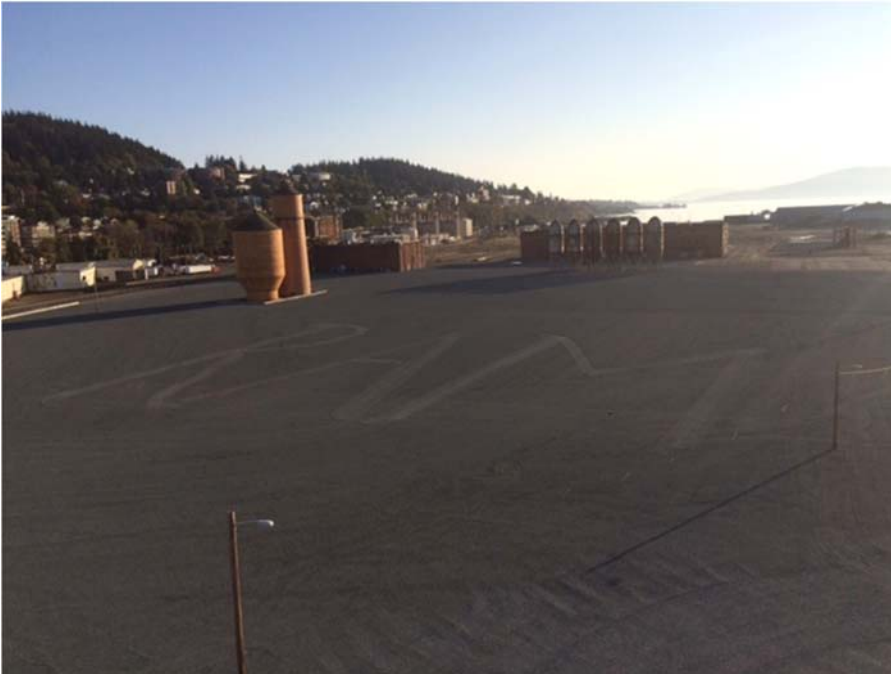
Photo 14. The completed cap, looking mill-west from Chestnut Avenue.
