SITE HAZARD ASSESSMENT

Worksheet 1: Summary Score Sheet

SITE NAME: Boeing Developmental Center

Cleanup Site ID: 5059

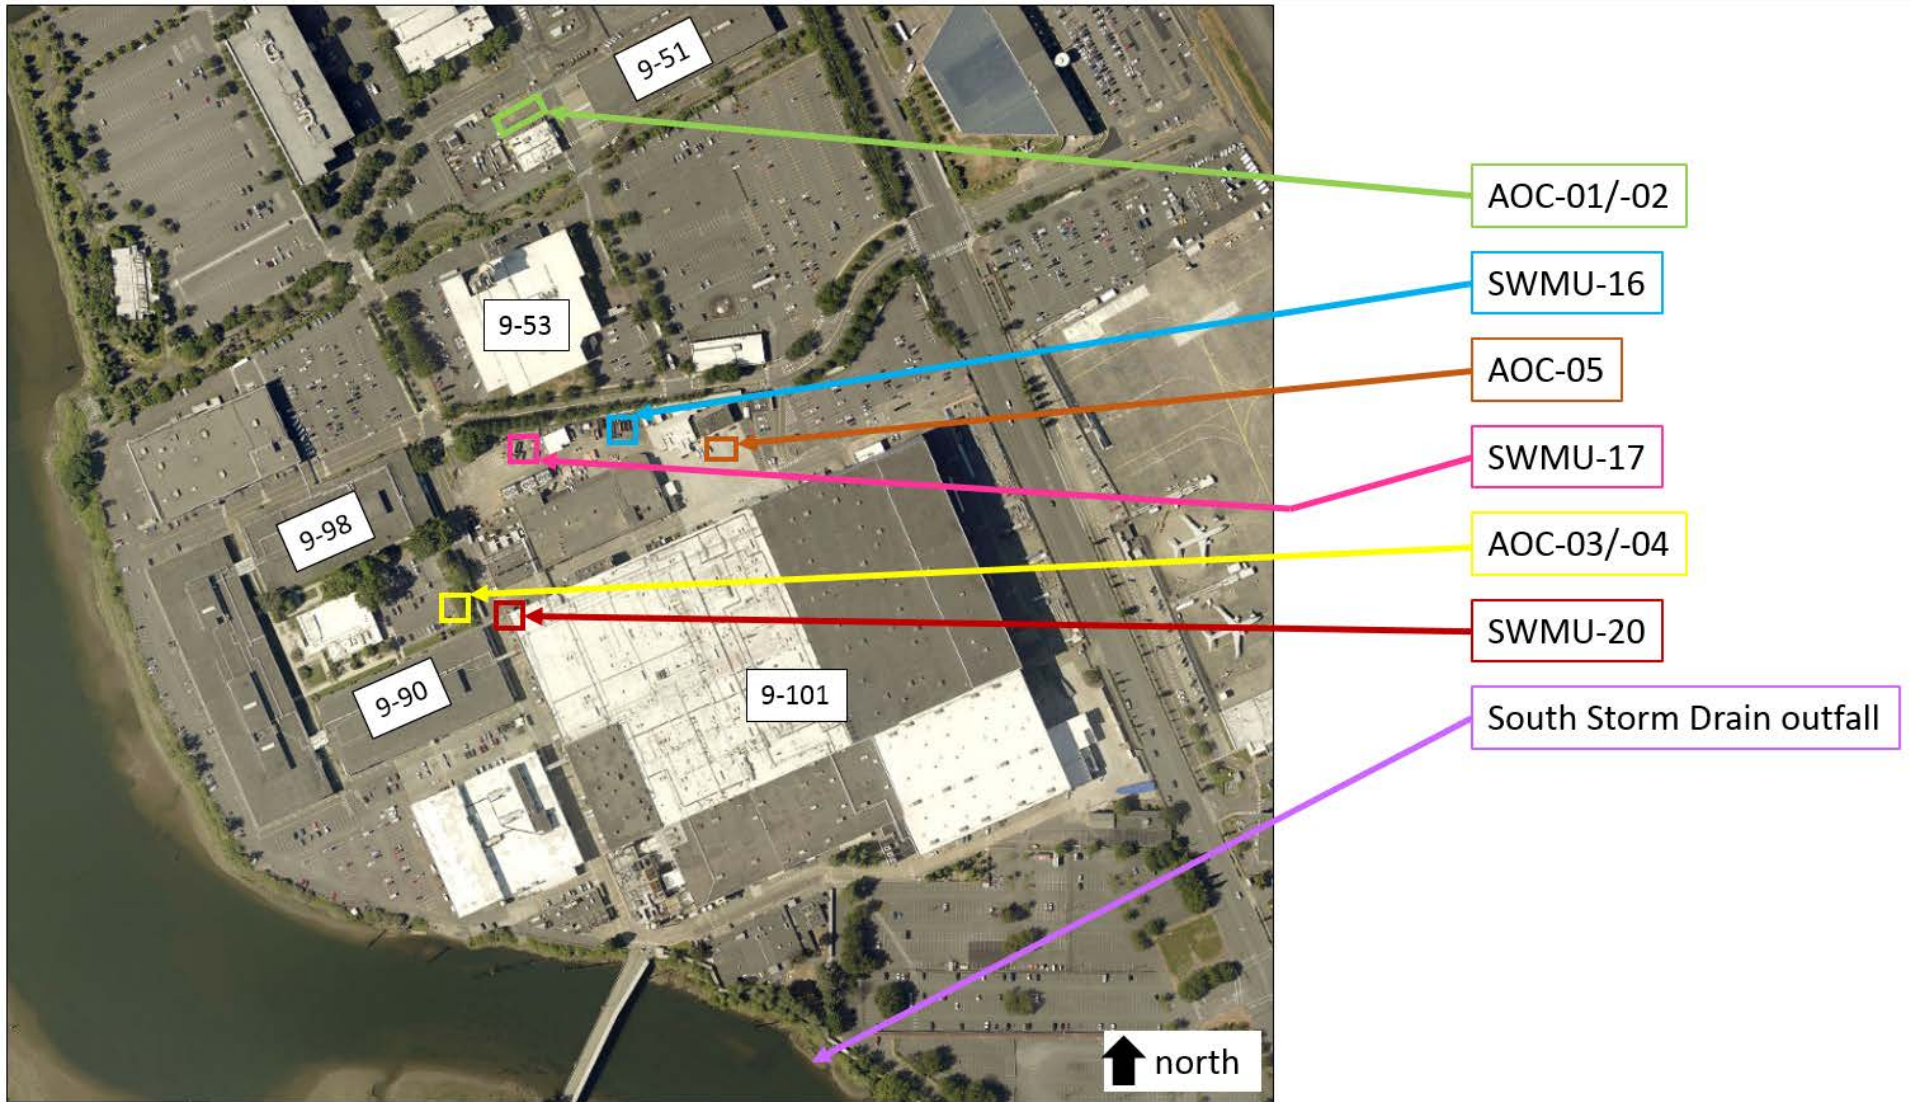
Figure 4. General location of areas of contamination detailed under Site Characterization and/or Remediation in the above report text. Northern and southern parts of the property are cut off on the base map, as contaminated areas are mostly on the center part of the property. Building numbers for some of the larger buildings area included.

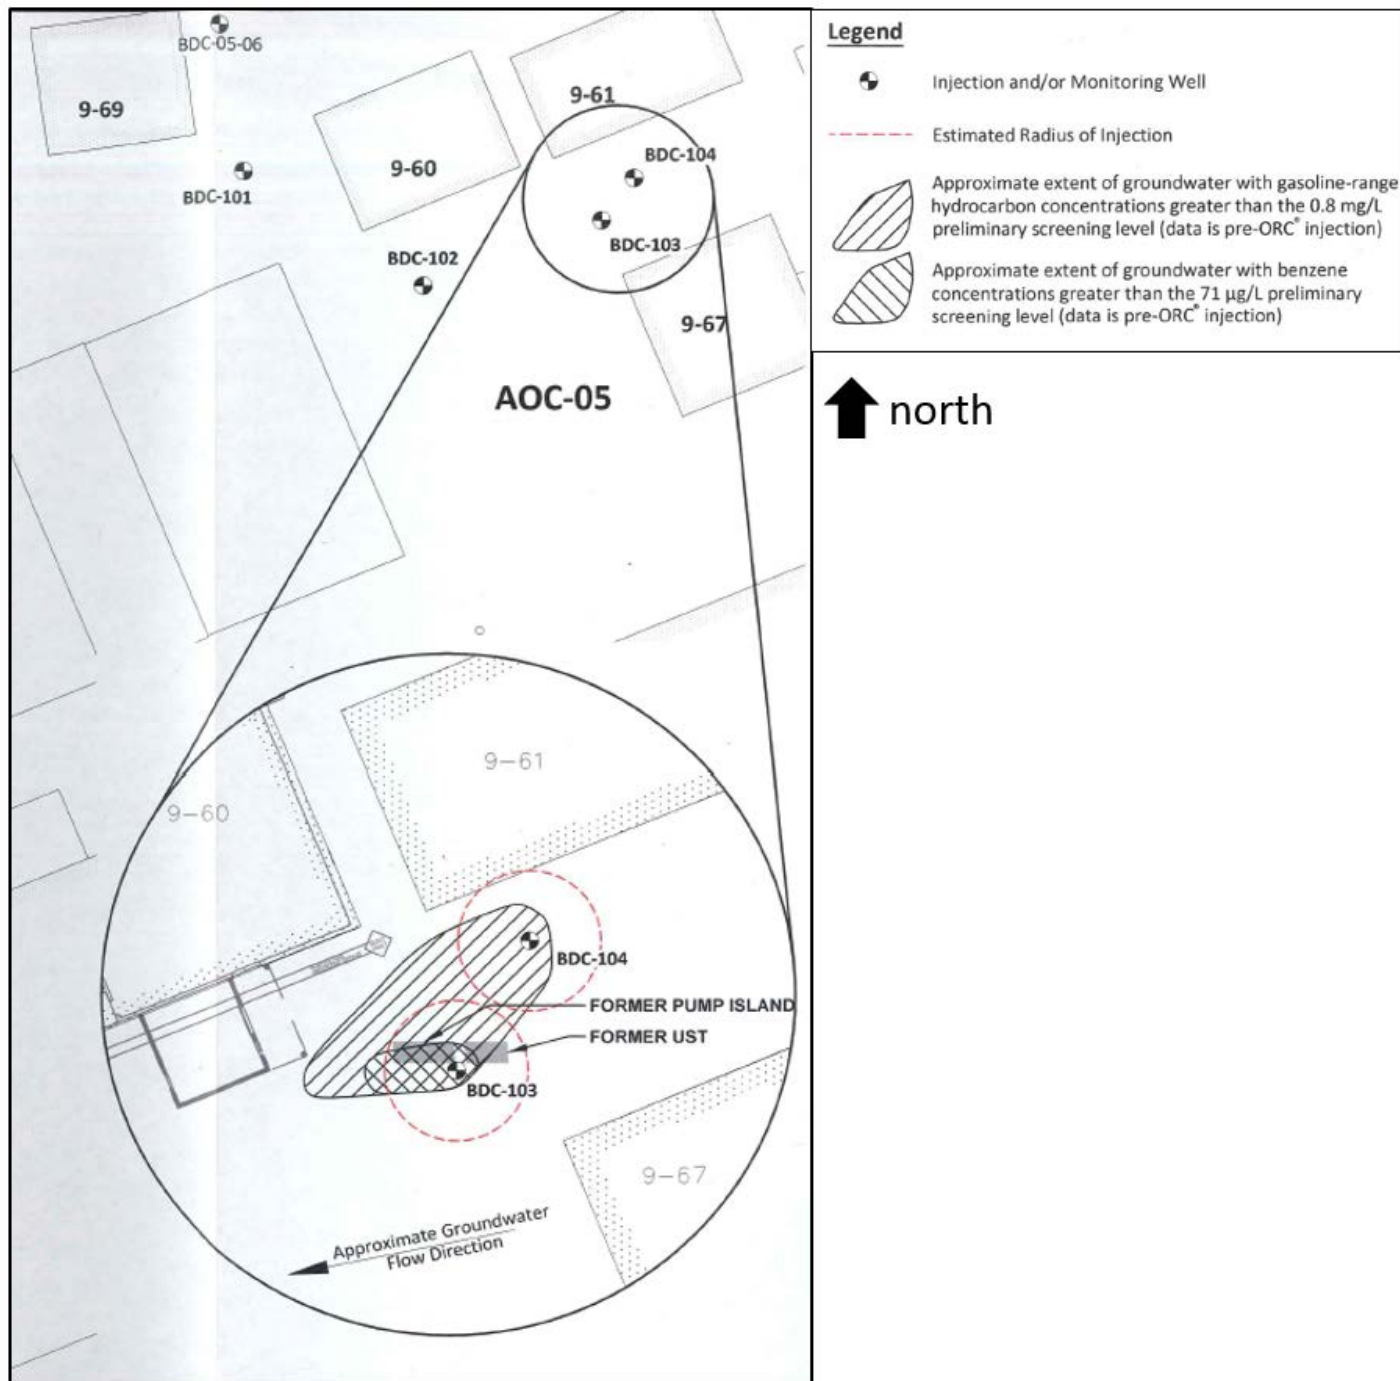
A 1000 gallon gasoline UST, located approximately 20 feet from the southwest corner of building 9-61, was punctured with a measuring rod in August 1985. This resulted in the release of 830 gallons of gasoline before the tank was removed in September 1985. An estimated 500-600 gallons of free product was also removed at the time of tank excavation. Further characterization of this area did not occur until 2001, at which time TPH-G and benzene were present above cleanup levels in groundwater. The first attempt to remediate groundwater in this area was performed in 2002. Oxygen Releasing Compound (ORC) was added to the groundwater to stimulate aerobic biodegradation of the hydrocarbons. This remedial action was not successful. Since groundwater at the Site is naturally anaerobic, the second remedial action was designed to stimulate anaerobic degradation of the petroleum hydrocarbons. A pilot study using nitrate amendment of groundwater was done in 2007. Based on good results from the pilot study, full scale nitrate injections began in this area in 2008. As of January 2019, a total of 11 injections have been done – 3 in 2008, 2 in 2009, 1 in 2010, 2 in 2012, 1 in 2013, and 2 in 2016. These injections have been successful in decreasing concentrations of TPH-G and BTEX in groundwater. Concentrations of these contaminants were below laboratory reporting limits in the May 2018 groundwater samples.

Figure 5. Details of AOC-05 area of contamination, including monitoring well locations and extent of contaminated groundwater prior to remedial actions.

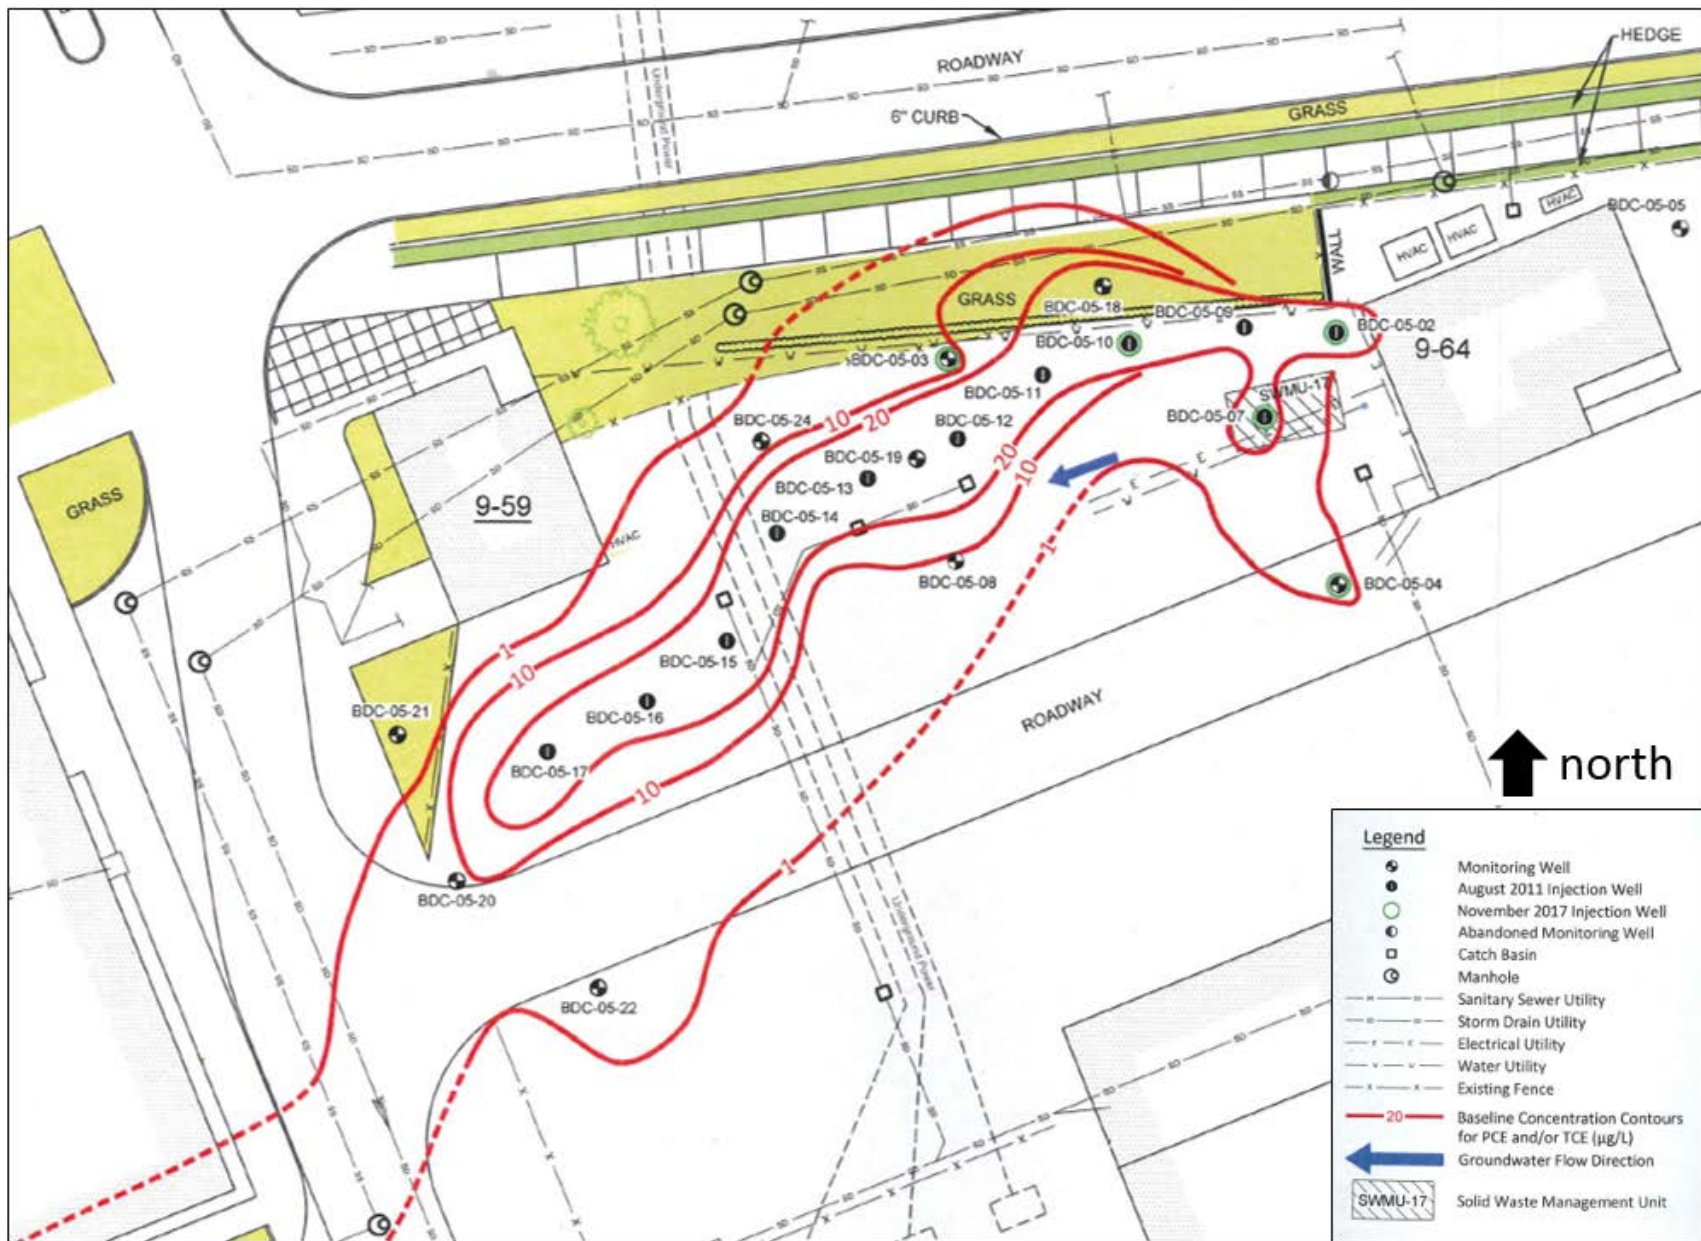
The source of contamination in this area was a waste oil UST and associated sump. The oil was collected from hydraulic testing shops, auto maintenance shops, and other sources across the Site. Soil contamination was discovered and the tank was removed in 1986. Groundwater in this area was found to be contaminated with tetrachloroethylene (PCE) and copper above cleanup levels. Remediation in this area has used the injection of amendments to stimulate bioremediation, enhance PCE breakdown, and immobilize copper. A pilot study was done in 2008 to confirm that the planned remediation strategy would be effective, and a full scale injection into 11 wells was done in 2011. The injection was a mixture of sodium lactate, vegetable oil, and ferrous sulfate. An additional injection was done in 2017 into 5 wells that still had groundwater with elevated concentrations of PCE and/or trichloroethylene (TCE), a PCE breakdown product. By the 2017 injection event, copper had decreased to below cleanup levels. Arsenic had increased, an expected side effect of the remedial action, and is present in groundwater above cleanup levels. As of May 2018, TCE remained present in groundwater from 1 well (BDC-05-02) above proposed cleanup levels and vinyl chloride, a PCE and TCE breakdown product, remained present in groundwater from 2 wells (BDC-05-09 and BDC-05-18) above proposed cleanup levels.

Figure 6. Details of SWMU-17 area of contamination, including monitoring well locations and extent of PCE and TCE contaminated groundwater prior to any remedial actions. As of May 2018, only the wells north of the SWMU-17 area remained contaminated (BDC-05-02, -09, and -18), so just a portion of the original area of contamination was considered in the area of remaining contamination for scoring.

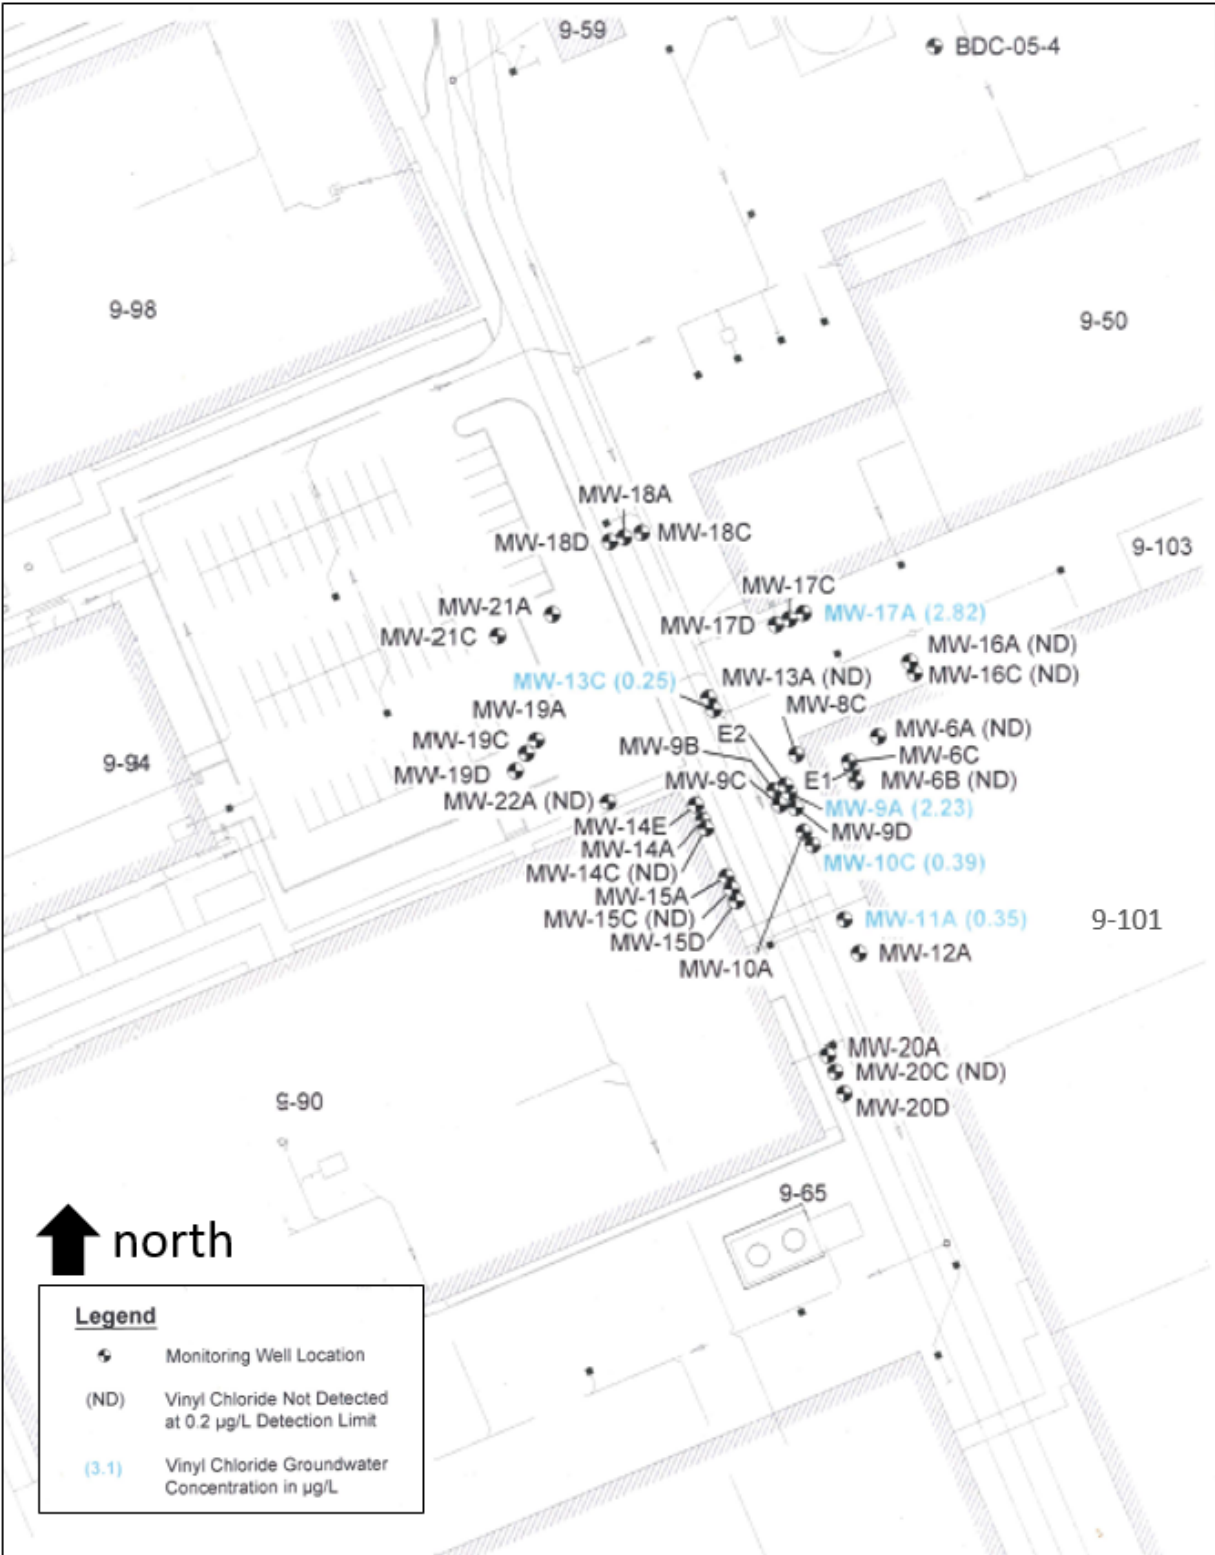
The primary contaminants of concern discovered in this area in 1989 were PCE and TCE in soil and groundwater. The source of this contamination was identified as a vapor degreaser and associated sump that were located in the northwest corner of building 9-101. The degreaser reportedly used PCE and TCE, and was in operation from approximately 1956 to 1984. Approximately 1400 tons of contaminated soil was removed during building improvements. Monitoring wells were installed in 1989 and 1991 to determine the extent of contamination; these targeted multiple groundwater depth ranges below ground. "A" wells are located 10-20 feet bgs, "B" wells are 22-28 feet bgs, "C" wells are 30-40 feet bgs, and "D" wells are 42-50 feet bgs. A, B, and C wells are all located in a shallow unconfined aquifer, while D wells are located in a deeper confined aquifer. Contamination was identified at multiple depths in the shallow aquifer, but never in the deeper aquifer.

Initially, groundwater was contaminated with PCE, TCE, cis-1,2-dichloroethylene (DCE), and vinyl chloride above cleanup levels. DCE and vinyl chloride are both breakdown products of PCE and TCE. A pump-and-treat system was installed and began operating in 1993 to address groundwater contamination. Treatment was done using a sieve tray aerating system to volatilize the contaminants and remove them from the groundwater. This system remained in operation until December 2001, when it was stopped to evaluate the potential use of monitored natural attenuation as a remedial action to address remaining contamination. Overall, the system is estimated to have removed 80 pounds of contaminants between 1993 and 2001.

Figure 7. Details of SWMU-20 area of contamination, including monitoring well locations and vinyl chloride concentrations from May 2018 sampling. Wells without concentration data are not currently included in semi-annual monitoring. All wells with concentrations in blue are above MTCA Method A cleanup levels, so an area including all of those wells was used to determine area of contamination for scoring.

Injection of amendments to promote biodegradation, similar to that used at SWMU-17, was the next remedial action implemented in this area. Injections were done twice in 2004 and once each in 2005, 2008, and 2015. The injection formula was primarily sodium lactate, with the addition of vegetable oil emulsion, yeast extract, and defoamer, depending on the injection date. As of the May 2018 groundwater sampling event, the only contaminant above proposed cleanup levels was vinyl chloride in 1 well in the shallow groundwater zone (MW-17A).

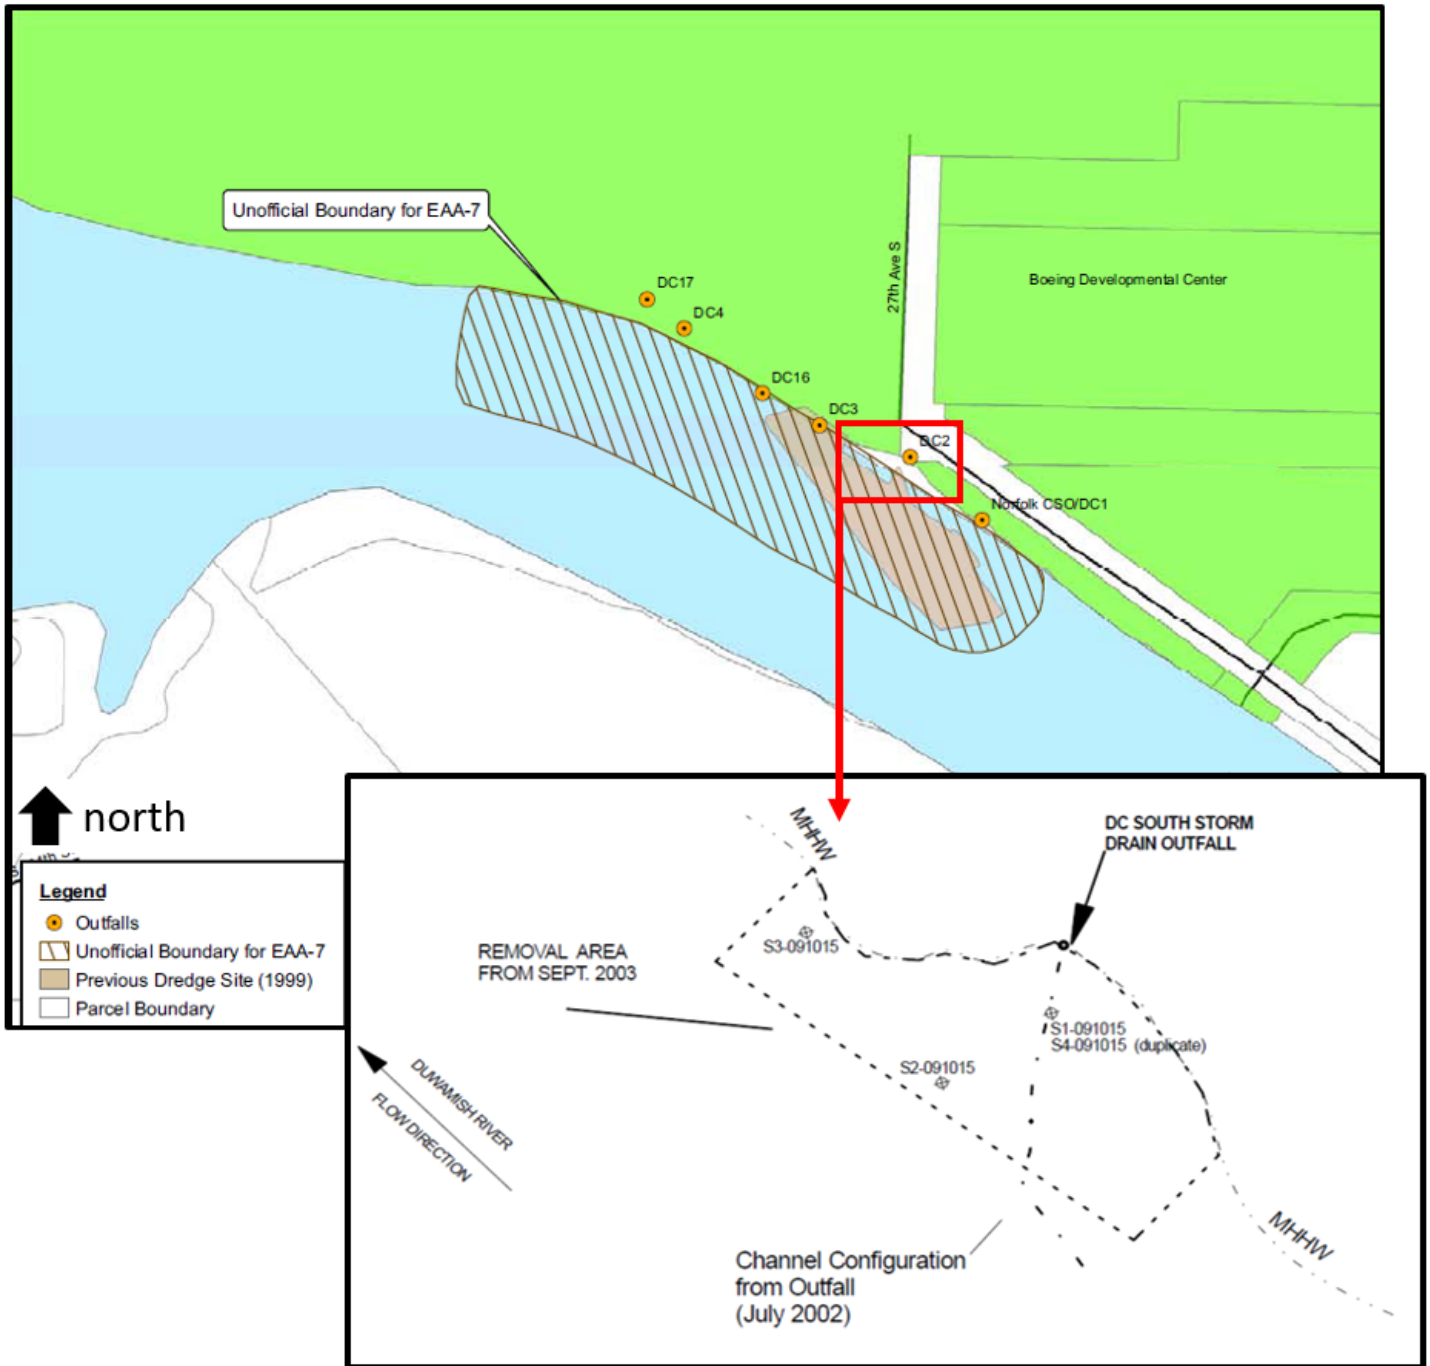
A 2001 evaluation of the South Storm Drain area had confirmed PCBs present in stormwater system solids, but sampling of the building materials within the drainage area did not identify a likely source of these PCBs.

Figure 8. Location of 1999 dredging in EAA-7 (top) and details on sampling locations within Boeing 2003 sediment remediation area (bottom). The Boeing south storm drain is location DC2 on the top figure, and the area of 2003 remediation was located between the 1999 dredge area and the shoreline.

Improvements to the stormwater system were made in 2003 to limit the reintroduction of PCBs to the excavated sediment area. These improvements included cleaning out the stormwater system to remove accumulated solids and installation of a new treatment vault within the South Storm Drain line to remove suspended solids from stormwater before they reach the river.

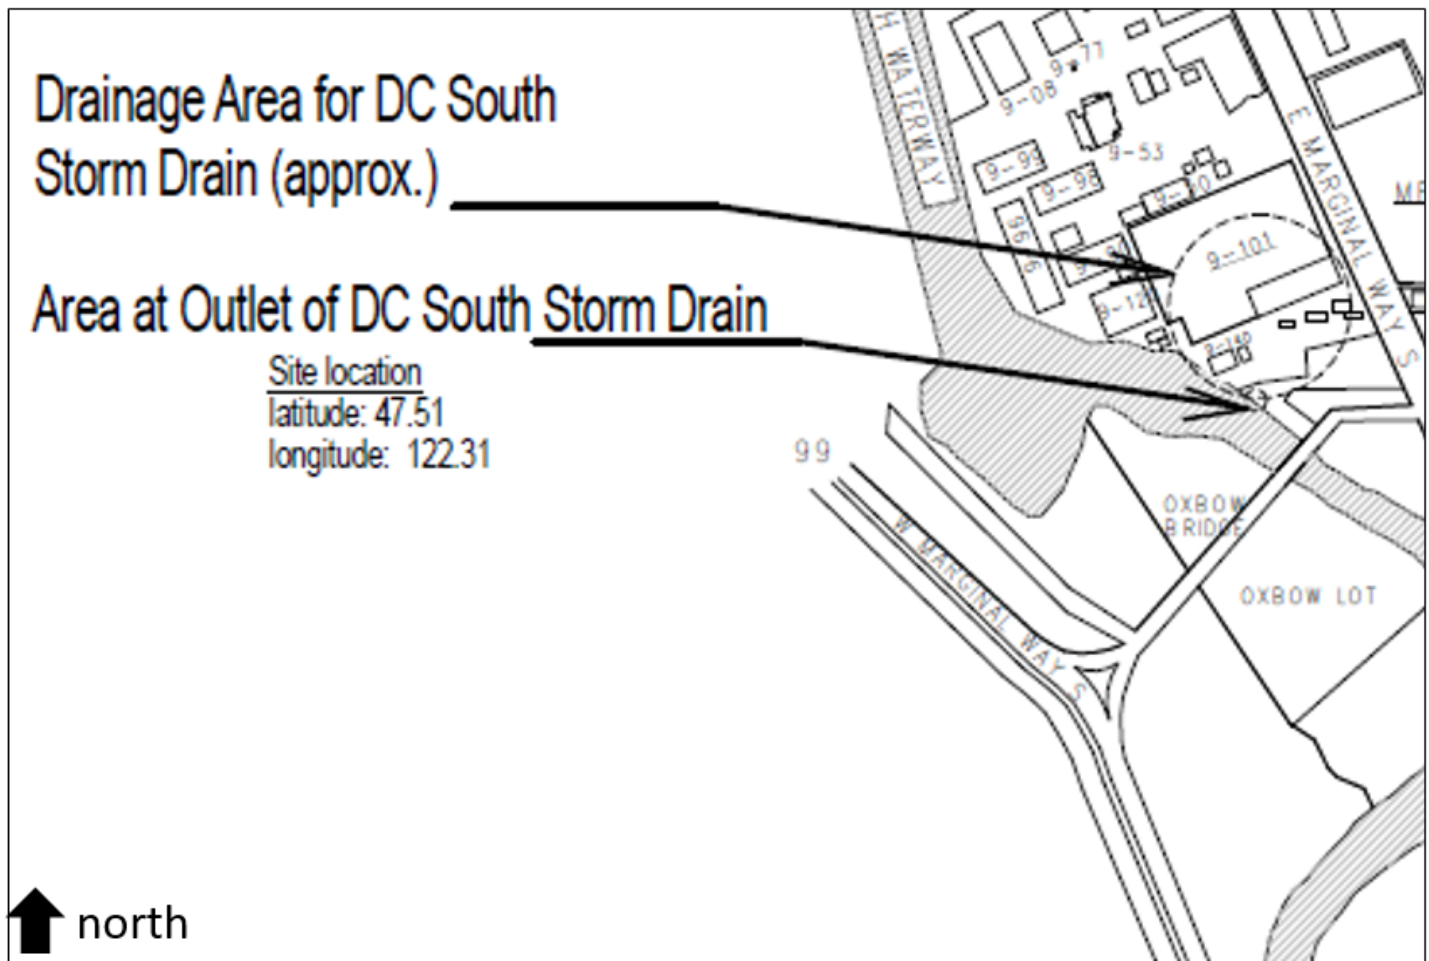
PCBs from the South Storm Drain outfall are likely entering surface water via direct discharge of stormwater and through the contact of surface water with recontaminated sediment in this area.

Figure 9. Area of Site drained by South Storm Drain stormwater infrastructure.
