APPENDIX B

WATER QUALITY MONITORING LOGS

RE: Interim Remedial Action G-P Log Pond – Weekly QA Report

INTERIM REMEDIAL ACTION: LOG POND CLEANUP/HABITAT RESTORATION

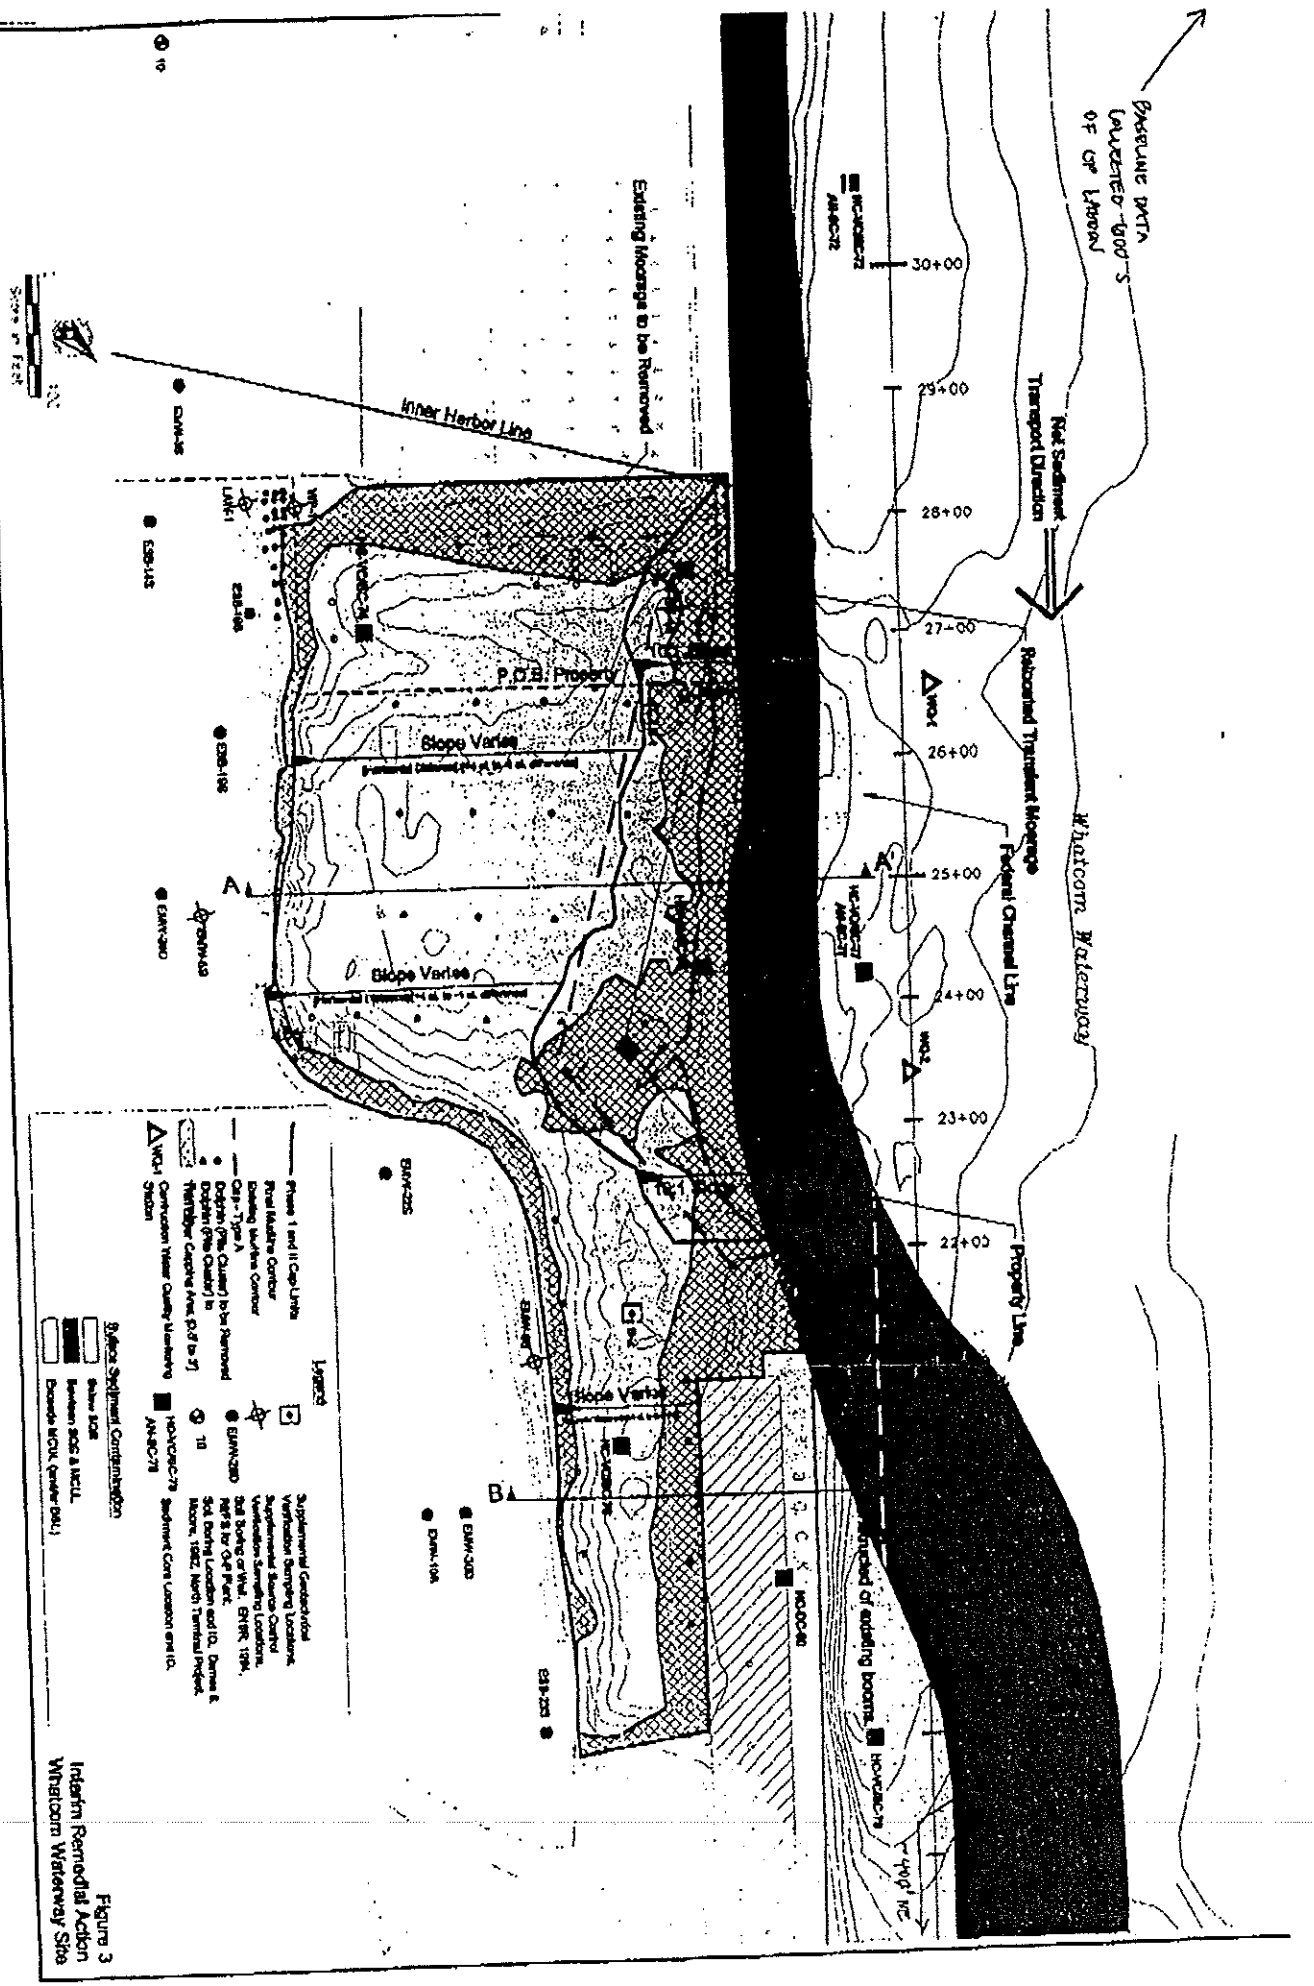
Figure 3
Interim Remedial Action
Whitcomb Waterway Site

All monitoring occurred 15.0 feet below the water's surface at three stations previously determined in the report entitled *GP Log Pond - Engineering Design Report* by Anchor Environmental (dated July 2000). A site plan of the water monitoring locations (WQ-1 through WQ-3) and approximate locations of the baseline monitoring sites are presented in the attached figure.
