January 17, 2012
Project 101.00855.00001

Re: Closure of Continental Fuel Hydrant System, SeaTac International Airport

PROJECT PHOTOGRAPHS
Closure of Continental Fuel Hydrant System
SeaTac International Airport

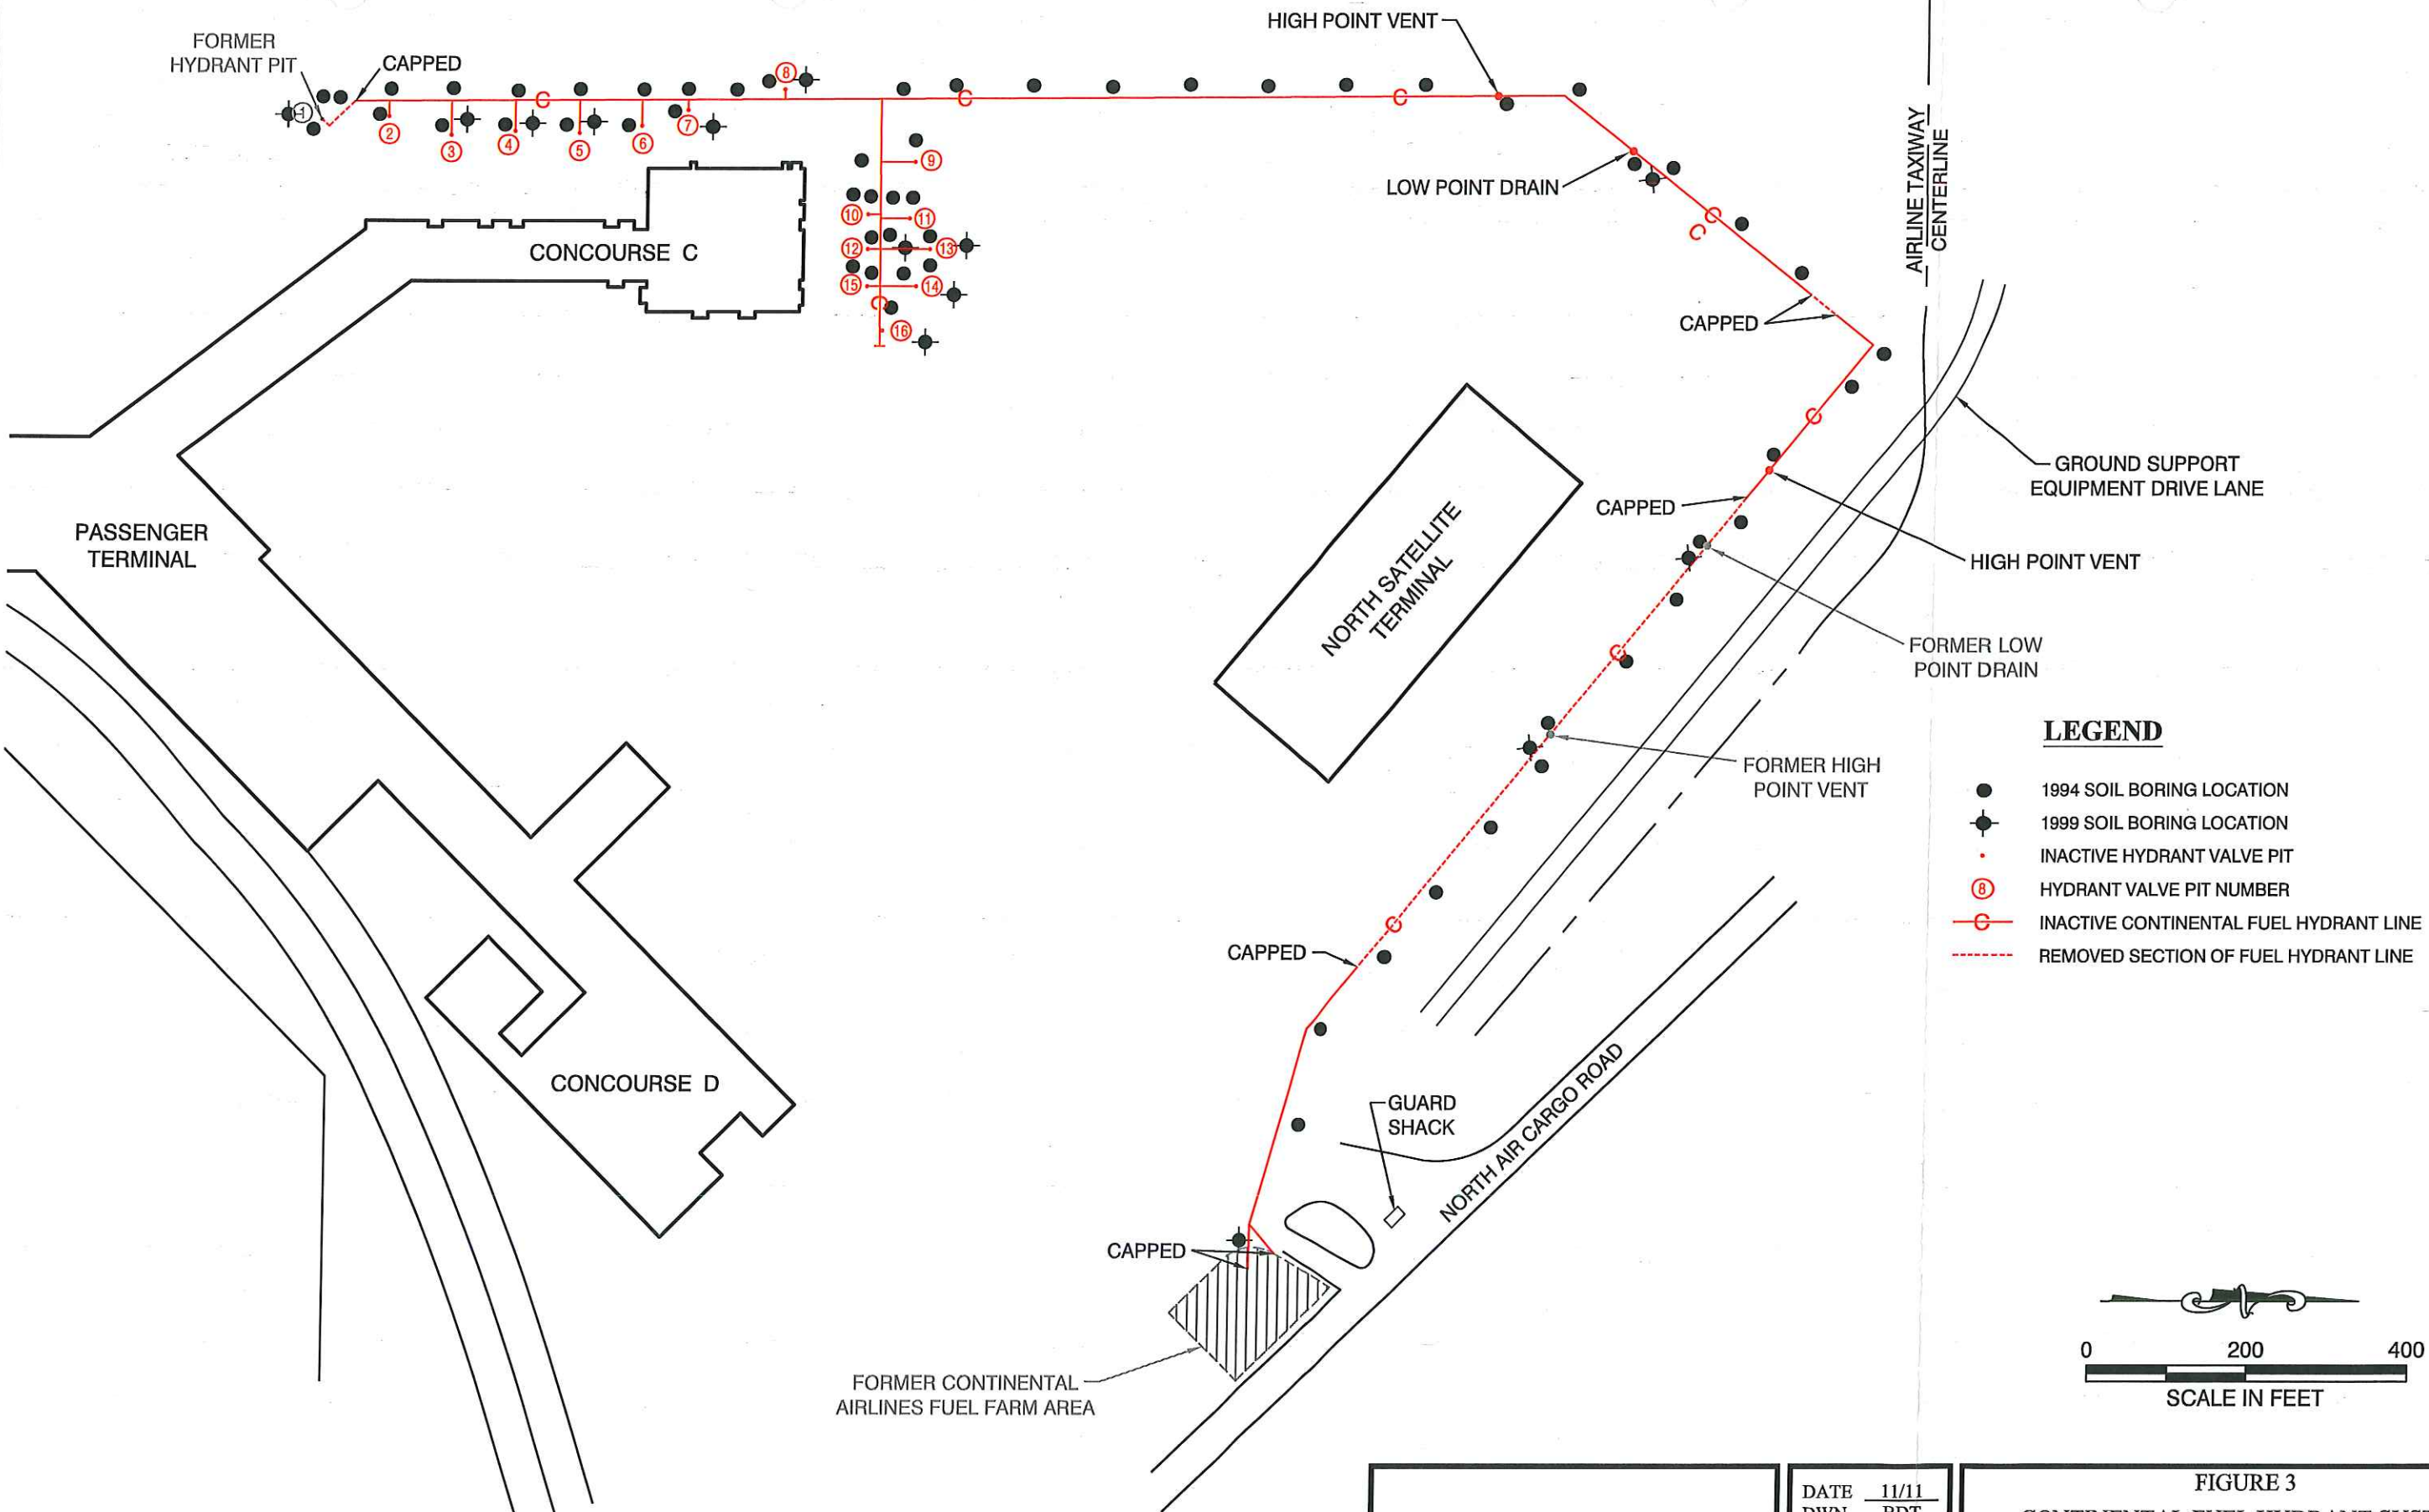
FIGURE 3
CONTINENTAL FUEL HYDRANT SYSTEM
SEATAC INTERNATIONAL AIRPORT
LOCATIONS OF PREVIOUS SOIL BORINGS

In 1994, ENSR conducted a subsurface investigation along the inactive Continental fuel hydrant system to assess the potential presence of petroleum hydrocarbons in the soil. The investigation consisted of drilling and sampling 61 soil borings to depths of approximately 10 to 15 feet bgs. The borings were spaced at approximate 100-foot intervals along the pipeline and were also located adjacent to all of the hydrant pits, high point vents, low point drains, and hydrant line junctions. The approximate locations of the borings are shown on Figure 3. A minimum of two soil samples were collected from each boring for analysis of total petroleum hydrocarbons (TPH) as Jet A fuel. The majority of the soil samples that contained TPH as Jet A concentrations greater than the Model Toxics Control Act (MTCA) Method A soil cleanup level were collected at locations adjacent to hydrant pits, high point vents, and low point drains. The impacted soil primarily occurred at depths between 5 and 10 feet bgs, and in several borings, the TPH as Jet A concentrations decreased significantly to near or below the Method A cleanup level by 15 feet bgs (ENSR, 1994).

In 1999, Foster Wheeler Environmental Corporation (Foster Wheeler) conducted a subsurface investigation along the inactive Continental fuel hydrant system to further characterize the vertical extent of the TPH as Jet A concentrations in the soil, and to determine if the petroleum hydrocarbons reached the groundwater. The investigation consisted of drilling and sampling 13 soil borings at locations of known impacted soil. The approximate locations of the borings are shown on Figure 3. The borings were advanced to depths ranging from approximately 20 to 45 feet bgs, and the soil sample analytical results showed that the impacted soil did not reach the groundwater table (Foster Wheeler, 1999). The shallowest groundwater (the Qva aquifer) beneath the hydrant system occurs at a depth of approximately 90 feet bgs.

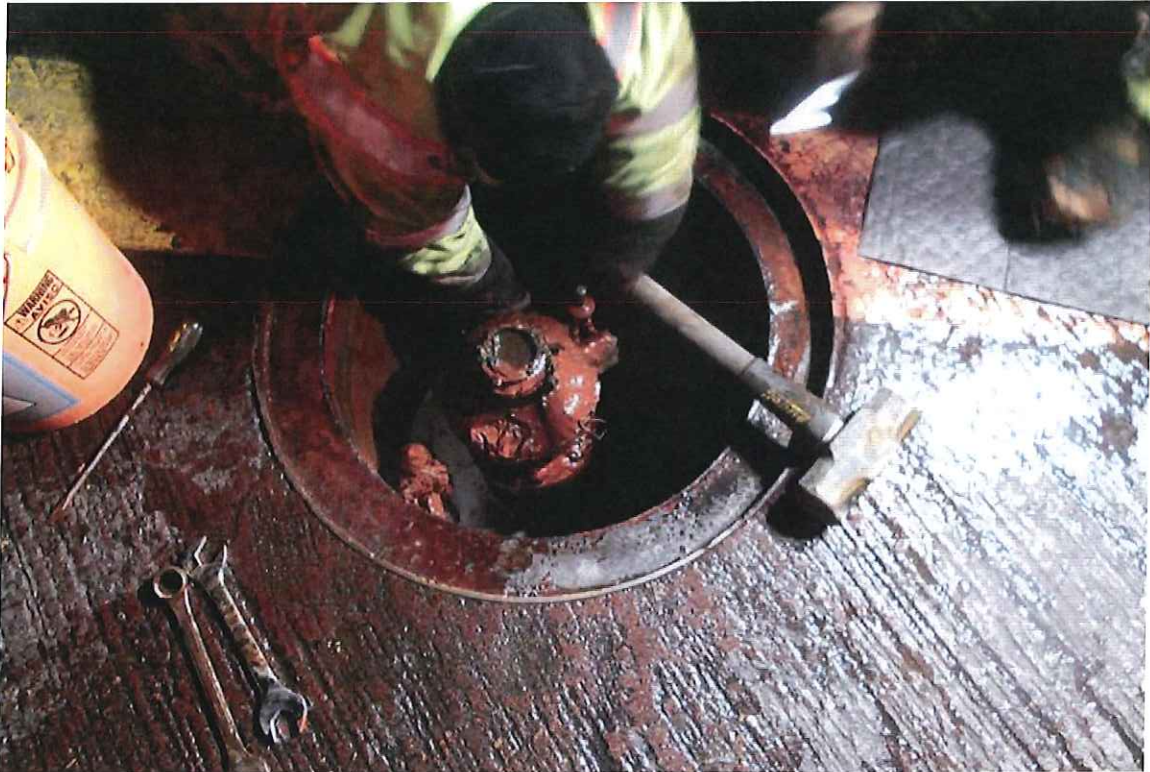
Fuel pit #9 during removal of the hydrant valve.

After Sound Testing certified that any remaining petroleum vapor concentrations in the hydrant system were below the lower explosion limit, then Wyser Construction, Inc. (Wyser) of Snohomish, Washington, removed the valve at each hydrant valve pit and bolted a cast iron cap on the remaining pipe flange. At the high point vents and the low point drain, bolted caps were already in place. After installing the caps, Wyser filled each hydrant valve pit, high point vent pit, and low point drain pit with concrete, and then covered the concrete-filled pits with the existing steel lids.

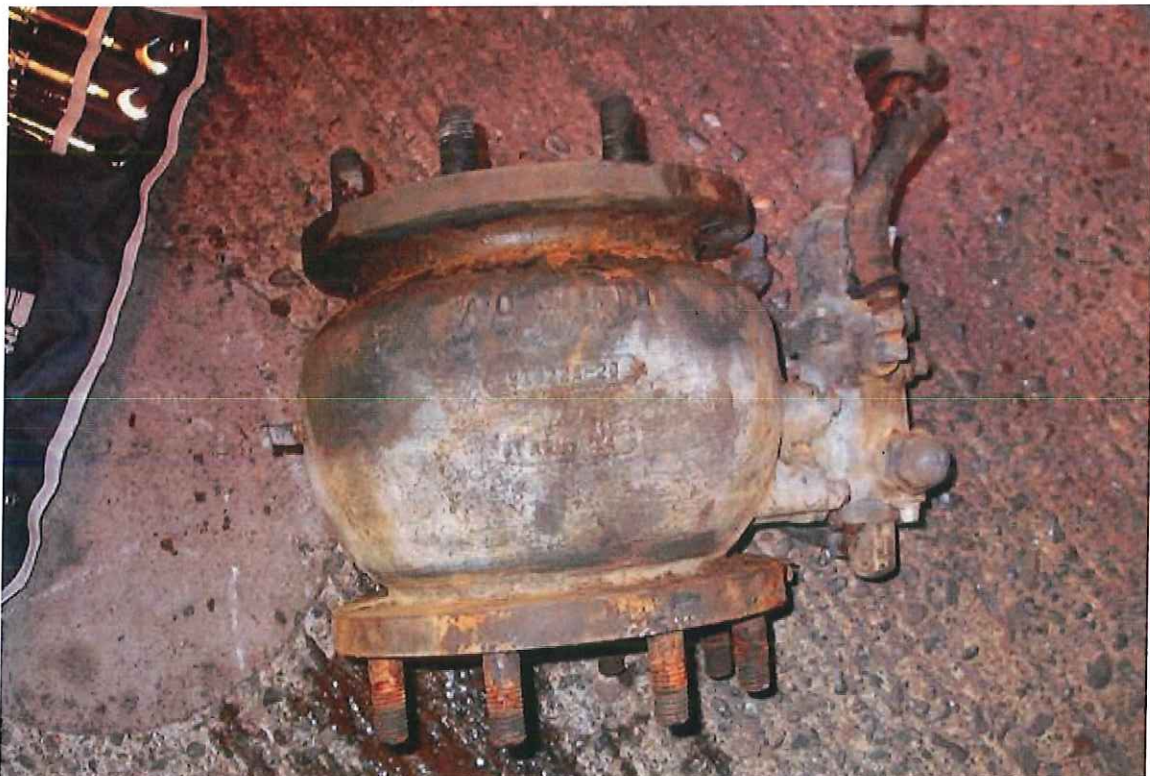
Hydrant valve removed from fuel pit #5.

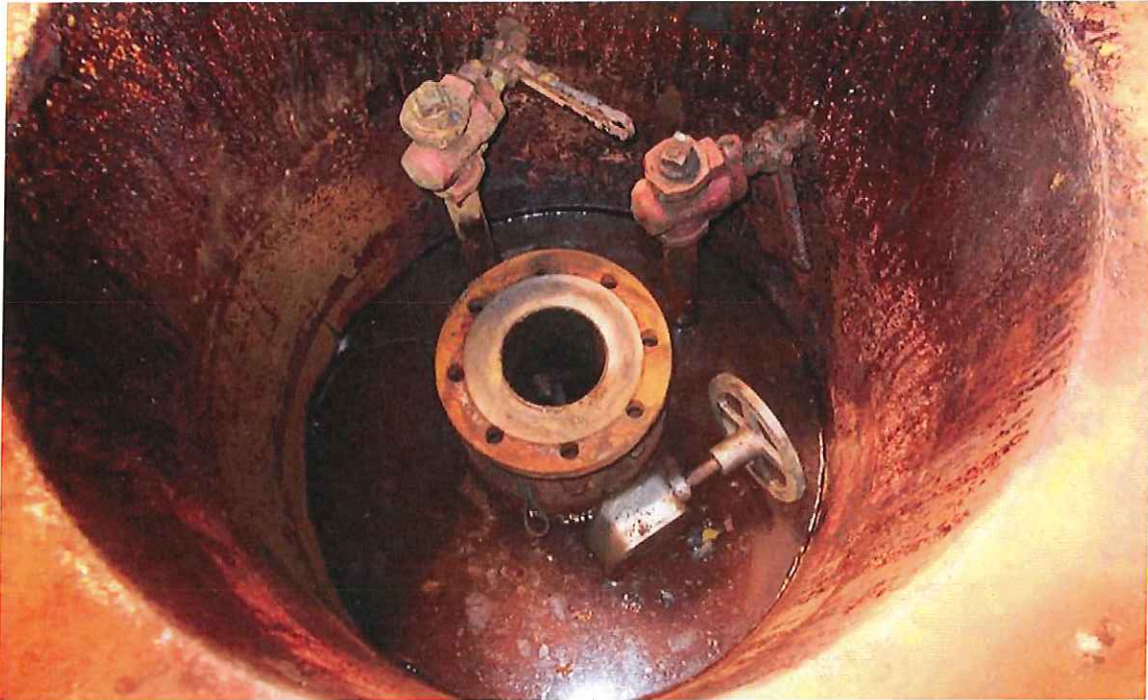
Fuel pit #2 after removal of valve and prior to cap installation. The two small compressed air pipes were previously disconnected from the valve and fitted with threaded plugs.

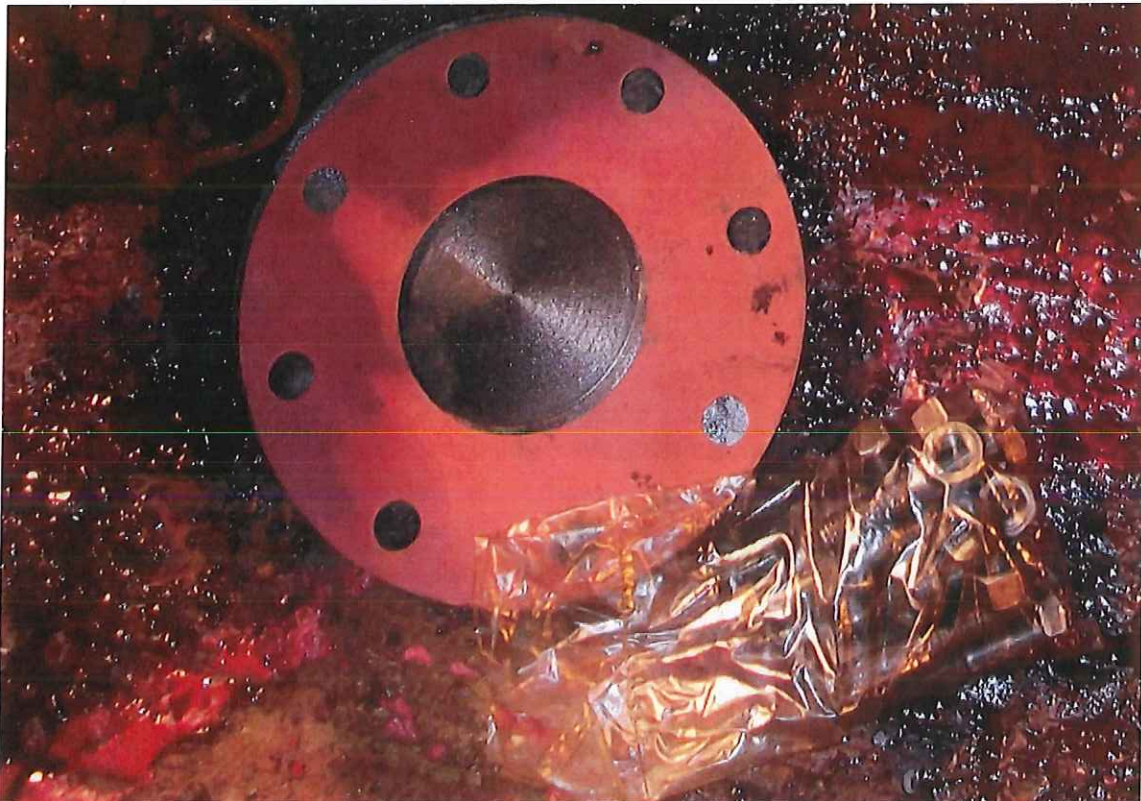
Typical cast iron cap, rubber gasket, and bolt kit used to cap fuel hydrant pipes after removal of the valves.

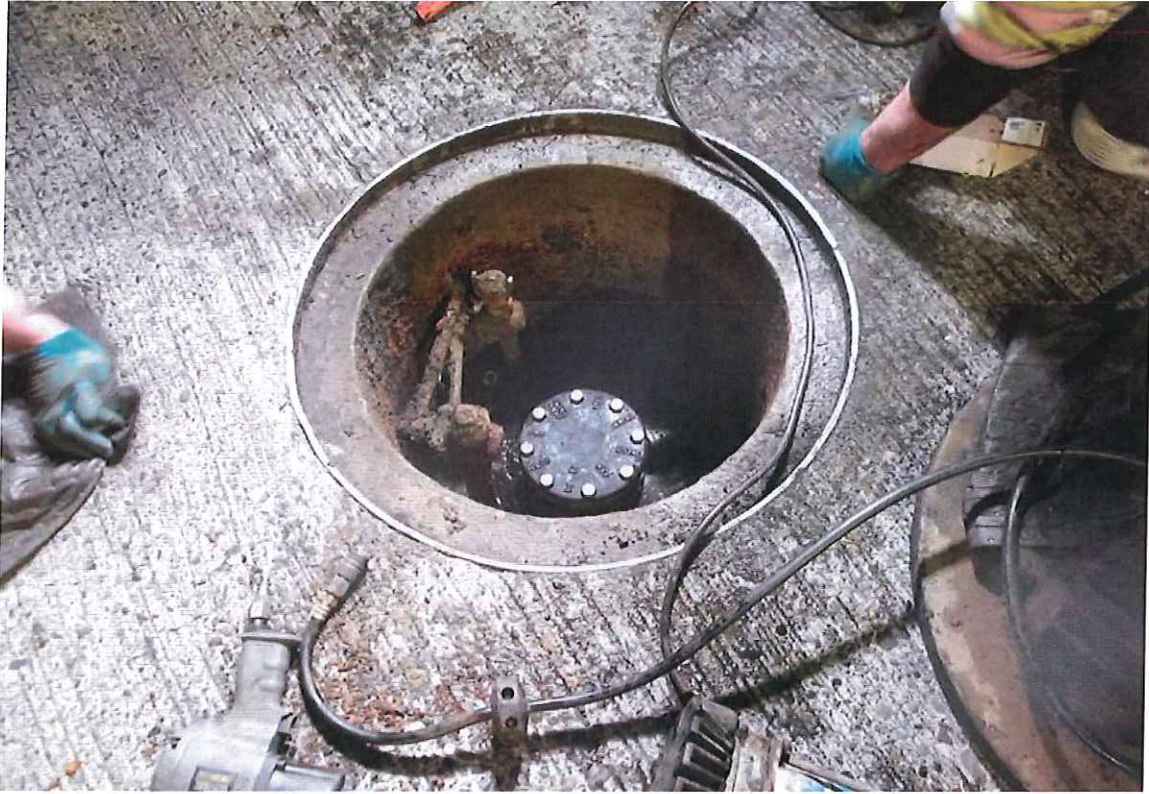
Fuel pit #14 after installation of cast iron cap.

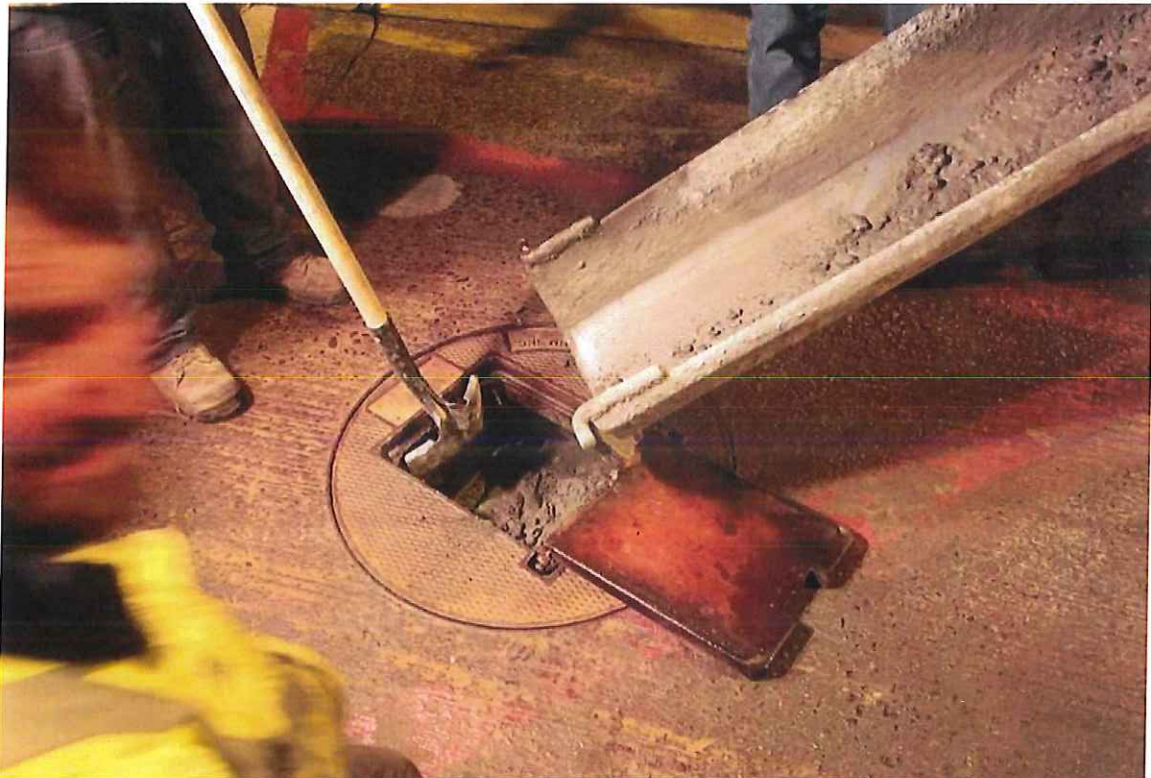
Filling fuel pit #2 with concrete.

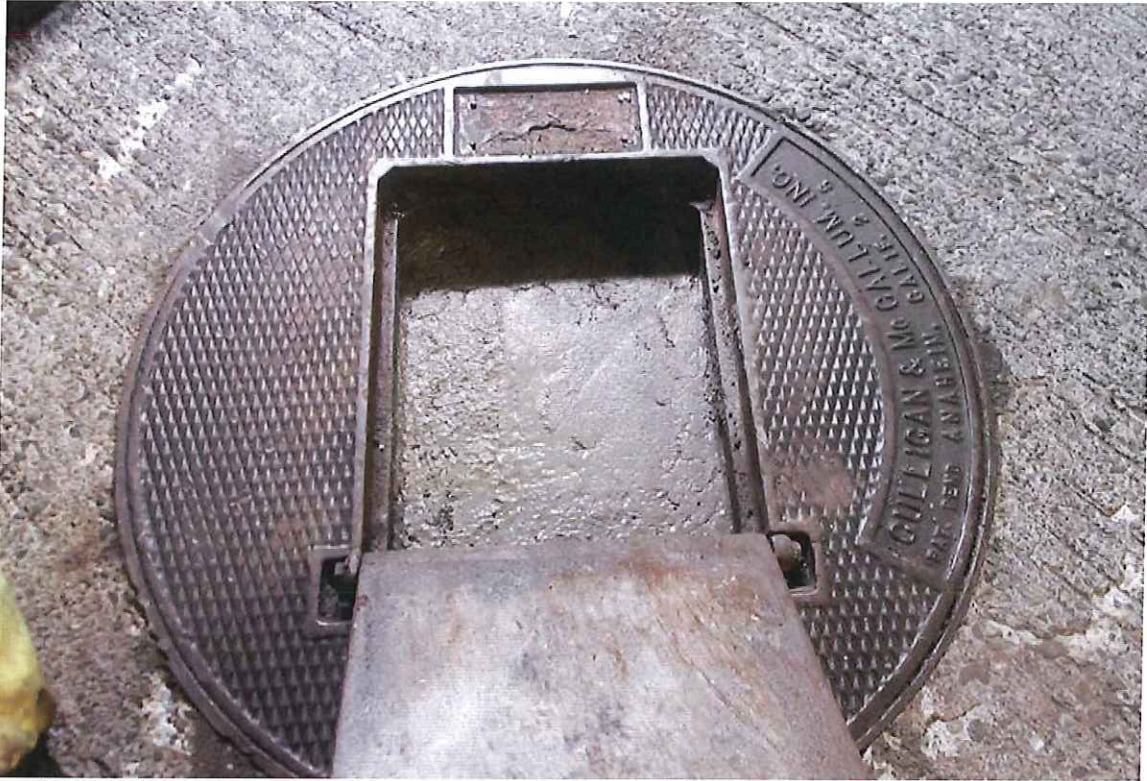
Fuel pit #7 after filling with concrete.

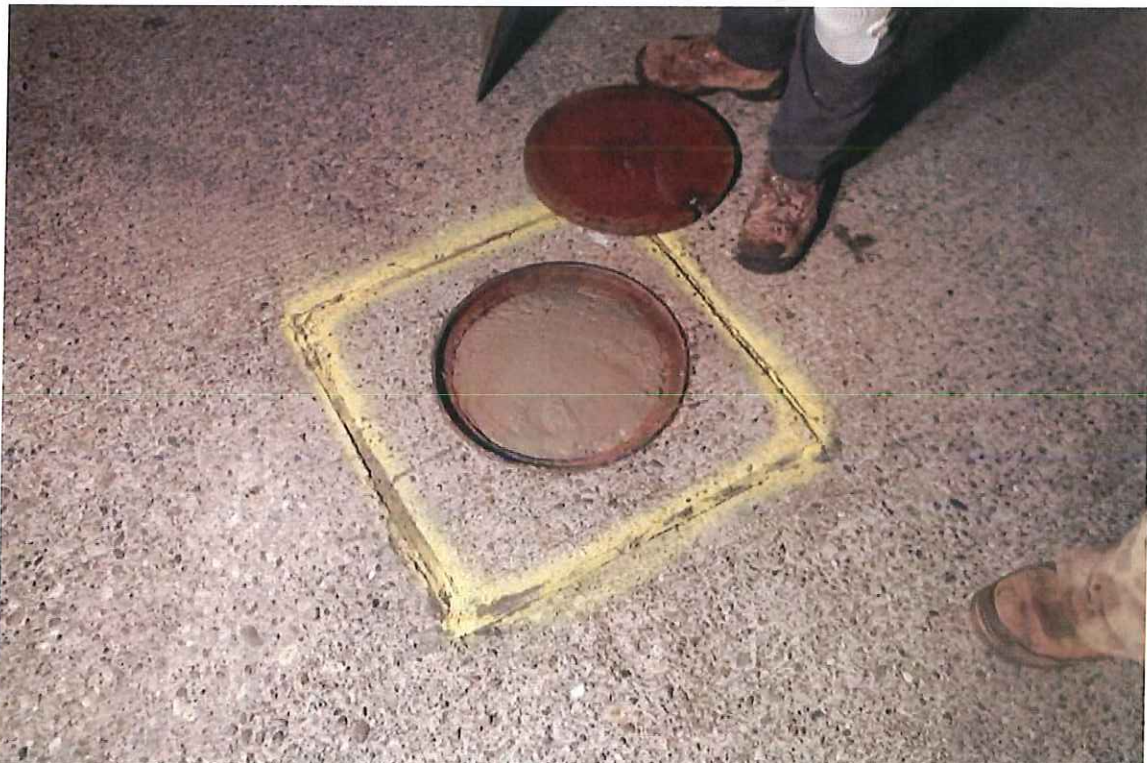
High-point vent after filling with concrete.
