STATE OF WASHINGTON
DEPARTMENT OF ECOLOGY

March 19, 2019

Re: Opinion pursuant to WAC 173-340-515(5) on Remedial Action for the following Hazardous Waste Site:

- **Site Name:** Park Lake Homes Maintenance Shop
- **Site Address:** 9800 8th Avenue SW, Seattle, WA 98106
- **Cleanup Site ID:** 8417
- **Facility/Site No.:** 24359391
- **VCP Project No.:** NW3033

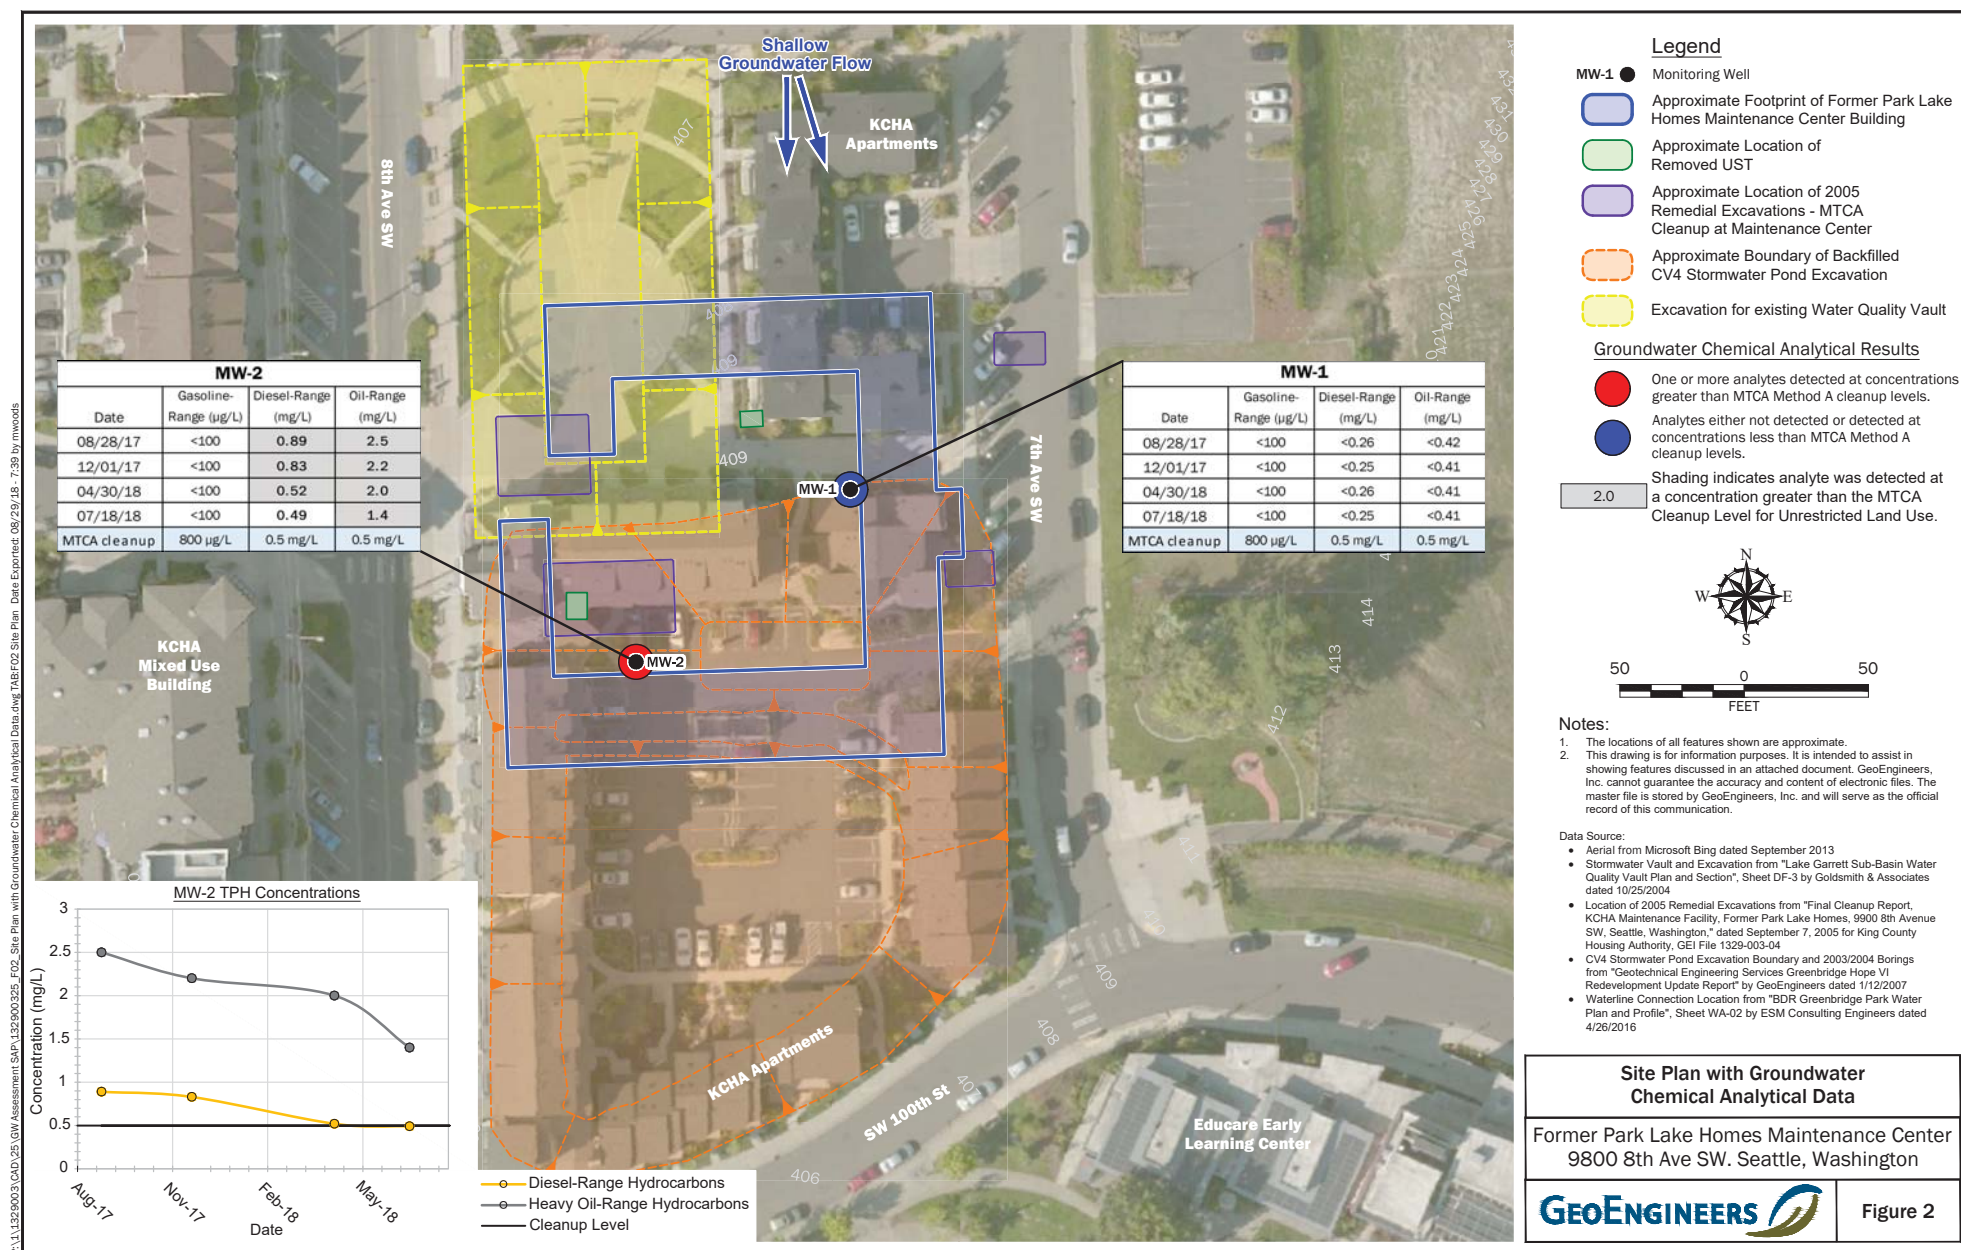
Enclosure A, Figure 2

Ground Water: Ground water was encountered in borings drilled at the Site at depths of 4 to 10 feet below ground surface (bgs), and ground water seepage was observed in remedial excavations at a depth of 12 to 13 feet bgs. This shallow ground water appears to be perched on top of the underlying dense glacial till. The likely ground water flow direction is to the south, based on the historic land topography (erosional surface on top of the glacial till). Two monitoring wells were installed at the Site in 2017 (see **Enclosure A, Figure 2**). Ground water flow directions and gradients have not been confirmed with Site-specific data.

Two monitoring wells were installed at the Site in July 2017 (see **Enclosure A, Figure 2**). Groundwater samples were collected from these wells in August 2017, December 2017, April 2018, and July 2018. Concentrations of TPHd and TPHo in MW-2 were above MTCA Method A cleanup levels for all four sampling events. The pesticide heptachlor epoxide was above the MTCA Method B cleanup level in MW-2 during two of the sampling events. None of the results for ground water samples from MW-1 were above MTCA cleanup levels.

- Ground water sampling results from monitoring well MW-1 show no exceedances of MTCA cleanup levels for four quarterly monitoring events. Ecology therefore concurs with the GeoEngineers recommendation to discontinue ground water sampling from MW-1. However, Ecology does not concur with the GeoEngineers recommendation to decommission MW-1, because water level data from this well will be needed to assess ground water flow directions, as previously discussed in this opinion letter.

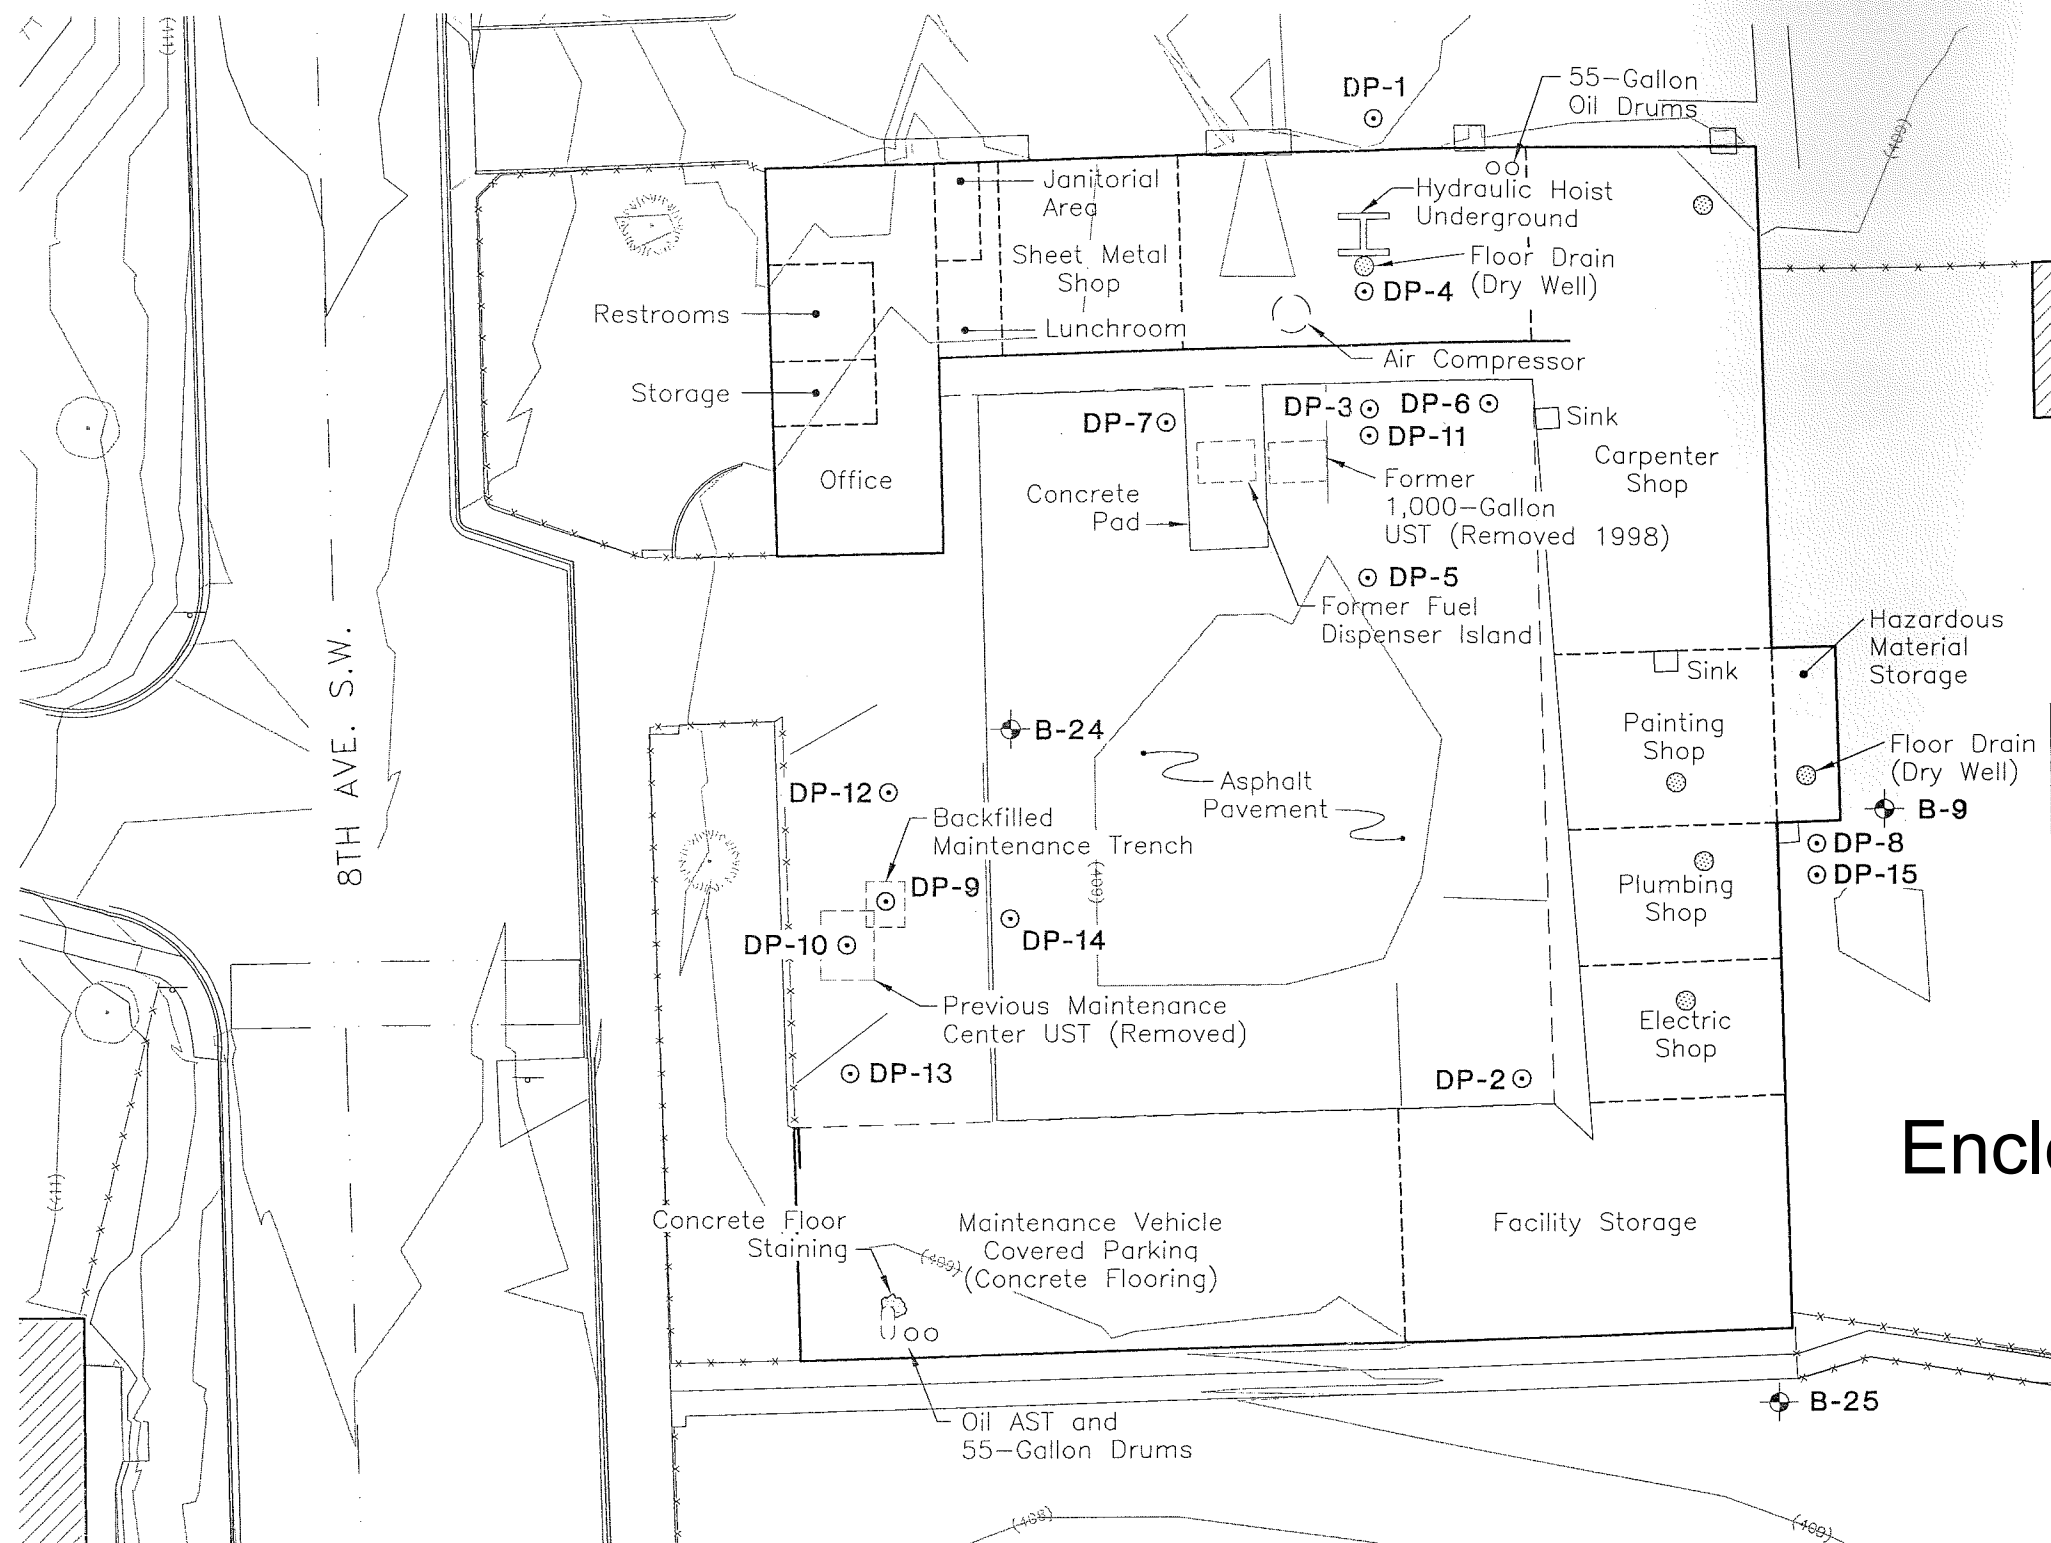
Enclosure A, Figure 3

A subsurface investigation was conducted at the Site in 2004 prior to redevelopment of the Property and included 15 direct-push borings (see **Enclosure A, Figure 3**). Soil samples from four borings showed concentrations of gasoline-, diesel-, and lube oil-range hydrocarbons (TPHg, TPHd, and TPHo, respectively) above MTCA Method A soil cleanup levels for unrestricted land use. Ground water was encountered between depths of 4 and 10 feet bgs during drilling; however, ground water samples were not collected.

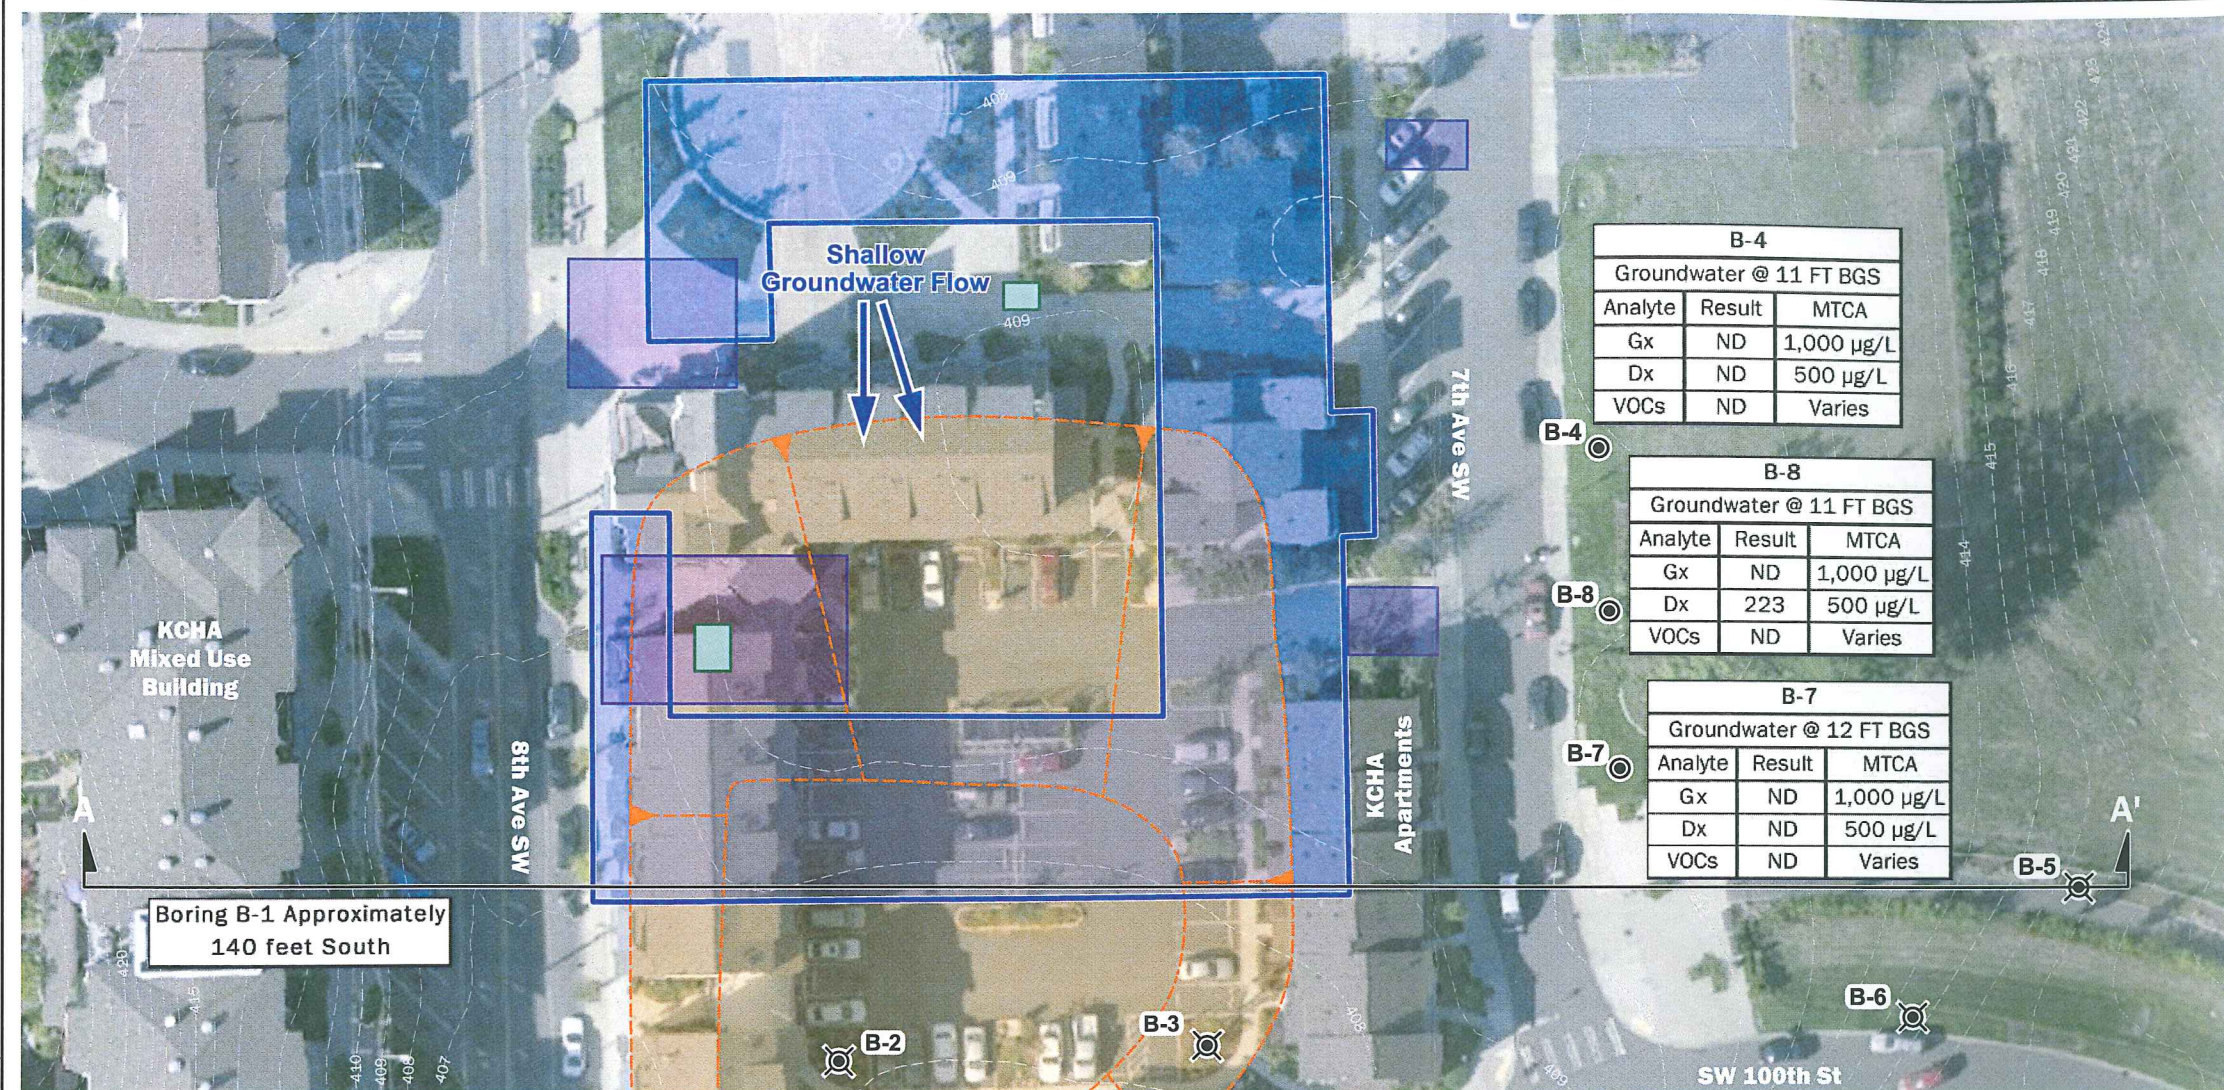
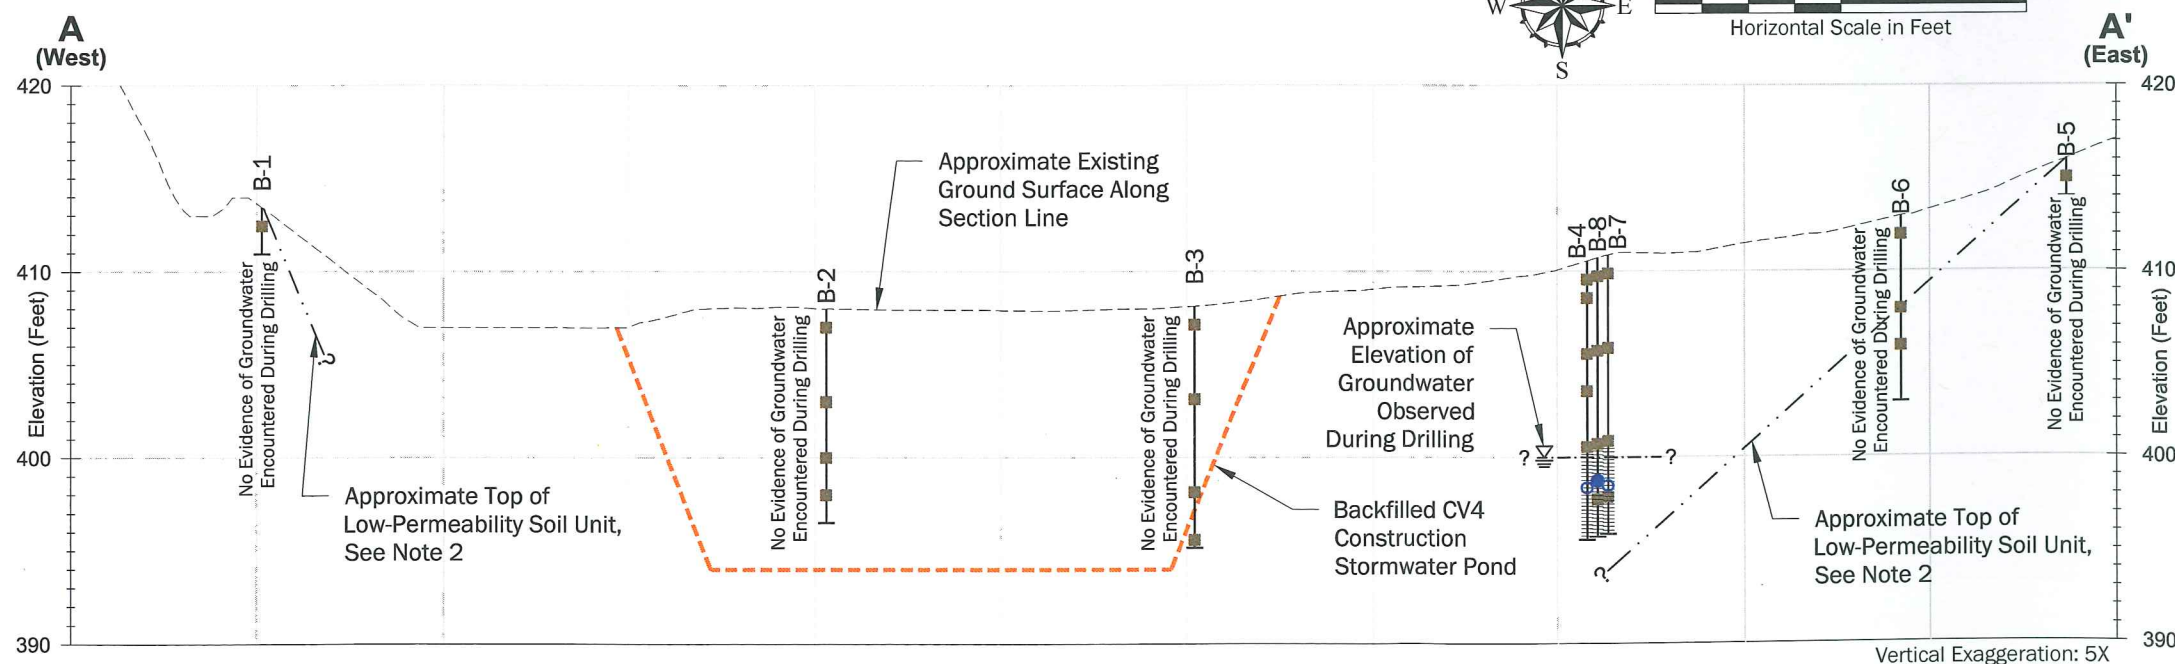
Enclosure A, Figure 4

Seven direct-push borings were drilled at the Site in 2015 (see **Enclosure A, Figure 4**). Ground water samples were collected from temporary monitoring wells in three of these borings. None of the tested chemical parameters (TPHg, TPHd, TPHo, and volatile organic chemicals) were present in concentrations above MTCA ground water cleanup levels. However, based on the likely southerly shallow ground water flow direction, these temporary monitoring wells appear to be located cross-gradient of former potential contamination sources at the Site.

B-4		
Groundwater @ 11 FT BGS		
Analyte	Result	MTCA
Gx	ND	1,000 µg/L
Dx	ND	500 µg/L
VOCs	ND	Varies

B-8		
Groundwater @ 11 FT BGS		
Analyte	Result	MTCA
Gx	ND	1,000 µg/L
Dx	223	500 µg/L
VOCs	ND	Varies

B-7		
Groundwater @ 12 FT BGS		
Analyte	Result	MTCA
Gx	ND	1,000 µg/L
Dx	ND	500 µg/L
VOCs	ND	Varies

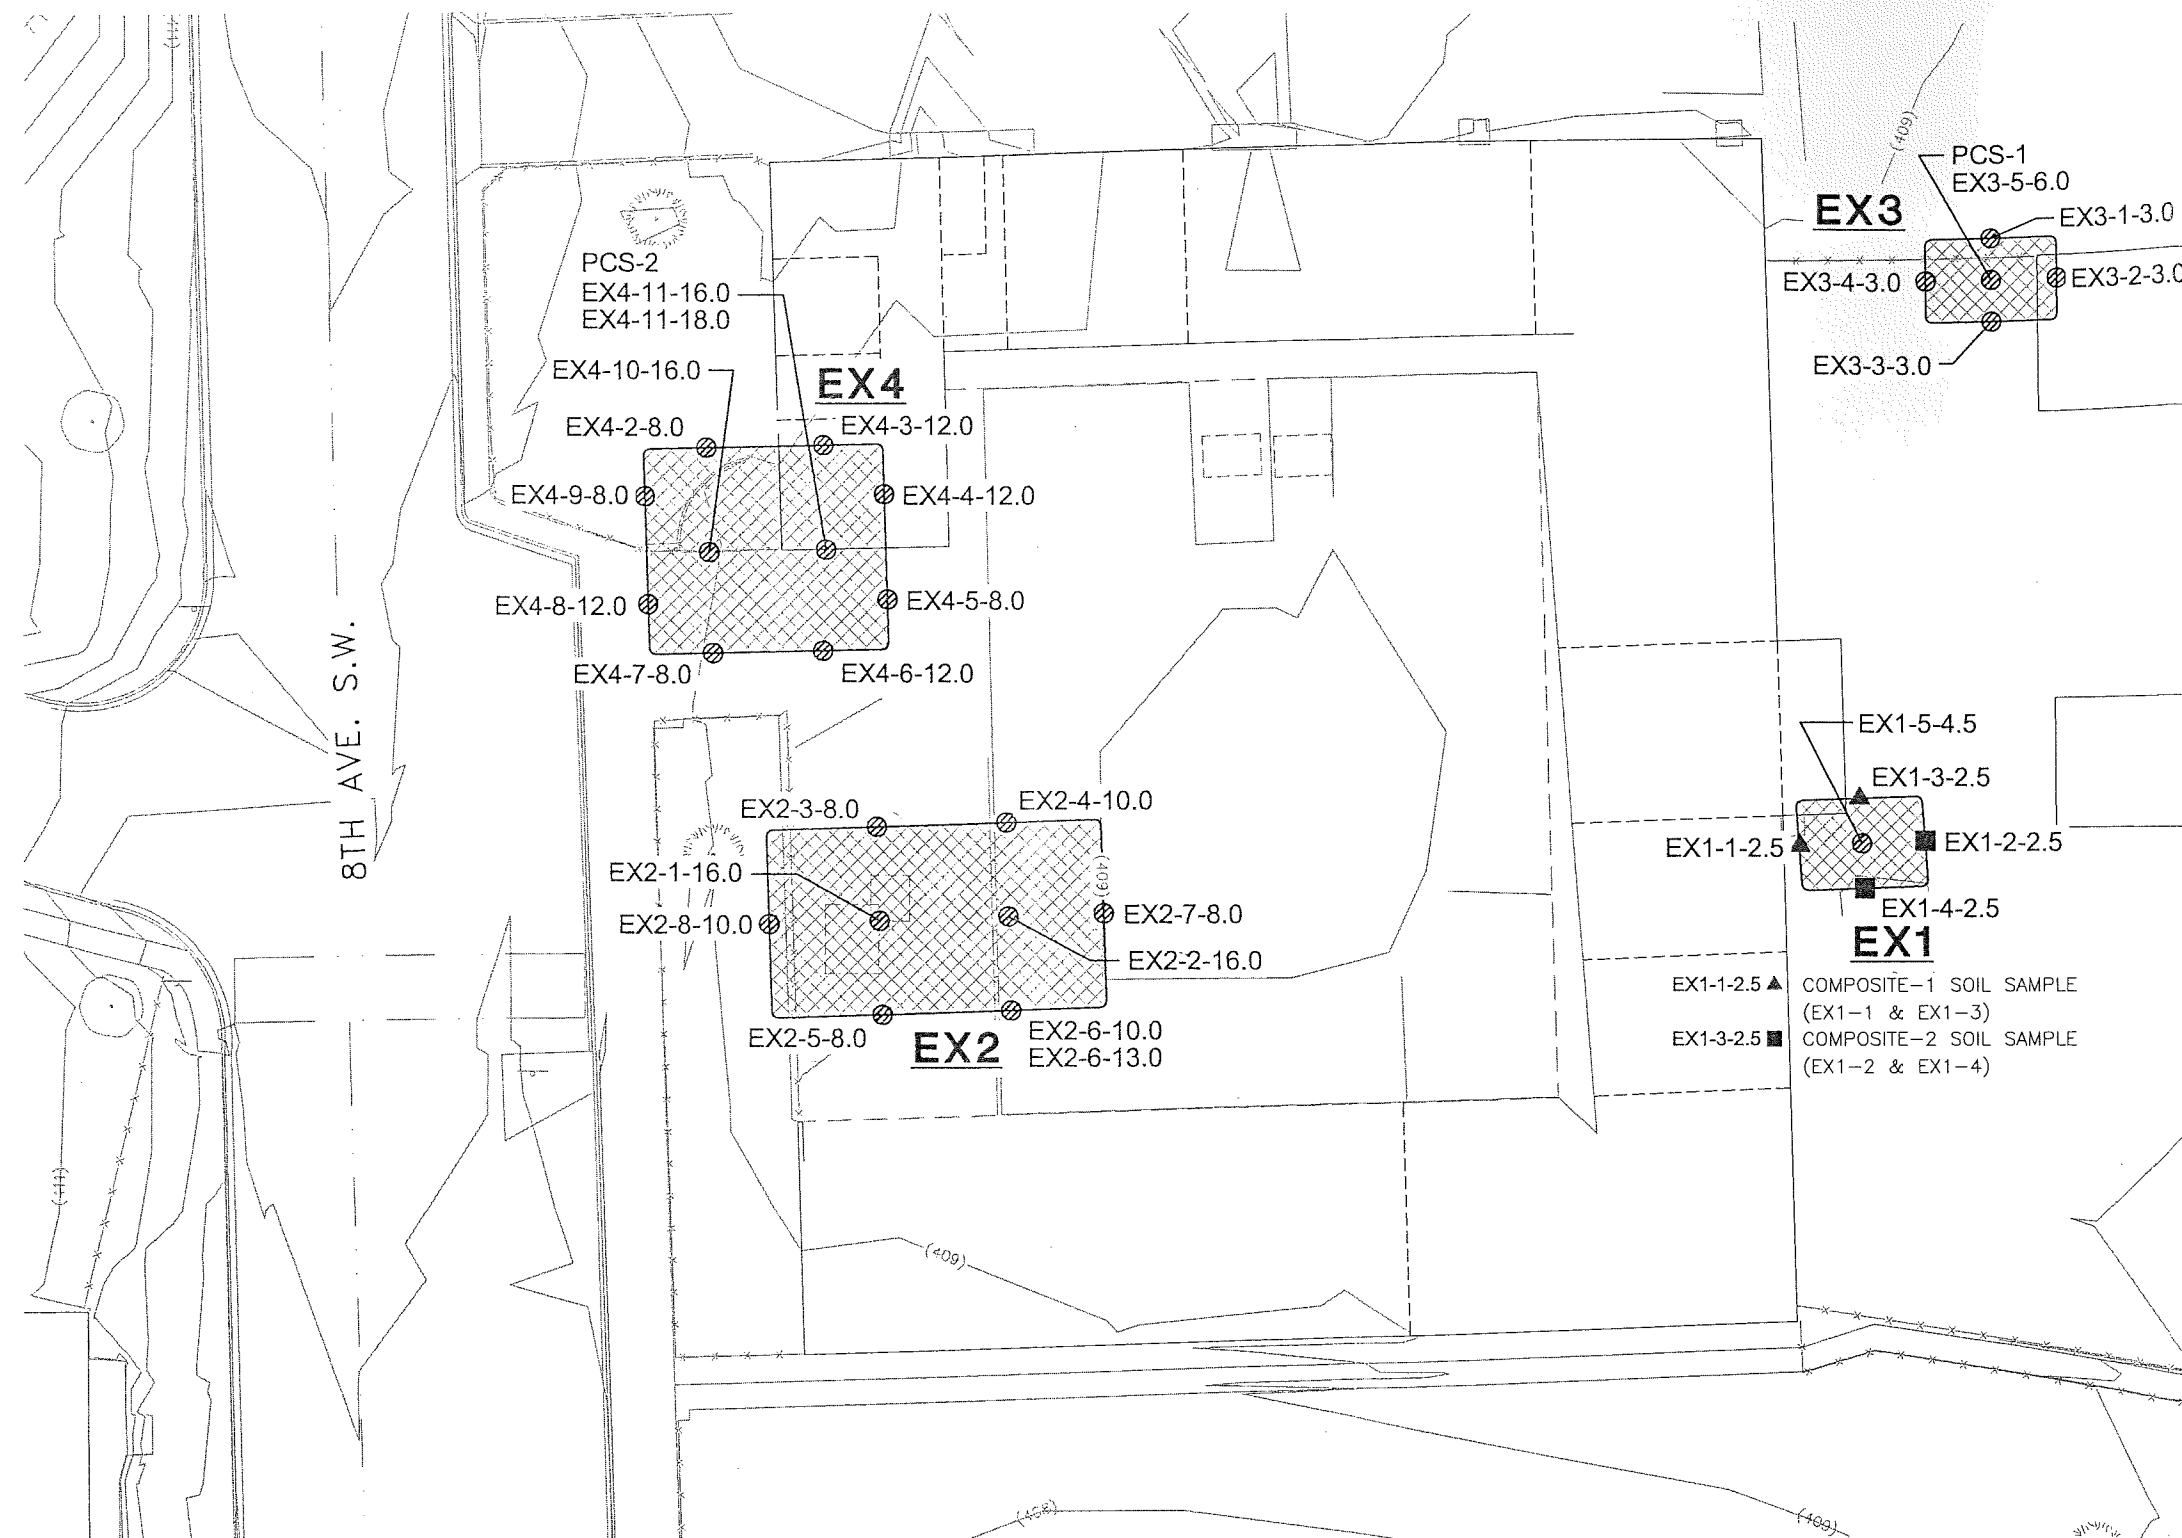
Enclosure A, Figure 5

Interim Cleanup Actions: Four excavations ranging in depth from 4.5 to 18 feet bgs were completed at the Site in 2005 (**Enclosure A, Figure 5**). Confirmation soil samples were tested for BTEX, TPHg, TPHd, and TPHo and showed concentrations below Method A soil cleanup levels for unrestricted land use. A total of 2,296 tons (approximately 1,200 cubic yards) of petroleum-contaminated soil was removed for off-Site disposal. Moderate ground water seepage was observed in two of the four excavations at depths of 12 to 13 feet bgs.
