State of Washington  
**POLLUTION LIABILITY INSURANCE AGENCY**  
300 Desmond Drive SE • PO Box 40930 • Olympia, Washington 98504-0930  
(360) 407-0520 • (800) 822-3905 • FAX (360) 407-0509  
[www.plia.wa.gov](http://www.plia.wa.gov)

**Re: No Further Action at the Following Site:**

- **Facility/Site Name:** H&H Diesel
- **Facility/Site Address:** 407 Porter Way, Milton, WA 98354-9686
- **Facility Site ID:** 89863773
- **PTAP Project No.:** PSW031

### H&H Diesel Site – PSW031

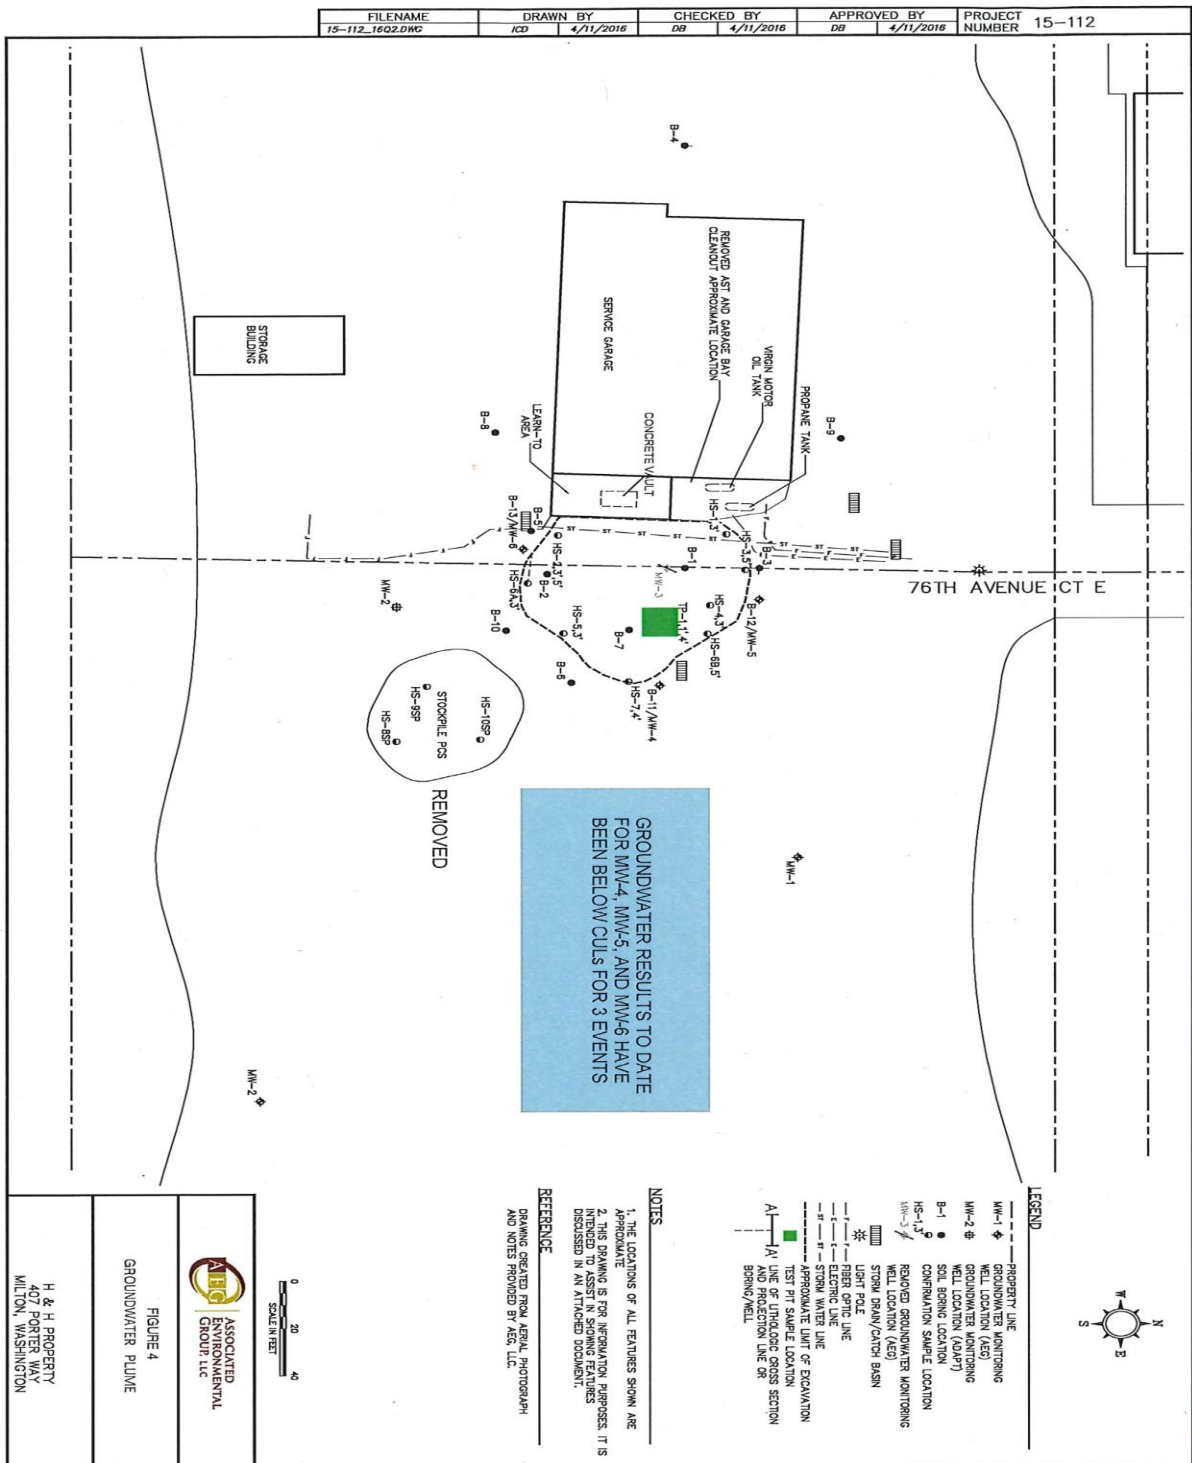
**Figure 3: Extent of GW TPH Impact & GW POC**

Petroleum contaminated groundwater (PCGW) detected at this Site is limited to the Property boundary and is defined by monitoring wells (MW), former MW-3 and bounded by MW-4, MW-5 and MW-6 (Fig. 3).

PCGW detected at this Site is limited to the Property boundary and is defined by monitoring wells (MW), former MW-3 and bounded by MW-4, MW-5 and MW-6 (Fig. 3).

- d. **Points of Compliance for contaminated groundwater:** The limit of the PCGW is bounded by the extent of PCGW performance sampling results below cleanup levels. The Performance sampling results for the PCGW are below the MTCA Method A Cleanup levels for unrestricted land-use depicted by MW-4, MW-5 and MW-6 for four consecutive quarters (Fig. 3).

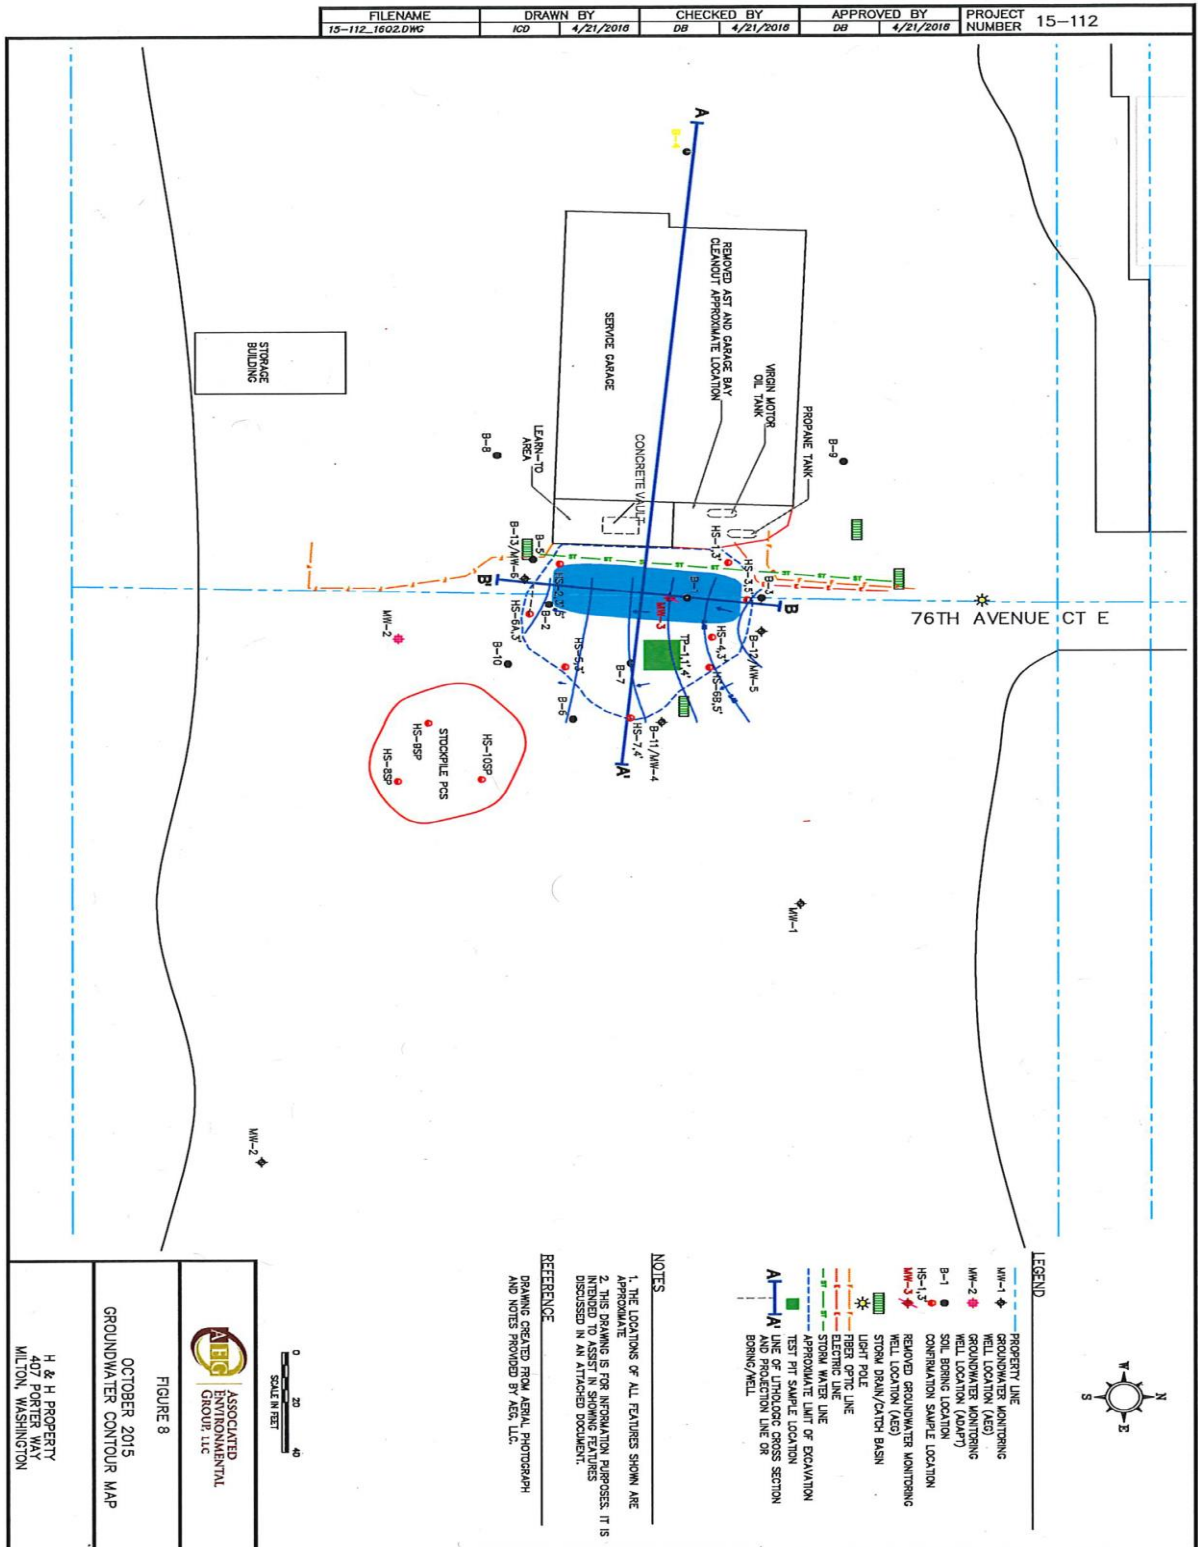
**Fig. 4: Groundwater Flow Direction**

Groundwater was encountered at the Site ranging from 6' to 11' bgs, and the direction of groundwater flow is to the south. Hylebos Creek is located approximately 600' to the west of the Site, and the Puyallup River is located approximately 2.5 miles south (Figs. 1 and 4).

- iv. **Surface water:** The nearest surface water body is the Hylebos Creek located approximately 600' to the west of the Site, and the Puyallup River is located approximately 2.5 miles south (Figs. 1 and 4).

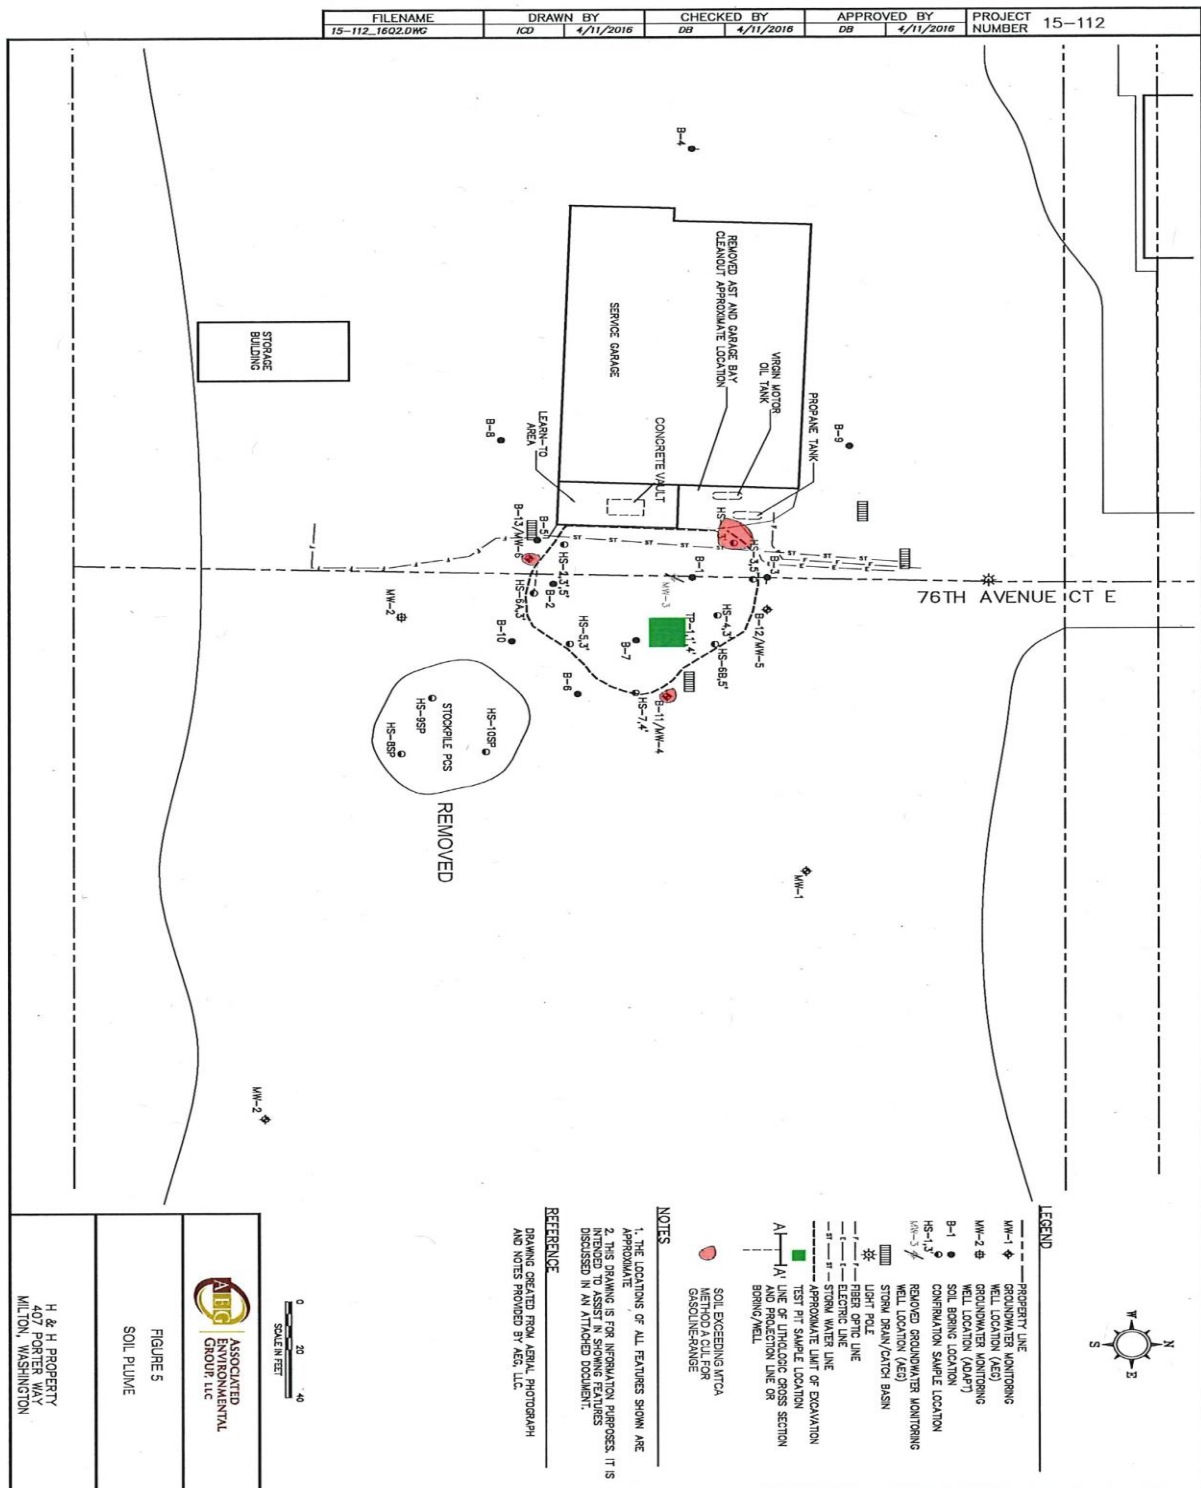
Fig. 5: Extent of Residual PCS about Cleanup Levels – Post Excavation

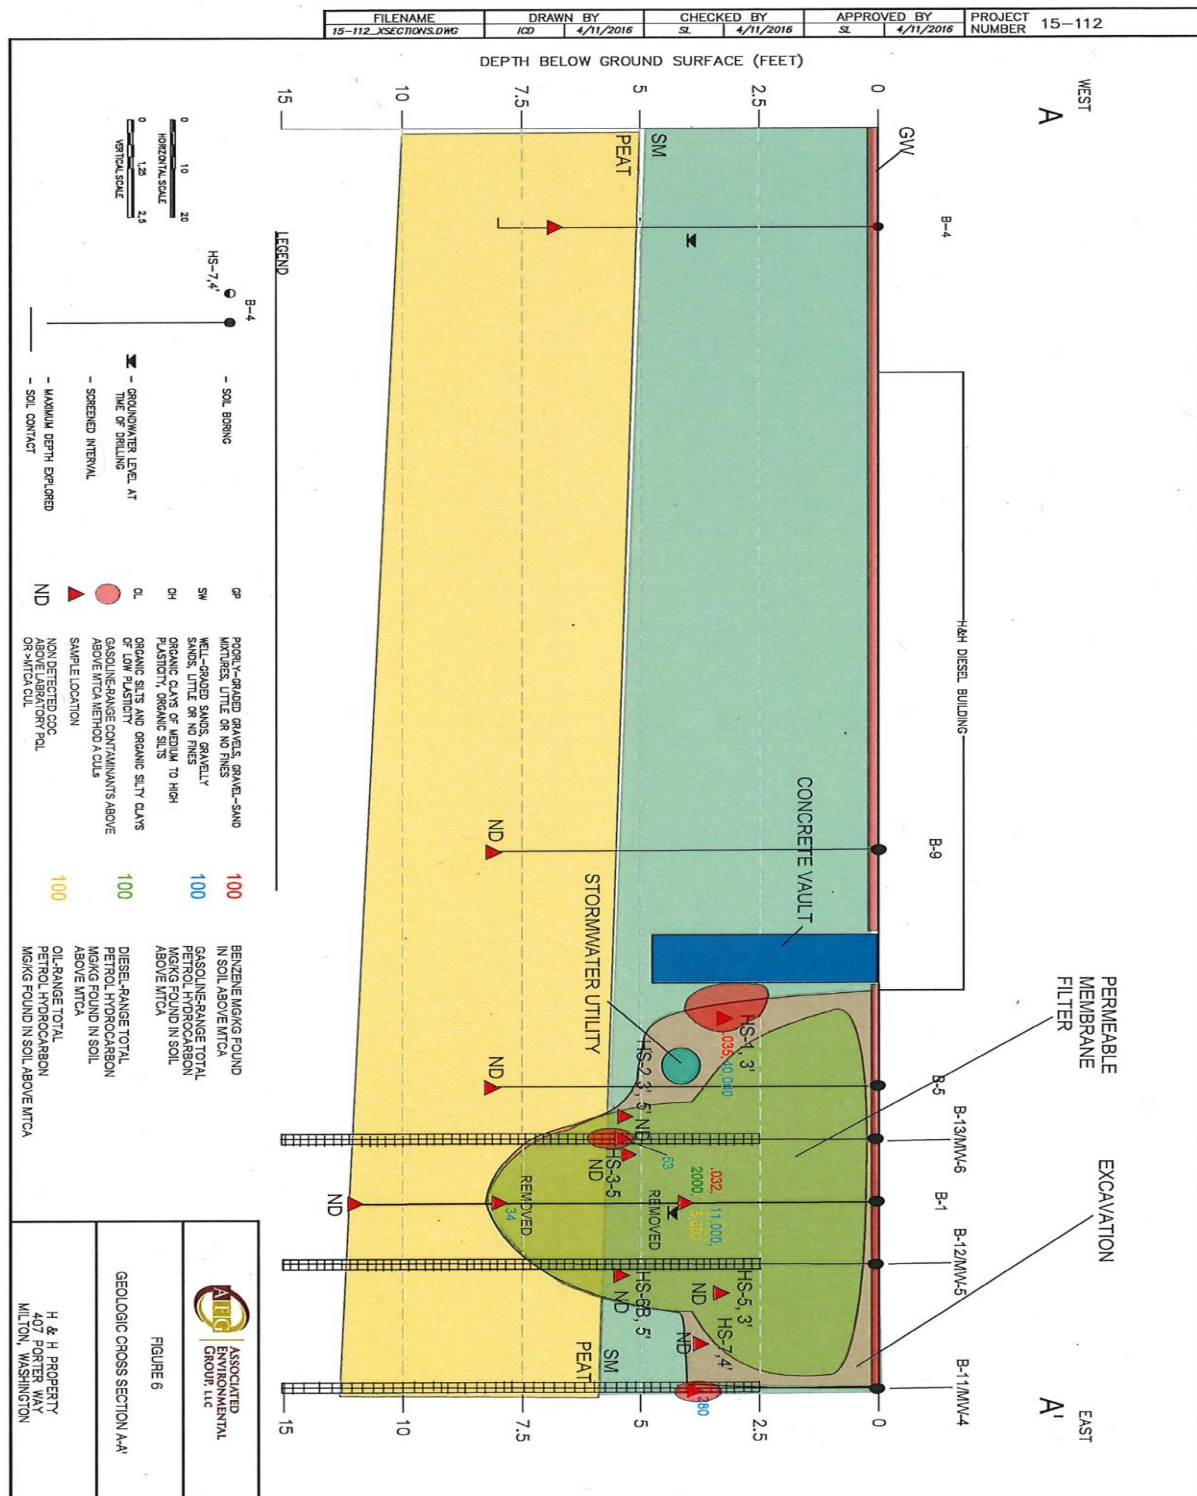
Fig. 6: Vertical Extent AA' of Soil TPH Excavation, Residual & PMF

- c. Installed Permeable Membrane Filter (PMF) to facilitate bio-attenuation of the inaccessible residual PCS and groundwater within the excavation limits (Figs. 2, 4 and 6).

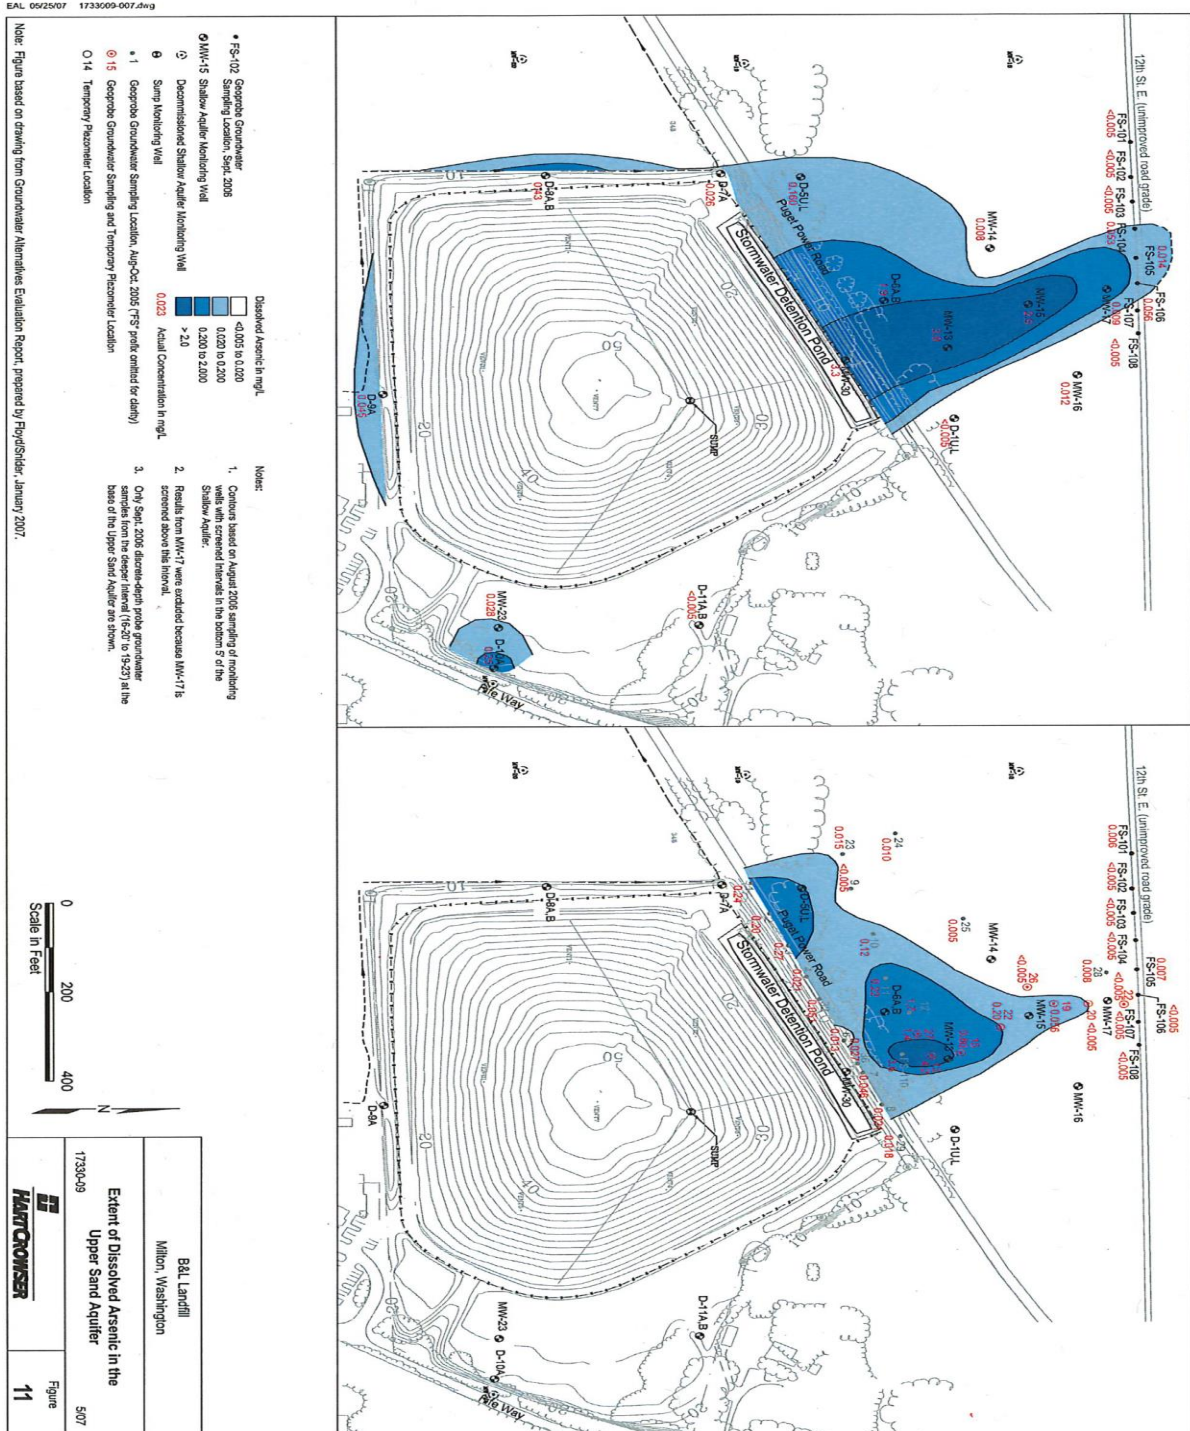
**Fig. 7: Sources of Off Property Arsenic in GW near the Site**

Please note a parcel of real property can be affected by multiple sites. At this time, we have **no** information that this Property is affected by arsenic in groundwater from off property sources, e.g. the B&L Wood-waste Landfill FS ID# 1203, 0.3 miles south of this Property; and the US Gypsum Highway 99 Site FS ID# 84531356, 0.3 miles southwest of the Site. Arsenic contaminated groundwater flow from these properties is north towards the H&H Diesel Site (Figs. 1 and 7).

The arsenic plumes from the nearby formal sites (B&L Woodwaste Landfill and USG Hwy 99) do not extend to the H&H Diesel site. Based on limited other available data surrounding the site, it is likely the source of impacts in GW beneath the site above the MTCA cleanup standards are from a non-point source likely associated with filling of the area (containing Asarco slag). Groundwater impacted with arsenic beneath the site is fairly ubiquitous; however, only 3 out of about 30 or so soil samples from the site exceed CULs for arsenic, none of which are high enough to be the source of the GW impacts. **This NFA determination does not include non-point sources of arsenic groundwater impacts.**
