## ENVIRONMENTAL CAP INSPECTION REPORT

### FORMER WASSER & WINTERS LOG SORT YARD

Consent Decree No. 93-2-08684-4 (August 27, 1993)  
Washington State Department of Ecology Facility ID # 1218  
Inspection Dates: February 21 and March 1, 2017

April 14, 2017

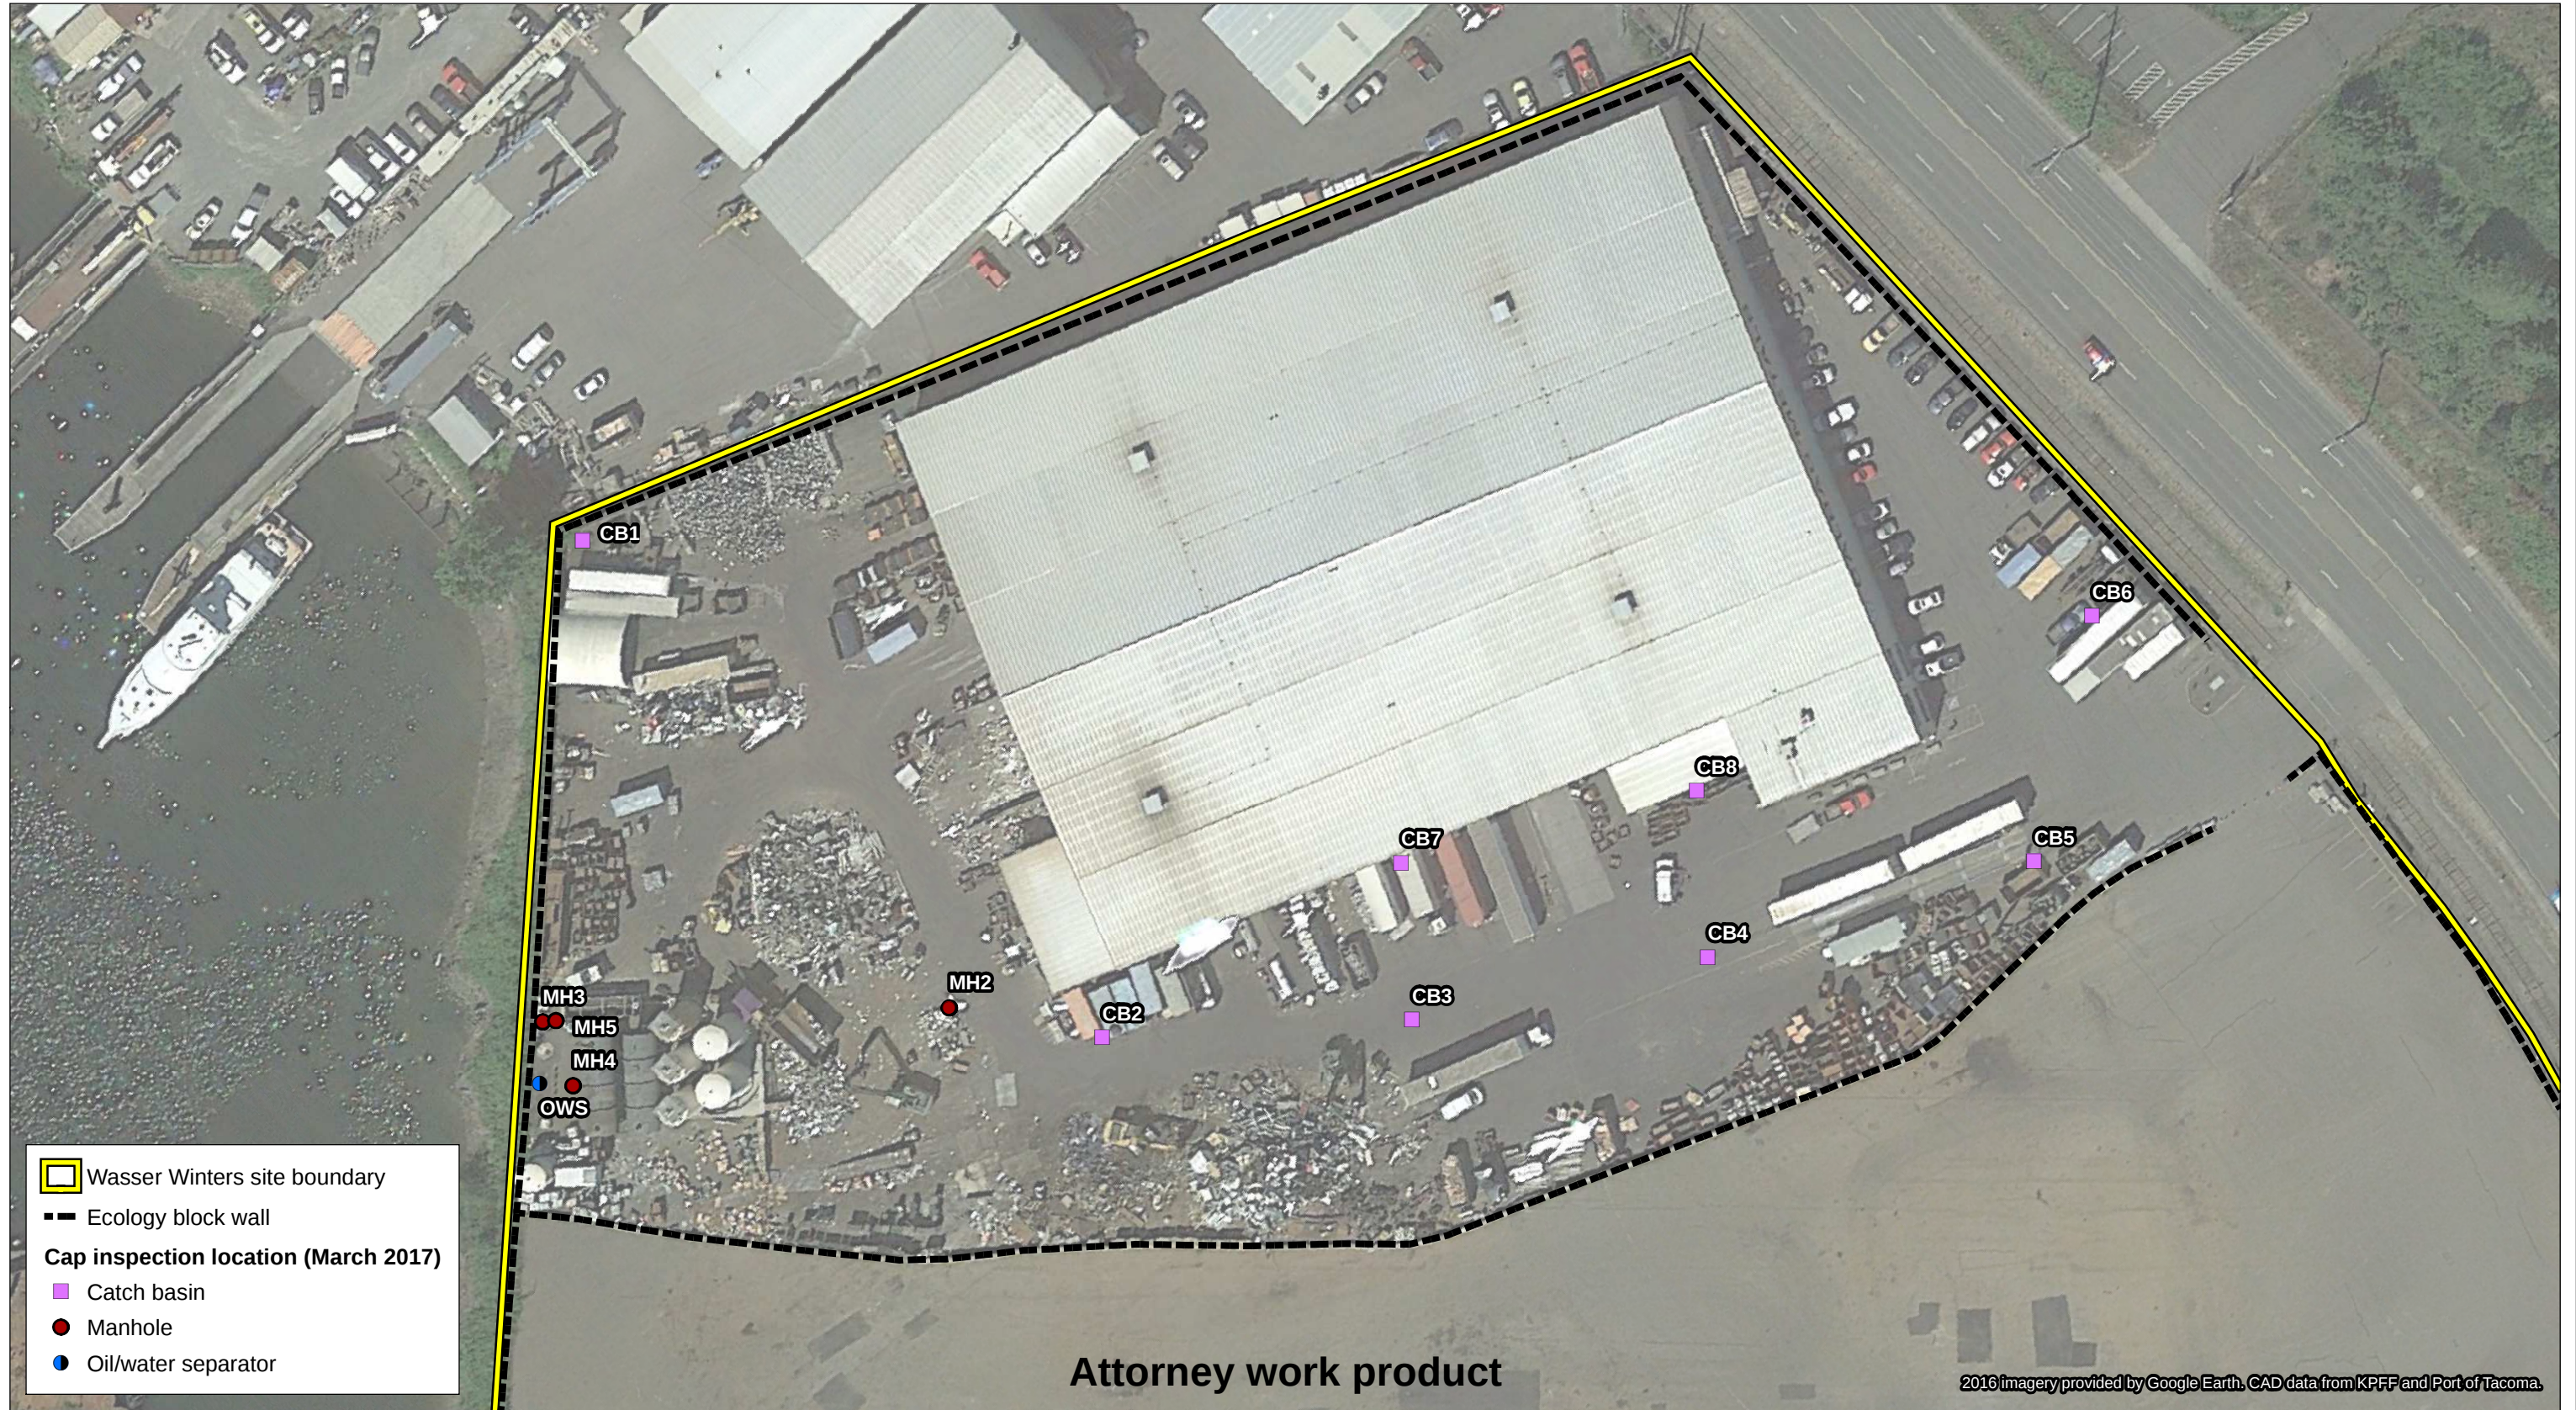
Figure 2. Wasser & Winters field observations — north area

A large portion of the pavement on the north area was covered by scrap metal and equipment during Windward's inspection. The visible portions of the environmental cap showed signs of wear, likely from heavy equipment and scrap metal storage. The majority of the visible pavement surface was covered with shallow gouges; however, these were less than 1 in. deep and did not extend deeply into the cap cross section. Figures 4 through 7 show representative areas of the north area environmental cap. Figures 4 and 5 show typical gouges and debris on the cap. Figure 6 shows a divot (i.e., small depression) in the pavement surface. Figure 7 shows loose gravel and debris, which may be present as the result of raveling (i.e., dislodging aggregate from pavement) on the cap (USACE 2009). This gravel is not sub-base material; the raveling is limited to the cap surface.

The east and southeast portions of the north area (near the employee parking and site entrance) showed signs of narrow cracks, many of which have been sealed using hot-applied surface crack sealant. The seals appeared to be in good condition.

It is recommended that the pavement cracking and separation around catch basins CB3 and CB4 on the north area be repaired (Figure 2; Appendix B).

The divots, gouges, and cracks on the north area should be monitored. These conditions should be repaired if they begin to impact the integrity of the environmental cap

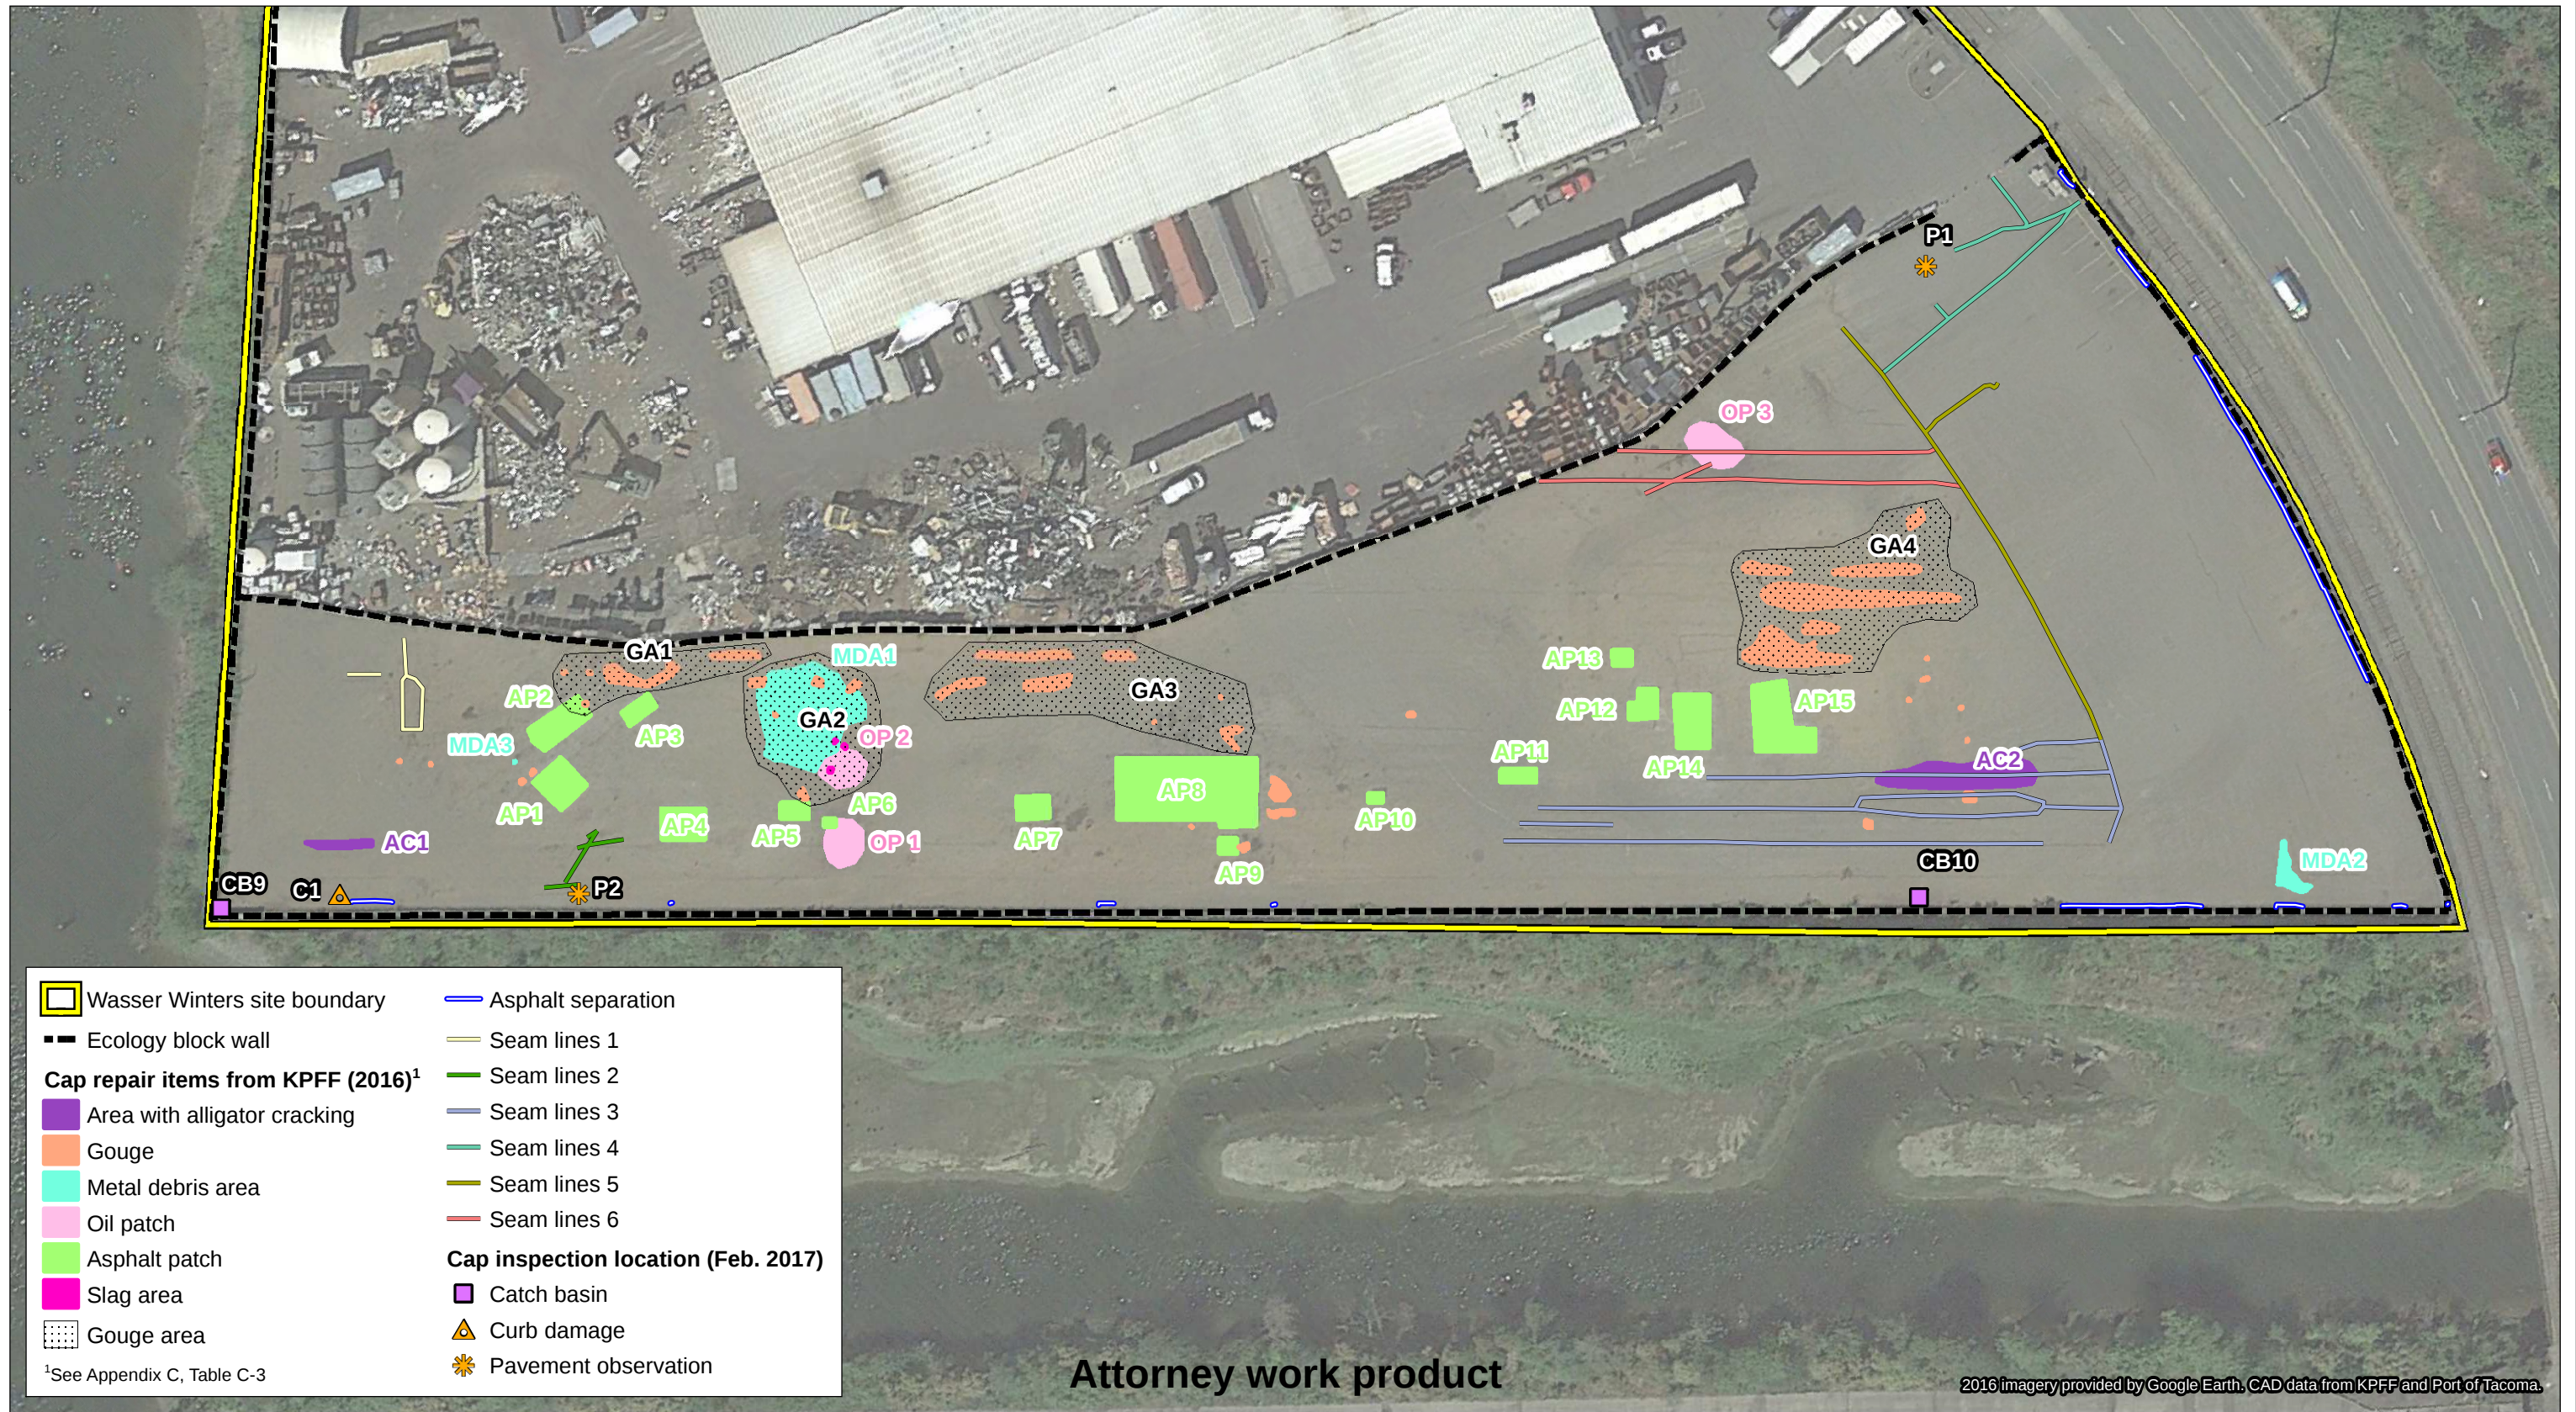
Figure 3. Wasser & Winters field observations — south area

The environmental cap on the south area of the site was also observed to be showing signs of wear, likely from heavy equipment and scrap metal storage. Divots and gouges did not penetrate the pavement surface but were present throughout the area.

The pavement surface was rough, and was observed to be in worse condition than pavement in the north area. Some repairs, including asphalt patching and seam line sealing, have been performed. However, a number of the items shown in the 2016 repair design provided by the Port (KPFF 2016) (Appendix A) are still present and have not been addressed, including alligator cracking, gouges, metal debris, oil patches, and asphalt separation along the curb. Appendix B provides details on those repair items that have been addressed.

The observed cracks and gouges on the south area should be repaired, as they are sufficiently extensive to be potentially impacting the integrity of the cap. These cracks and gouges were observed to be retaining stormwater during the inspection, and are likely interfering with stormwater drainage from the cap surface (Figure 3; Appendix B). Metal debris and oil should be removed from the pavement; any damage to the pavement resulting from removal of metal debris and oil should be repaired (Figure 3; Appendix B).

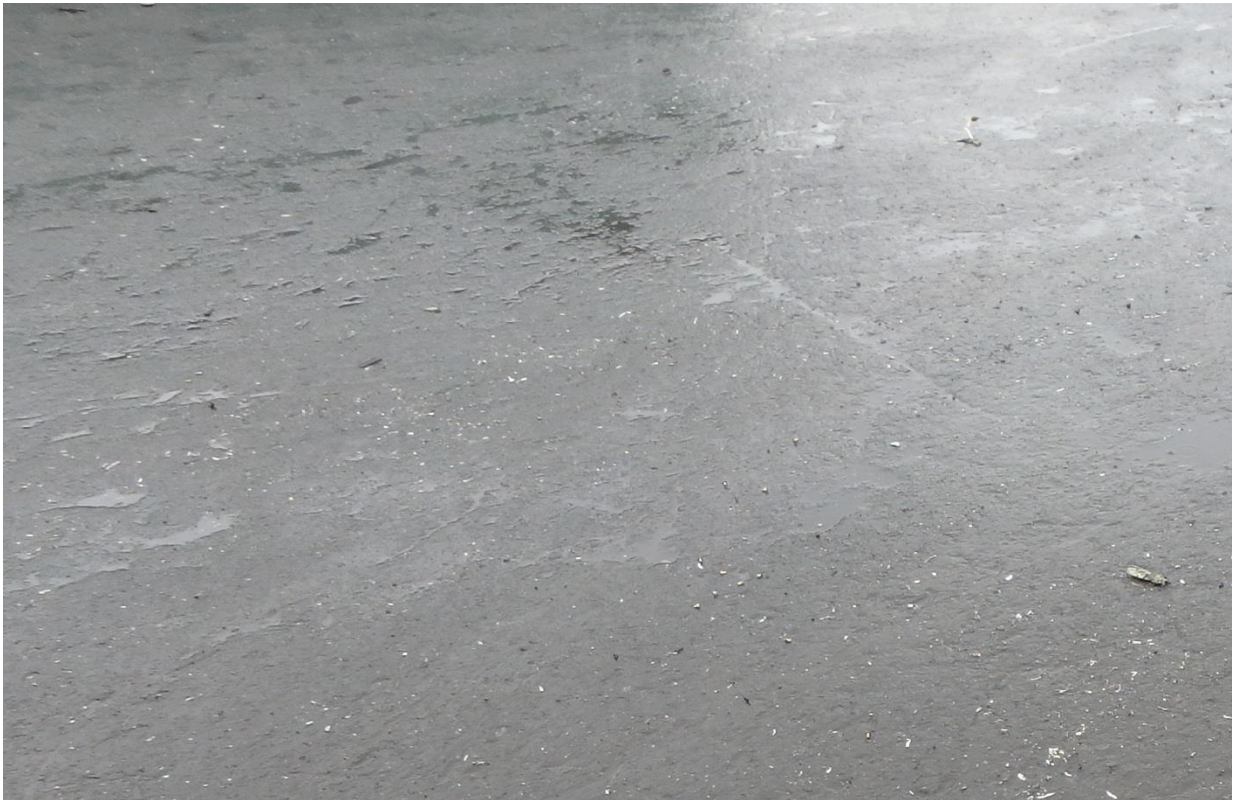
**Figure 4. Gouges and debris on north area cap pavement surface**

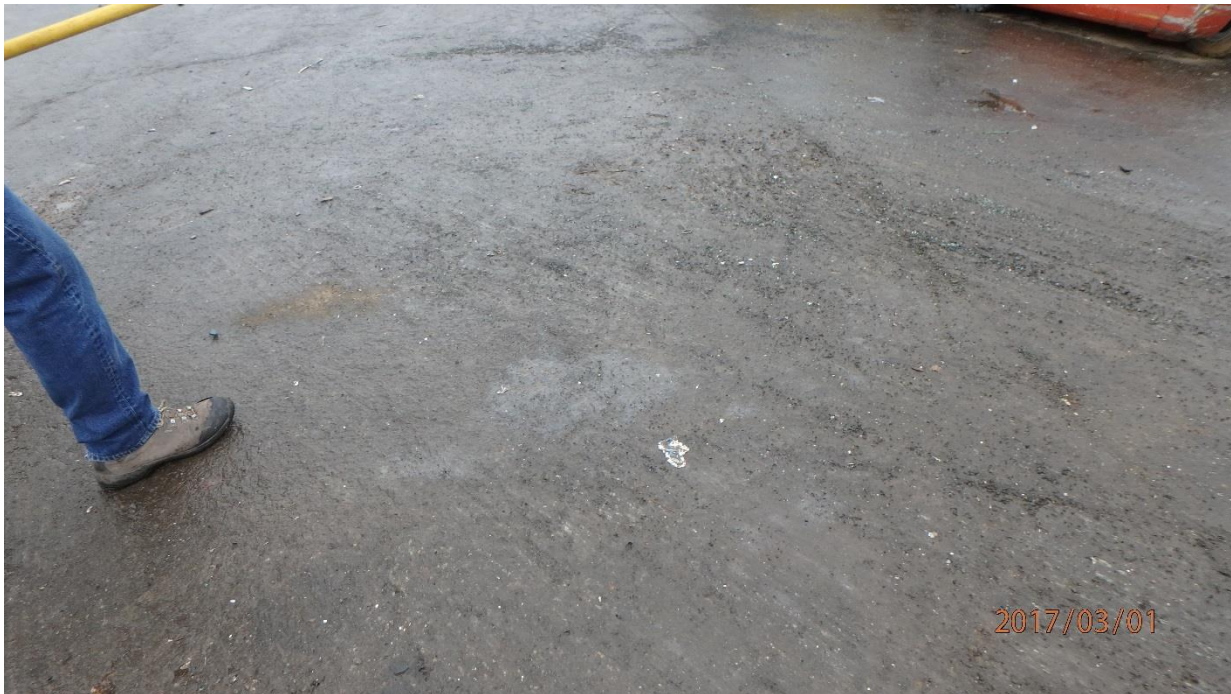
**Figure 7. Loose gravel and debris resulting from surface raveling on north area cap pavement surface**

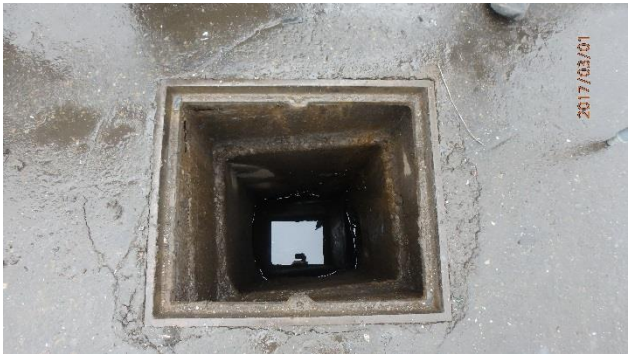
Pavement separation and cracking was observed around catch basins CB3 and CB4 during the inspection, indicating that the joints have not been resealed. The cracks and pavement separation should be repaired.

| Location ID <sup>a</sup> | Observations | Recommended Actions | Photos |
|---|---|---|---|
| CB3 | cracking and separation wider than 1/8 in. around catch basin | repair pavement | |

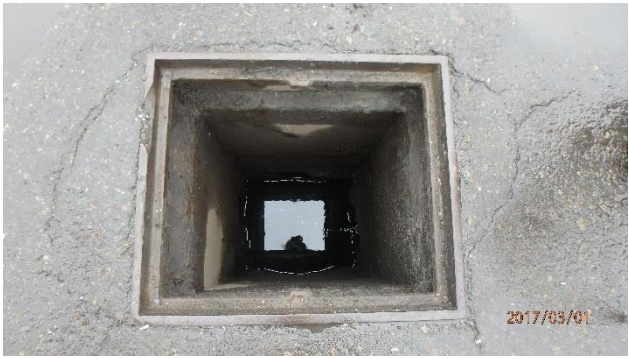
| Location ID <sup>a</sup> | Observations | Recommended Actions | Photos |
|---|---|---|---|
| CB4 | cracking wider than 1/8 in. around catch basin | repair pavement | |

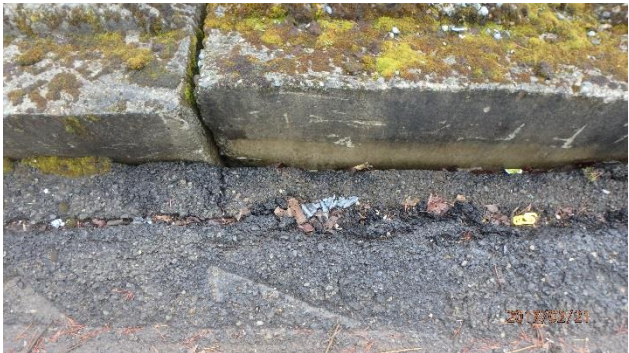
| Location ID <sup>a</sup> | Observations | Recommended Actions | Photos |
|---|---|---|---|
| C1 | pavement curb sloughing;<br>pavement section approximately 15 ft long and located in front of concrete block wall | repair pavement curb | |

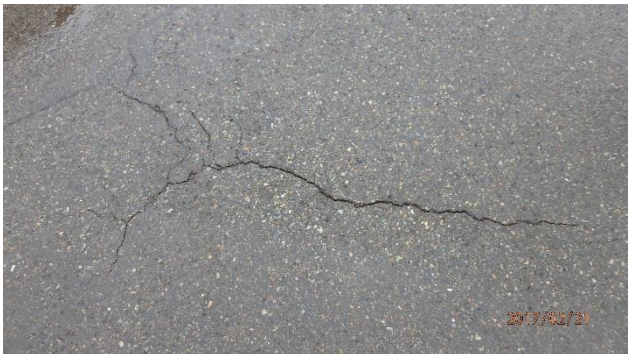
| Location ID <sup>a</sup> | Observations | Recommended Actions | Photos |
|---|---|---|---|
| P1 | cracks in pavement wider than 1/8 in. | repair or seal cracks | |

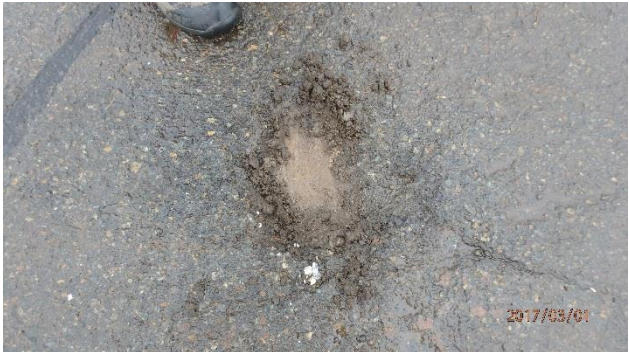
| Location ID <sup>a</sup> | Observations | Recommended Actions | Photos |
|---|---|---|---|
| P2 | hole in pavement approximately 8 by 4 in.; dirt in hole | remove accumulated dirt;<br>repair pavement | |

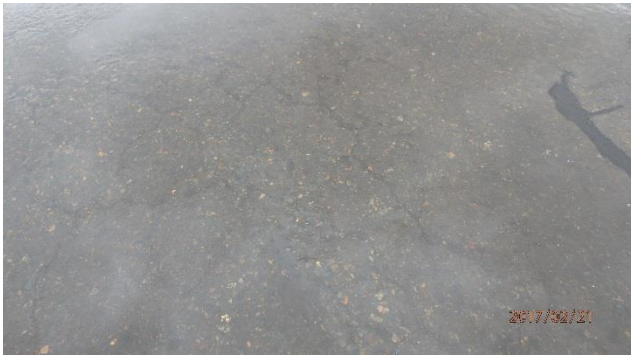
| Location ID <sup>a</sup> | Observations | Recommended Actions | Photos |
|---|---|---|---|
| AC2 | not repaired | monitor; repair pavement if damage beings to affect cap integrity or cracks become wider than 1/8 in. | |

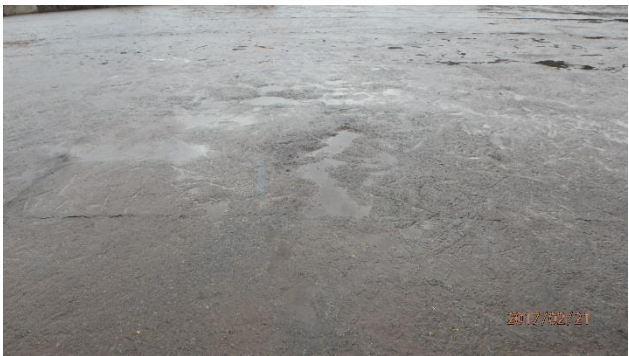
| Location ID <sup>a</sup> | Observations | Recommended Actions | Photos |
|---|---|---|---|
| AP13 | not repaired | repair pavement | |

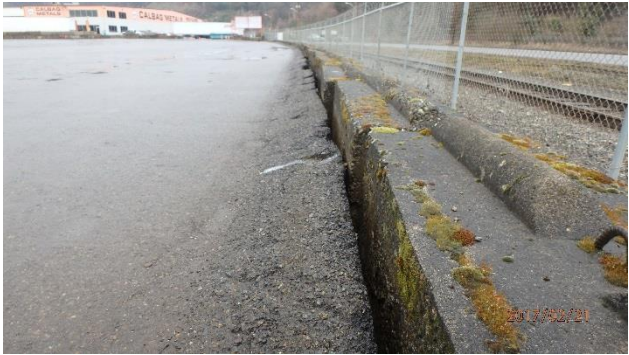
| Location ID <sup>a</sup> | Observations | Recommended Actions | Photos |
|---|---|---|---|
| Asphalt separation | none of the areas marked as asphalt separation by KPFF have been repaired; vegetation in some areas of asphalt separation | monitor; repair if condition worsens | |

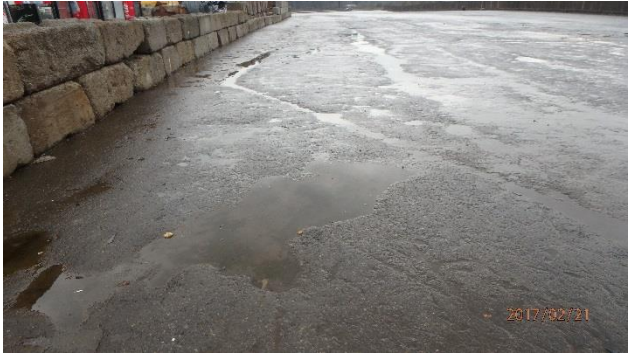
| Location ID <sup>a</sup> | Observations | Recommended Actions | Photos |
|---|---|---|---|
| GA1 | not repaired | repair pavement | |

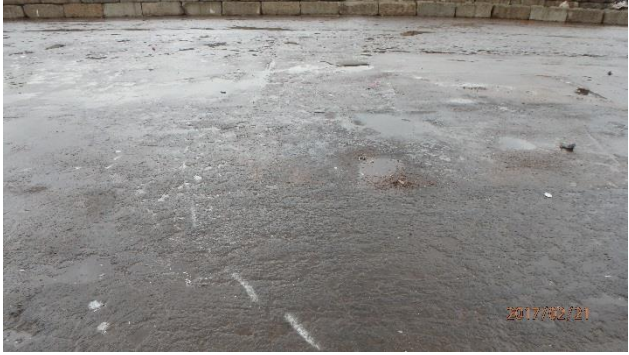
| Location ID <sup>a</sup> | Observations | Recommended Actions | Photos |
|---|---|---|---|
| GA2 | still present | repair pavement | |

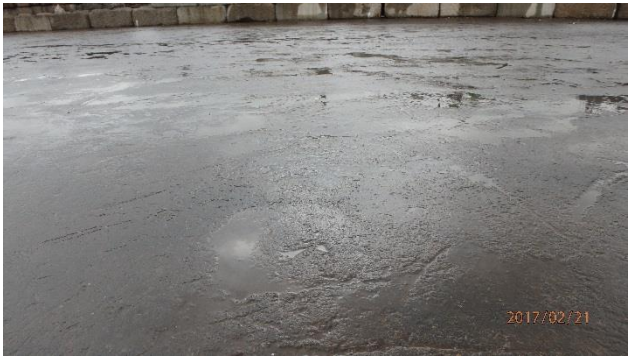
| Location ID <sup>a</sup> | Observations | Recommended Actions | Photos |
|---|---|---|---|
| GA3 | still present | repair pavement | |

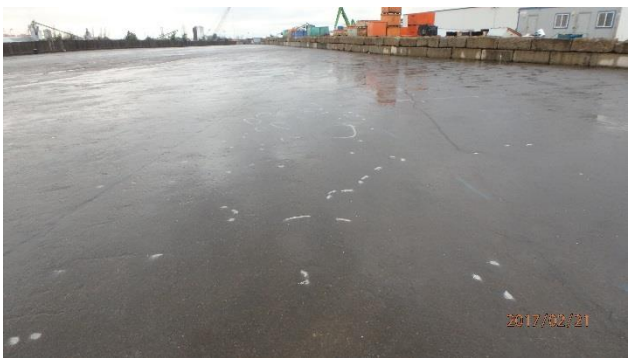
| Location ID <sup>a</sup> | Observations | Recommended Actions | Photos |
|---|---|---|---|
| GA4 | still present | repair pavement | |

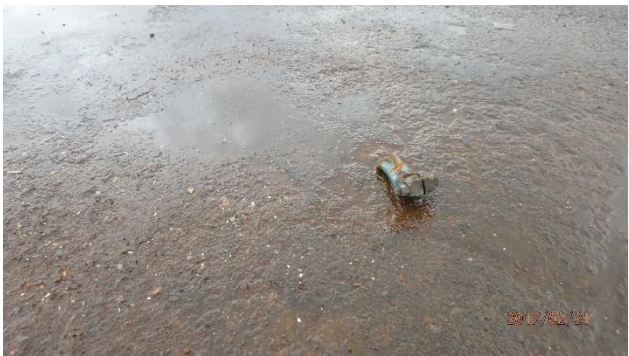
| Location ID <sup>a</sup> | Observations | Recommended Actions | Photos |
|---|---|---|---|
| MDA1 | still present | remove metal debris and repair pavement | |

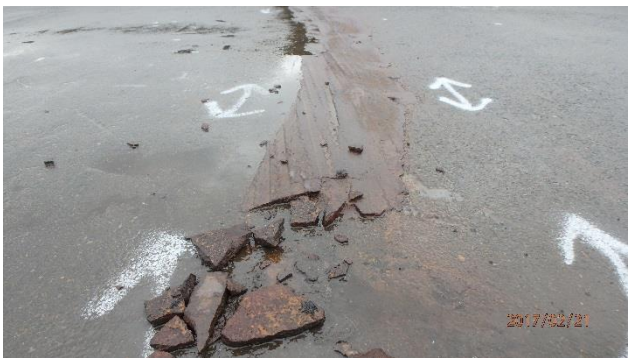
| Location ID <sup>a</sup> | Observations | Recommended Actions | Photos |
|---|---|---|---|
| MDA2 | still present;<br>metal debris<br>breaking into<br>pieces | remove metal<br>debris and repair<br>pavement | |

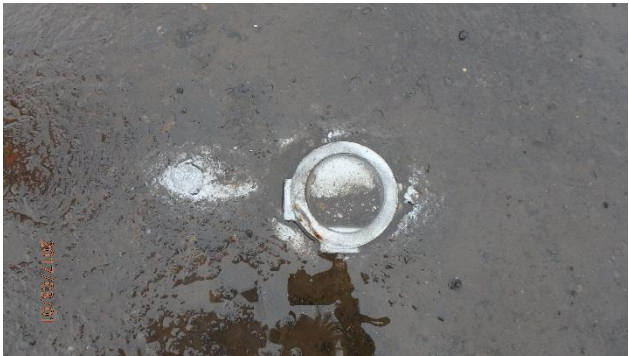
| Location ID <sup>a</sup> | Observations | Recommended Actions | Photos |
|---|---|---|---|
| MDA3 | still present | remove metal debris and repair pavement | |

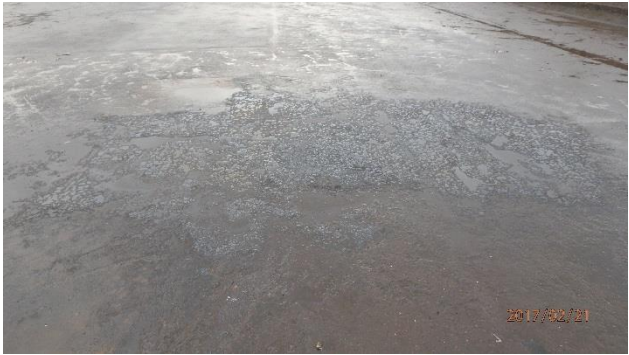
| Location ID <sup>a</sup> | Observations | Recommended Actions | Photos |
|---|---|---|---|
| OP1 | still present | remove oil and repair pavement | |

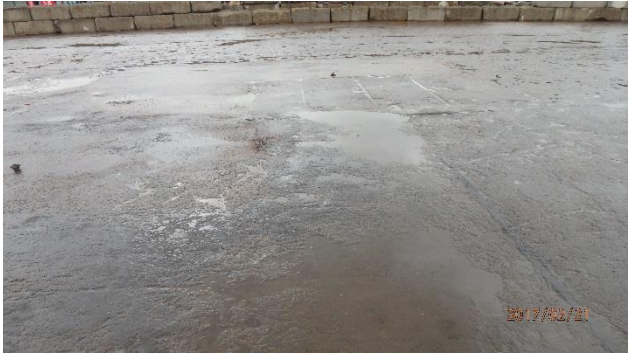
| Location ID <sup>a</sup> | Observations | Recommended Actions | Photos |
|---|---|---|---|
| OP2 | still present | remove oil and repair pavement | |

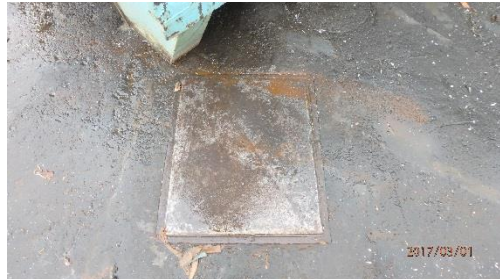
The inlet to catch basin CB2 was observed to be covered with a welded plate. Calbag mentioned that this was done because CB2 is located at a higher elevation than the surrounding pavement and therefore did not receive any drainage, and is located near scrap metal storage. The interior of CB2 was not inspected.

| Location ID <sup>a</sup> | Type of Structure | Observed Condition | Sediment Accumulation (in.) | Additional Observations | Recommended Actions | Photos |
|---|---|---|---|---|---|---|
| CB2 | catch basin | structurally sound at surface; did not view interior | nm | catch basin sealed closed with a metal plate/does not receive stormwater | none | |

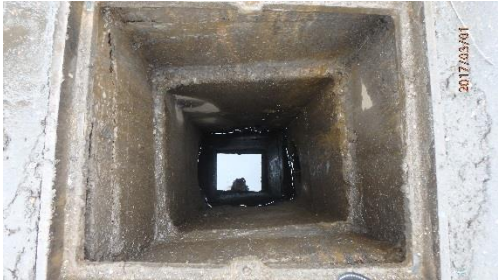
| Location ID <sup>a</sup> | Type of Structure | Observed Condition | Sediment Accumulation (in.) | Additional Observations | Recommended Actions | Photos |
|---|---|---|---|---|---|---|
| CB3 | catch basin | functioning normally | 4–6 | insert in catch basin; cracking and separation wider than 1/8 in. in pavement surrounding inlet | repair cracking and separation; remove accumulated sediment in accordance with stormwater maintenance requirements | |

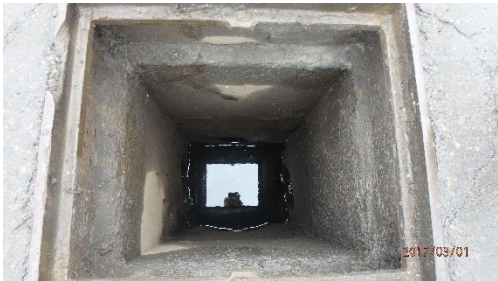
| Location ID <sup>a</sup> | Type of Structure | Observed Condition | Sediment Accumulation (in.) | Additional Observations | Recommended Actions | Photos |
|---|---|---|---|---|---|---|
| CB4 | catch basin | functioning normally | 2–3 | insert in catch basin; cracking and separation wider than 1/8 in. in pavement surrounding inlet | repair cracking and separation; remove accumulated sediment in accordance with stormwater maintenance requirements | |

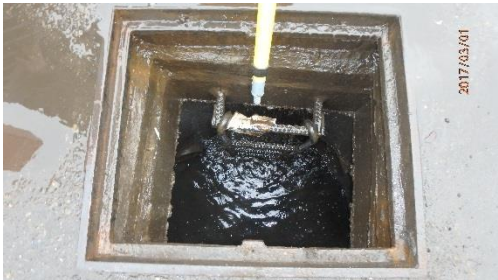
| Location ID <sup>a</sup> | Type of Structure | Observed Condition | Sediment Accumulation (in.) | Additional Observations | Recommended Actions | Photos |
|---|---|---|---|---|---|---|
| CB5 | catch basin | functioning normally | 4–5 | insert in catch basin; no debris on grate or in vicinity of catch basin | remove accumulated sediment in accordance with stormwater maintenance requirements | |

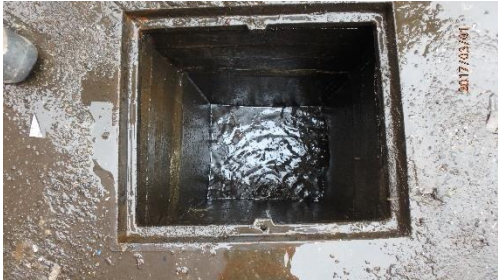
| Location ID <sup>a</sup> | Type of Structure | Observed Condition | Sediment Accumulation (in.) | Additional Observations | Recommended Actions | Photos |
|---|---|---|---|---|---|---|
| CB6 | catch basin | functioning normally | 4–6 | insert in catch basin; debris accumulation on grate | remove accumulated sediment in accordance with stormwater maintenance requirements | |

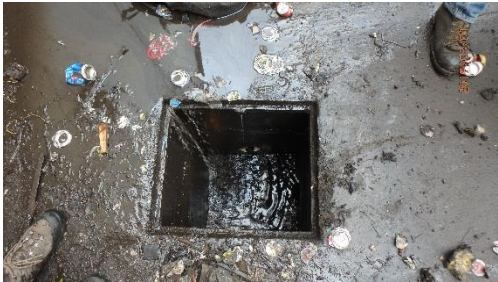
| Location ID <sup>a</sup> | Type of Structure | Observed Condition | Sediment Accumulation (in.) | Additional Observations | Recommended Actions | Photos |
|---|---|---|---|---|---|---|
| CB7 | catch basin | functioning normally | 3 | insert in catch basin; debris and sediment accumulation in vicinity | remove accumulated sediment from interior of structure in accordance with stormwater maintenance requirements; remove accumulated sediment and debris from vicinity of structure | |

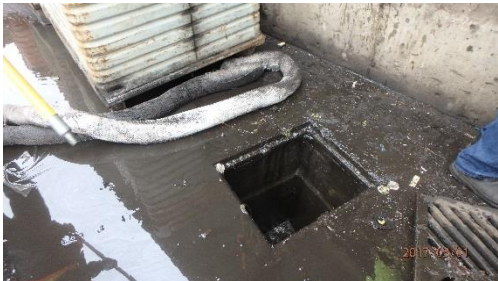
| Location ID <sup>a</sup> | Type of Structure | Observed Condition | Sediment Accumulation (in.) | Additional Observations | Recommended Actions | Photos |
|---|---|---|---|---|---|---|
| CB8 | catch basin | functioning normally | 0 | insert in catch basin; boom around catch basin; some debris and sediment accumulation around grate | remove accumulated debris and sediment from vicinity of structure | |

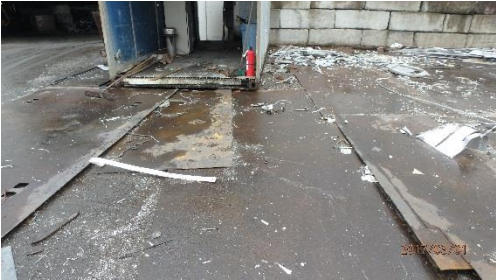
| Location ID <sup>a</sup> | Type of Structure | Observed Condition | Sediment Accumulation (in.) | Additional Observations | Recommended Actions | Photos |
|---|---|---|---|---|---|---|
| MH1 | manhole | not observed | nm | unable to observe structure because it was located under steel plates (see photo) | observe during next inspection | |

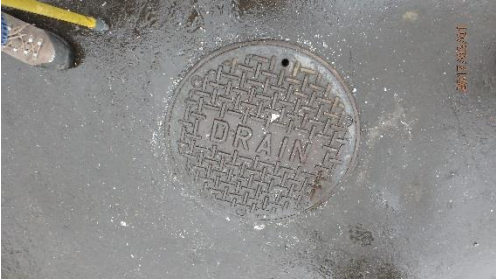
| Location ID <sup>a</sup> | Type of Structure | Observed Condition | Sediment Accumulation (in.) | Additional Observations | Recommended Actions | Photos |
|---|---|---|---|---|---|---|
| MH2 | manhole | interior not observed | nm | large cover; did not open as it was tightly wedged into the opening by heavy machinery; structure does not appear to collect stormwater | observe during next inspection | |

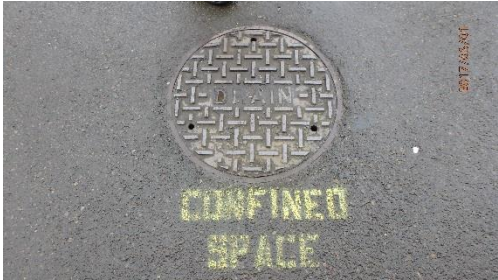
| Location ID <sup>a</sup> | Type of Structure | Observed Condition | Sediment Accumulation (in.) | Additional Observations | Recommended Actions | Photos |
|---|---|---|---|---|---|---|
| MH4 | manhole | not observed | nm | large cover; did not open as it was tightly wedged into the opening | observe during next inspection | |

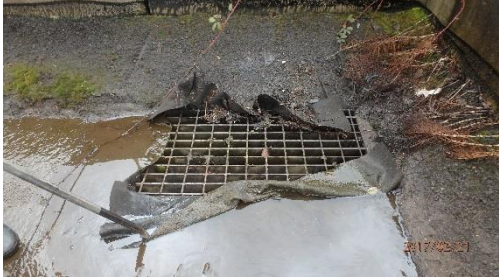
| Location ID <sup>a</sup> | Type of Structure | Observed Condition | Sediment Accumulation (in.) | Additional Observations | Recommended Actions | Photos |
|---|---|---|---|---|---|---|
| CB9 | catch basin | functioning normally | 0 | insert in catch basin; organic debris accumulated on grate; sediment accumulated around grate approximately 1 in. deep; did not pull insert due to recent rain, ongoing stormwater flow, and accumulated sediment in vicinity of grate | remove organic debris and accumulated sediment from vicinity of structure | |

It is recommended that accumulated debris and sediment on and near catch basins CB9 and CB10 on the south area be removed (Figure 3; Appendix C, Table C2).

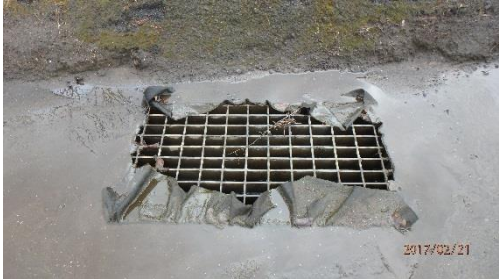
| Location ID <sup>a</sup> | Type of Structure | Observed Condition | Sediment Accumulation (in.) | Additional Observations | Recommended Actions | Photos |
|---|---|---|---|---|---|---|
| CB10 | catch basin | functioning normally | 0 | insert in catch basin; organic debris accumulated on grate; sediment accumulated around grate less than 1 in. deep; did not pull insert due to recent rain, ongoing stormwater flow, and accumulated sediment in vicinity of grate | remove organic debris and accumulated sediment from vicinity of structure | |
