Subject: Fourth Quarter 2018 Progress Report, Southwest Harbor Project Remediation Areas 1, 2, 3, and 5 Ecology Facility/Site Numbers 2384, 2385, 2127, and 2383

Attachment 3 – Semiannual Inspection of T-5 Ecology-lead Sites: 2018 Year-End Inspection – Fourth
Quarter 2018

Terminal 5 Ecology-lead remediation areas –
Locations of observations noted in report

January 2019 inspection

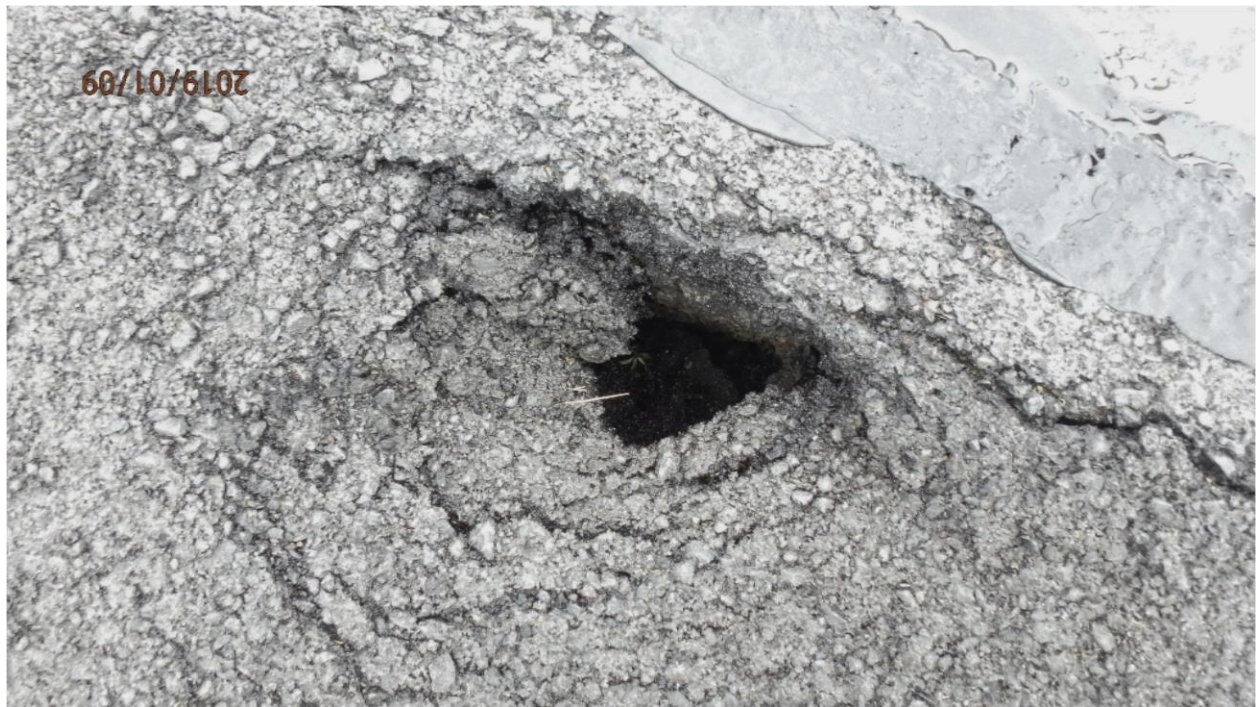
Repairs to the localized settling (approximately 115 × 40 ft) at RA-3 adjacent to the rails in the south portion of the terminal were made in 2016 (noted in the 2017 reports [2017 mid-year report: map note 1 in Attachment 1; 2017 end-of-year report: photos 1 and 2 in Attachment 2]); the majority of these repairs continue to be in good condition. However, settlement appears to be continuing. A hole approximately 8-10 in. deep has opened up along the west boundary of the area (Attachment 1: map note 1; Attachment 2: photo 1). Cracking was also observed along the west side of this area. The hole should be filled and patched, and cracks should be sealed.

Photo 1. Hole on west side of pavement settlement area: RA-3 (map note 1)

The hole in the pavement with adjacent cracking at the area of settlement in RA-3 should be addressed as described in Section 1. The hole in the pavement near the northeast corner of RA-5 should also be addressed; the Port was notified of this hole following the inspection. The five localized areas of pavement mounding and cracking located in RA-2 and RA-3 and the five cracks located in RA-3 should be addressed as described in Section 2.

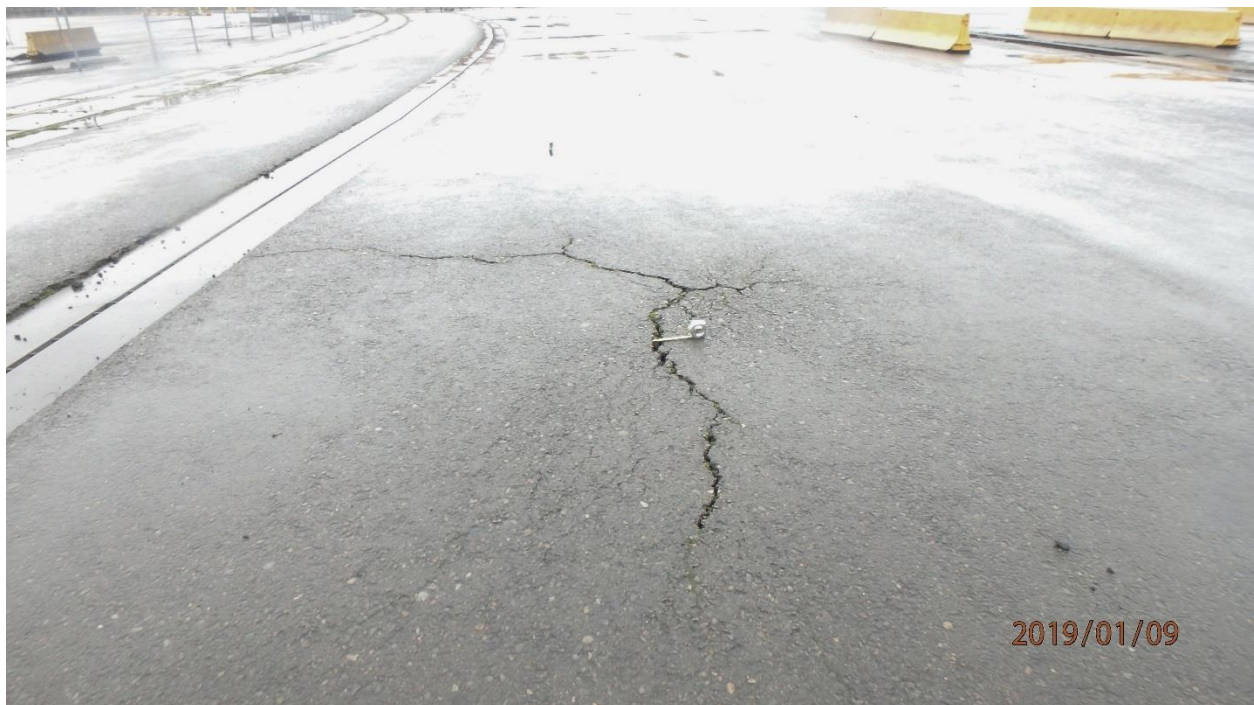
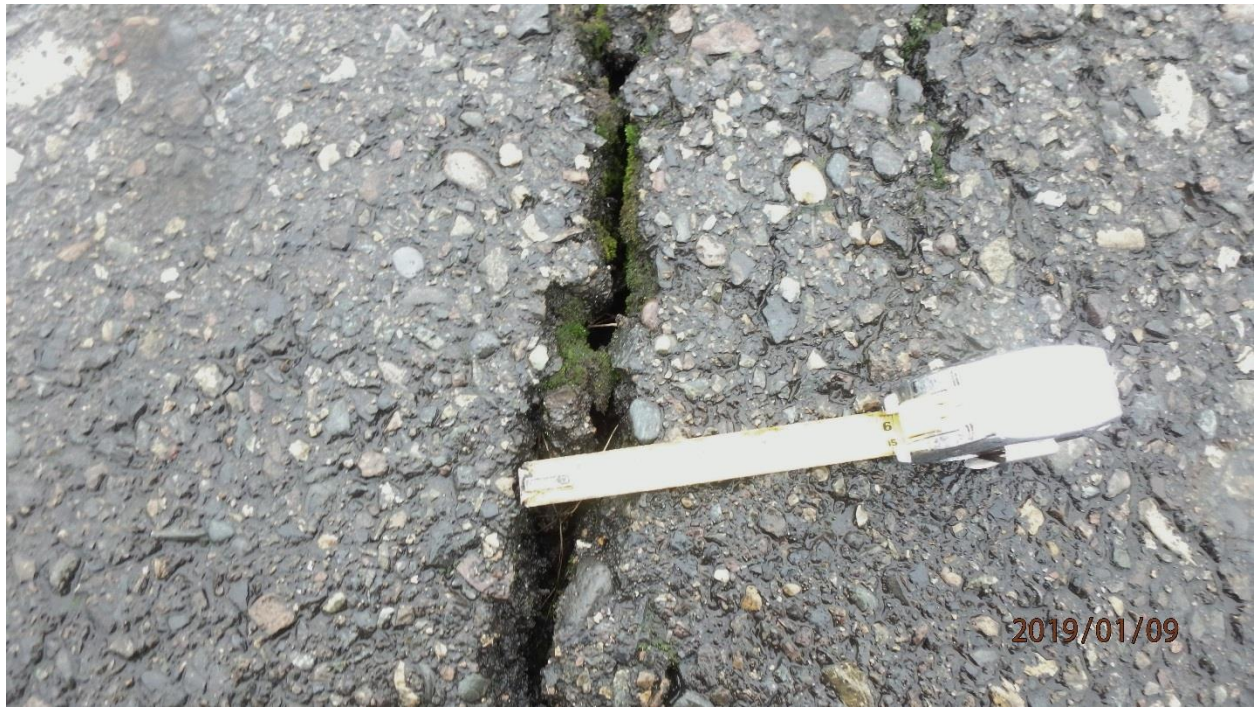
1. Map note 4 (RA-2): The impacted area is approximately 10 × 10 ft (photo 2). The cracks are approximately as wide as 2 in. and as deep as 4 in. (photo 3).

These conditions are localized and do not compromise the overall cap performance. However, these mounding areas are in traffic areas and should be addressed before a new tenant occupies the terminal. The cause of the mounding in the five areas (possibly buried piles or old foundations) should be determined and, if possible, removed, and the cracked areas should be repaired. Near-term (i.e., temporary) sealing of the cracks should also be done to prevent further deterioration in these four locations.

Photo 2. Mound in pavement with cracks as wide as 2 in.: RA-2 (map note 4)

Photo 3. Close-up of mound in pavement with cracks as wide as 2 in.: RA-2 (map note 4)

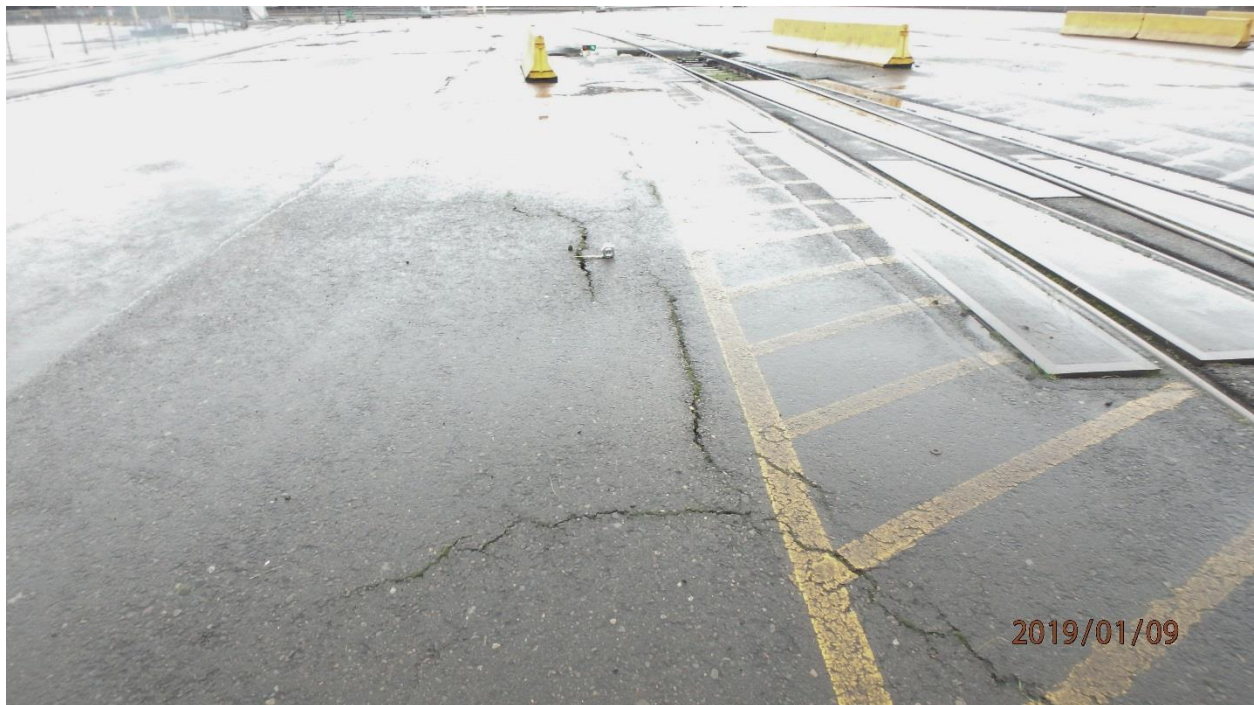
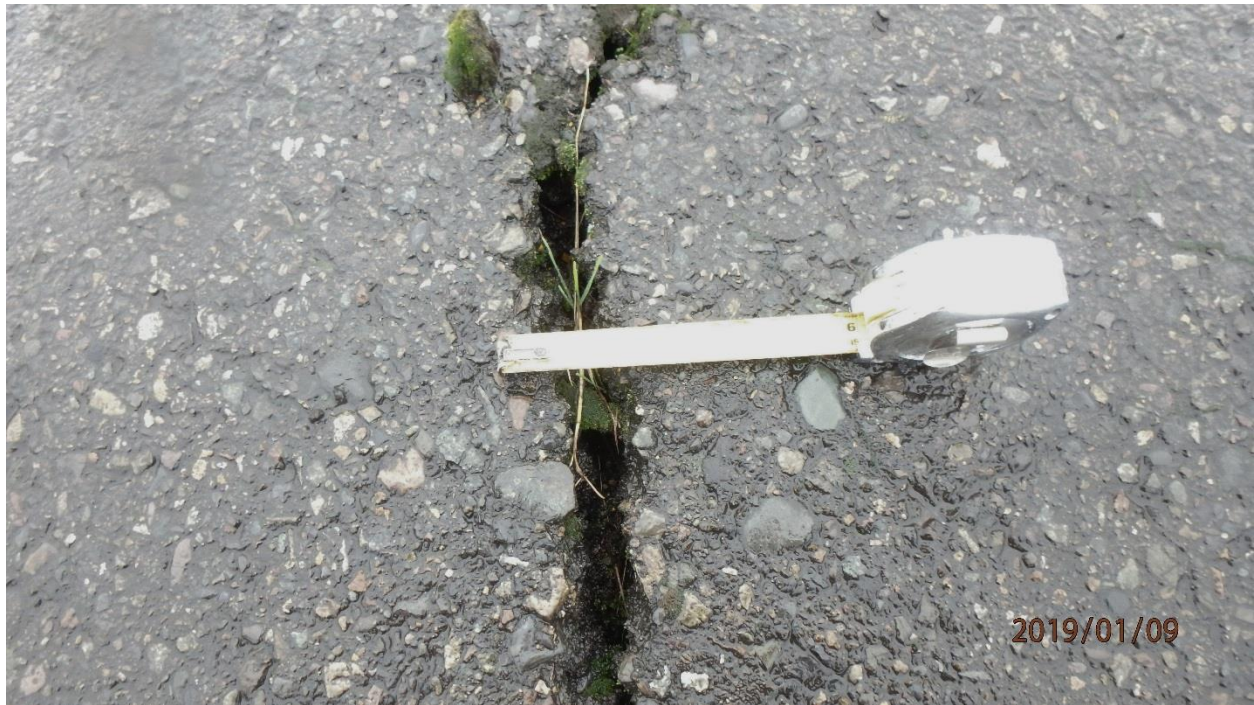
2. Map note 5 (RA-2): This impacted area is approximately 15 × 3 ft and the cracks are approximately as wide as 2 in. and as deep as 4 in. (photos 4 and 5).

Photo 4. Mound in pavement with cracks as wide as 2 in.: RA-2 (map note 5)

Photo 5. Close-up of mound in pavement with cracks as wide as 2 in.: RA-2 (map note 5)

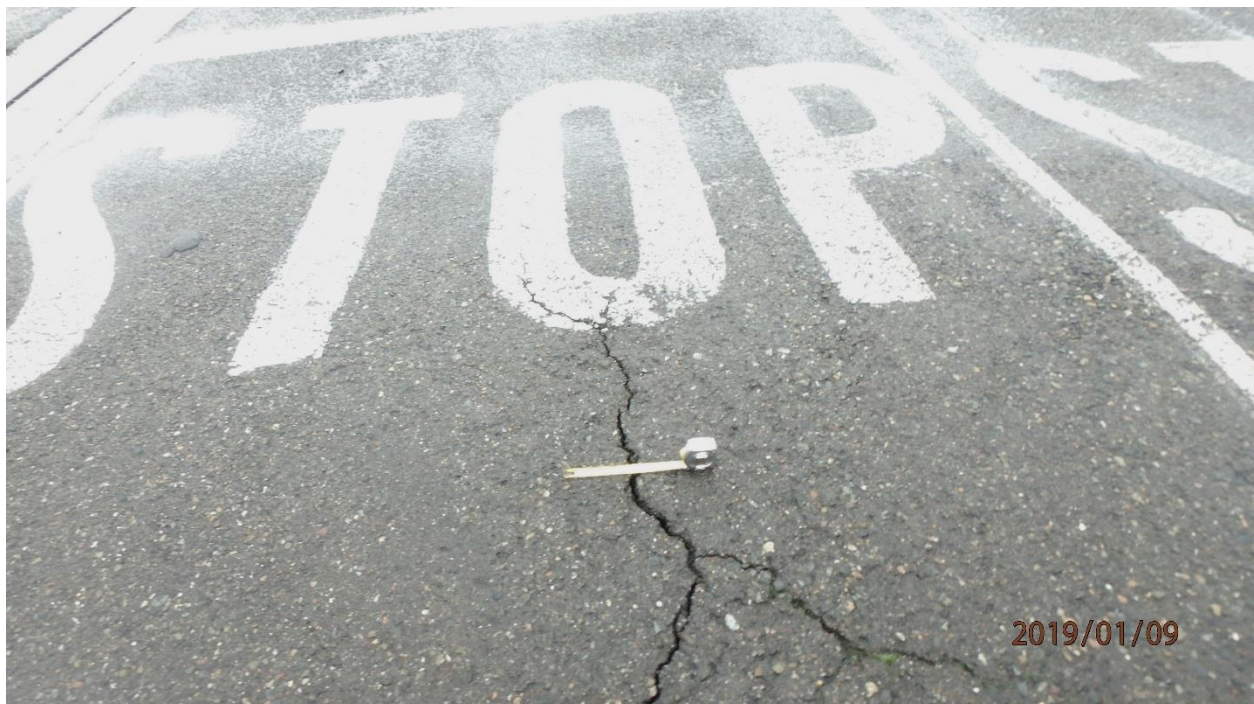
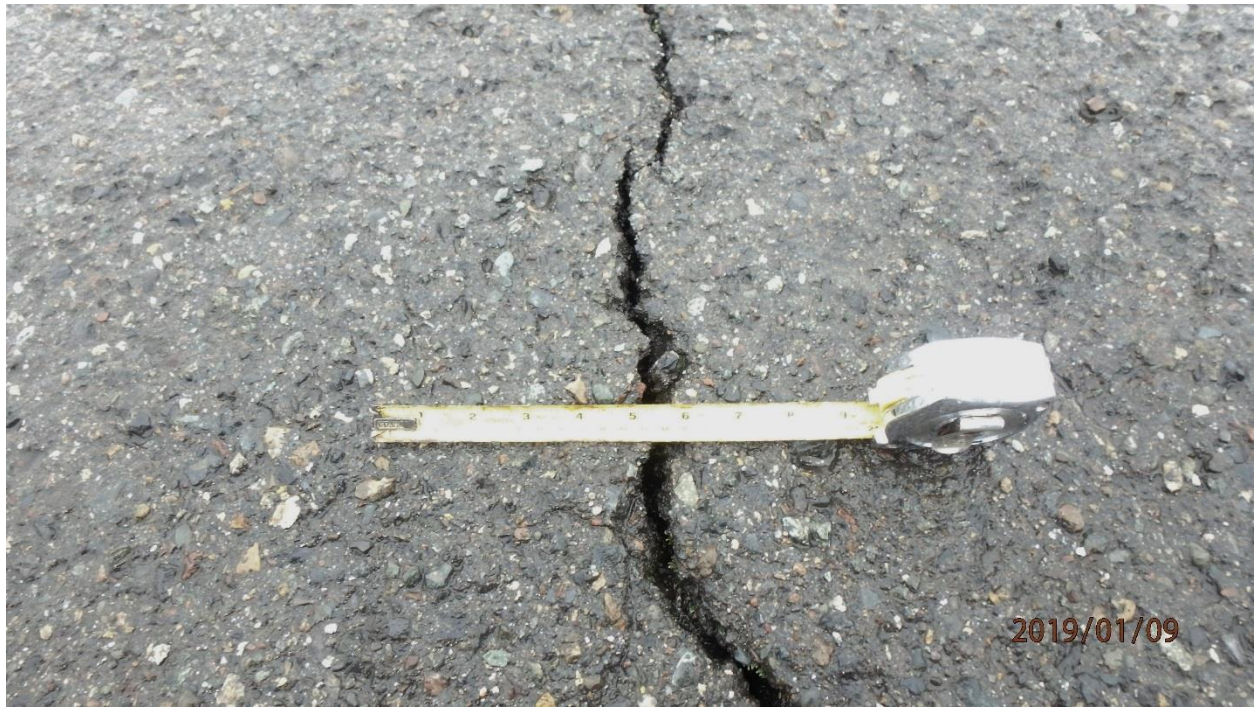
3. Map note 6 (RA-3): This area is approximately 5 × 3 ft, with cracks as wide as approximately 1 in. and as deep as approximately 3 in. (photos 6 and 7).

Photo 6. Mound in pavement with cracks as wide as 1 in.: RA-3 (map note 6)

Photo 7. Mound in pavement with cracks as wide as 1 in.: RA-3 (map note 6)

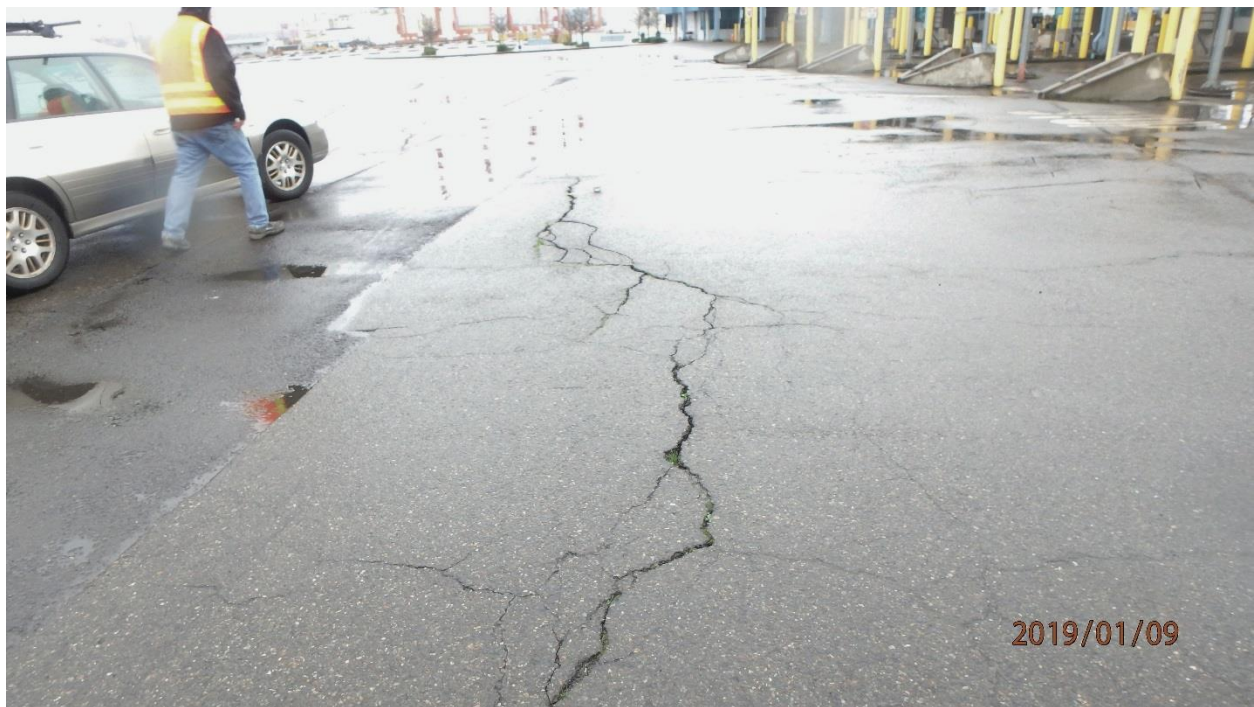
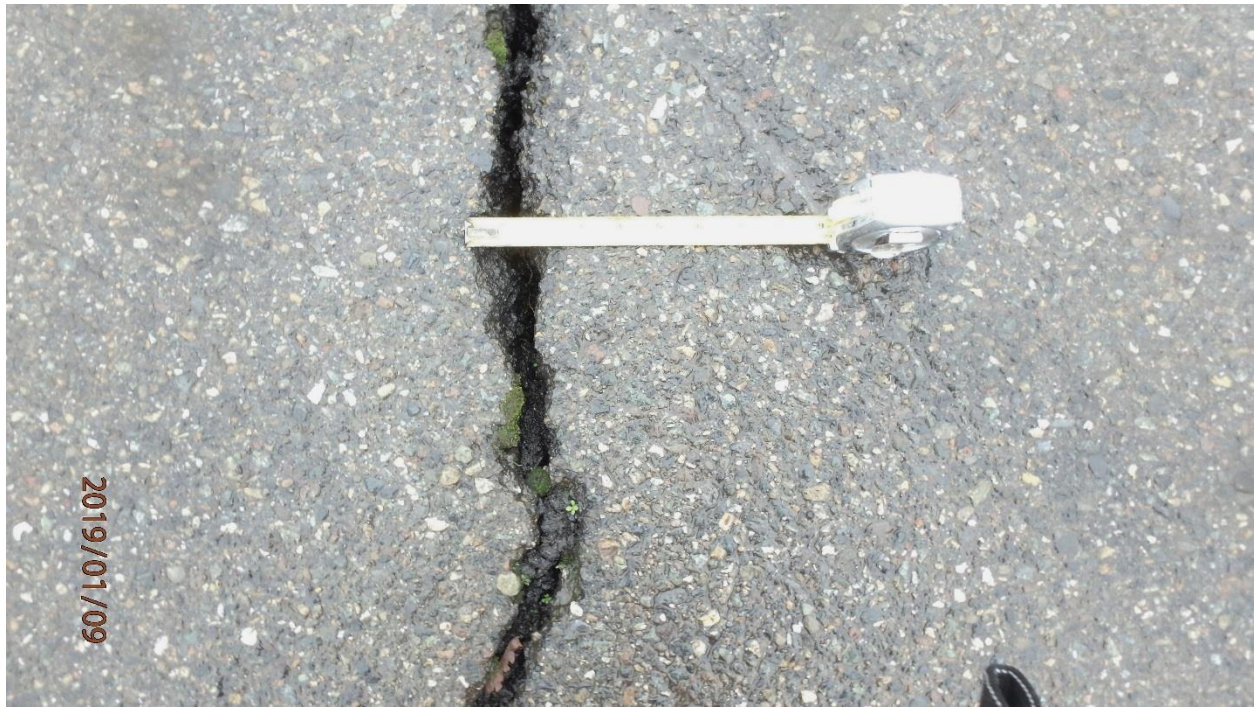
4. Map note 7 (RA-2): The impacted area is approximately 25 × 6 ft (photo 8). The cracks are approximately as wide as 2 in. and as deep as 5 in. (photo 9).

Photo 8. Elongated mound in pavement with cracks as wide as 2 in.: RA-2 (map note 7)

Photo 9. Close up of elongated mound in pavement with cracks as wide as 2 in.: RA-2 (map note 7)

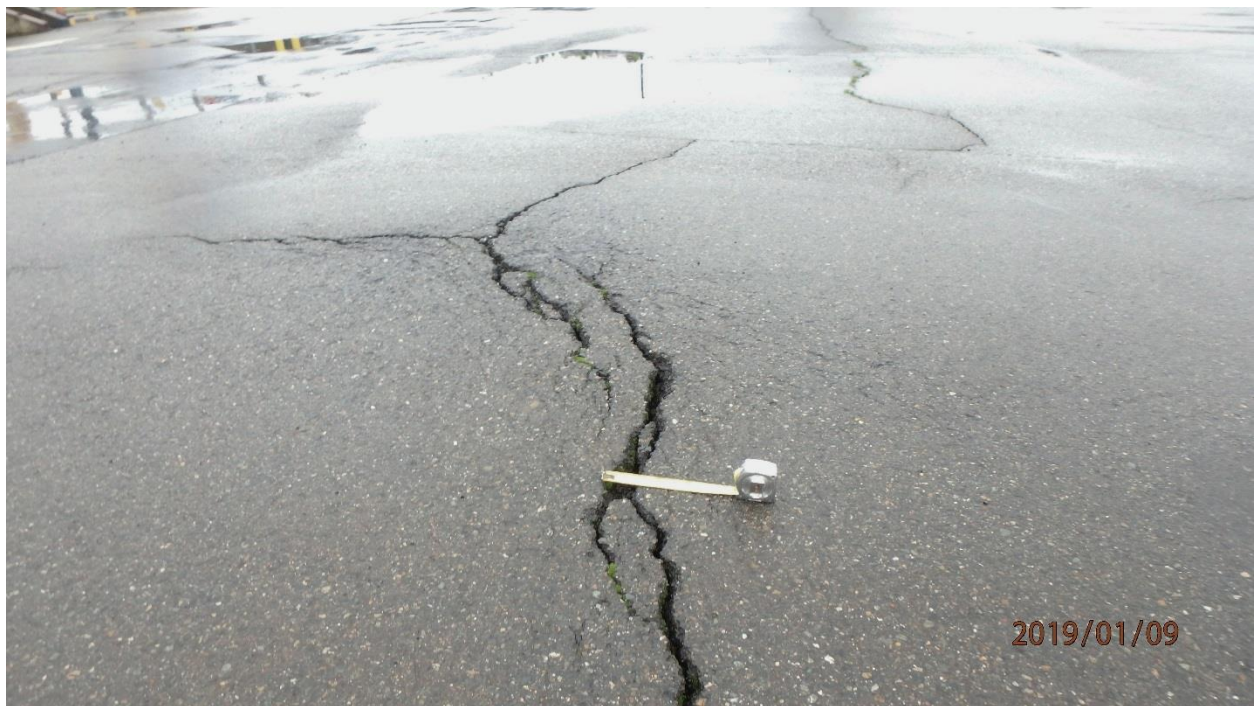
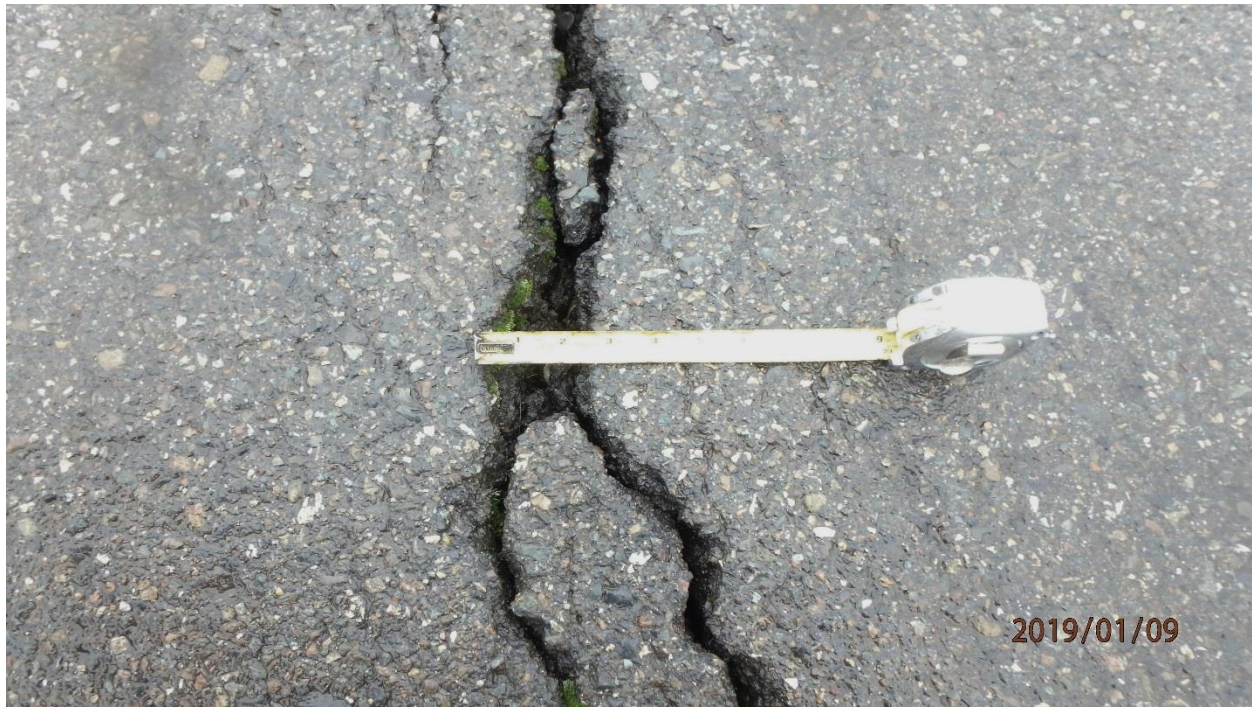
5. Map note 8 (RA-2): This area includes cracking over an area of approximately 15 × 5 ft and mounding over an area of approximately 5 × 5 ft (photo 10). The cracks are as wide as approximately 3 in (photo 11). This is the first time this condition has been observed at this location.

Photo 10. Mound in pavement with cracks as wide as 3 in.: RA-2 (map note 8)

Photo 11. Close-up of mound in pavement with cracks as wide as 3 in.: RA-2 (map note 8)

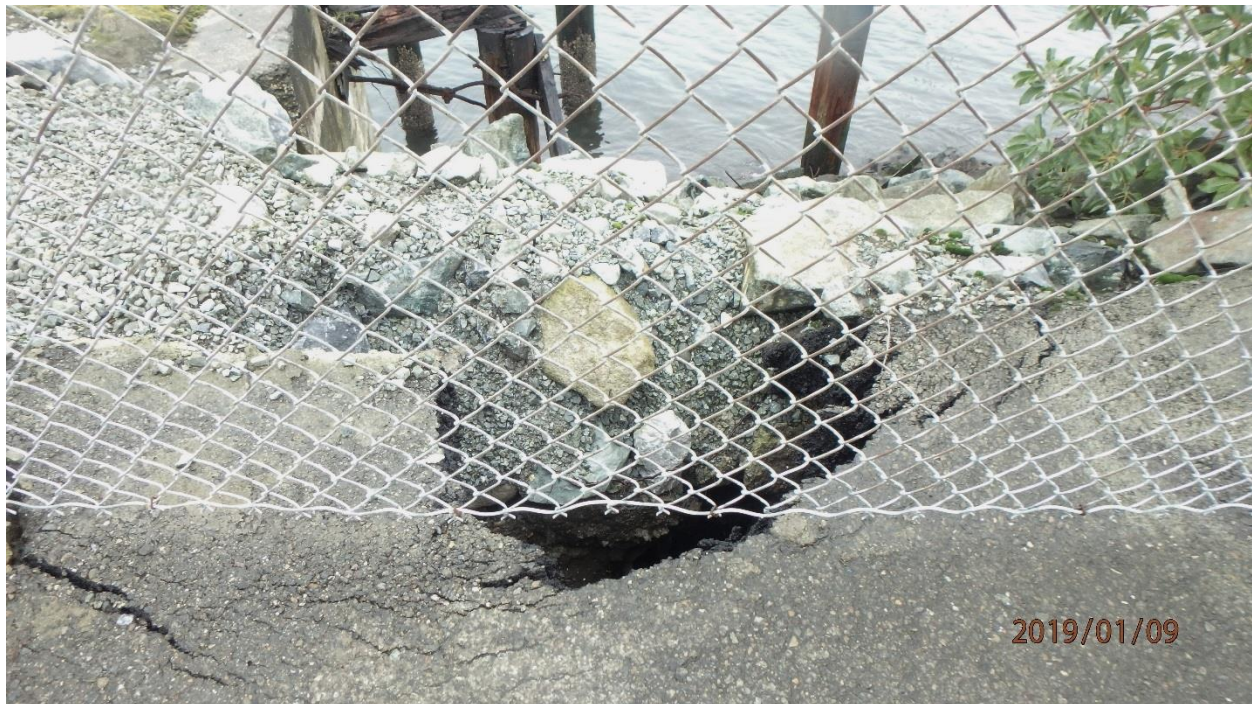
A hole in the pavement approximately 2 × 2 ft and approximately 4 ft deep was observed near the northeast corner of RA-5 at the shoreline where the West Waterway enters Elliott Bay (map note 9; photo 12). Pavement cracking was observed in the vicinity of the hole and is probably attributable to undermining of material by wave action. The Port was

immediately notified of this hole, the cause of which should be verified and corrected. The area appeared to be barricaded; Ecology blocks were observed around the area.

Photo 12. Hole and cracking in pavement near northeast corner of site: RA-5 (map note 9)

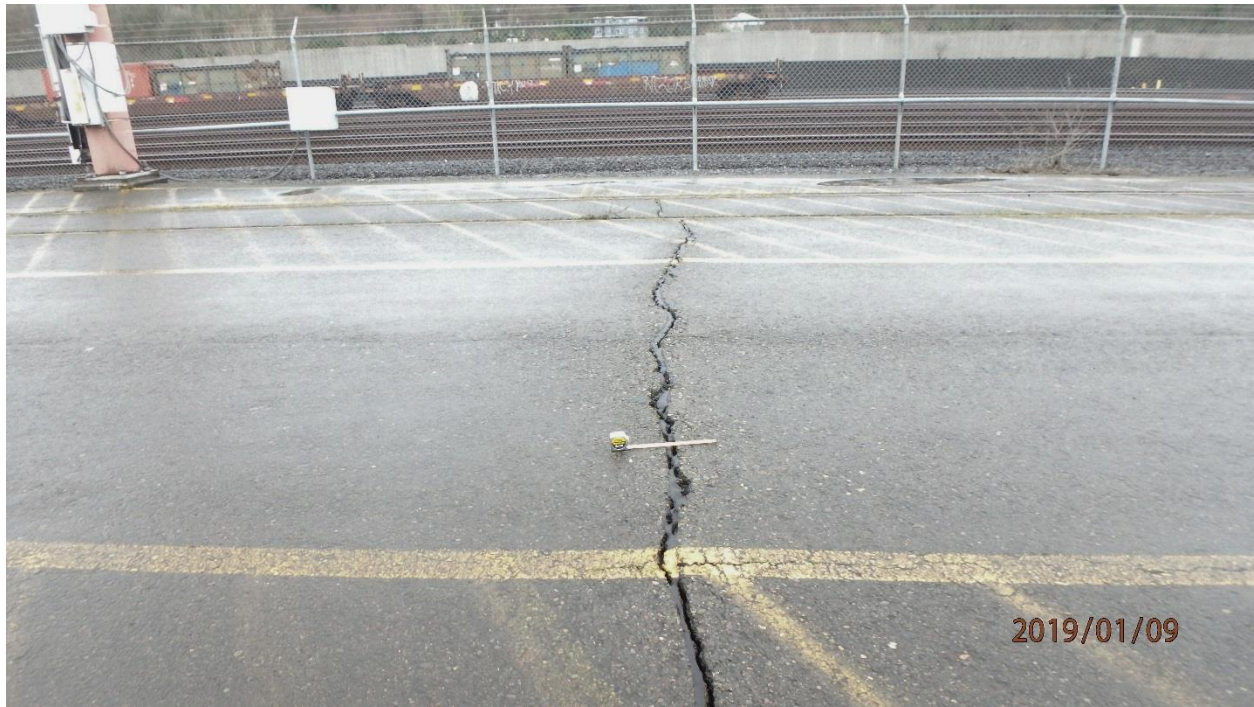
1. Map note 10 (RA-3): This crack is located northwest of the area of settlement in RA-3. It runs east to west; the pavement on the north side of the crack is slightly higher than the pavement on the south side, indicating some degree of recent settlement in this area. The crack is as wide as approximately 1.25 in. and is approximately 21-25 yards in length (photo 13). The crack was observed to have been previously sealed but the seal is no longer sufficient and should be replaced.

Photo 13. Crack as wide as 1.25 in.: RA-3 (map note 10)

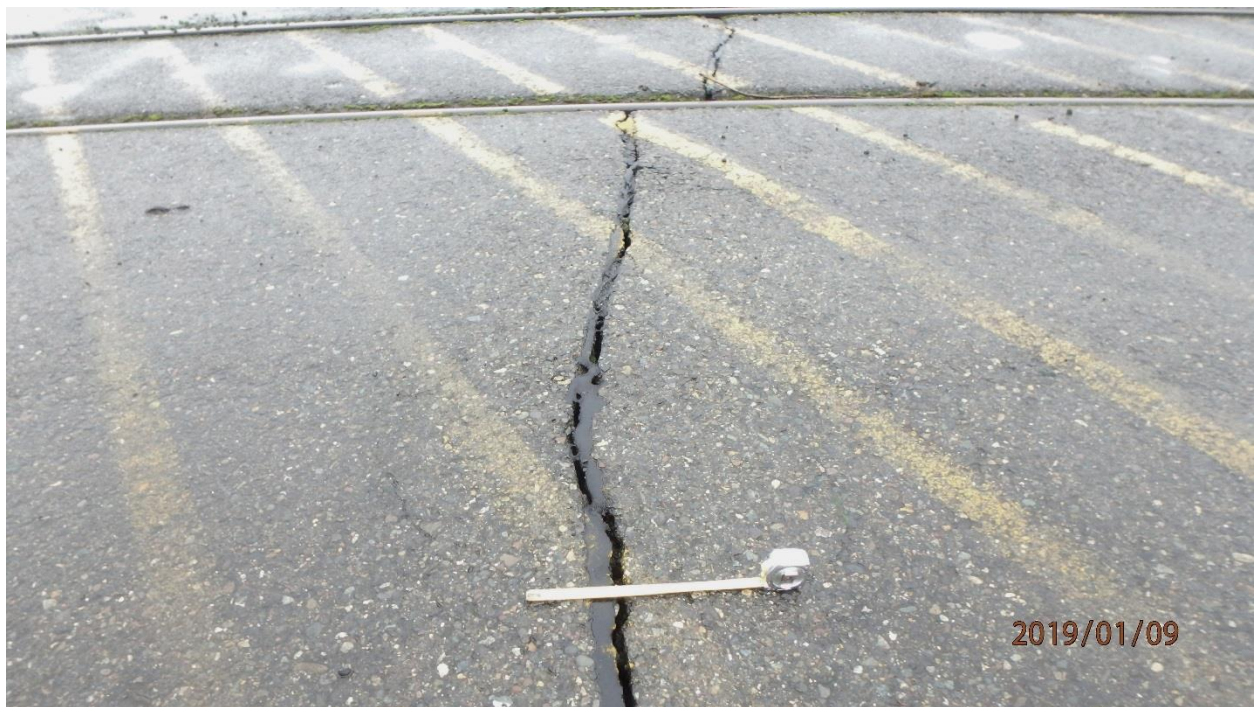
2. Map note 11 (RA-3): This crack is located southeast of the area of settlement in RA-3. It runs east/ west, is as wide as approximately 2 in. in some places and as deep s as approximately 6 to 8 in (photo 14). The pavement surrounding this crack is not level. The crack has previously been sealed but the sealant is failing in some areas and should be replaced.

Photo 14. Crack as wide as 2 in.: RA-3 (map note 11)

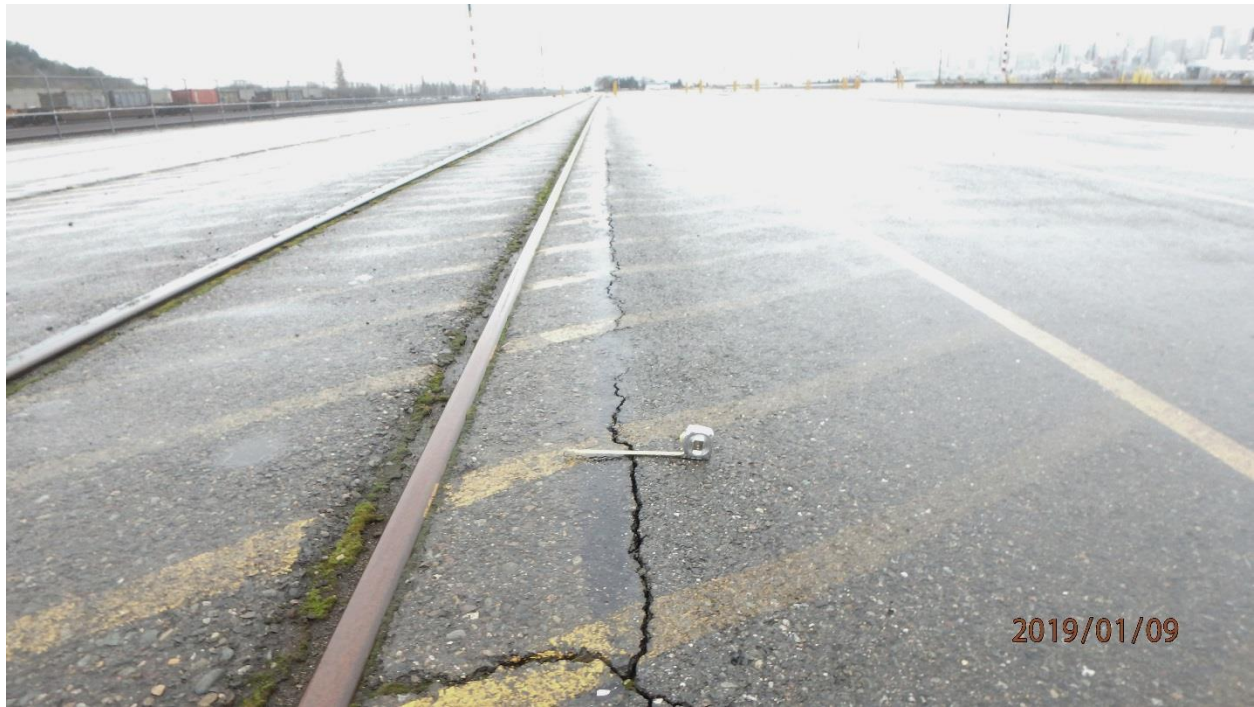
3. Map note 12 (RA-3): This crack extends approximately 340 ft south from the southwest corner of the area of settlement in RA-3 (photo 15). It is as wide as approximately 1 in.

Photo 15. Crack as wide as 1 in.: RA-3 (map note 12)

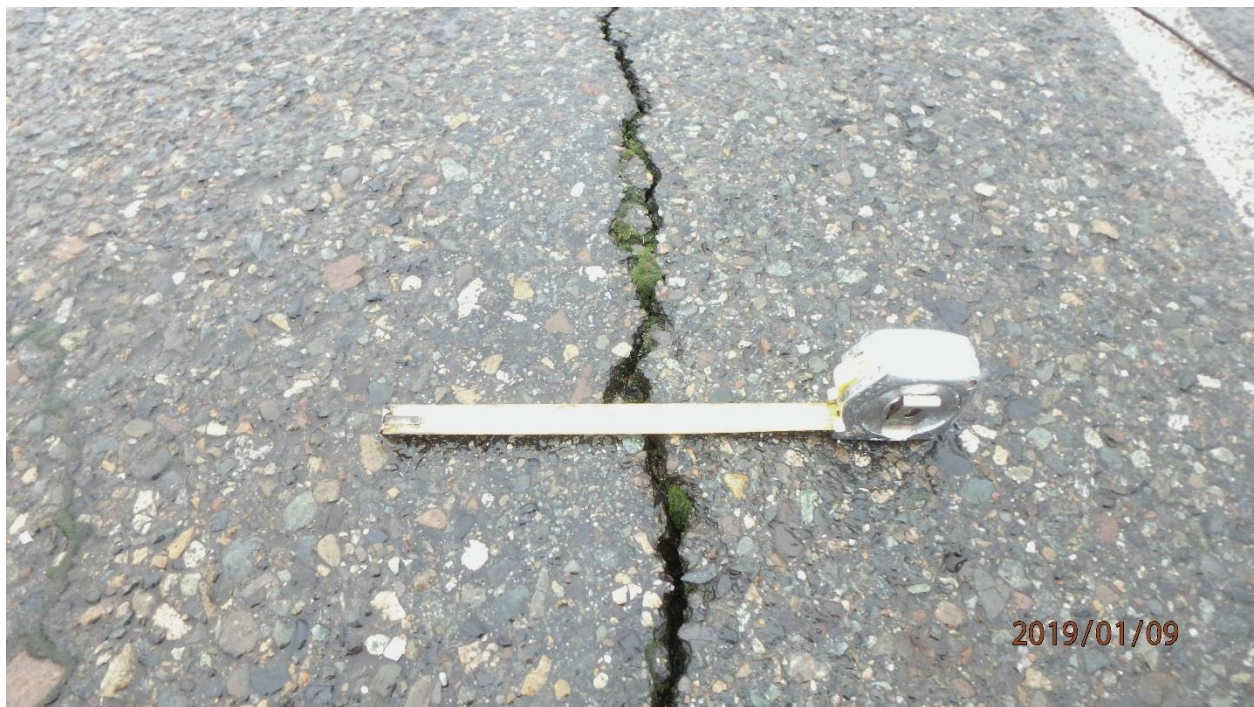
4. Map note 13 (RA-3): This crack extends approximately 450 ft south from the southeast corner of the area of settlement in RA-3 (photo 16). Moss and grass growth are present in some parts of the crack. The northernmost 150 ft were observed to be in better condition than the southern 300 ft.

Photo 16. Crack as wide as 1 in.: RA-3 (map note 13)

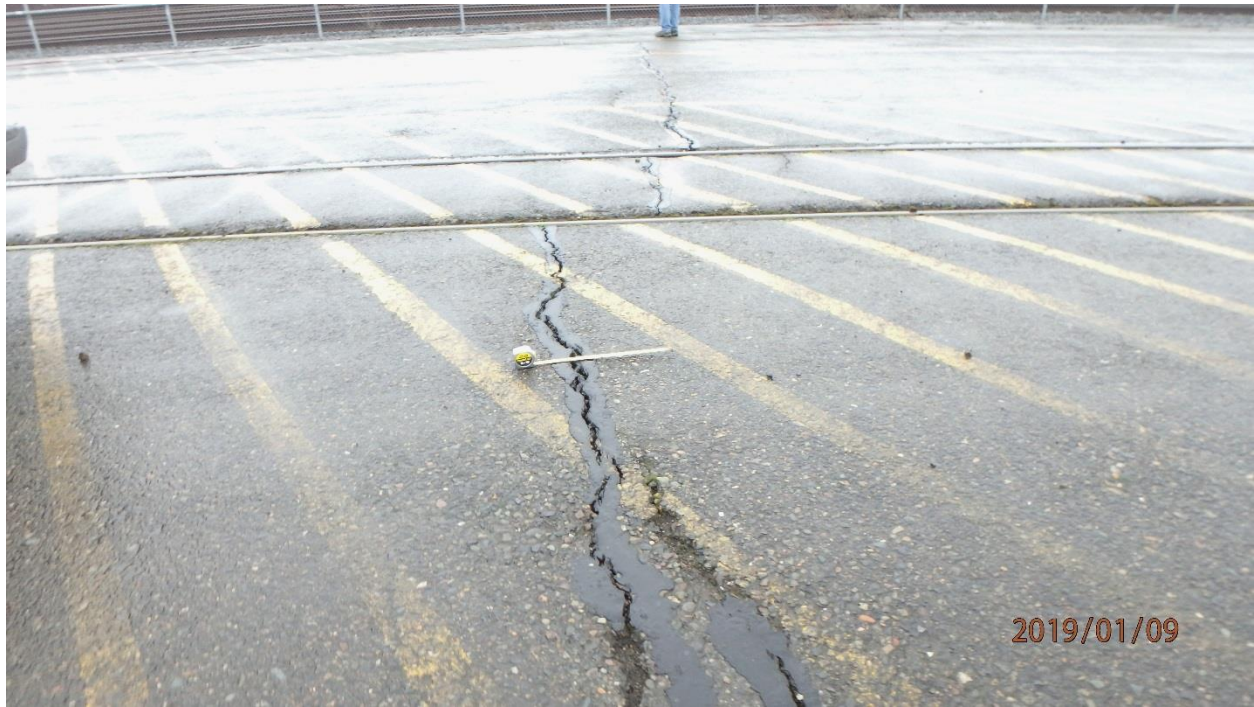
5. Map note 14 (RA-3): This crack is located south of the area of settlement in RA-3. It extends east/ west and is as wide as approximately 2 in (photo 17).

Photo 17. Crack as wide as 2 in.: RA-3 (map note 14)

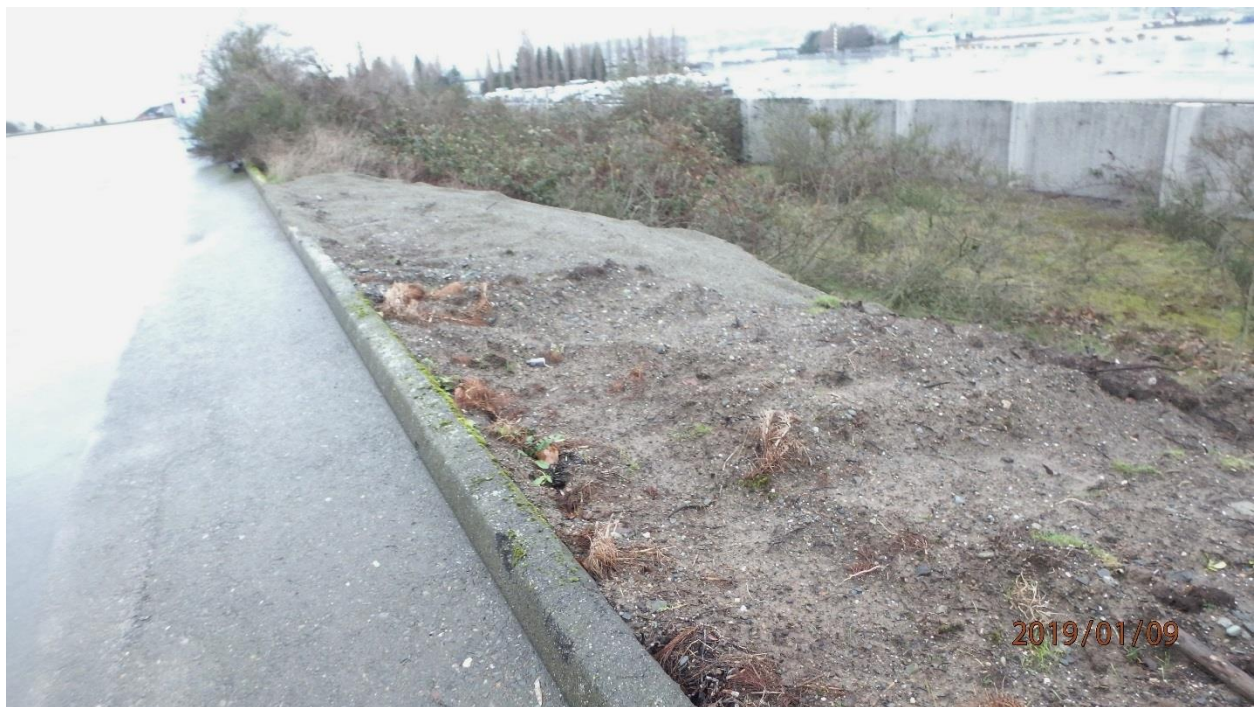
Vegetation has been cleared from the western side of the consolidated landfill, on both sides of the drainage swale. Vegetation had been cleared from the eastern side of the landfill before the 2017 end-of-year inspection. Vegetation has been removed from along the southern fence since the 2018 mid-year inspection. There were no signs of erosion or exposure of the underlying consolidated landfill liner during this inspection. Three locations were observed on the eastern side of the landfill from which vegetation had been completely cleared and loose dirt/sand had been placed (map notes 17, 18, and 19). A representative photo of these three areas is included in Attachment 2 (photo 18). These areas have the potential to erode; they should be inspected during future inspections (if not more often). There was no visual evidence that the underlying liner was exposed.

Photo 18. Representative photo of three areas on east landfill slope, cleared of vegetation and covered with loose soil: RA-3 (map notes 17, 18, and 19)
