STATE OF WASHINGTON
DEPARTMENT OF ECOLOGY

September 8, 2011

Re: Further Action at the following Site:

- **Site Name:** Whatcom Falls Market
- **Site Address:** 1480 Electric Avenue, Bellingham, WA 98225
- **Facility/Site No.:** 53569739
- **VCP Project No.:** NW2414

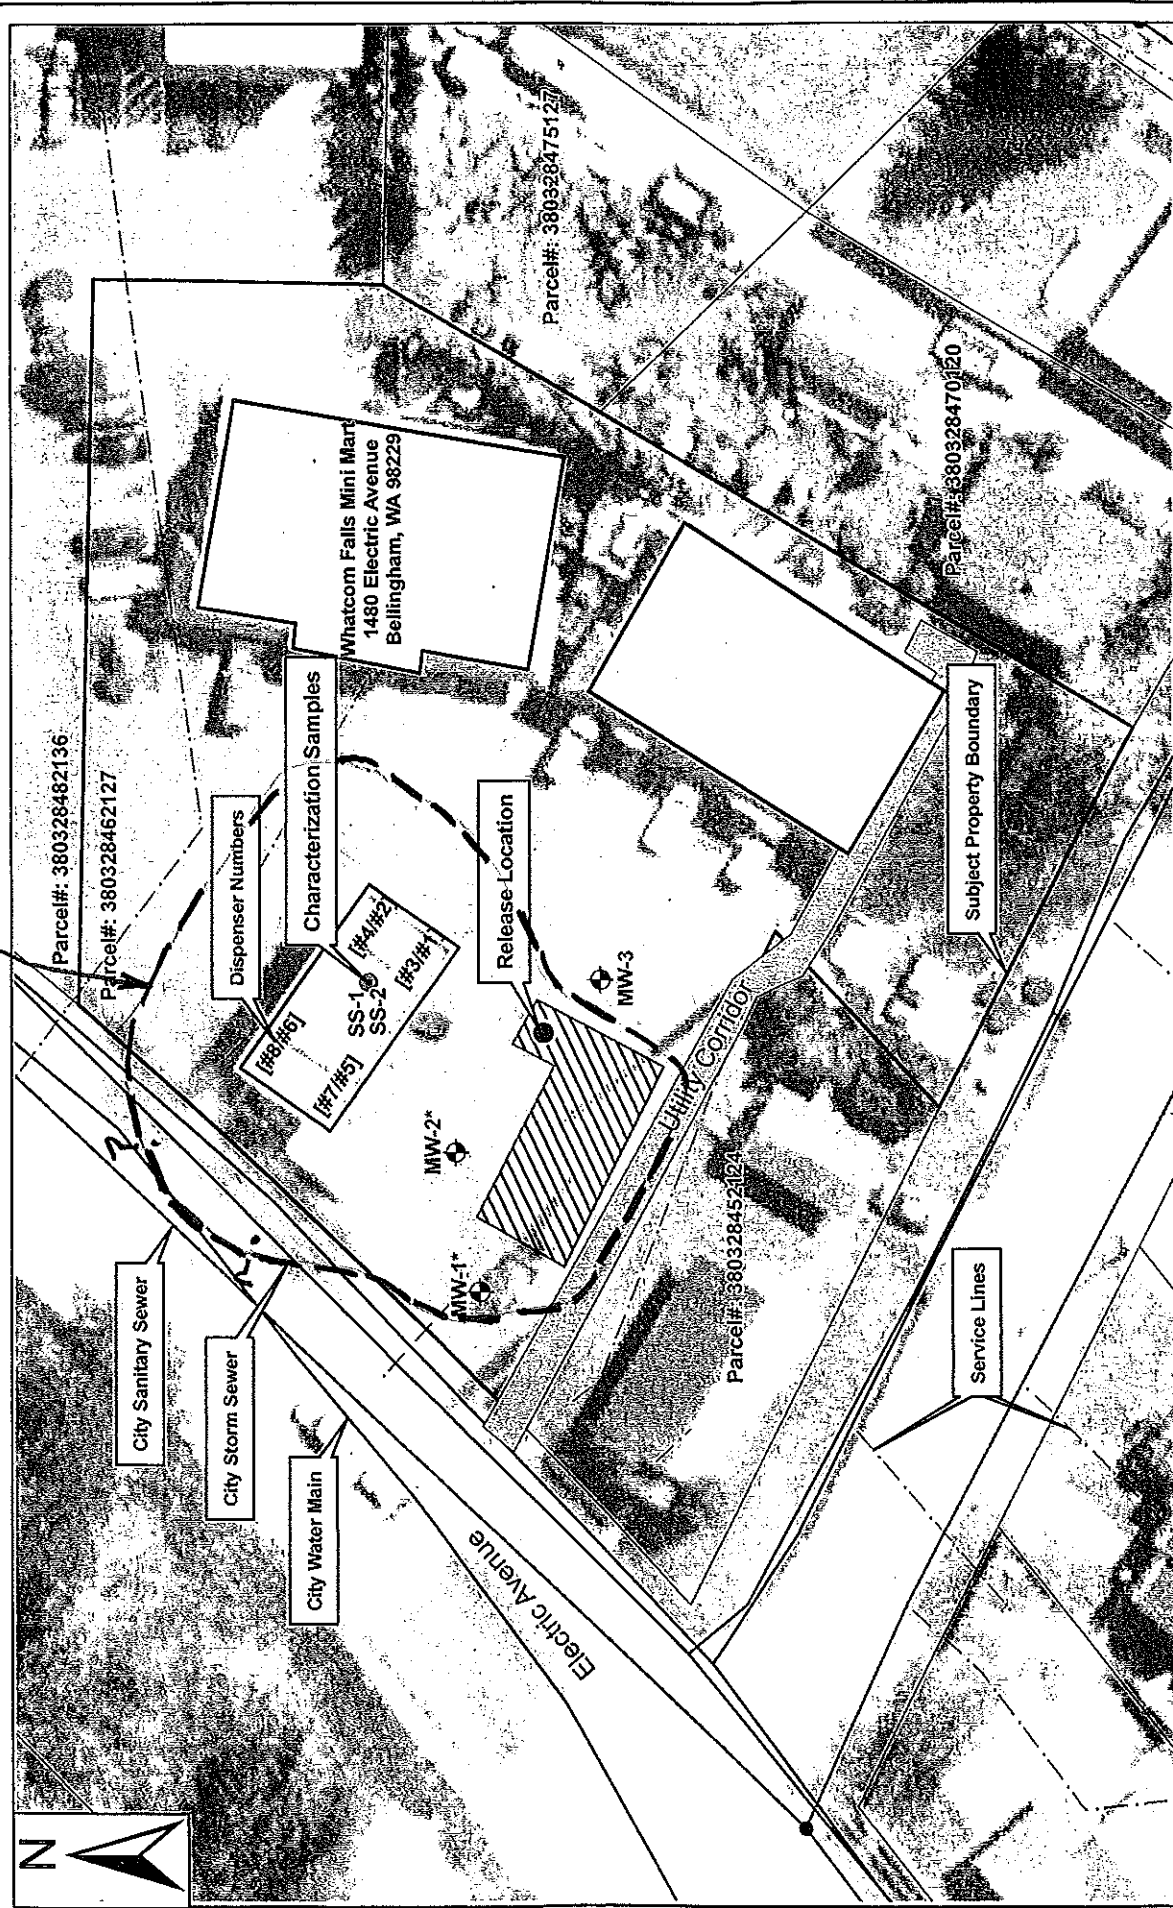
Subject Property Map
Figure 2

The contamination extended from near land surface, to a depth ranging from 13 feet (in the tank nest area) to between 5 and 8 feet (within the remainder of the Site). The areal extent of contamination, as defined by the remedial excavation, was approximately 80 feet by 125 feet in plan dimension. However, the Site is actually wider than 80 feet because contamination extends some unknown distance north beneath Electric Avenue.

Extent of Contamination – Ground Water: The extent of uppermost ground water contamination was never confirmed, except to the west. In this area a series of grab samples from soil borings showed no detectable contamination. Within the rest of the Site only two wells were installed in locations potentially impacted. One of these wells (MW-1) showed both TPHg and benzene detections, with only the benzene above cleanup levels. The other well showed no impact. The potential for impact to deeper ground water has also not been evaluated.

APPROXIMATE BOUNDARY OF SITE
