## **SECOND PERIODIC REVIEW REPORT DRAFT**

**Murray Pacific 2  
Facility Site ID#: 1211  
Cleanup Site ID# 3075**

**2407 Port of Tacoma Road  
Tacoma, Washington 98421**

**May 2019**

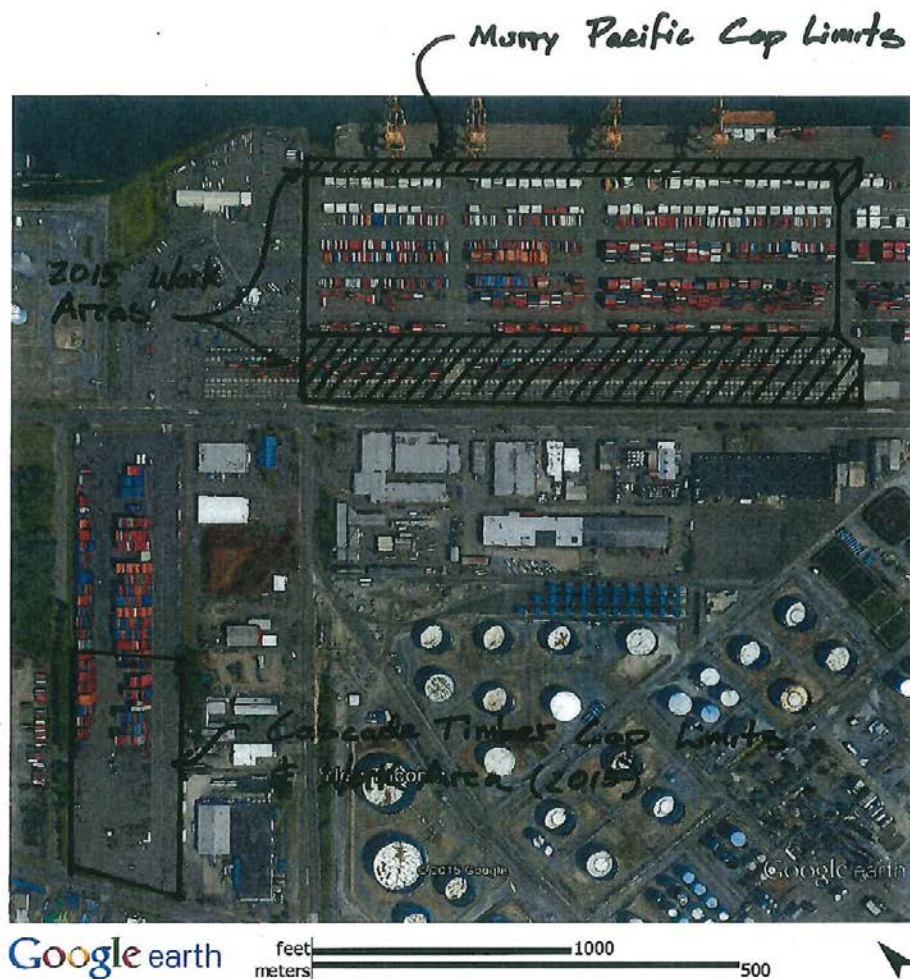
Since September 2011, a total of three rounds of cap inspections (February 2012, December 2014, and March 2017) have been conducted at the Site. As per these cap inspection reports recommendations and cap maintenance, the Port sealed or resealed approximately 8,712 feet of cracks, repaired, replaced, or removed 111 concrete wheel stops in the intermodal yard and adjacent to the pier on the drive aisle (Photo 1, Appendix 6.9).

**Photo 1: Completed Cap Area Repairs in 2015**

- Crack and slurry seal overlay in the intermodal yard and adjacent to the pier on the drive aisle.
- Also removed some concrete landing pads and repaired the fabric liner in the asphalt section

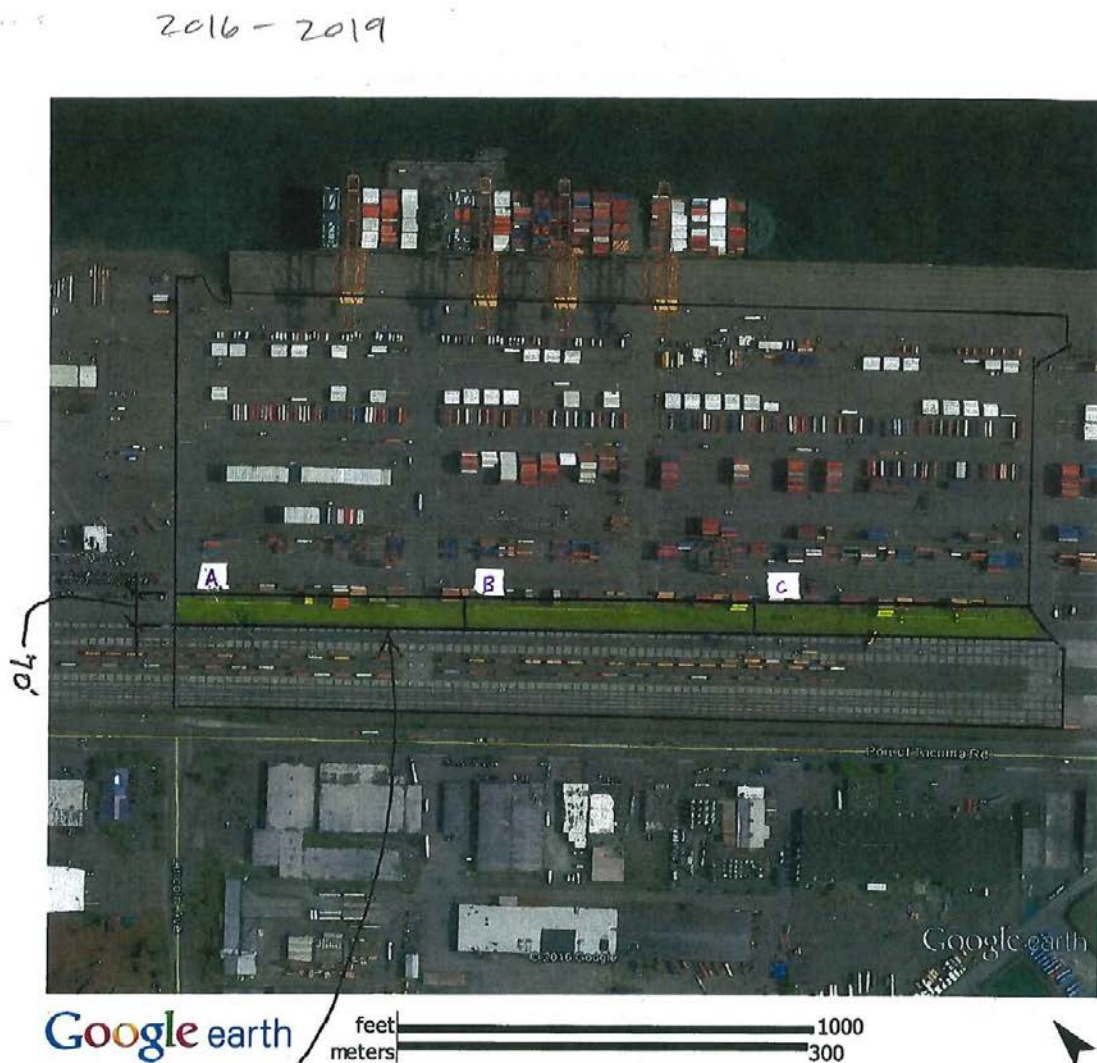
In addition, the Port resurfaced approximately 136,500 square-foot of the low permeability asphalt cap during 2016 through 2018 (Photo 2, Appendix 6.9). The cap section consists of 4 inches of dense grade asphalt concrete (DGAC) within which a geotextile fabric was placed to improve the long-term performance of the cap. To provide a suitable working surface for constructing the cap, 4 to 12 inches of aggregate base was placed on the subgrade. The cap was installed on top of the aggregate base, and the pavement section was constructed above this cap layer. The pavement section in the container storage yard consisted of 3.33 inches of Class B asphalt, overlaid with an asphalt-impregnated fabric, then overlaid with two more lifts of Class E asphalt for a total section thickness of 10 inches (Photo 3, Appendix 6.9). The Port has also scheduled to resurface the cap in the drive aisle behind the Pier and address settlement around the trench drain in 2019.

**Photo 2: Completed Cap Area Repairs from 2016 through 2018**

Area to be resurfaced over the next  
3 yrs

- A - completed in 2016
- B - Completed in 2017
- C - completed in 2018

planned for 2019 -  
mill and pave in the  
drive aisle behind the  
pier. Address settlement  
around the trench drain

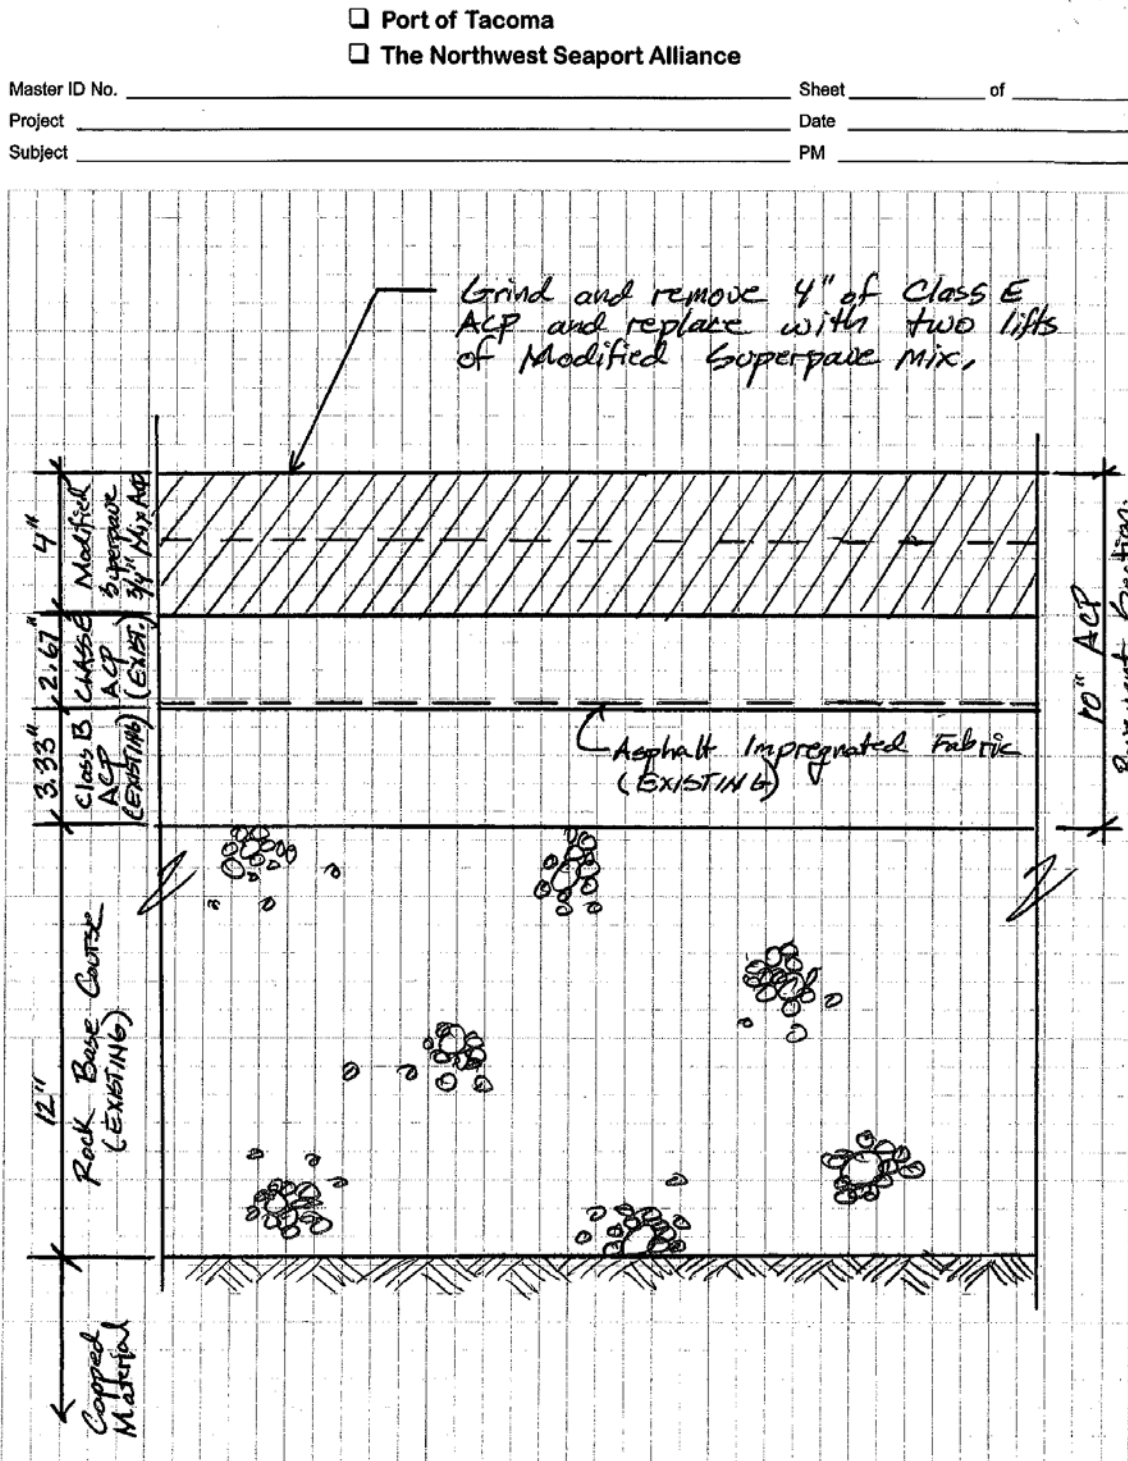
Photo 3: Asphalt Cap Pavement Section

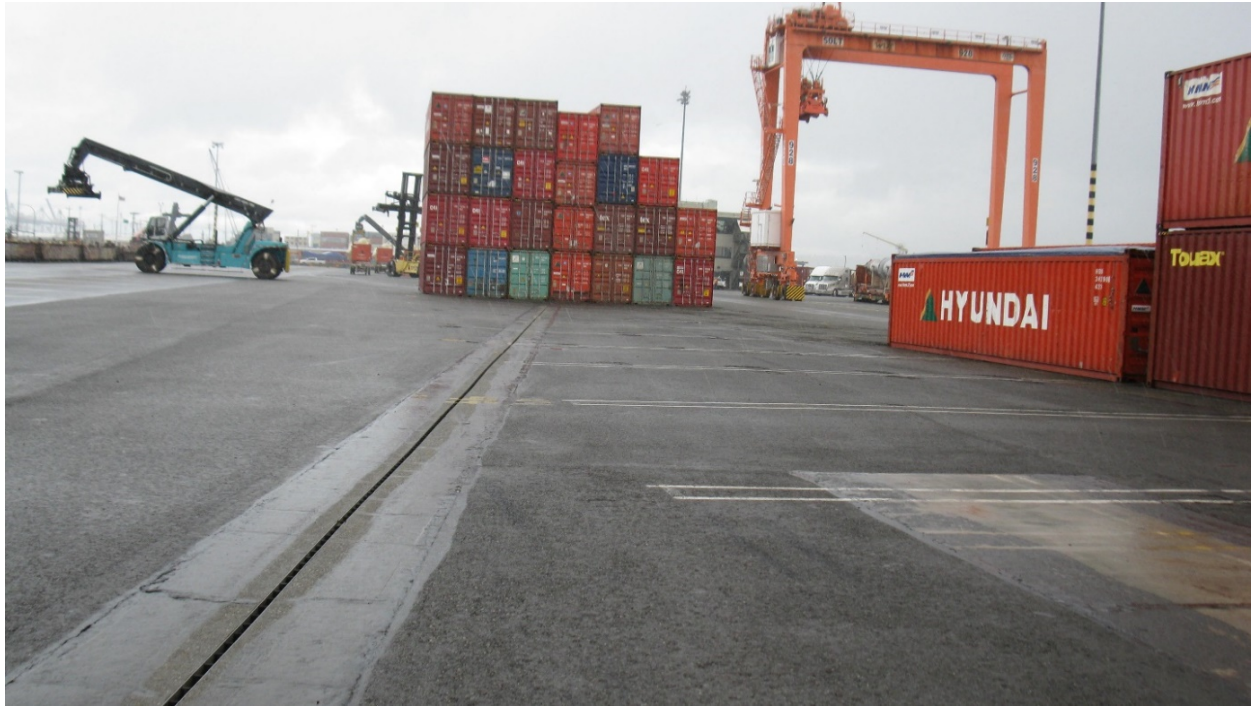
**Photo 4: Part of the Cap Repaired Area from 2016 through 2018 and the Slot Drain – From the West**

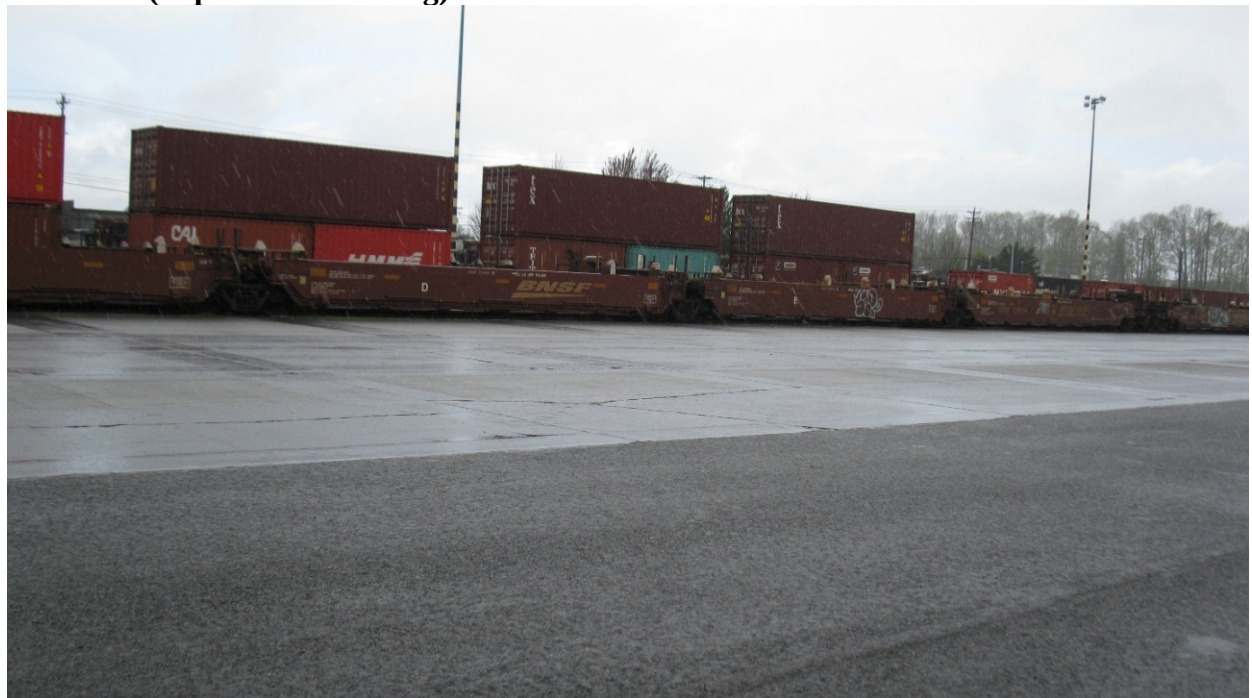
**Photo 5: Container Storage Area, Asphalt/Concrete Cap and Repaired Cap Area (Asphalt Resurfacing) – From the Southeast**

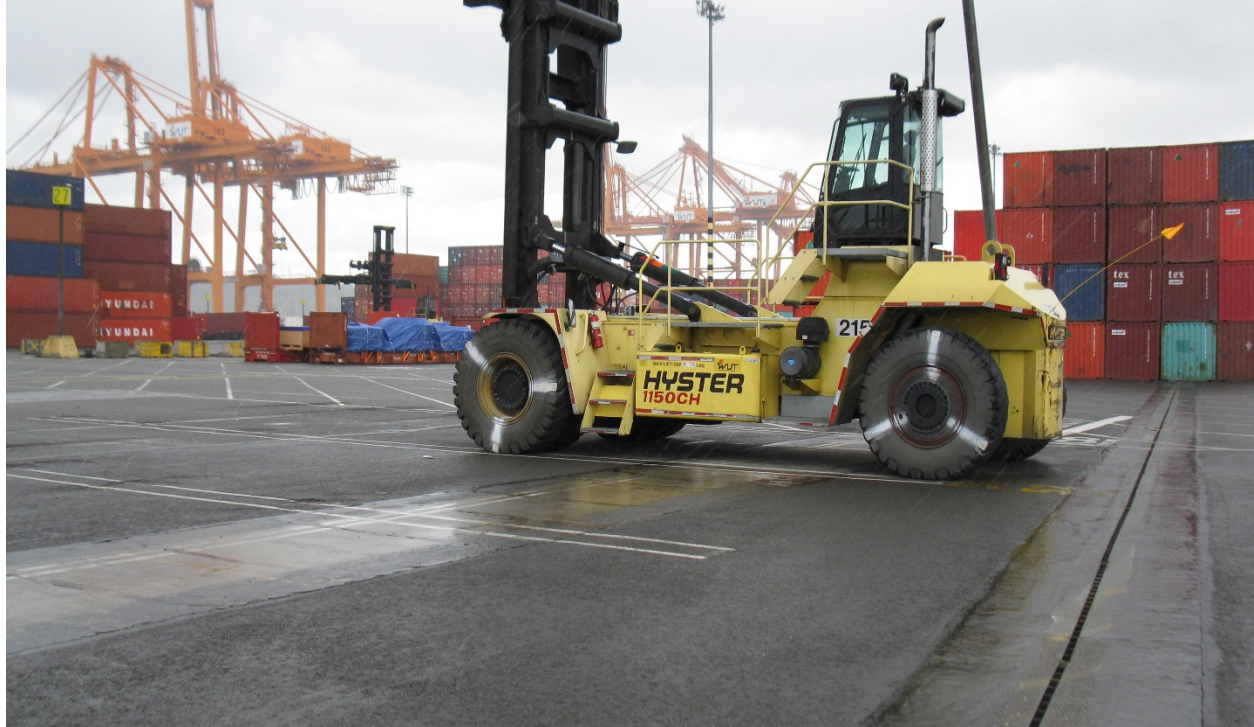
**Photo 6: Container Storage Area, Asphalt Cap, and Slot Drain – From the Northwest**

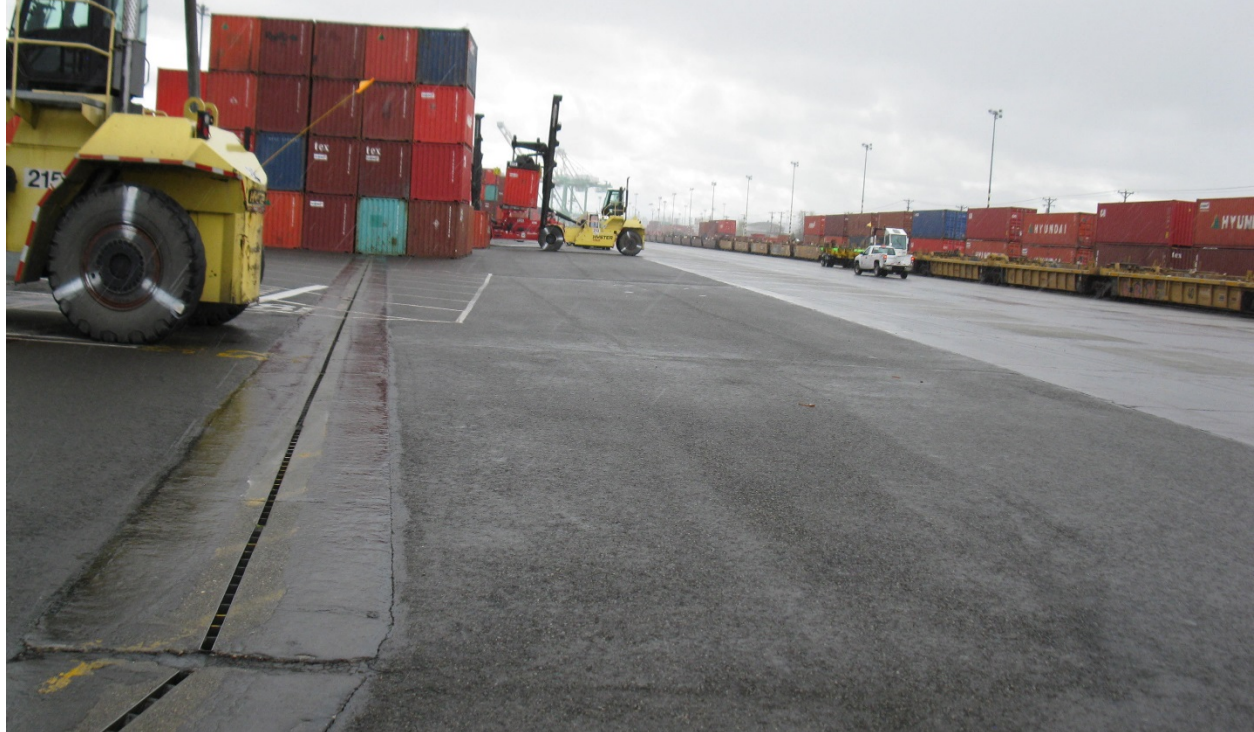
**Photo 7: Container Storage Area, Resurfaced Cap Area, and Slot Drain – From the North**

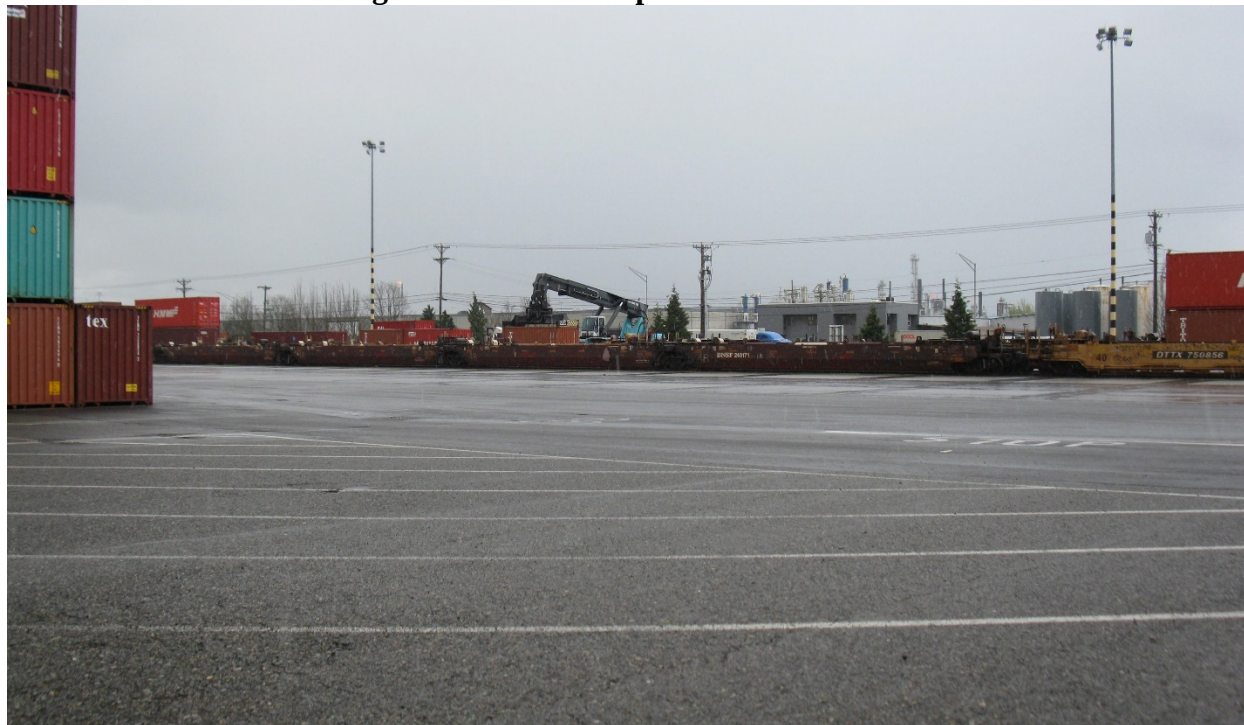
**Photo 8: Container Storage Area and the Cap – From the South**
