STATE OF WASHINGTON  
DEPARTMENT OF ECOLOGY

**Re: Further Action at the following Site:**

- **Site Name:** Glacier Recycle
- **Site Address:** 32300 148<sup>th</sup> Ave., SE, Auburn, WA
- **Facility/Site No.:** 21135
- **Cleanup Site ID No.:** 12326
- **VCP Project No.:** NW3202

# Enclosure A

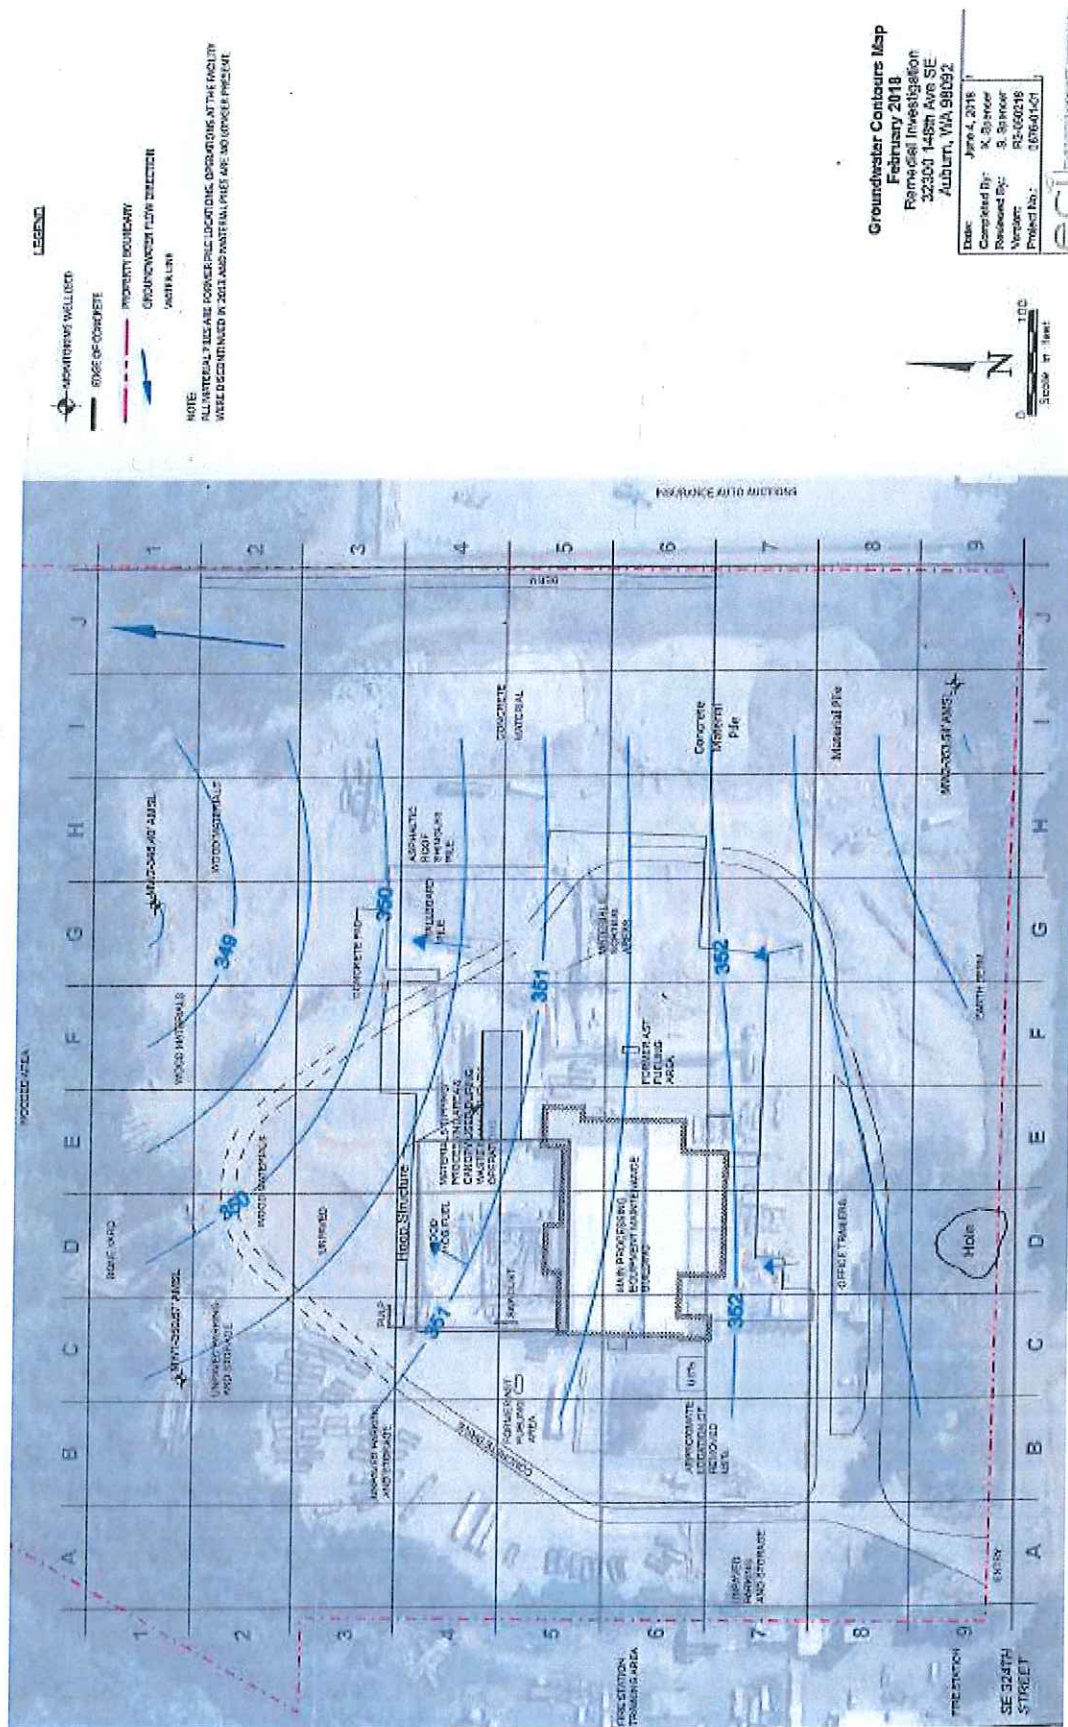
Figure 3 Ground Water Contour Map and Flow Direction

**Ground Water:** Perched ground water was reportedly encountered at the base of the fill at depths of 3 to 9 feet bgs, and in the former underground storage tank (UST) excavation at approximately 14 feet bgs. Regional ground water at the Site occurs under unconfined conditions at depths ranging from 31 to 50 feet bgs, with a north to north-west flow direction towards Big Soos Creek (**Figure 3**).

In 2014, three of the monitoring wells were installed to identify contamination status in ground water at the Site (**Figure 3**). Ground water encountered at 31 to 50 feet bgs in MW -1, MW-2 and MW-3 were collected for the COCs analysis. The following table lists copper, manganese and zinc were detected with maximum concentrations in the water samples during the four quarterly monitoring events from February to November 2018:

- All the three existing ground water monitoring wells were installed around the Property boundary. Ecology recommends addition of at least three monitoring wells at locations within the Property boundaries, to identify contamination status in the ground water immediately downgradient of identified soil contamination (see **Enclosure A, Figure 4**). The data can also provide more information to develop an accurate ground water contour map and assess the ground water flow directions.

- Contaminant concentrations in soil and ground water samples, at depth intervals where the samples were collected.
- Include ground water elevations at monitoring well control points on any ground water elevation contour maps.
