## PERIODIC REVIEW

**Weyerhaeuser Everett East Site**

**TOXICS CLEANUP PROGRAM**

**July 9, 2012**

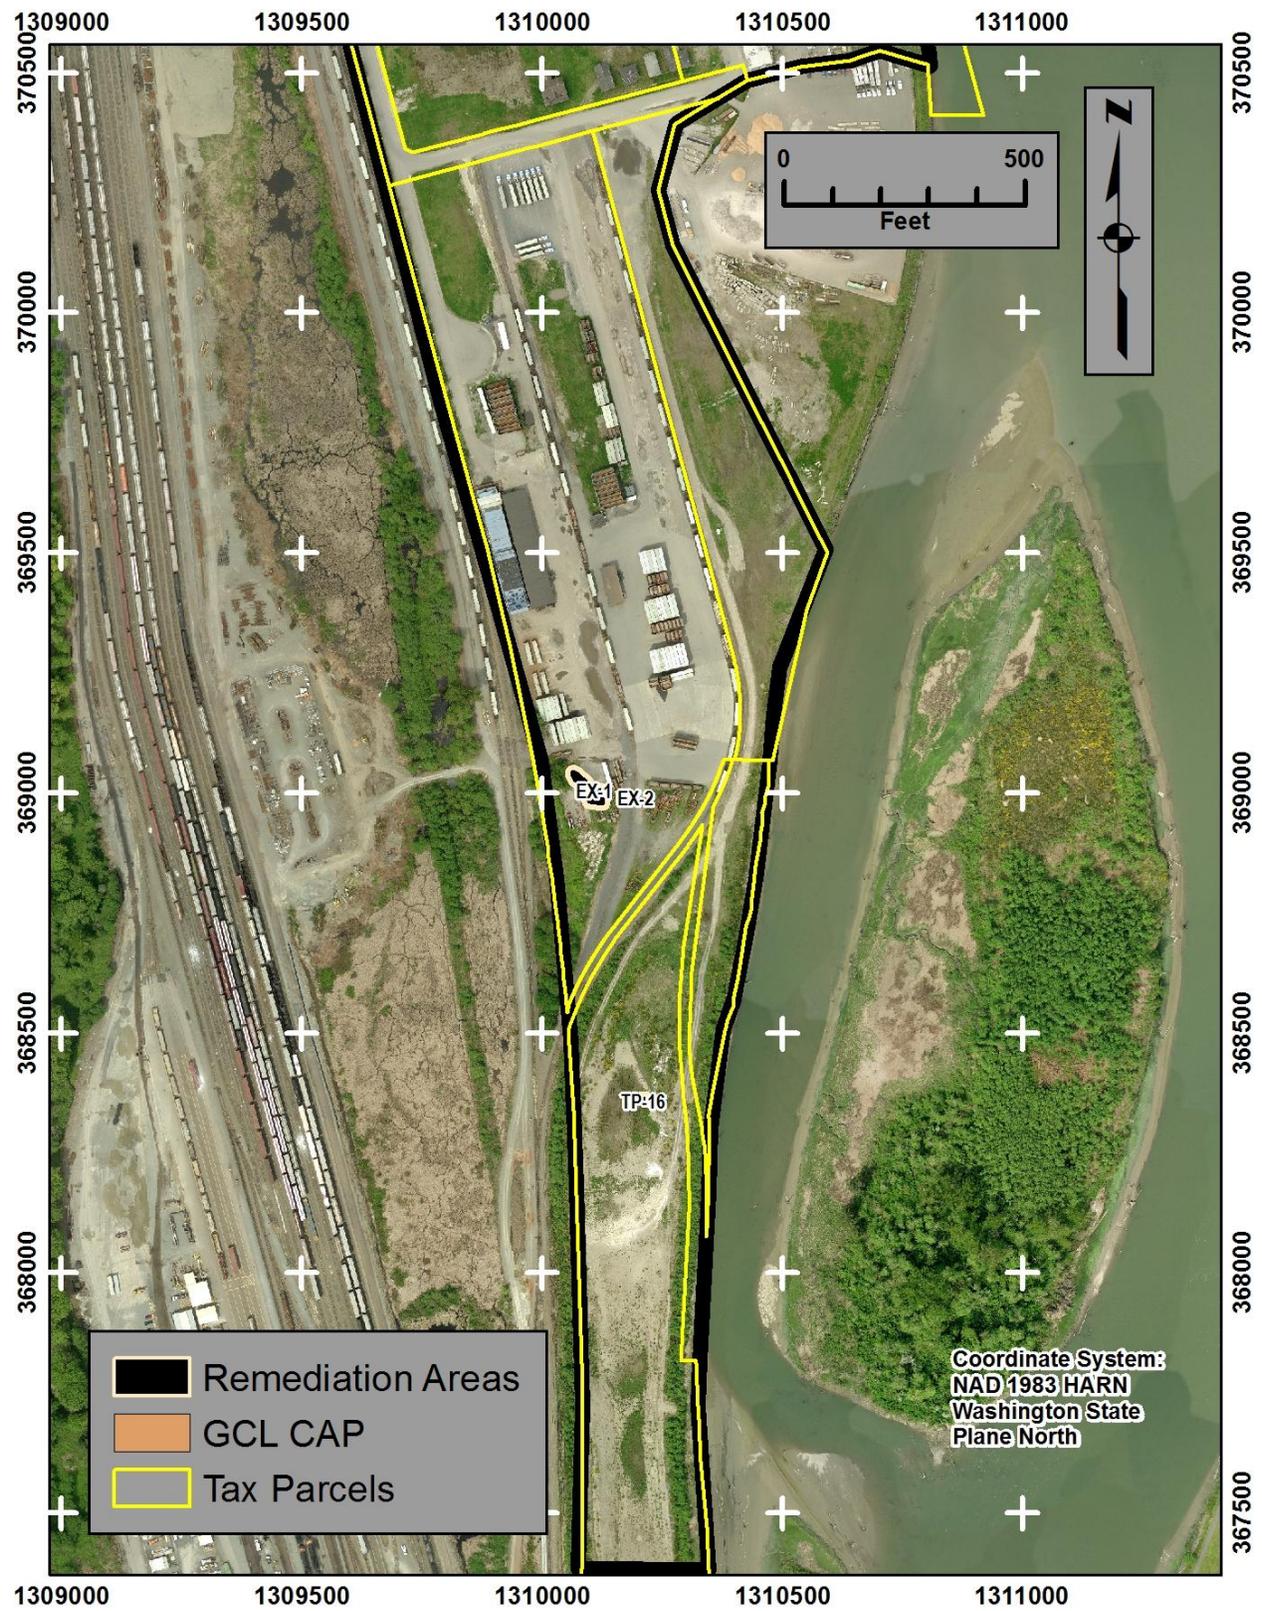
Figure 6: Remediation Areas, South

Conditions on the south end of the site were reported in *Environmental Assessment of South End Residual Wood Storage Operable Unit Site and Ferry Baker Island Site - Survey Parcels 4 and 5* ([8]). This area is the narrow area south of the paved area that is currently being used as an intermodal facility. See Figure 6.

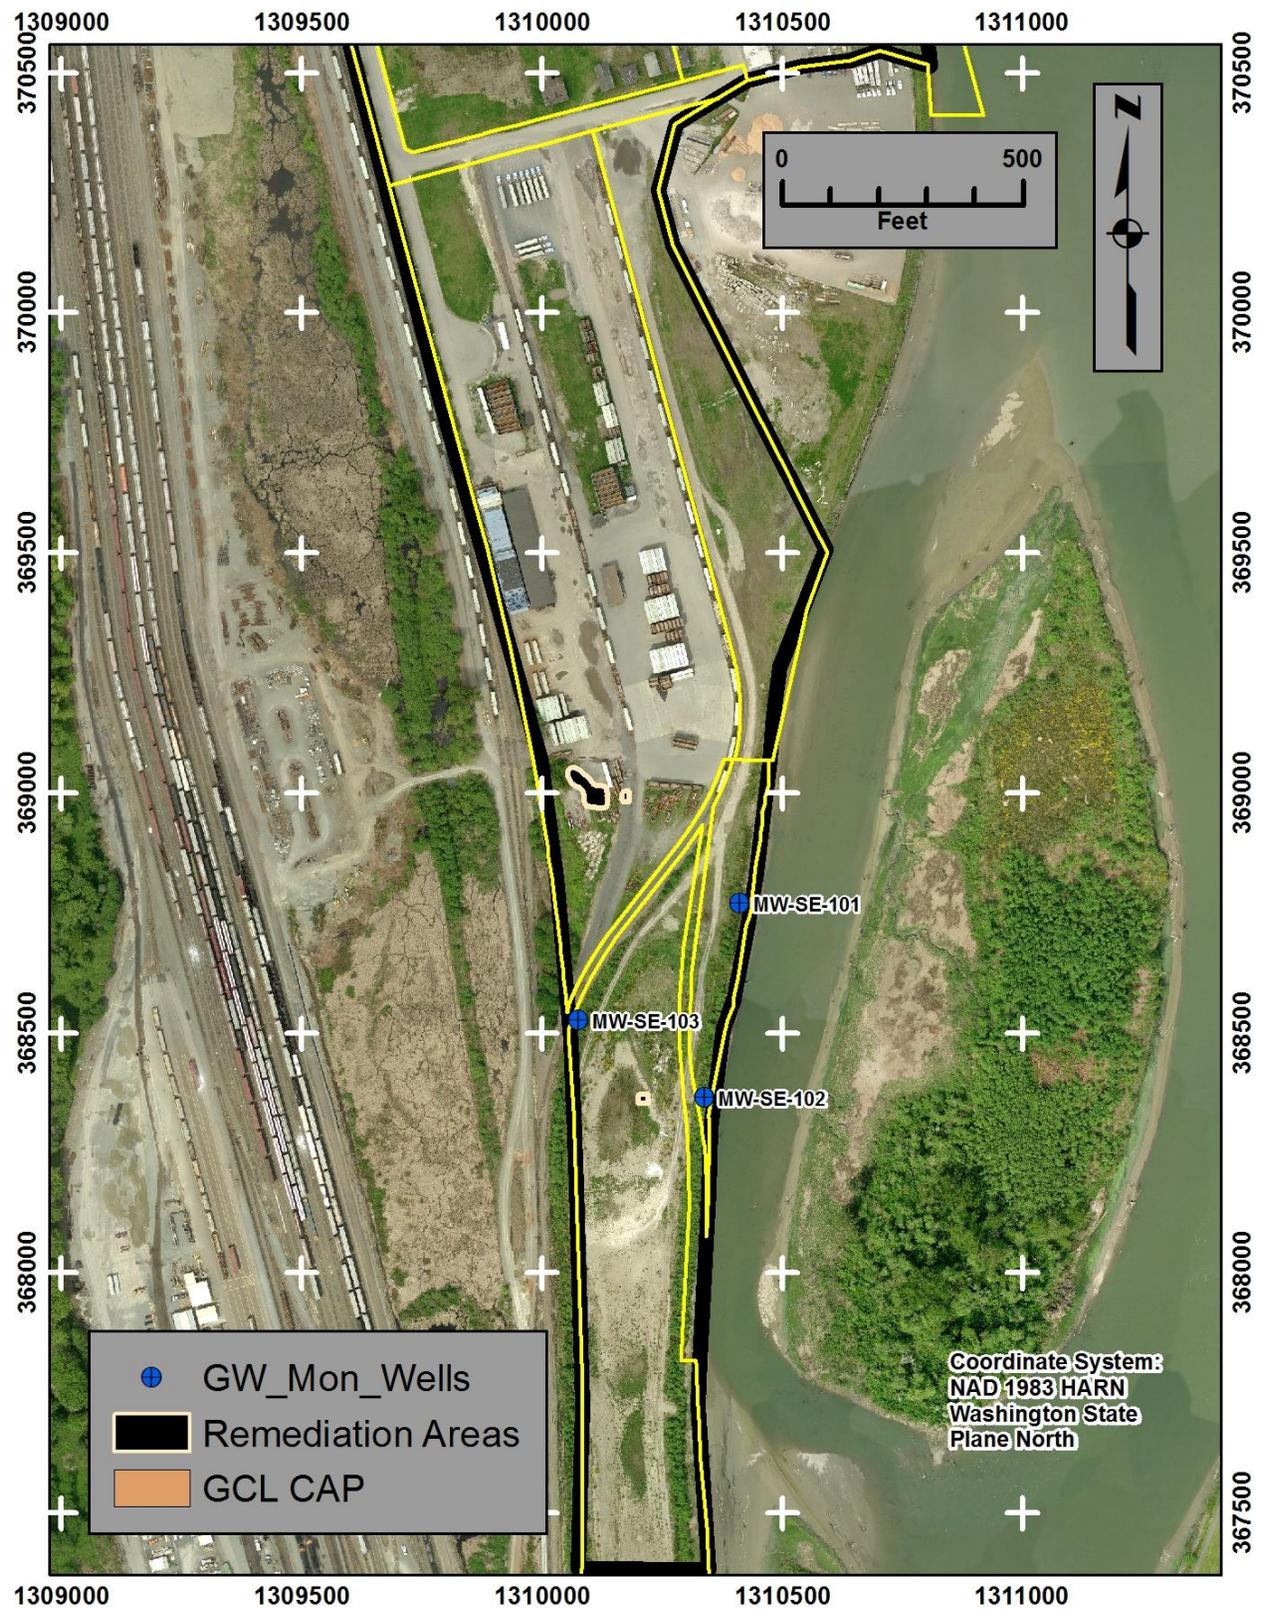
Figure 8: Ground Water Monitoring Well Locations, South.

Abandonment documentation was not found for South End wells MW-SE-101, MW-SE-102, and MW-SE-103. A field tour of the site by Weyerhaeuser of January 26, 2012, was unable to find visible evidence of installed wells, such as a monument riser or concrete base at the mapped locations of the wells shown in [10]. The area is overgrown with vegetation.

- Abandonment documentation was not found for South End wells MW-SE-101, MW-SE-102, and MW-SE-103. A field tour of the site by Weyerhaeuser of January 26, 2012, was unable to find visible evidence of installed wells, such as a monument riser or concrete base at the mapped locations of the wells shown in [10]. The area is overgrown with vegetation. Should these wells be encountered on the South End of the site by future property users, their condition should be ascertained. They should be properly abandoned if necessary.

- Ascertain the condition of South End ground water wells if encountered. Properly abandon the wells if necessary.
- Assess PCP concentration distribution in ground water in the Lower Sand aquifer in the vicinity of Sierra Pacific location GP-10 and report the results to Ecology. This is in the vicinity of Remediation Area RA-8-3A.
