DEPARTMENT OF ECOLOGY

Re: Opinion pursuant to WAC 173-340-515(5) on Remedial Action for the following Hazardous Waste Site:

- **Name:** Time Oil 01-284
- **Address:** 12807 Des Moines Memorial Drive S, Seattle, WA
- **Facility/Site No.:** 45191292
- **VCP No.:** NW3173
- **Cleanup Site ID No.:** 9267

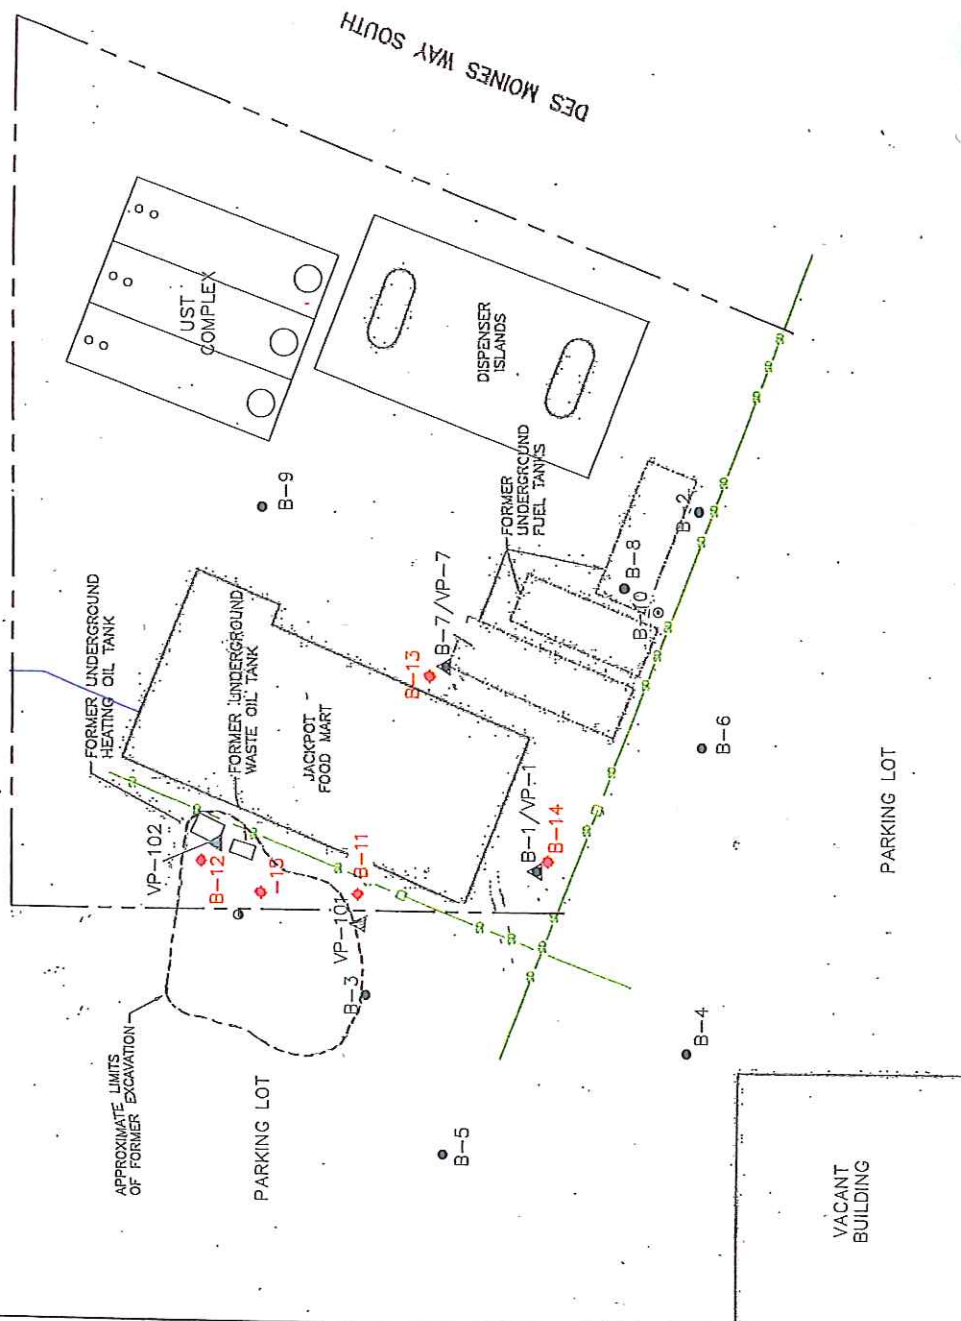
FIGURE 4
SITE PLAN SHOWING BORING/ WELL LOCATIONS
 Site #2840
 12807 Des Moines Memorial Drive
 Burien, Washington

During August 2017, five borings (B-11 through B-15) were drilled to test for any remaining soil contamination in areas where contaminated soil was suspected or known to remain in 1997 (see **Enclosure A, Figure 4**). The areas explored included the former gasoline USTs, the south end of the building, and west side of the building. The borings extended to depths ranging from 35 to 55 feet bgs. Forty-three soil samples (total) were acquired and, based on location and field screening, 19 samples were analyzed.

3. The characterization of soil at the Site is not complete. **Figure 4 of Enclosure A** depicts the areas of the Site where characterization is complete via borings and a remedial investigation. Given the long history of the Property as an automobile fueling and services facility, however, additional characterization is needed in northern, central, and eastern portions of the Property. The dispenser islands have been in the same location since the 1960s, and are typical sources of release from older UST systems. There are no data near, or in any direction from, the dispenser islands.

Surface/Storm Water System: The surface water body nearest the Site is a tributary of Miller Creek, located approximately 1,900 feet southwest of the Site. Miller Creek flows south and joins Walker Creek, which discharges to Puget Sound. As shown in Figure 4, storm water enters drains along the west and south edges of the Property, and then flows to the municipal storm water system.

An auto service bay was likely located in the building, and additional data is needed north and east of the building. If significant contamination is detected, sampling would be needed near the current USTs installed in 1991. Furthermore, if elevated levels of TPHo indicative of waste oil are detected in any additional soil samples collected, those samples should include analyses for the chemical parameters listed in Table 830-1 of WAC 173-340, the MTCA cleanup regulation.
