T E C H N I C A L M E M O R A N D U M

RE: **LANDFILL CAP**
ANNUAL INSPECTION SUMMARY REPORT—2015
SPPD PROPERTY
SOUTH PARK LANDFILL SITE
SEATTLE, WASHINGTON
FARALLON PN: 408-002

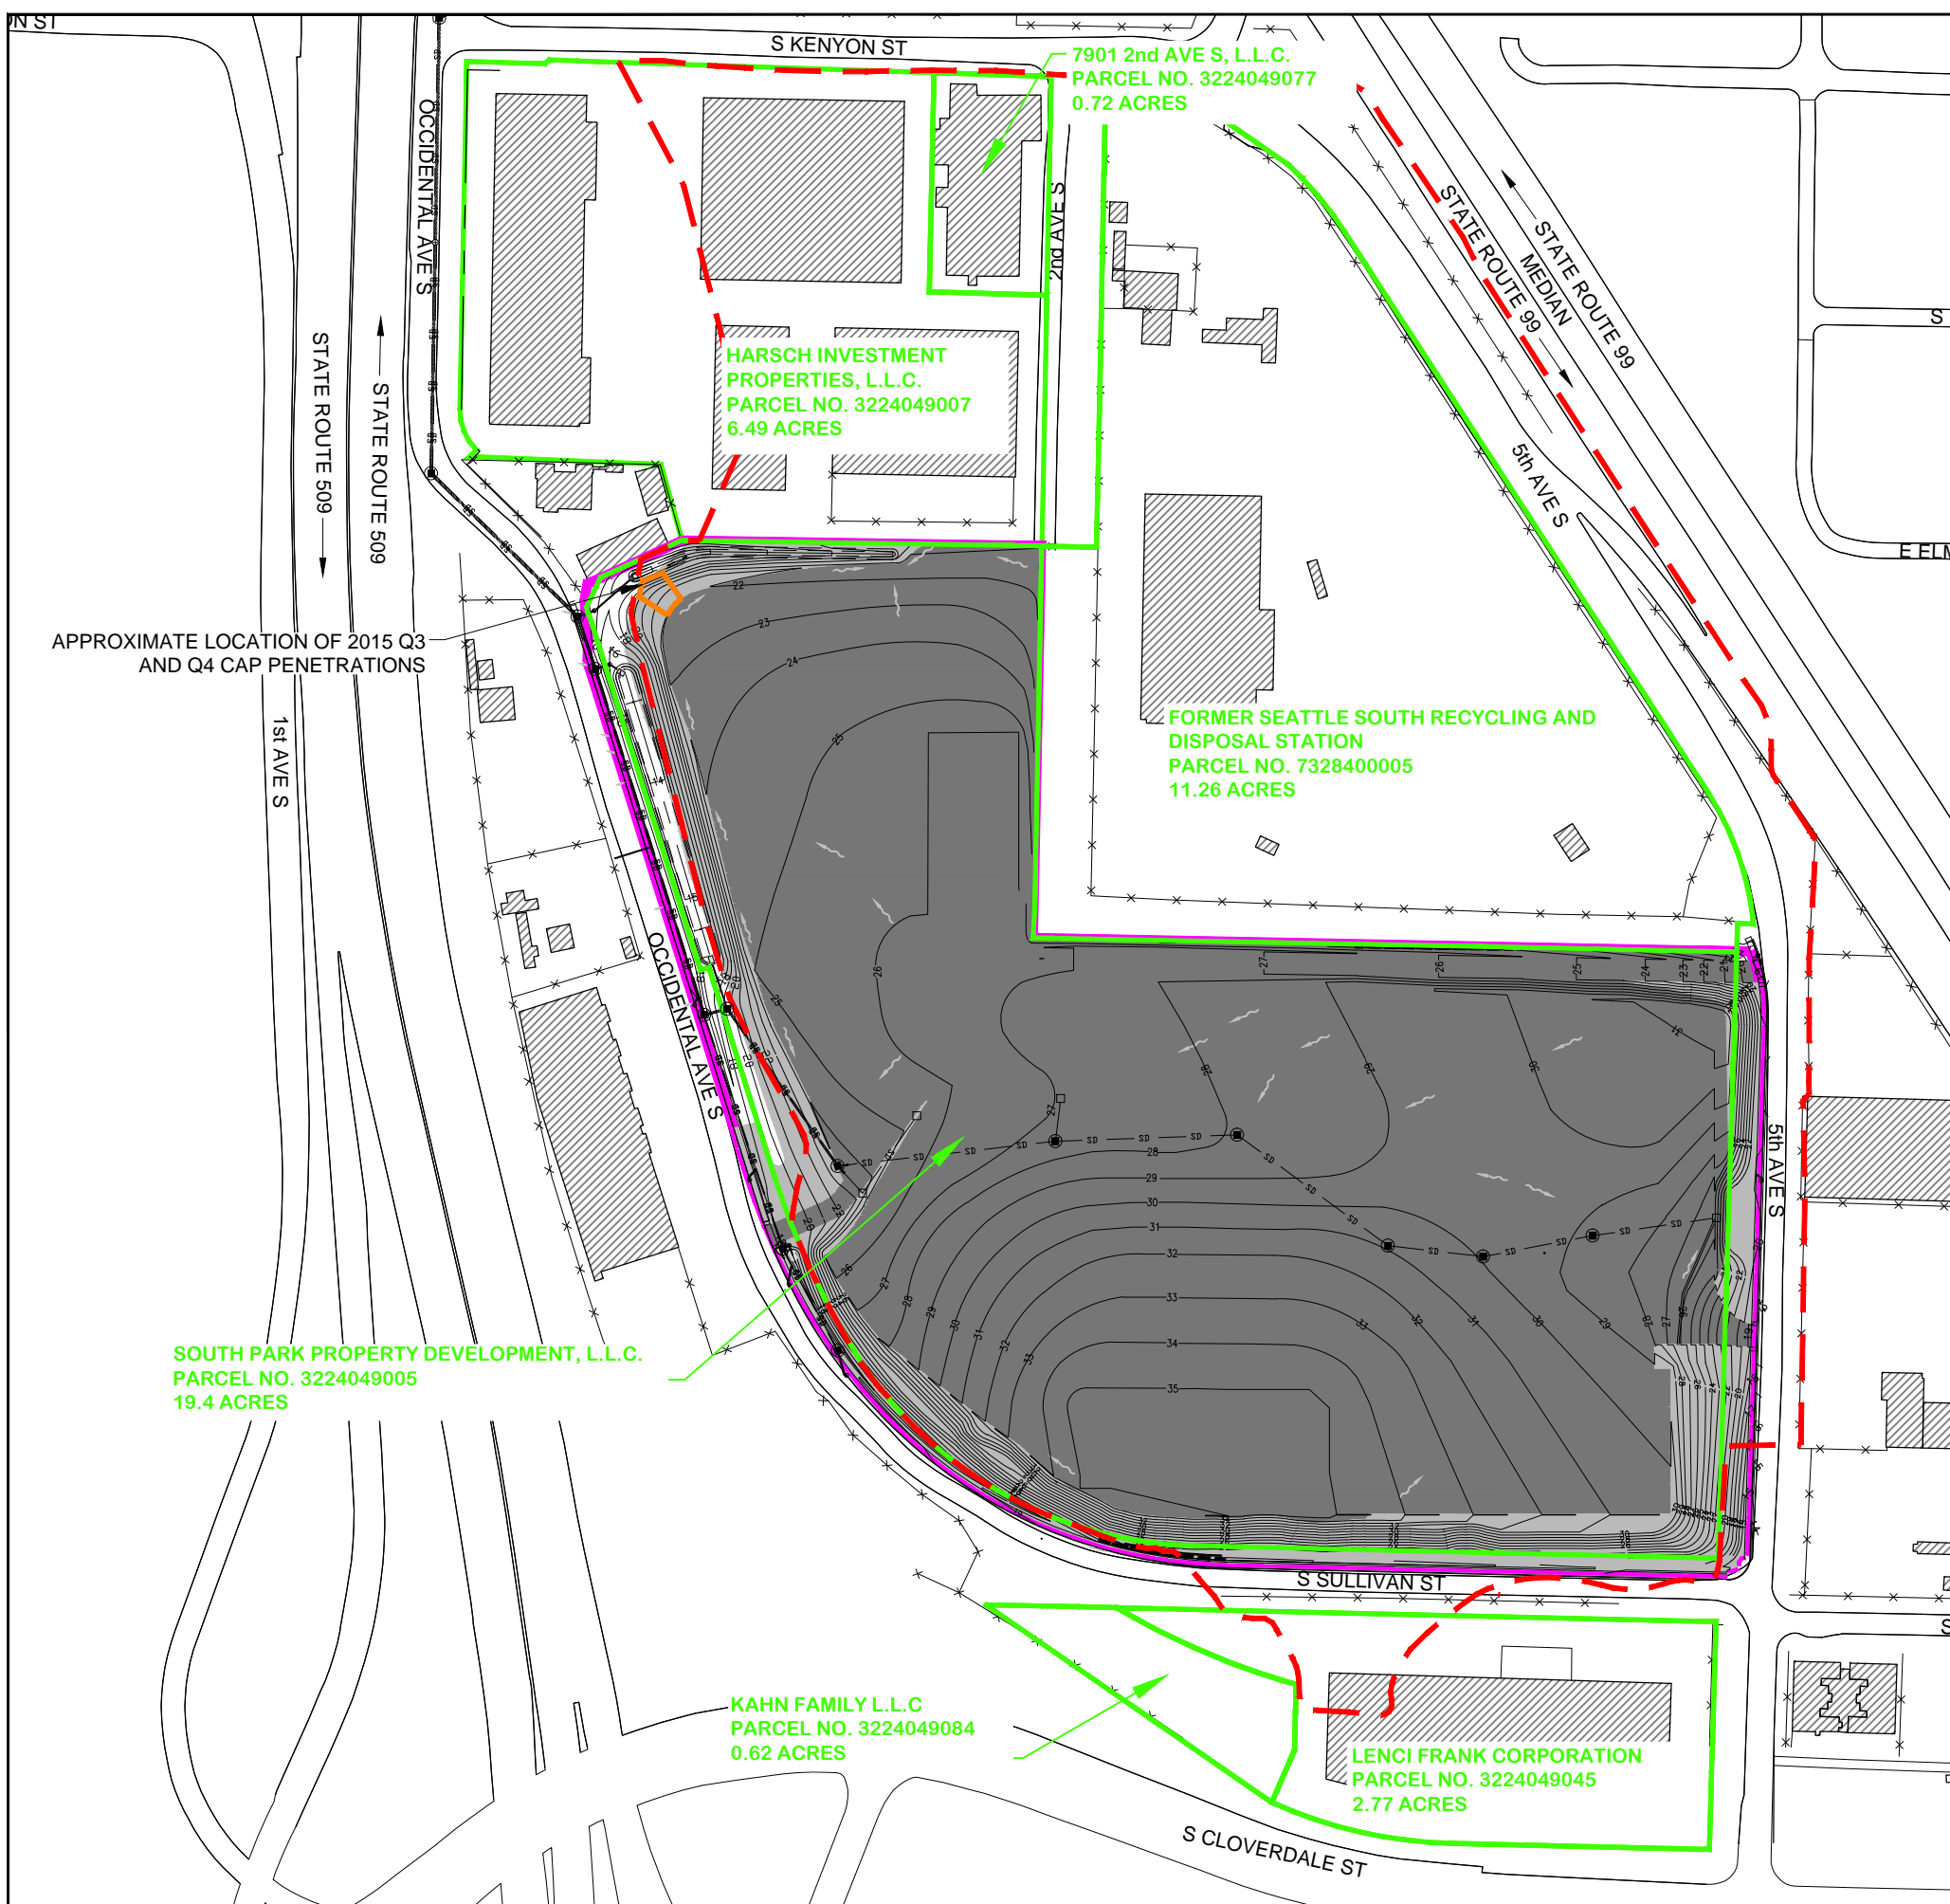
FIGURE 2
LANDFILL CAP
SPPD PROPERTY, SOUTH PARK LANDFILL SITE
SEATTLE, WASHINGTON

The third quarter 2015 inspection was performed on July 10, 2015. Minor erosion of soil covering the low-permeability membrane was observed in some areas upslope of the northern stormwater bioswale. Runoff from the asphaltic concrete cap flowing through breaks in top-of-slope curbing and onto the low-permeability membrane cap was observed to be initiating erosion. The erosion resulted in penetrations of the low-permeability membrane cap that were classified as Type C

The fourth quarter 2015 inspection was performed on October 10, 2015. Erosion of soil covering the low-permeability membrane was observed upslope of the northern stormwater bioswale in areas adjacent to the parking lot curb cuts. The soil erosion exposed the low-permeability membrane, but no solid waste was visible. The erosion resulted in penetrations of the low-permeability membrane cap that were classified as Type B Penetrations². On October 18, 2015, repairs were completed in these areas with new sod and biodegradable mesh screening. Adjacent curb cuts were filled with concrete grout to limit future soil erosion. No other maintenance issues were observed during the fourth quarter 2015 inspection.

APPROXIMATE LOCATION OF 2015 Q3 AND Q4 CAP PENETRATIONS

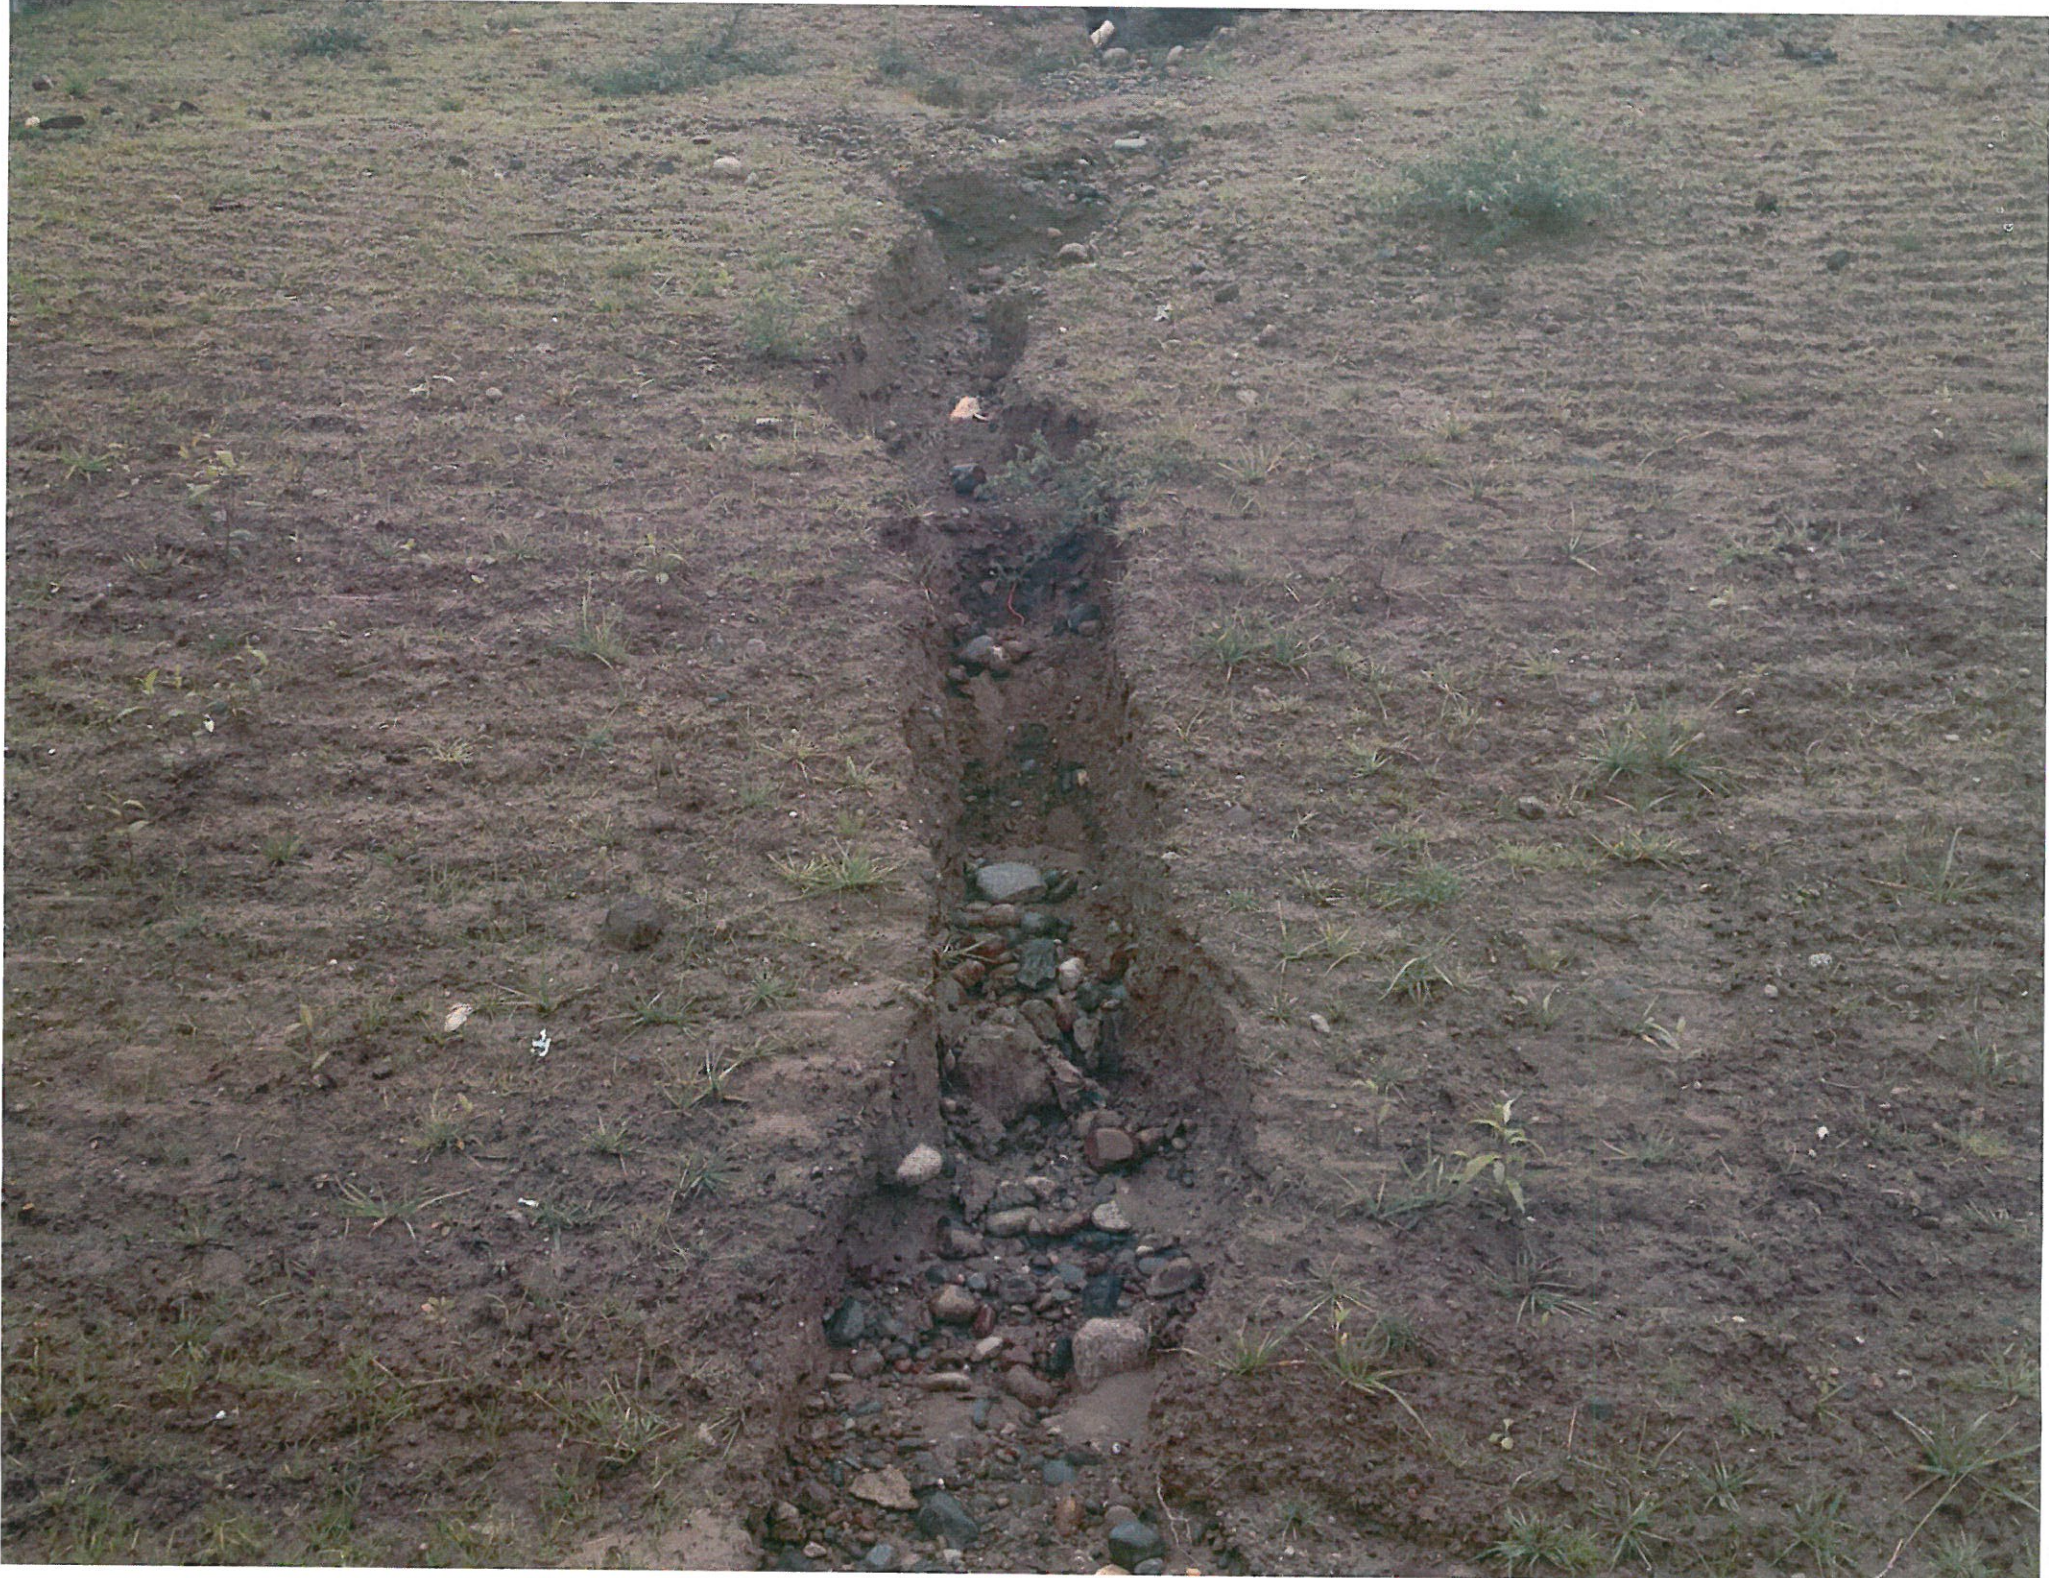
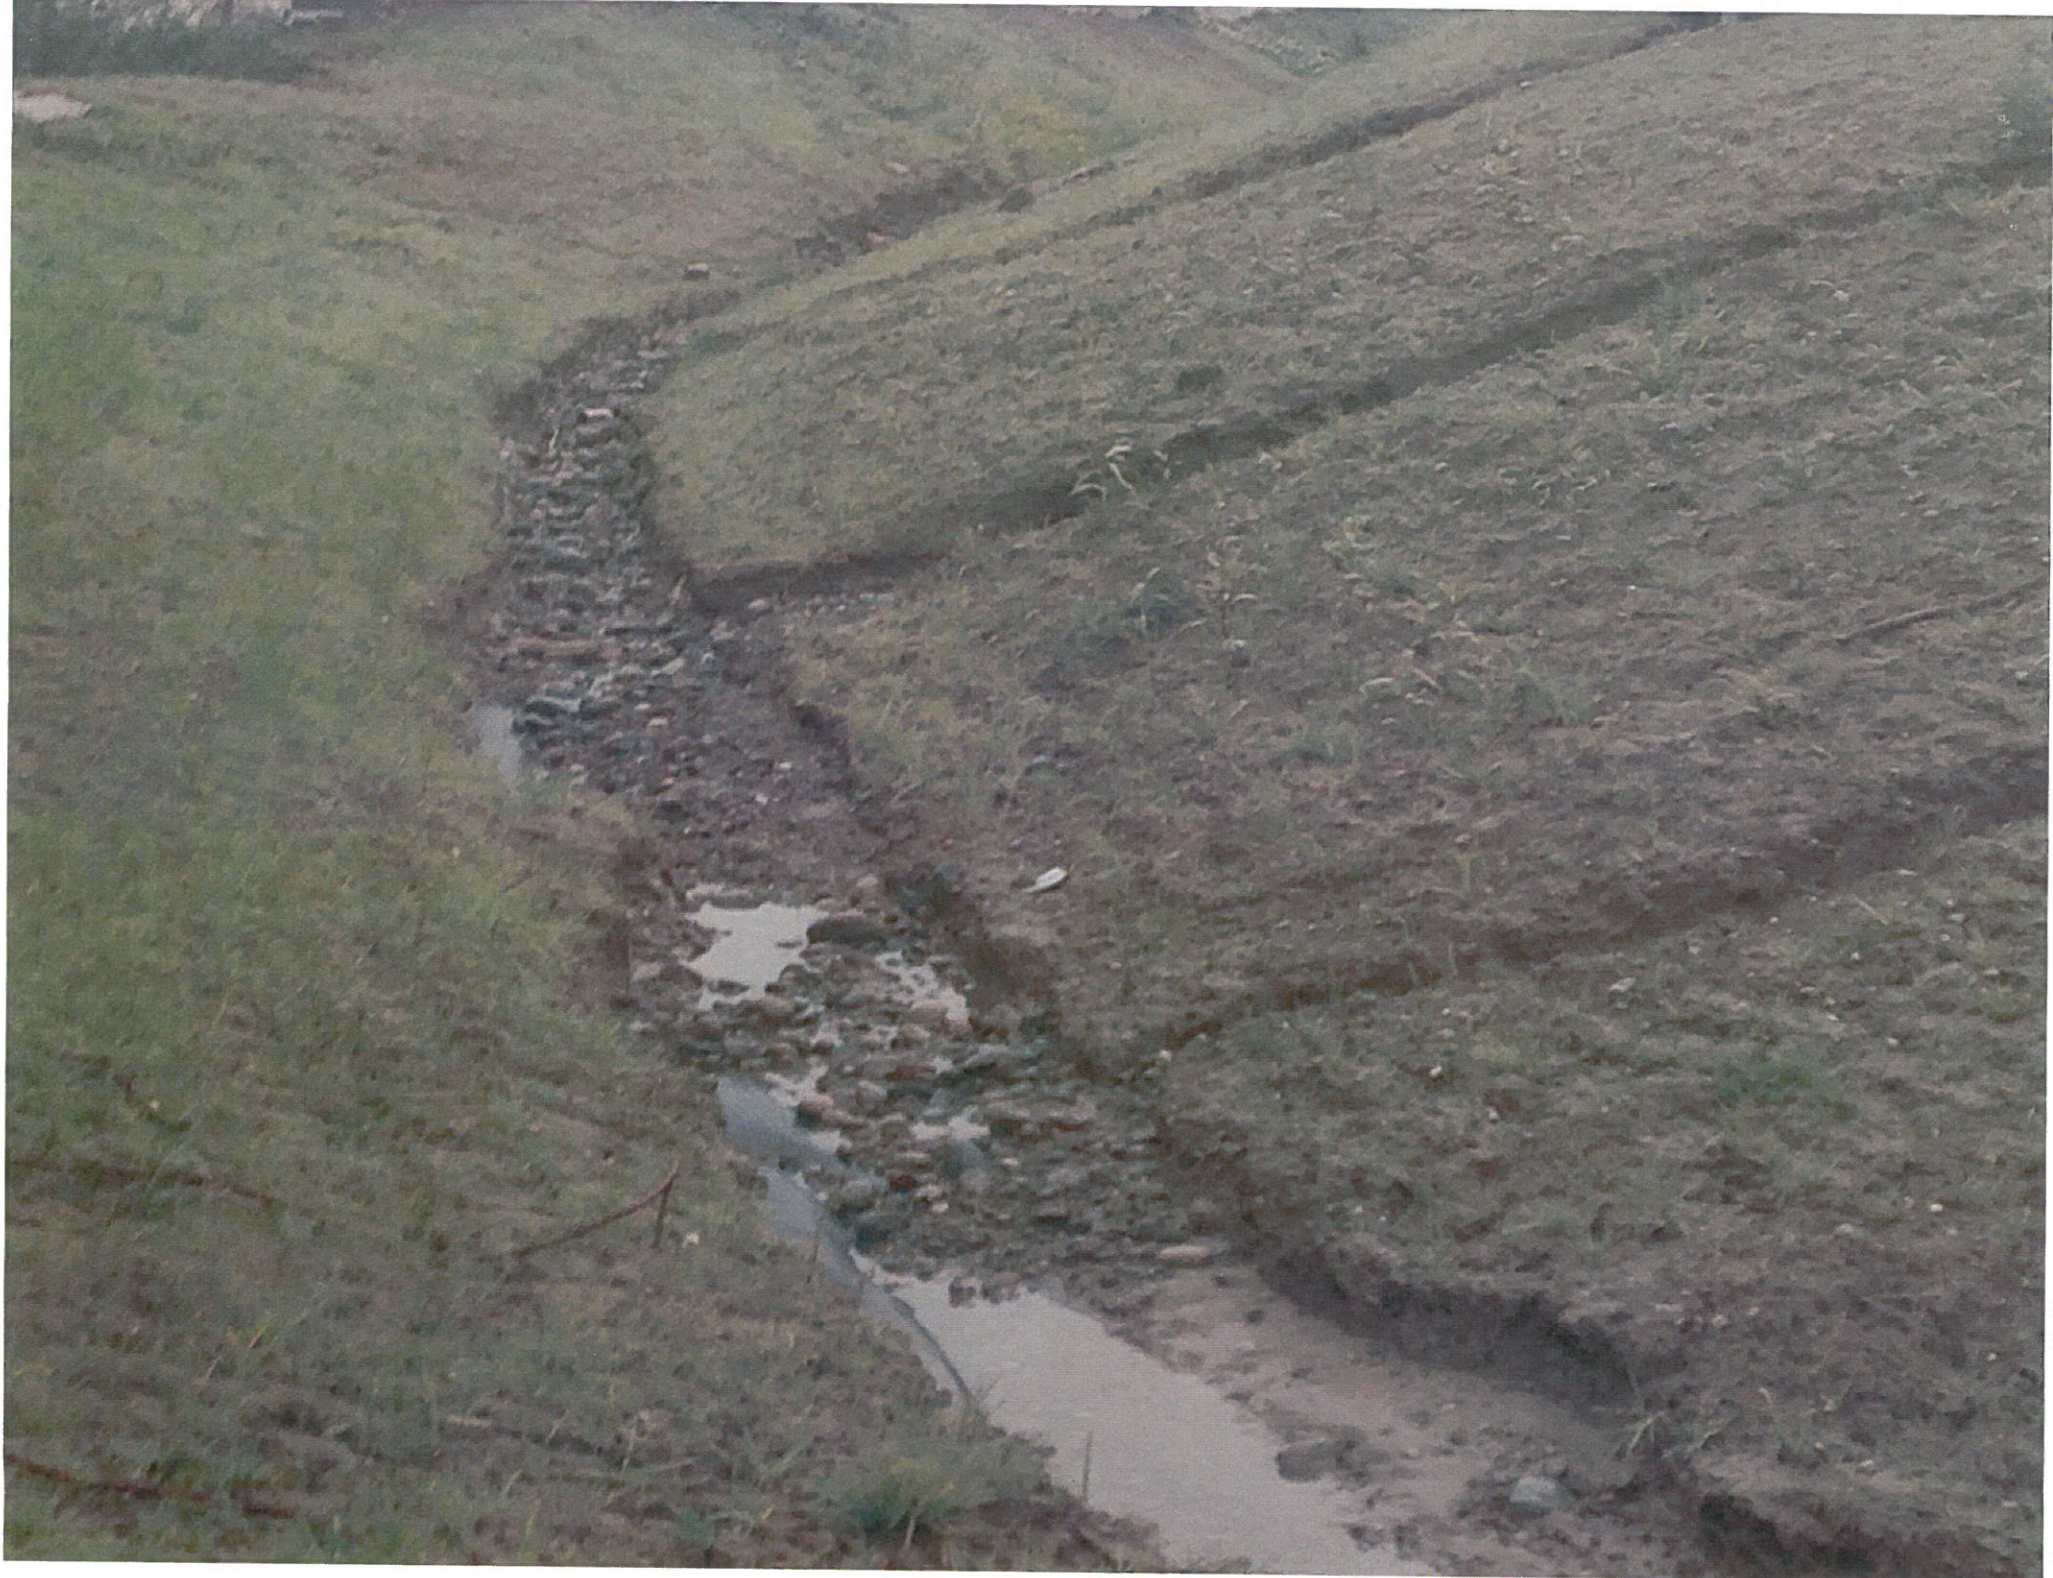
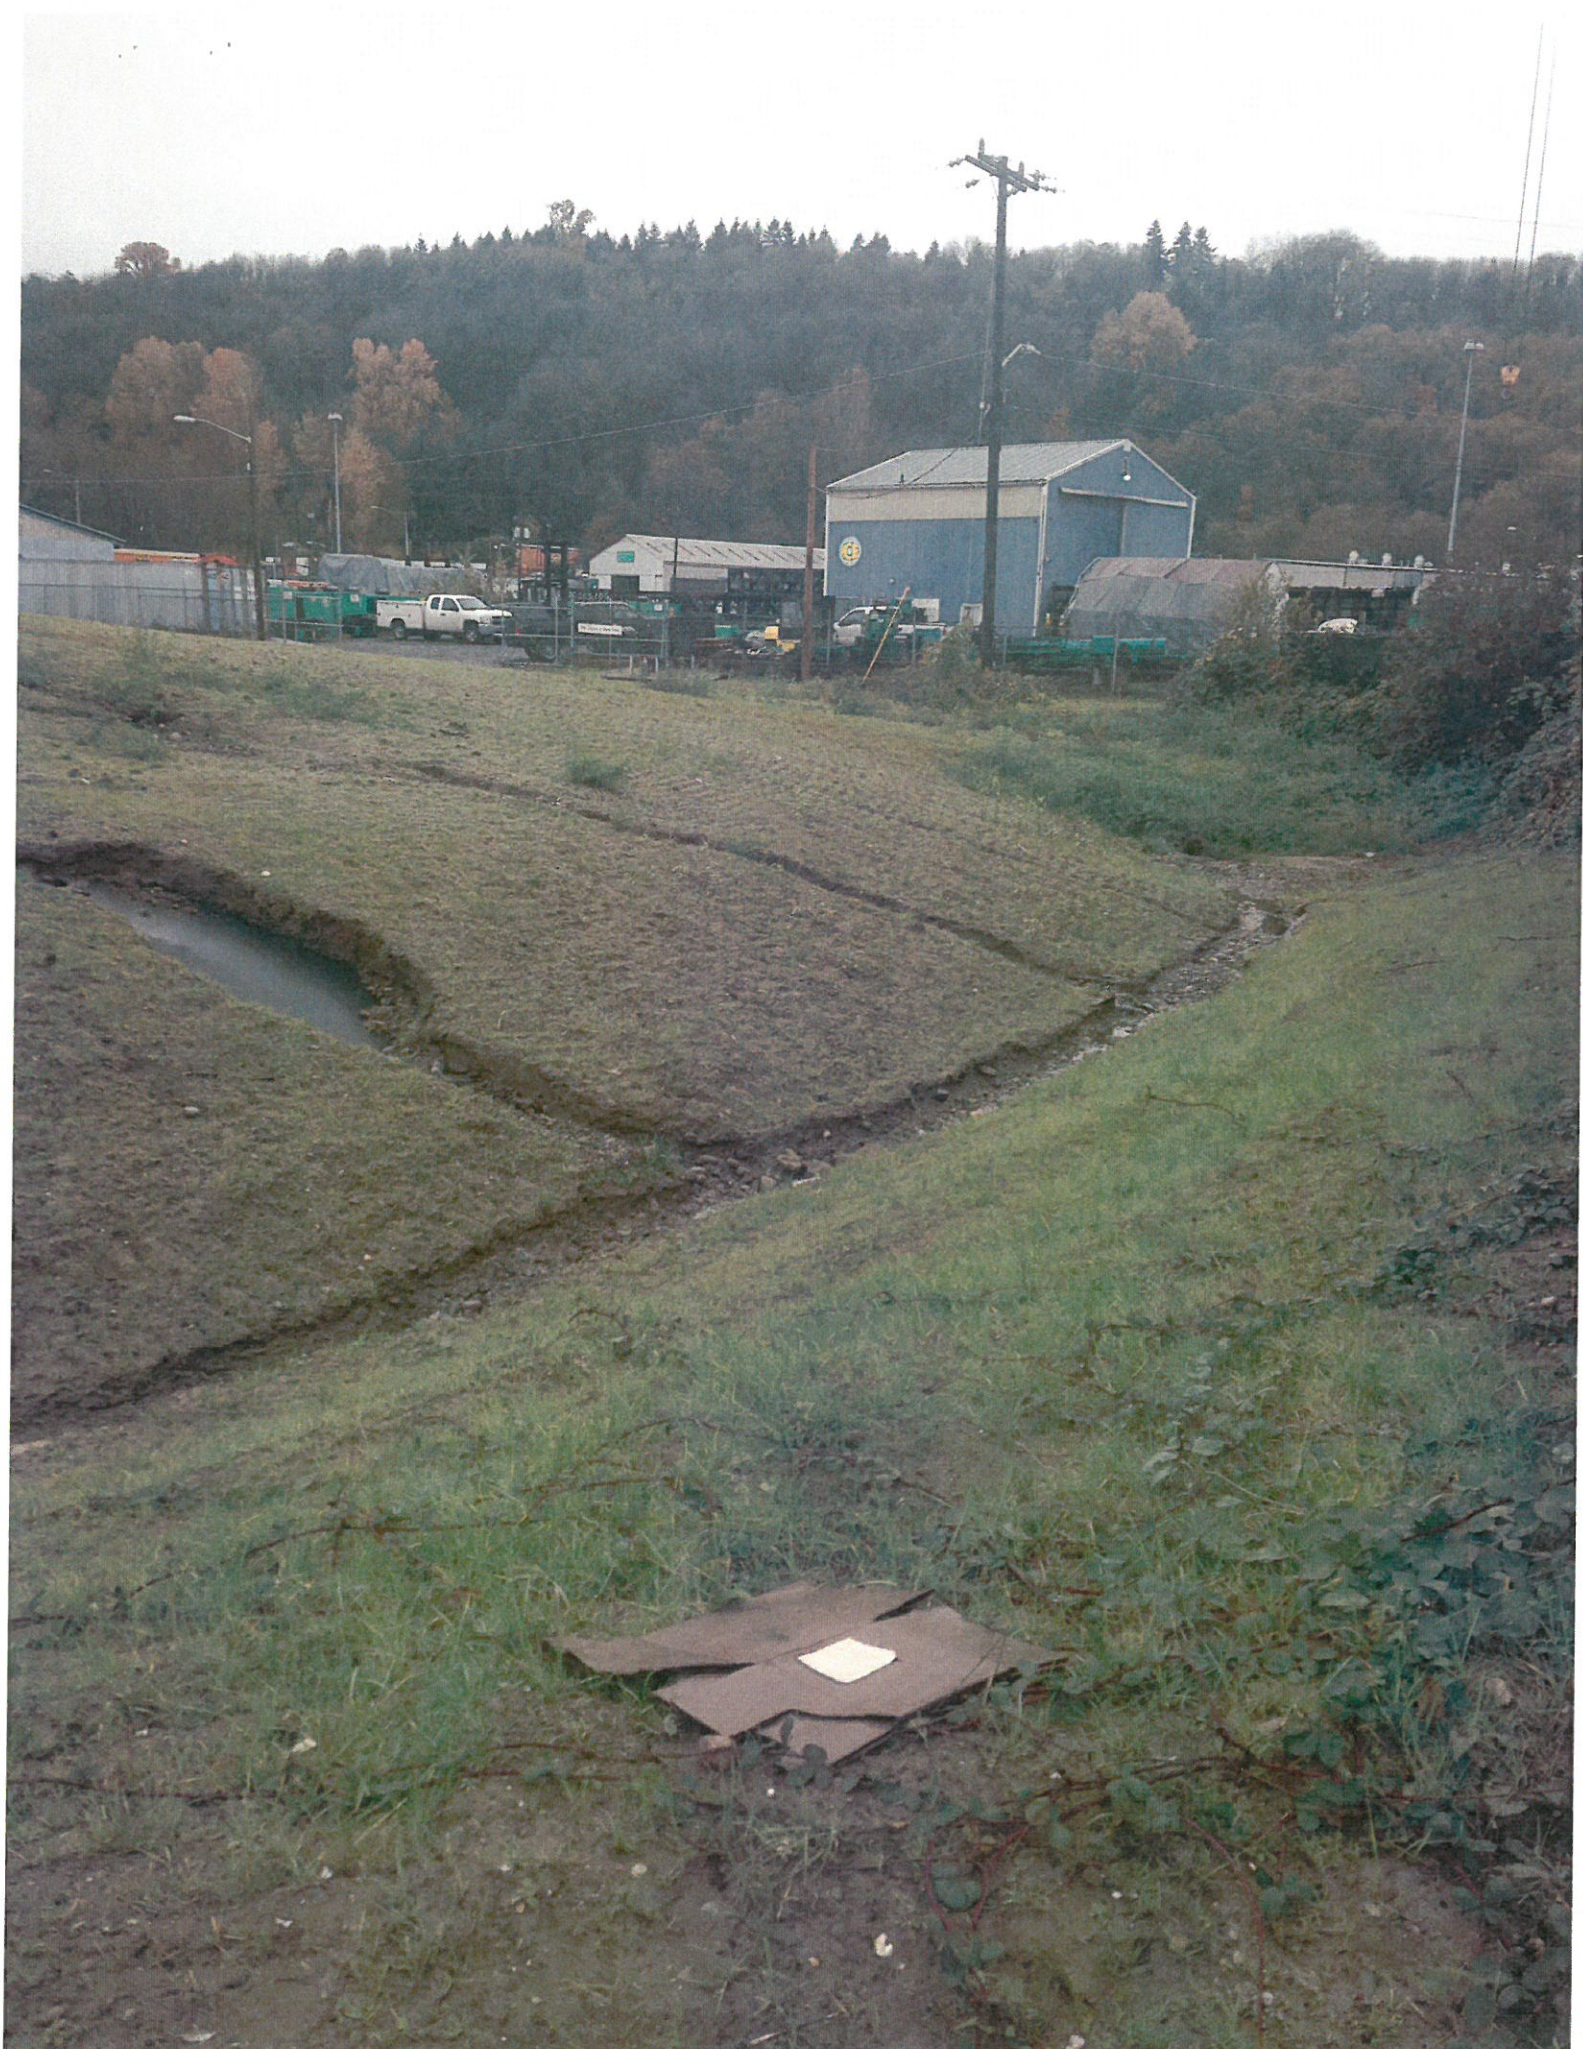
NW corner soude is showing signs of
water / soil erosion

~~Type A~~ Type B RPD

please repair The soil erosion that
has accrued @ The NW corner storm
water swale, dirt needs to be placed
Back and plan new grass as per site drawings.
spec.
