STATE OF WASHINGTON
DEPARTMENT OF ECOLOGY
Northwest Regional Office • 3190 160th Ave SE • Bellevue, WA 98008-5452 • 425-649-7000
711 for Washington Relay Service • Persons with a speech disability can call 877-833-6341

Re: Opinion on Proposed Cleanup of the following Site:

- **Site Name:** TD Auto Body & Repair
- **Site Address:** 1209 East Fir Street, Seattle, WA 98122
- **Facility/Site No.:** 2501
- **Cleanup Site ID No.:** 2666
- **VCP Project No.:** NW3194

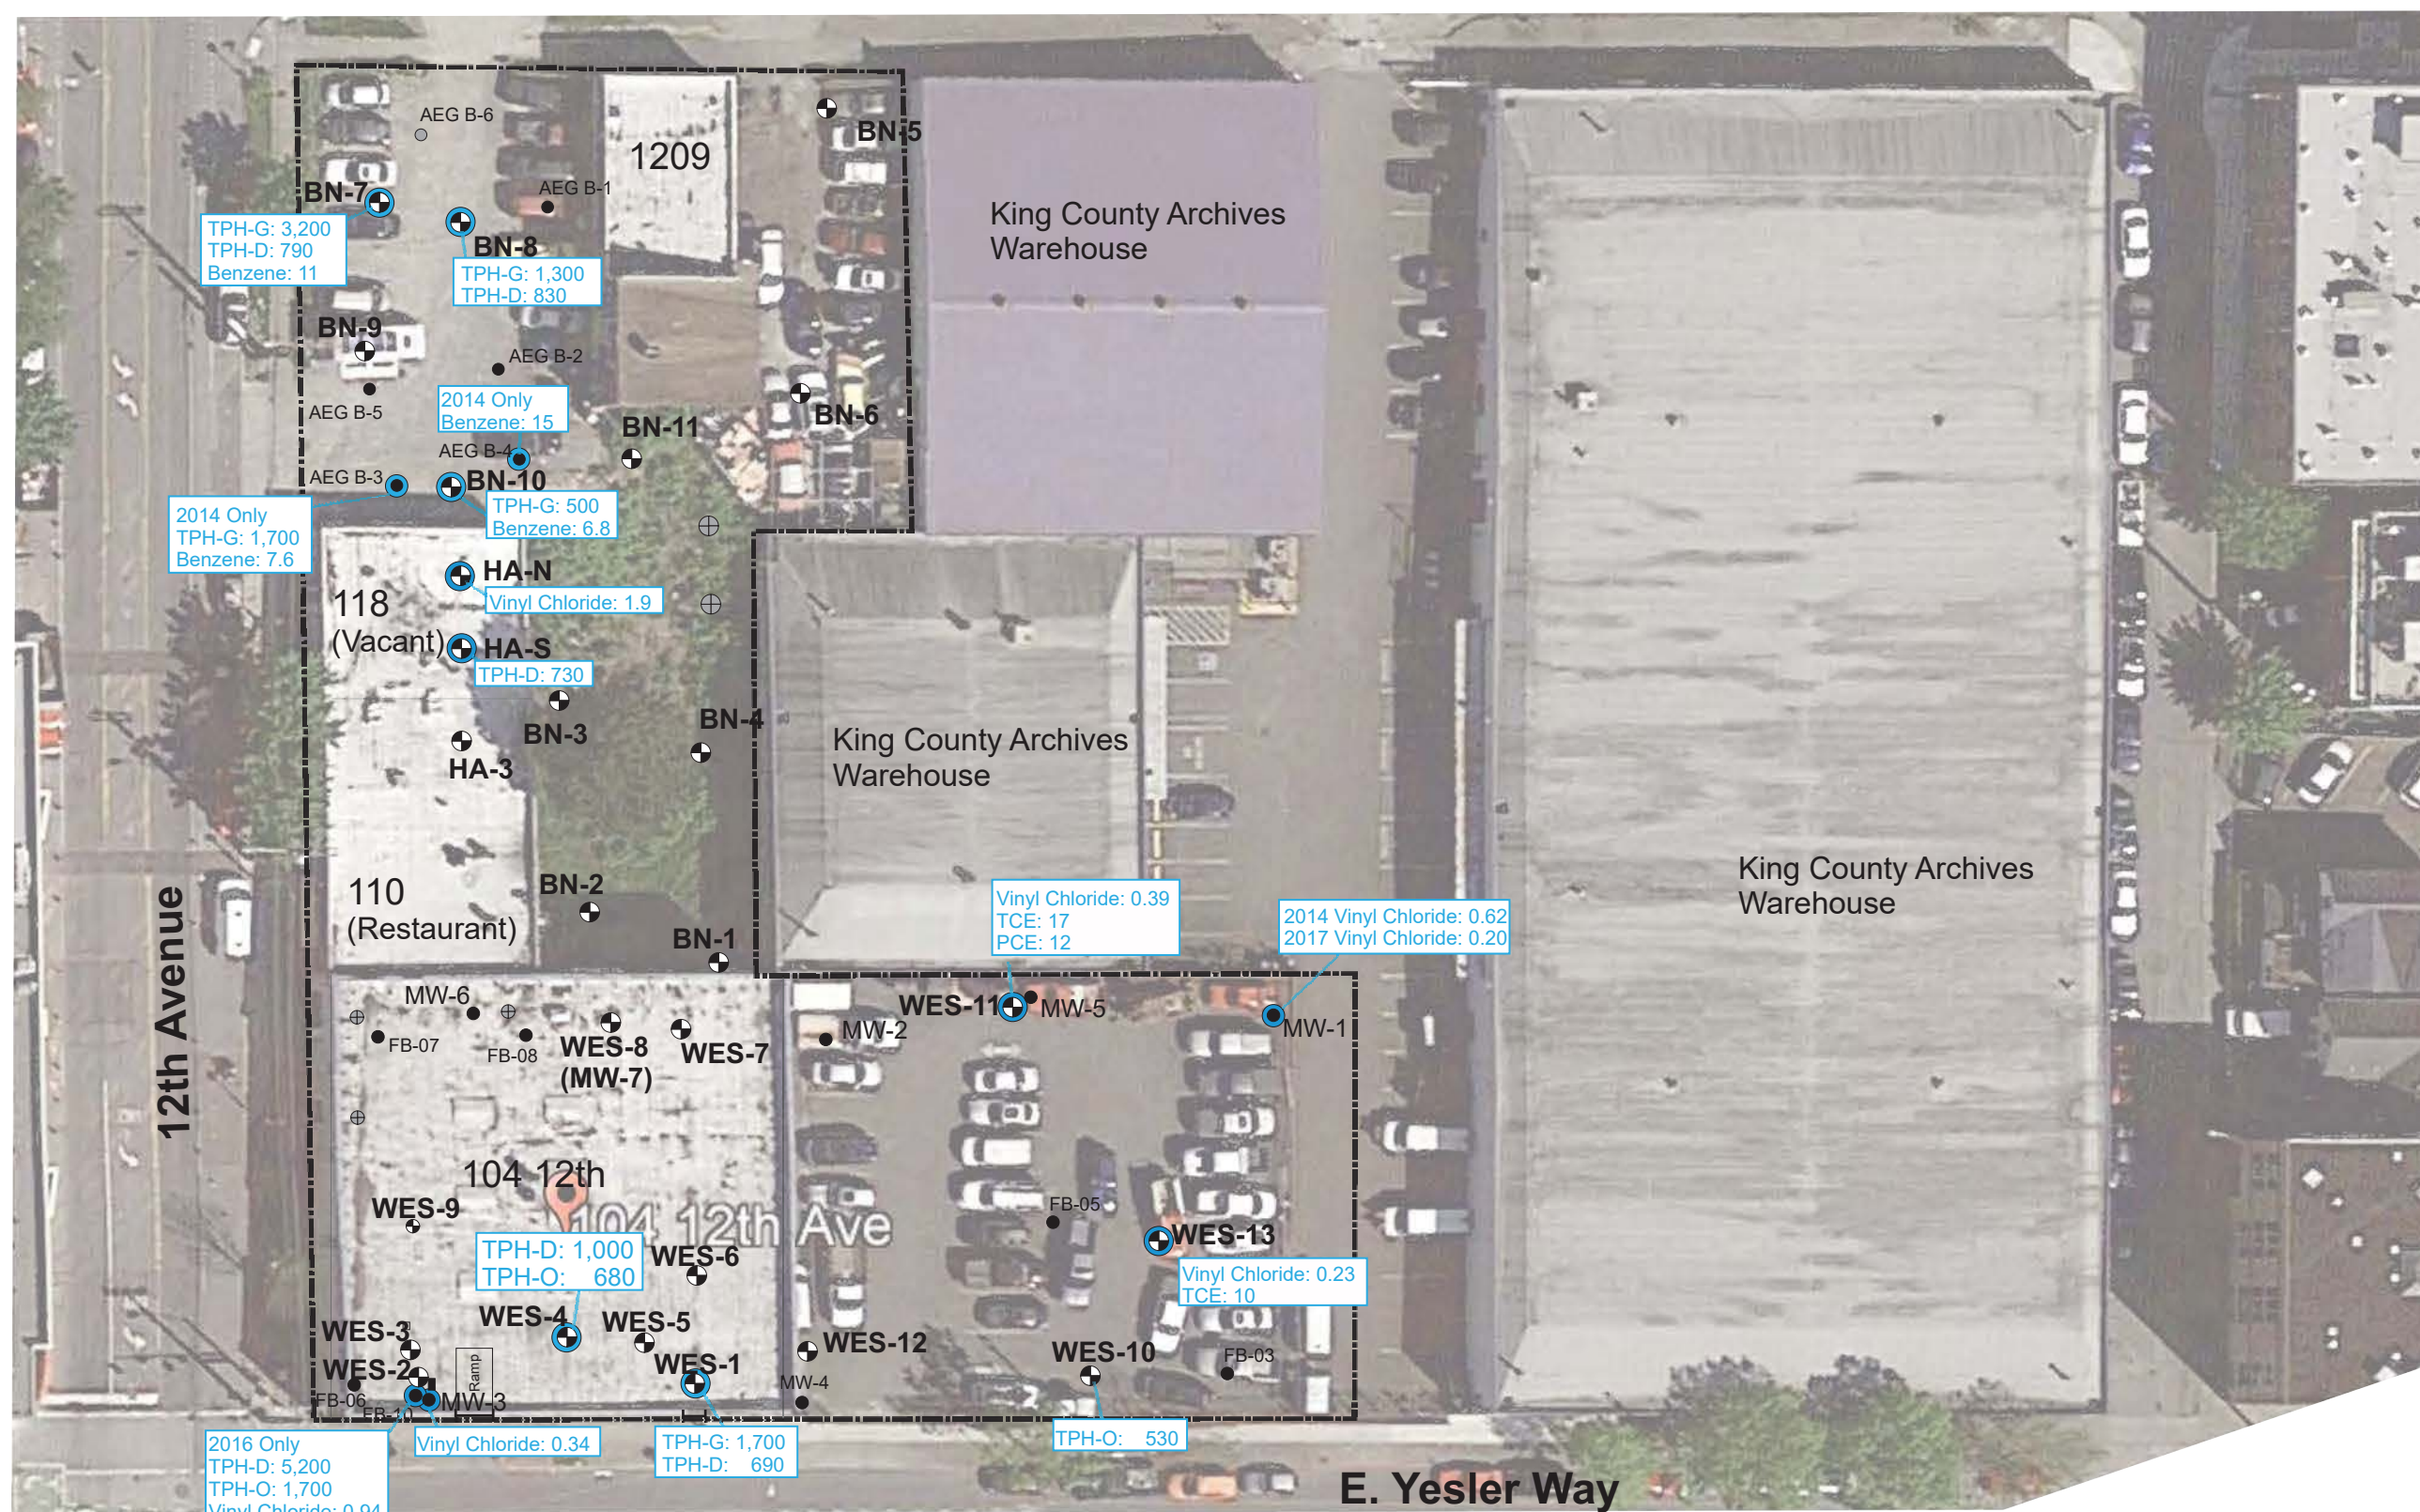
Figure 5 - Groundwater Sample Locations

- j. Table 2 in the 2017 *Phase I & II Environmental Site Assessment* does not include sample dates. Include sample dates for all data on all tables.
- k. Figure 5 in the 2017 *Phase I & II Environmental Site Assessment* includes inaccurate or missing concentrations of TPH-G, vinyl chloride, and/or TCE for sample locations AEG B-3, AEG B-4, MW-03, and MW-05. Update this information in your figures.

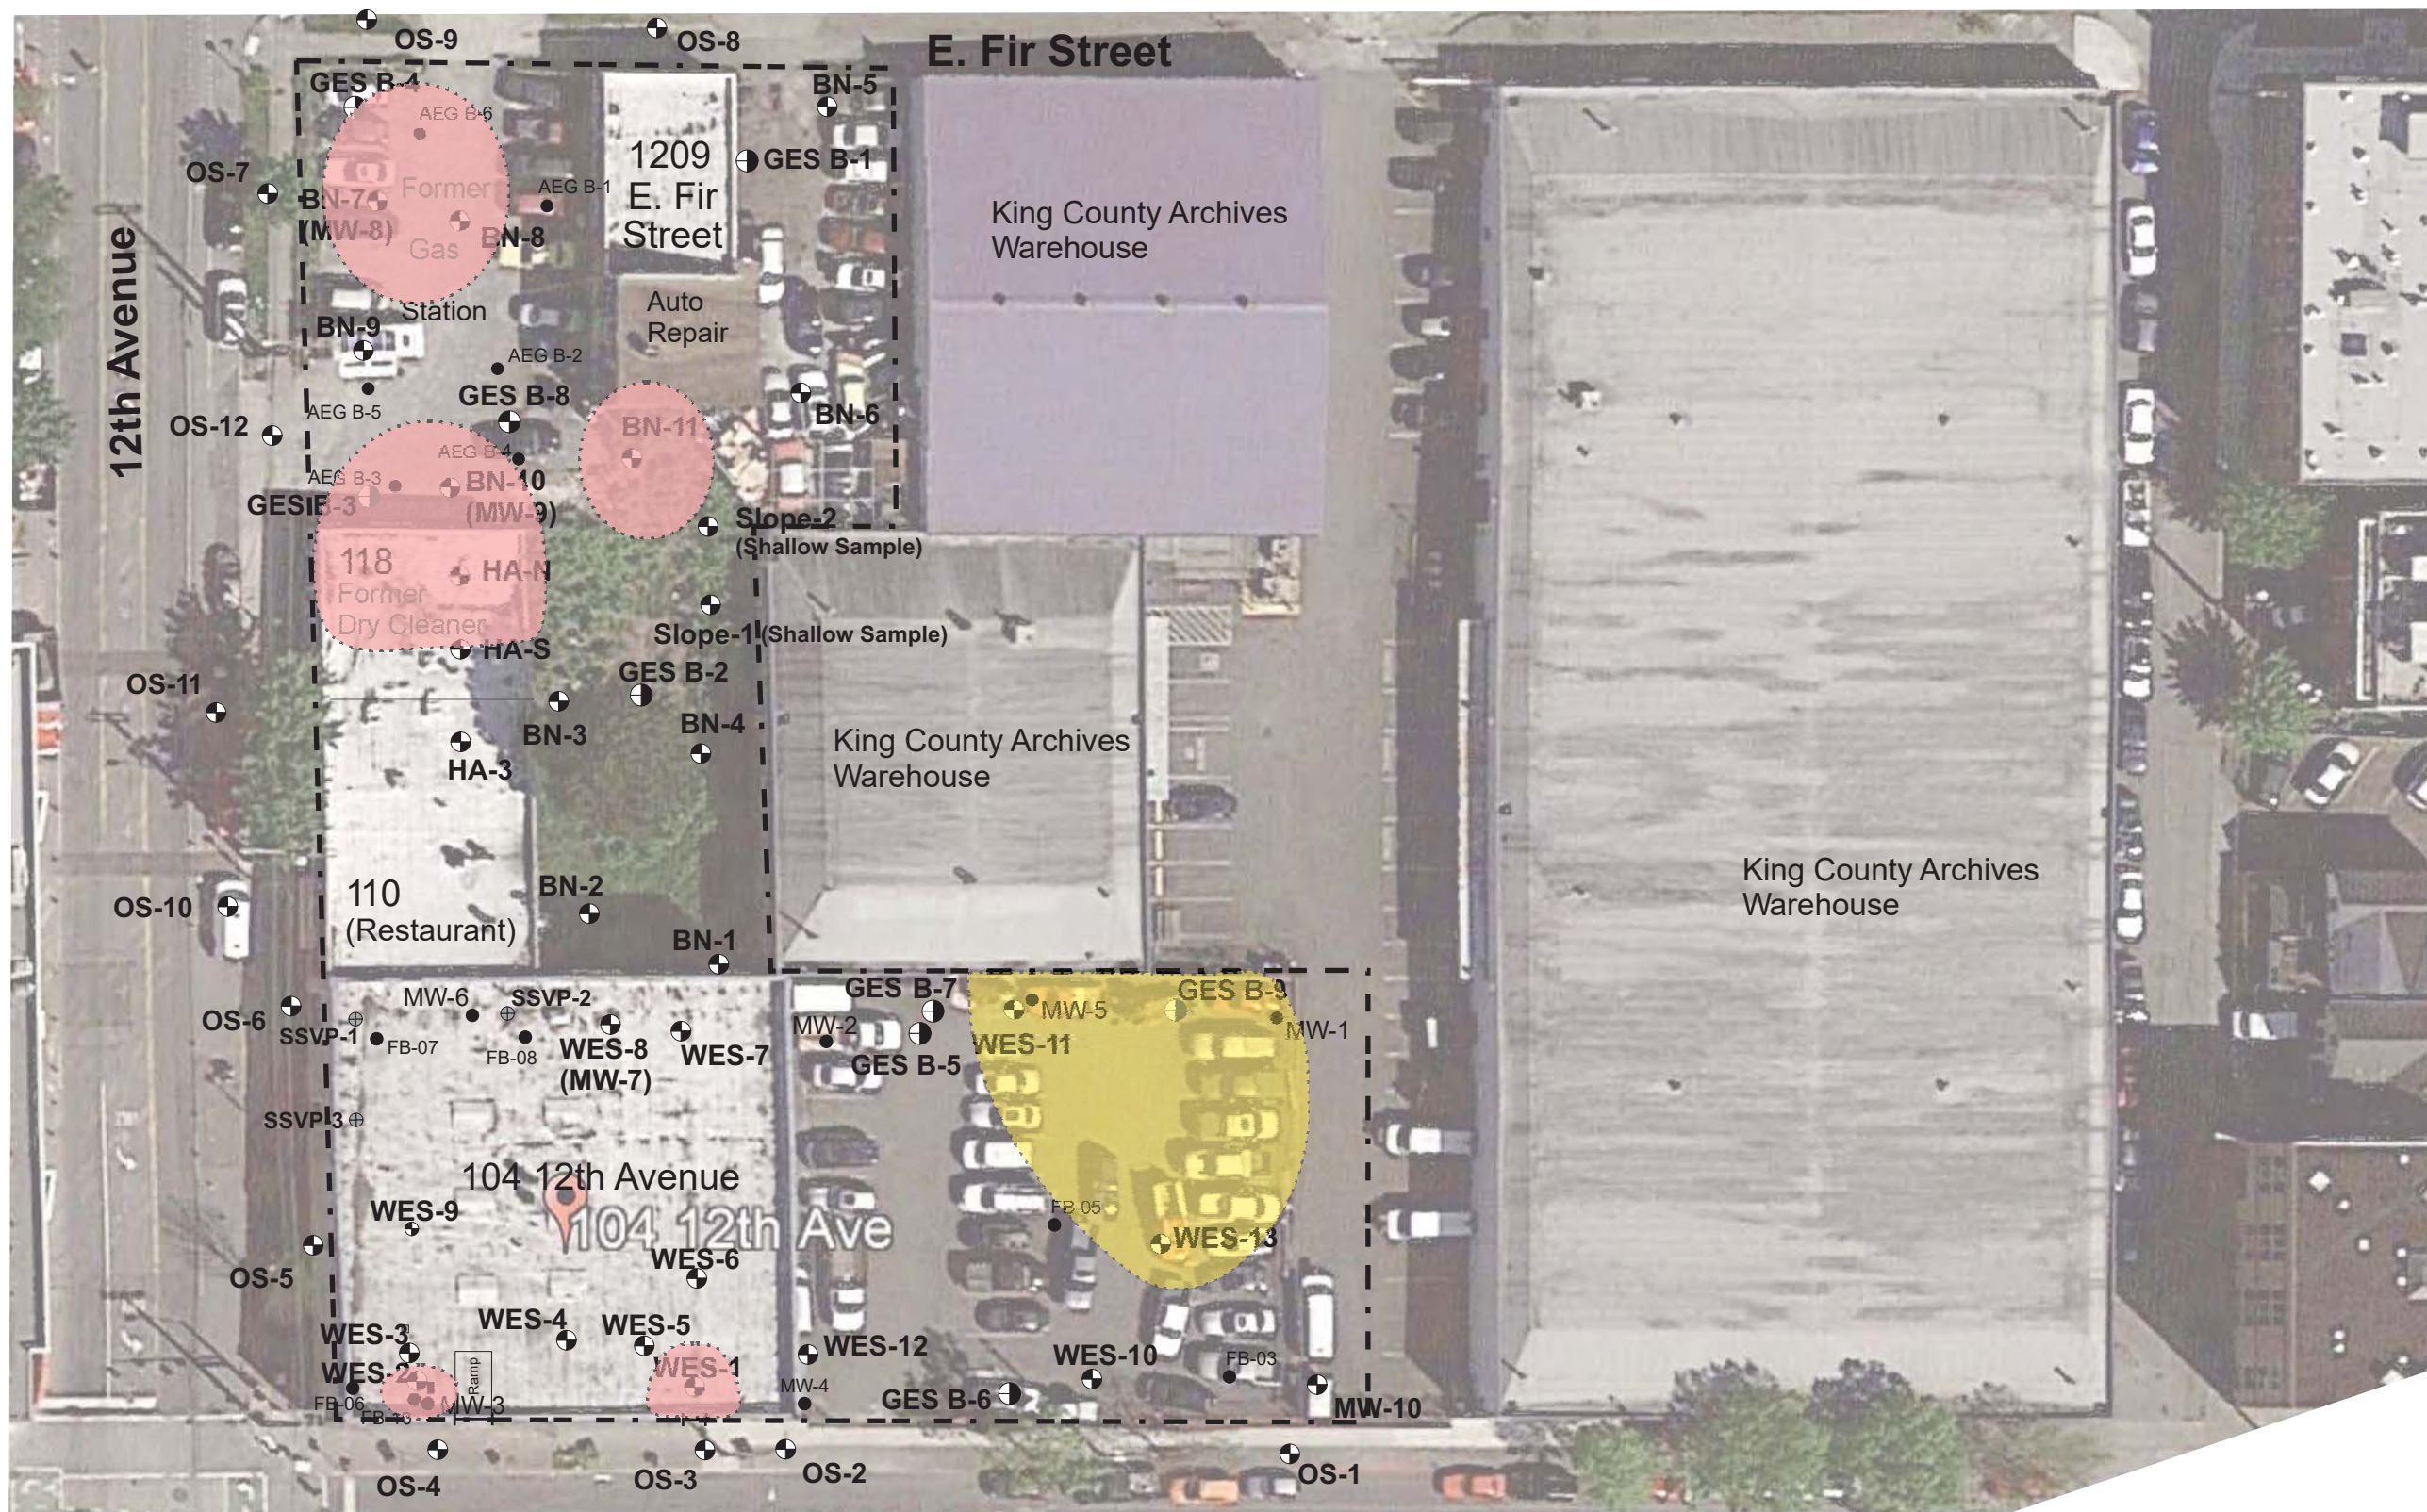
Figure 6 - Estimated Extent of Contaminated Soil and Groundwater

- i. Figure 6 depicts the estimated extent of contamination, but does not include any supporting analytical data, and as previously mentioned, there are data gaps in the southwestern and southeastern areas of the property. Figures should illustrate where contamination was and was not identified, supported by historical analytical data.

- ii. Figure 6, which depicts estimated extent of contaminated soil and ground water, does not highlight all the areas of petroleum contaminated ground water (for example, WES-4 and WES-10). Figure 6 also does not highlight all the areas of vinyl chloride-contaminated ground water (for example, MW-3, FB-10, and HA-N). Clearly depict all contaminated areas on your figure (based on all historical data), including petroleum and vinyl chloride-contaminated ground water and comingled plumes of both.
- iii. Figure 2 depicts some of the historical uses and features that could be sources of contamination. Also include on the figure the locations of the former gasoline station building, former or suspected underground storage tanks

Include all historical analytical data in your figures and data tables, including the 2014 and 2016 data by Farallon Consulting and Associated Environmental Group, LLC. Build upon existing figures by highlighting (via colors and/or symbols) samples that are above vs. below cleanup levels and, at minimum, include concentrations that have exceeded cleanup levels at any point in the past. Include ground water sample dates and soil sample depths, as applicable, in order to establish nature and extent of contamination.

(USTs), former remedial excavations, existing and former automotive repair facilities, former fertilizer manufacturer, former screen printing shop, oil/water separators, hoists, sumps, and any other potential sources.
