Hilton Hotel Parking
Garage

**Closure Services Related to
Hilton USTs
Seattle, Washington**

July 1998

**RE: CLOSURE SERVICES RELATED TO HILTON USTS,
SEATTLE, WASHINGTON**

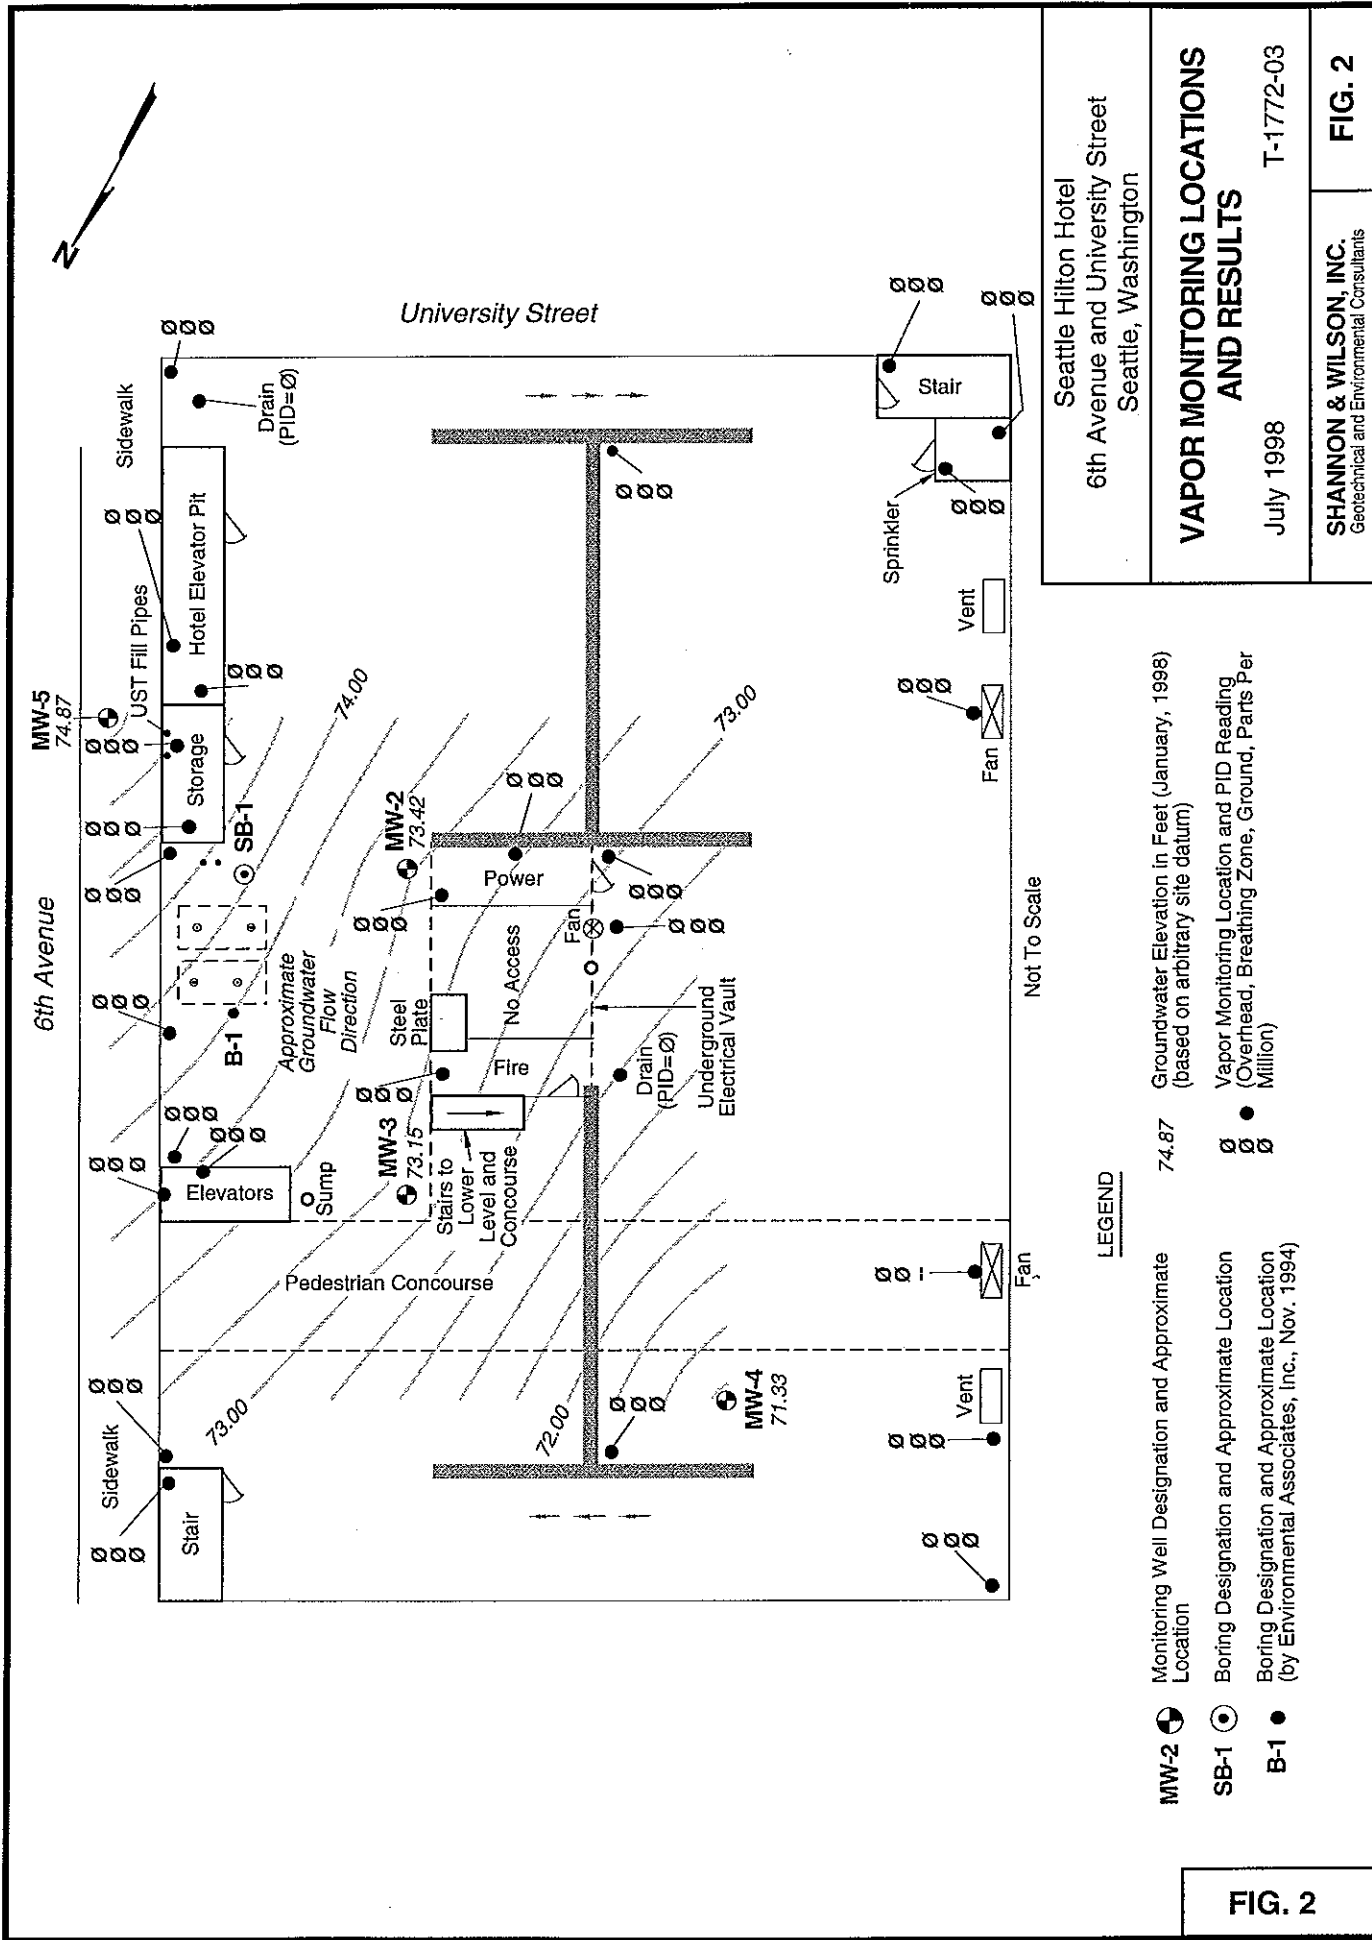
FIG. 2

Location	PID (ppm)
MW-2	159
MW-3	30
MW-4	0
MW-5	948
sump	0

PID measurements were also obtained on May 29, 1998, from representative areas of the lowest levels of the parking garage immediately above, or in contact with, subsurface soil. Measurements were collected from each location at ground level, within personnel breathing zones, and approximately 7 feet above the ground. No volatile organic compounds were detected during monitoring. Measurements were collected from all four corners of the parking garage, in lower areas where vapors may collect, stairwells, the pedestrian concourse, two elevator pits (one for the hotel and second for the pedestrian concourse), and in several rooms accessible only by hotel personnel. Access to restricted areas was performed in the presence of Mr. Jeff Jensen, chief hotel engineer. PID measurements were not collected from the garbage collection area because it is not enclosed within the garage and is always open in the direction of the alley. Locations where air monitoring data were collected are shown on Figure 2.

These were not opened and monitored, also due to the unknown source of the material collecting within them. No other underground conduits were observed during monitoring and discussions with Mr. Jensen. Locations where monitoring data were collected are shown on Figure 2.

Based on PID measurements, interviews, and review of hotel plans, it does not appear that vapors are posing a risk to human health. While elevated PID measurements were detected in the monitoring wells, the results serve as a worst case and are probably a result of the benzene detected in the groundwater. As expected, the upgradient well, which contains free product, has

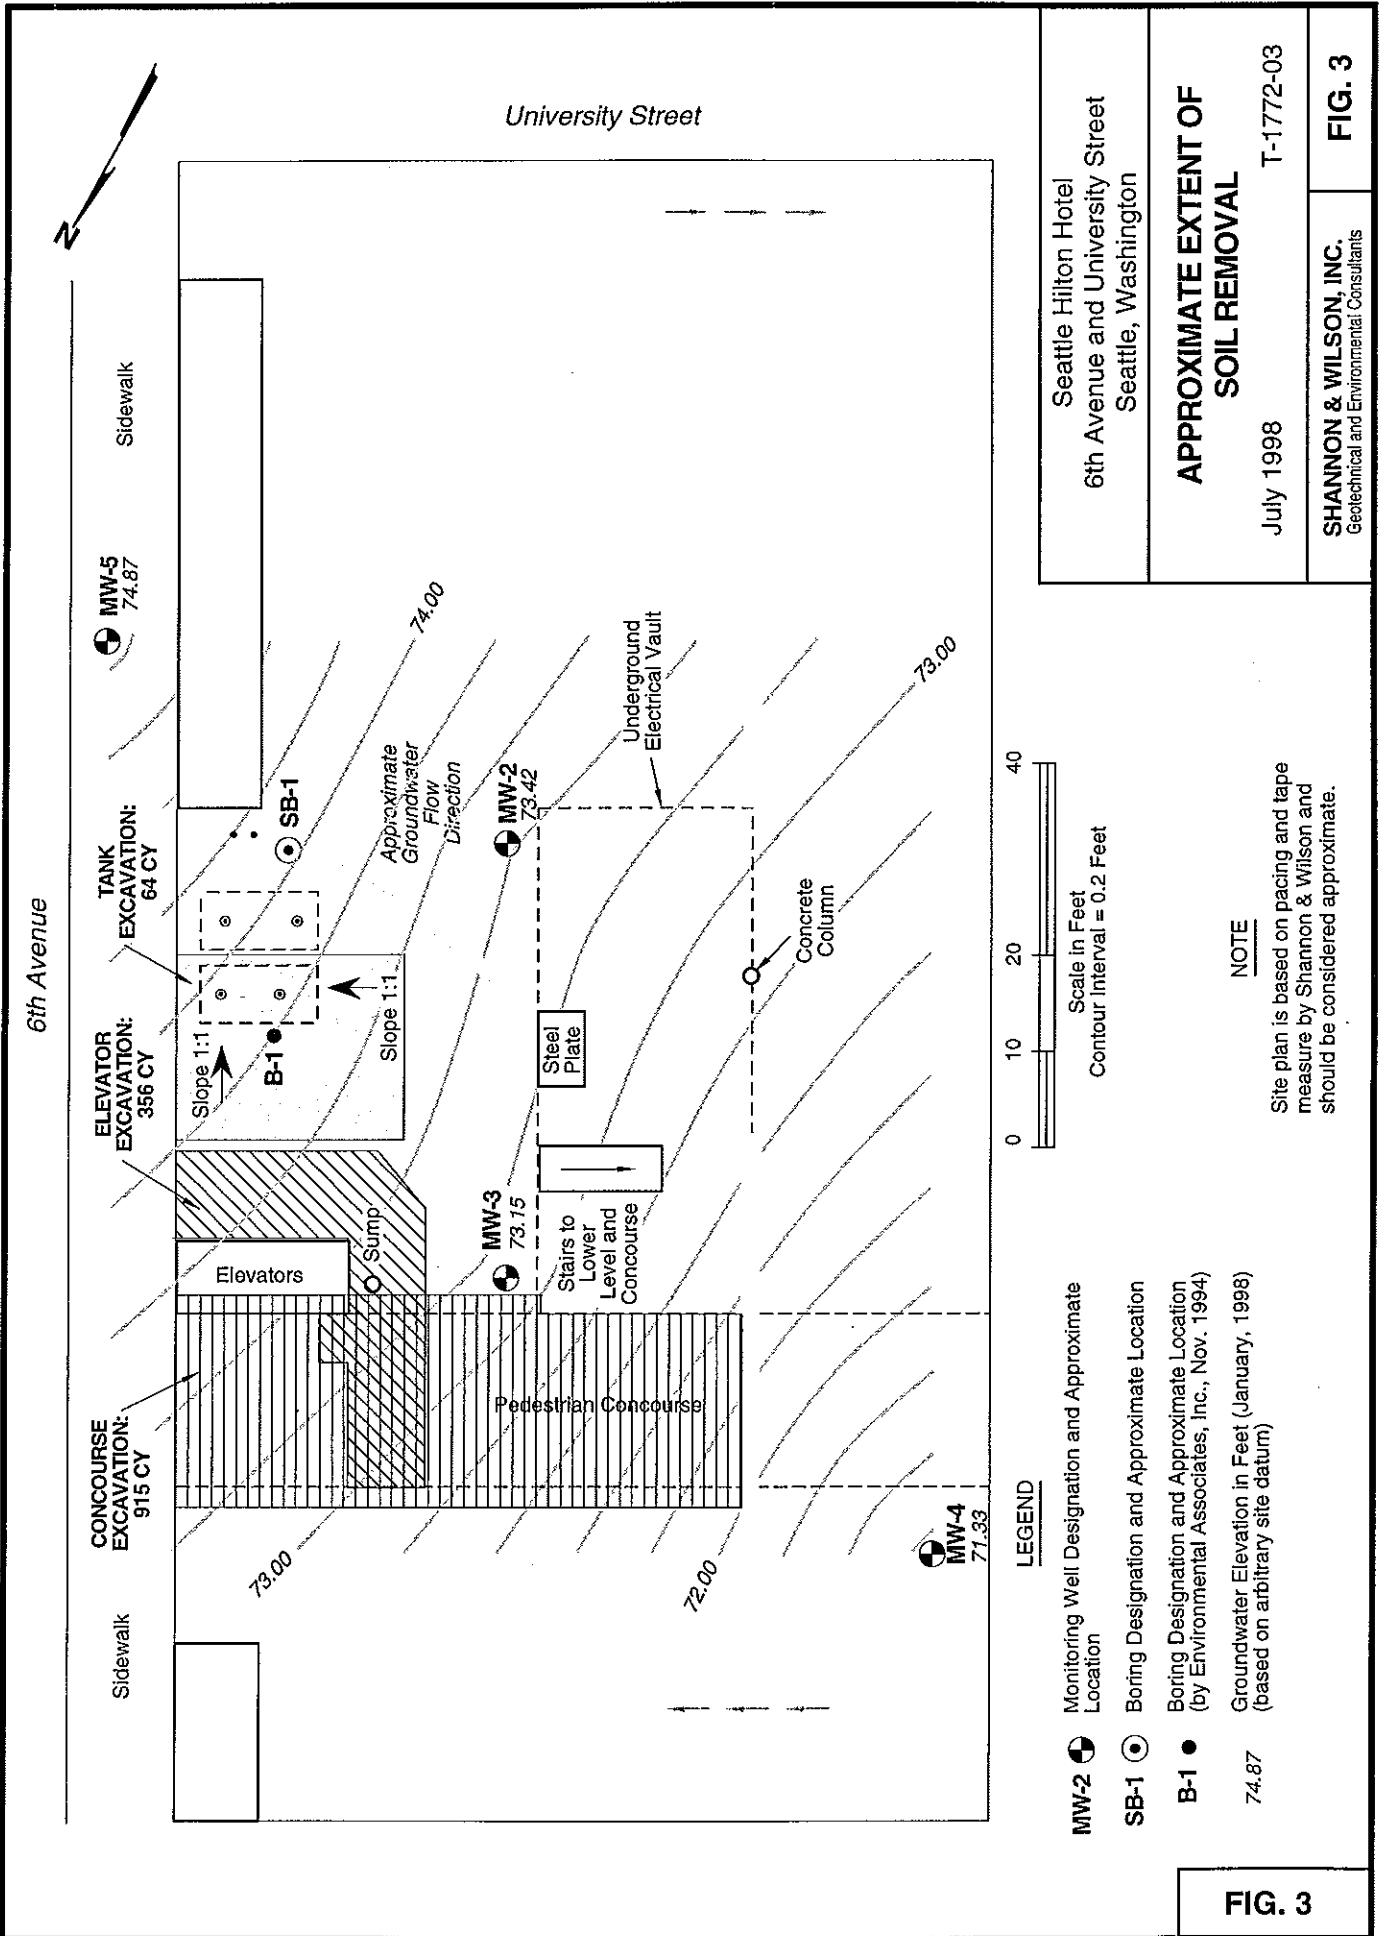
Limited residual soil contamination is present beneath the site. The exact extent of soil contamination is not known, although the extent is known to be limited, based on borings. Therefore, our calculations are based on the assumption that soil contamination does not extend past 25 feet southwest of MW-3. The approximate extent of contaminated soil removed is presented in Figure 3.

Based on our calculations, a majority of the contaminated soil has been removed from the site during previous site work. Any remaining soil contamination is most likely in the immediate area of the tanks. Current investigation data indicate that soil contamination does not extend downgradient to MW-2 or MW-3. The volume may be on the order of 300 cubic yards.

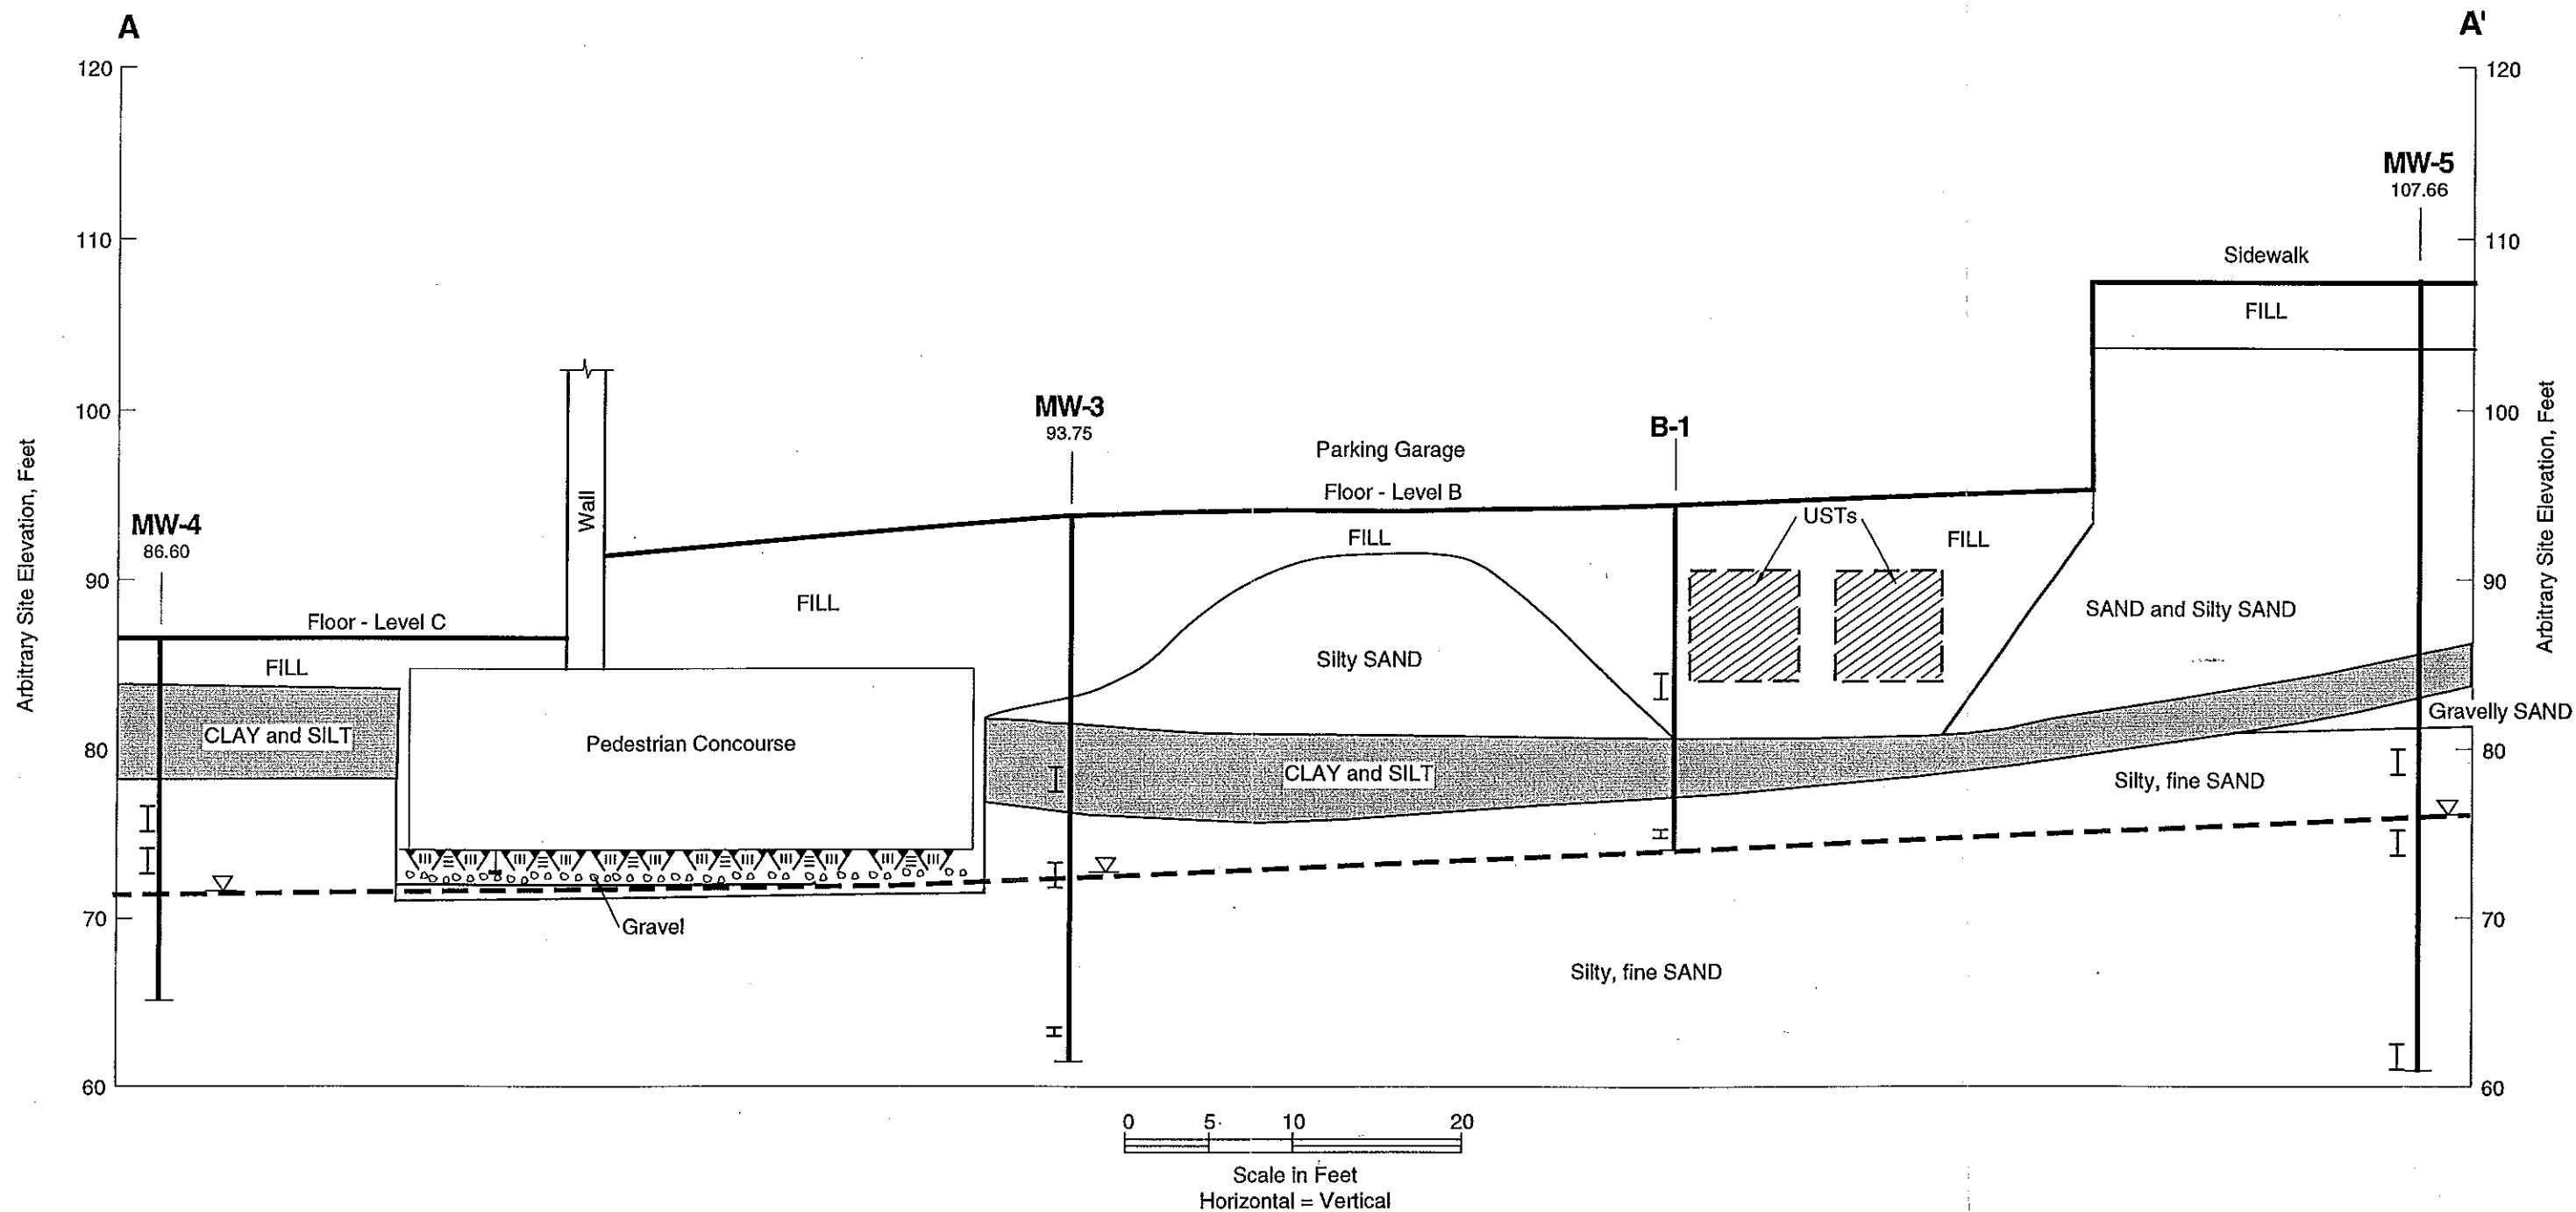
FIG. 4

- ▶ Migration to groundwater is retarded by a hard silt/clay layer. Figures 4 and 5 are cross sections through the UST area. As shown on the cross sections, the USTs are bedded in sandy fill that overlies a hard silt/clay layer. The native soil adjacent to the UST area is sand. The silt/clay layer appears to be continuous beneath the site and the street and is 3 to 6 feet thick. Soil samples were collected and analyzed from above and below the silt/clay layer at locations as shown on Figures 4 and 5. A sample from above the silt/clay layer at B-1 (drilled in 1994) did have gasoline contamination at 2,000 mg/kg. At MW-2 and MW-3 (drilled in 1998), samples from immediately above (and below) the silt/clay layer did not contain measurable concentrations of gasoline. The lack of soil contamination (and the lack of water) on top of the silt/clay layer indicates that contamination is not migrating along the layer.

- ▶ Groundwater does not flow through the UST area. No water was observed above the silt/clay layer during either of the subsurface investigations (1994, 1998). Groundwater is present at 3 to 7 feet below the silt/clay layer as shown on Figures 4 and 5.

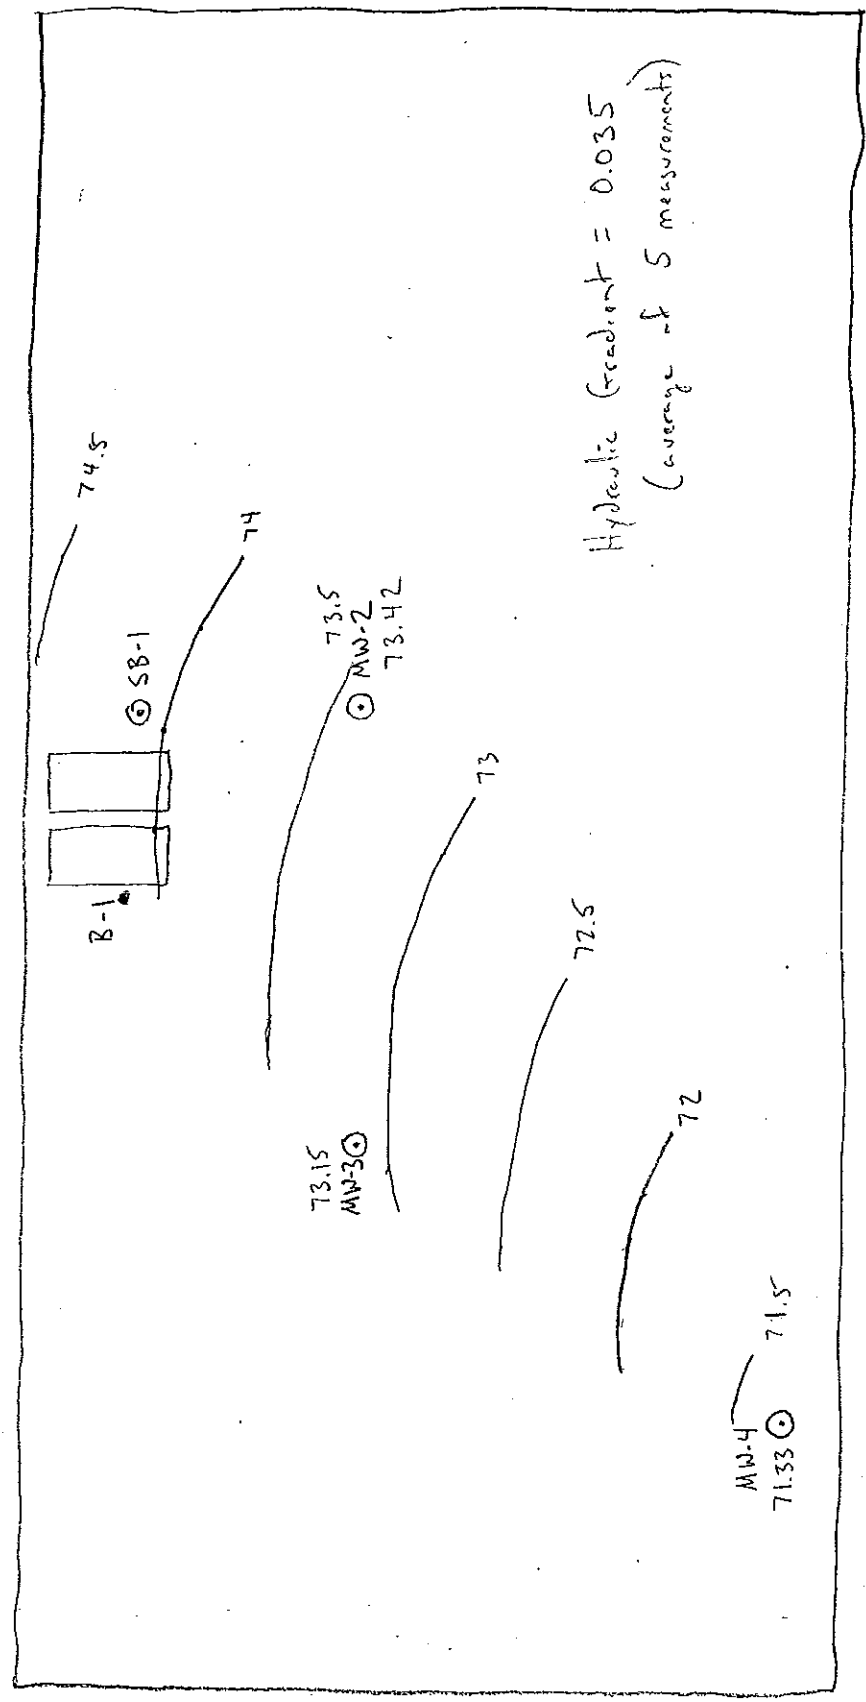
T-1772-02
GROUNDWATER CONTOUR
SW
Fig 2

1. The predominant groundwater flow direction based on the two sets of groundwater elevation measurements is west across the site, away from MW-5 (Refer to Figures 2 and 3). Given the topography, geology, and unconfined aquifer, the westerly flow direction measured at the site is reasonable and consistent with expected regional flow. This supports the conclusion that sufficient data points exist to accurately contour the water table elevation.
2. The hydraulic gradient is very steep, averaging 0.035 foot/foot, with MW-5 directly upgradient. It seems highly unlikely that a leak from USTs could have migrated very far up such a steep gradient.
