Subject: Phase I Environmental Site Assessment for Dodge of Bellevue Property, 126 through 316 116th Avenue NE, Bellevue, WA

**Phase I Environmental Site Assessment
Report**

**Dodge of Bellevue Property
126 through 316 116th Avenue NE
Bellevue, WA 98004**

ASTM E 1527-00

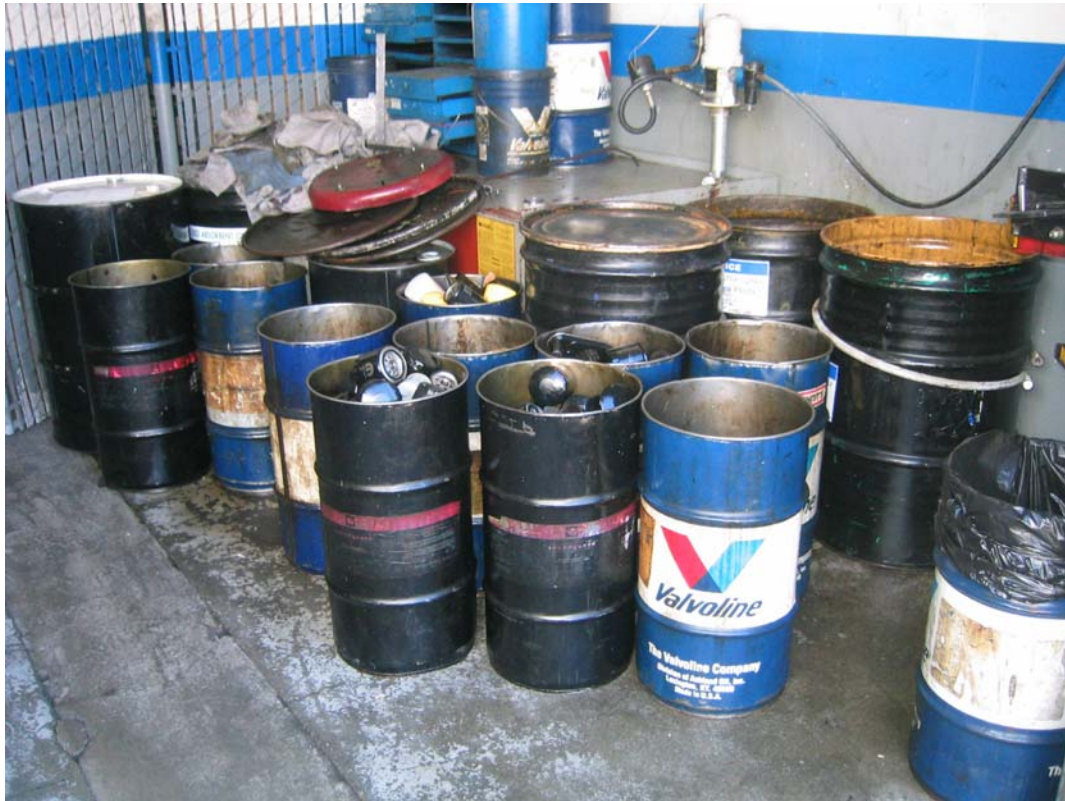
Photo 3. View of accumulated drums in the southeast portion of the Eastside Chrysler-Jeep service bays (126 116th Avenue NE). At least four of the smaller drums contain used oil filters.

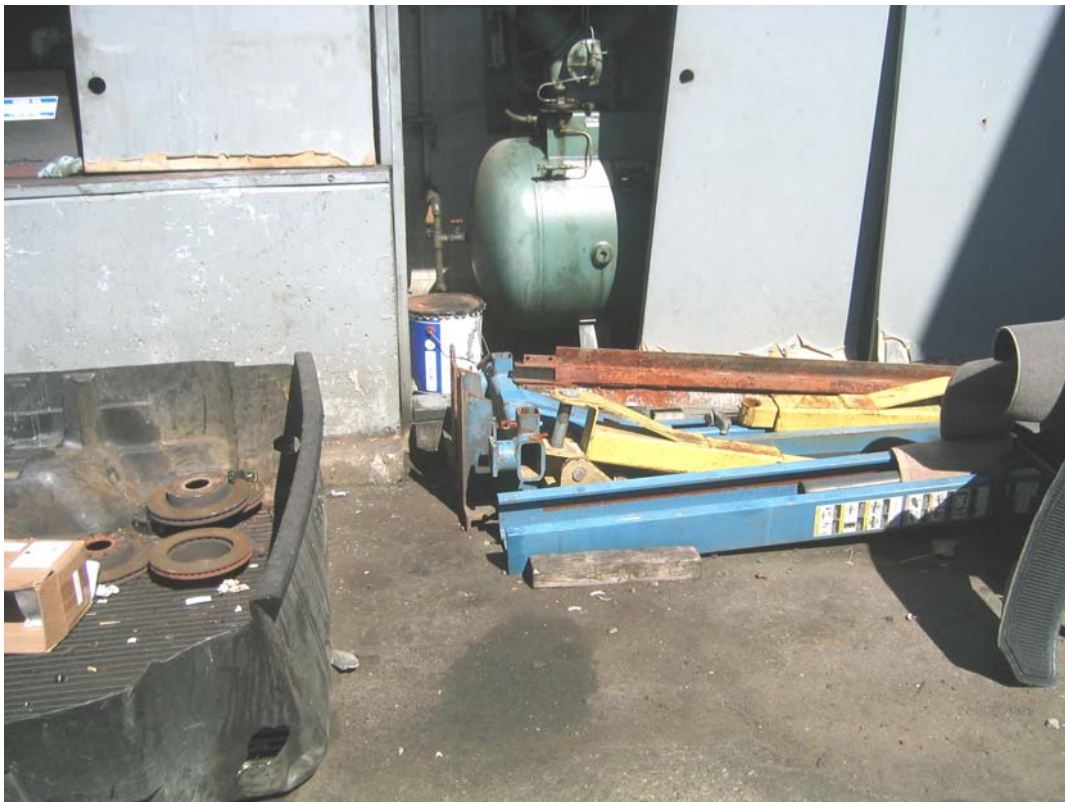
Photo 4. View of oil staining on pavement outside the air compressor shed on the south side of the service bays at Eastside Chrysler-Jeep. The staining appeared to be a result of draining oily condensate from the compressor directly on the ground.

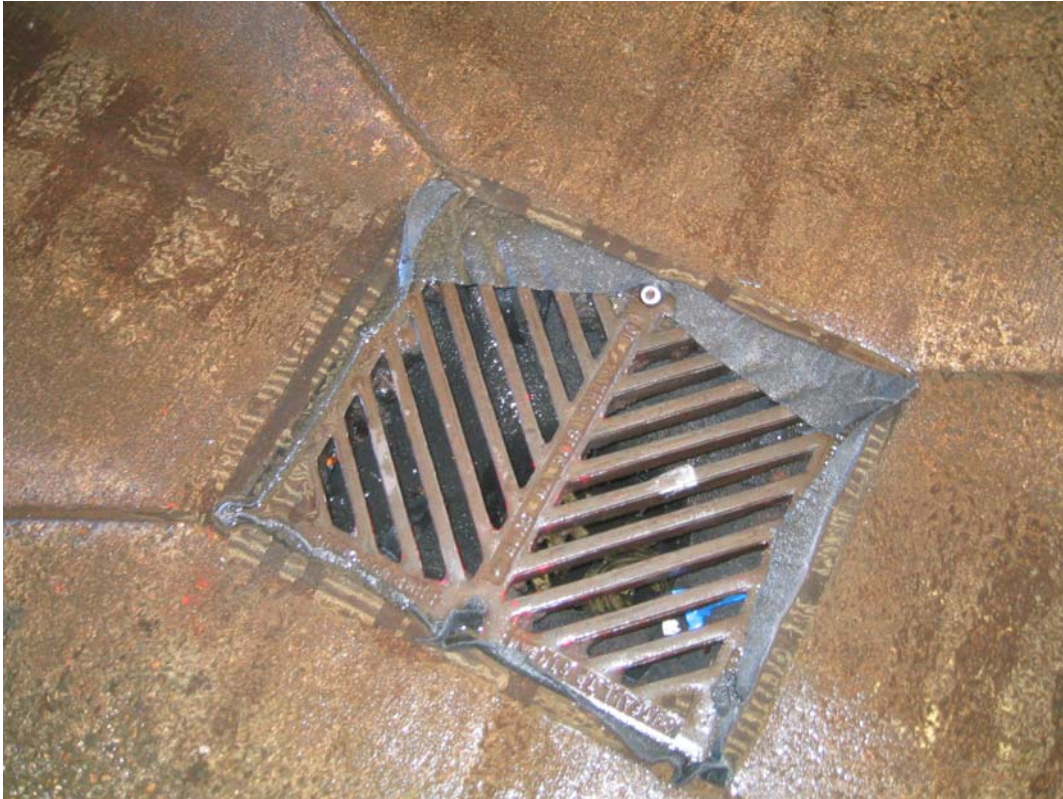
Photo 5. View of a sediment filter installed in the storm-catch basin at the wash rack at Eastside Chrysler-Jeep. Each of the storm drains at 126 116th Avenue NE has a sediment filter installed.

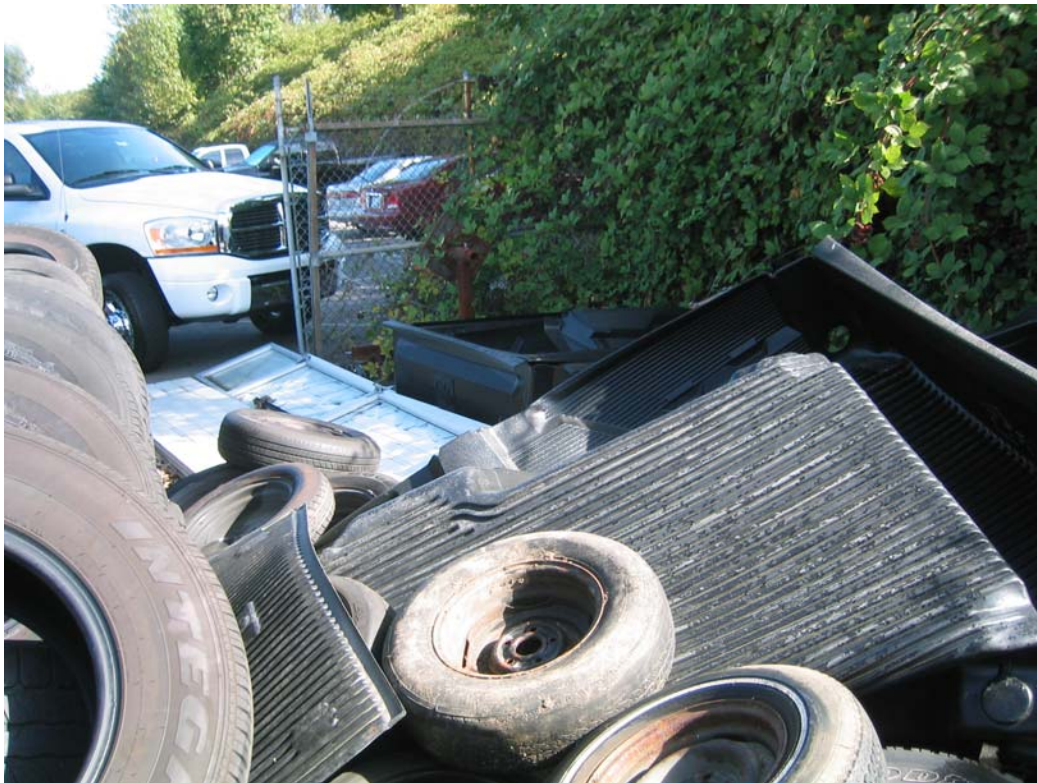
Photo 8. View of used tires and plastic truck-bed liners behind (east of) the Dodge of Bellevue service area.

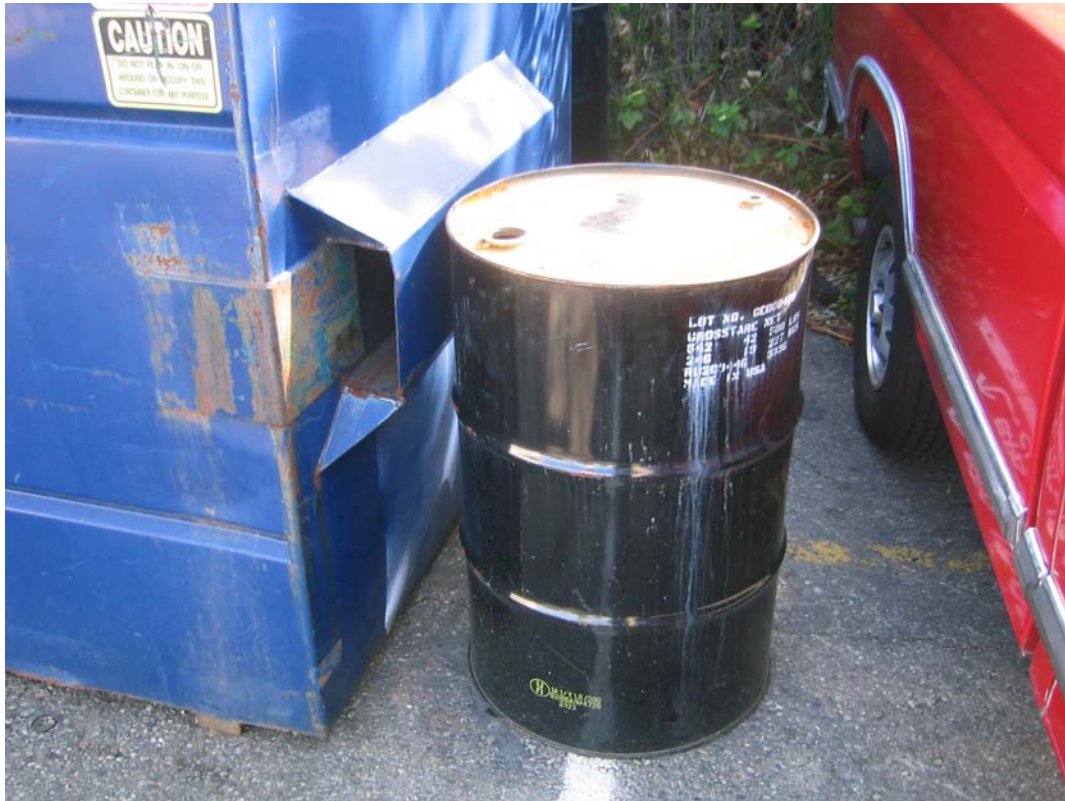
Photo 9. Evidence of solid waste dumping/filling near the east property boundary.

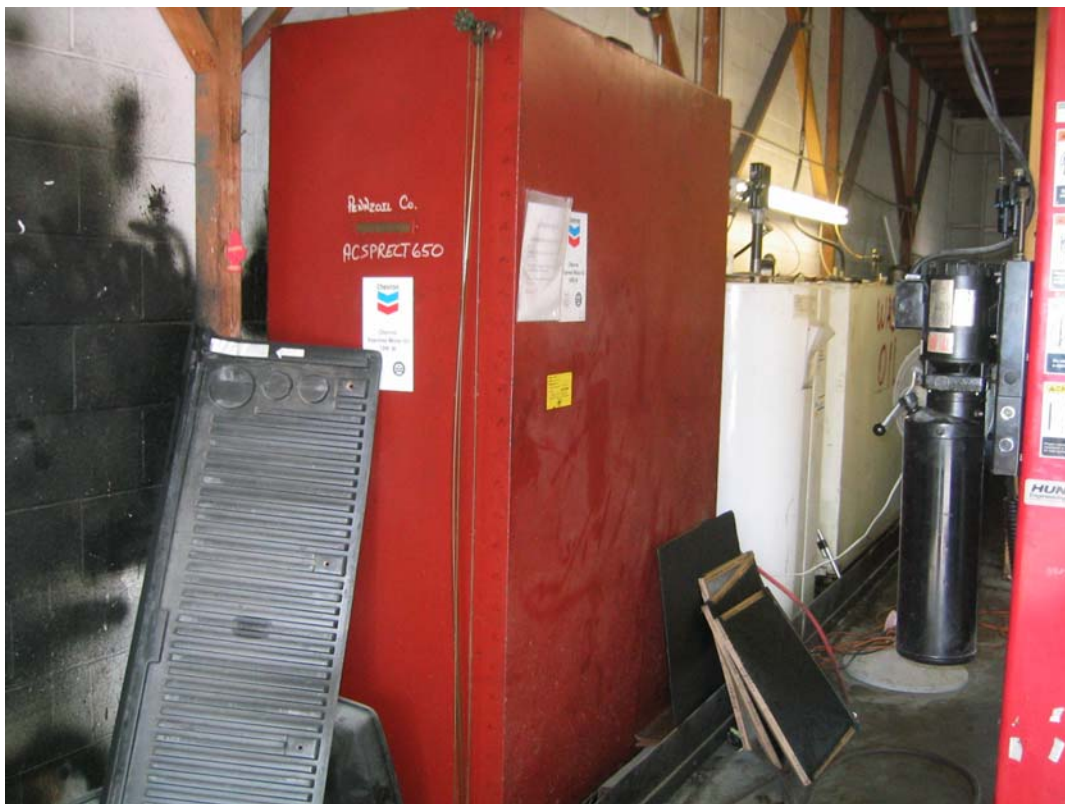
Photo 10. View of oil storage at the Dodge of Bellevue dealership. The near AST contains new oil. Two waste-oil ASTs are behind (to the right of) the new oil, as is an AST of automatic-transmission fluid.

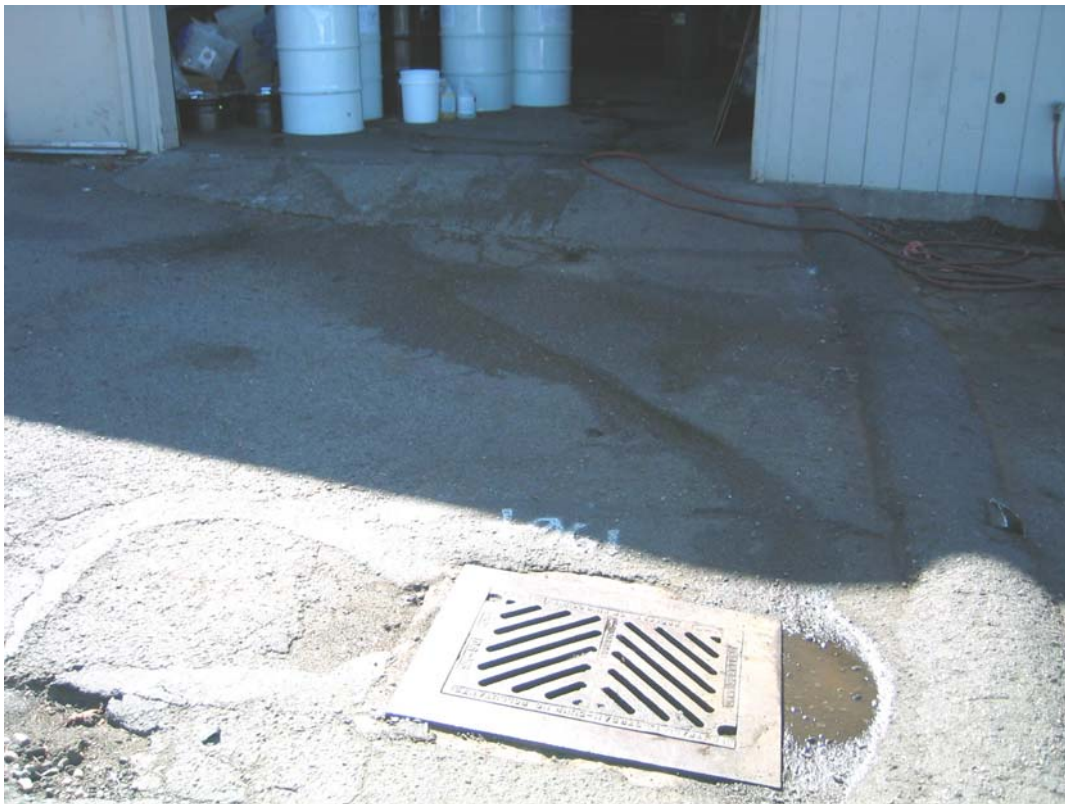
Photo 11. View of a storm-drain inlet near the northeast corner of the Dodge of Bellevue building. The image indicates the typical close proximity of service operations and storm drains. The drums visible in the background were mostly empty but contained approximately 1 to 2 inches of residual product from the spray application of truck-bed linings.

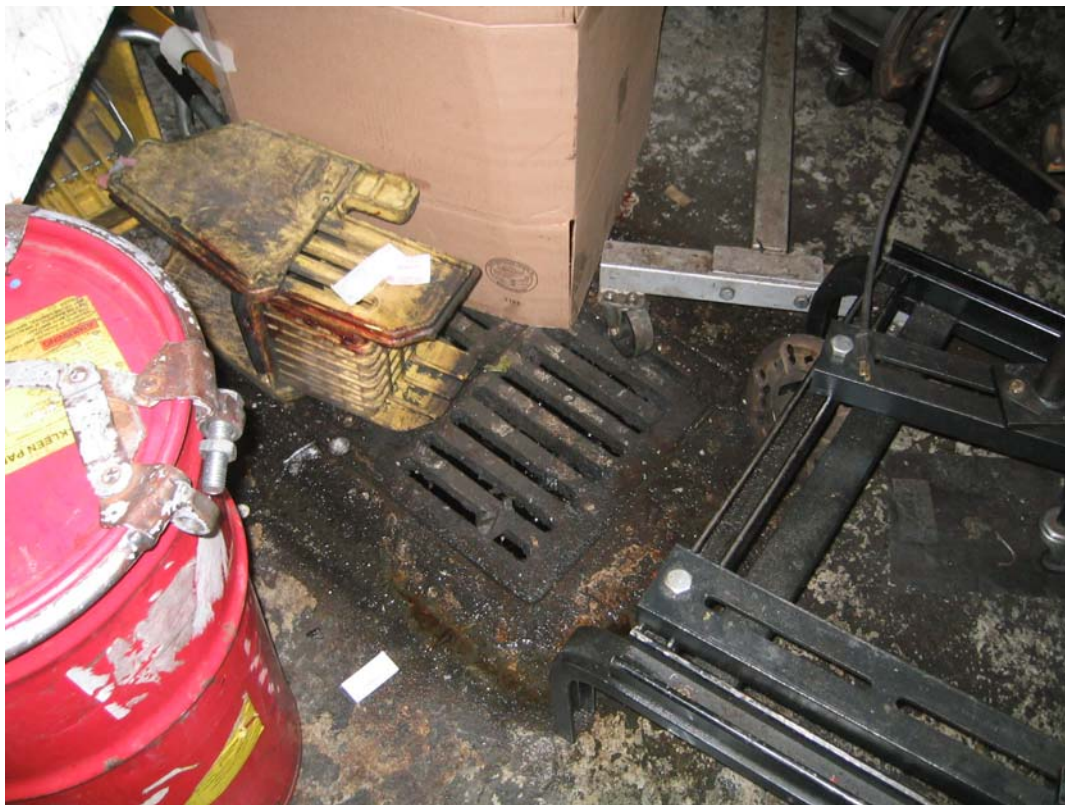
Photo 12. View of an interior floor drain in the service area at Dodge of Bellevue. Most floor drains in the service area showed evidence of oil staining but were cleaner than this one.

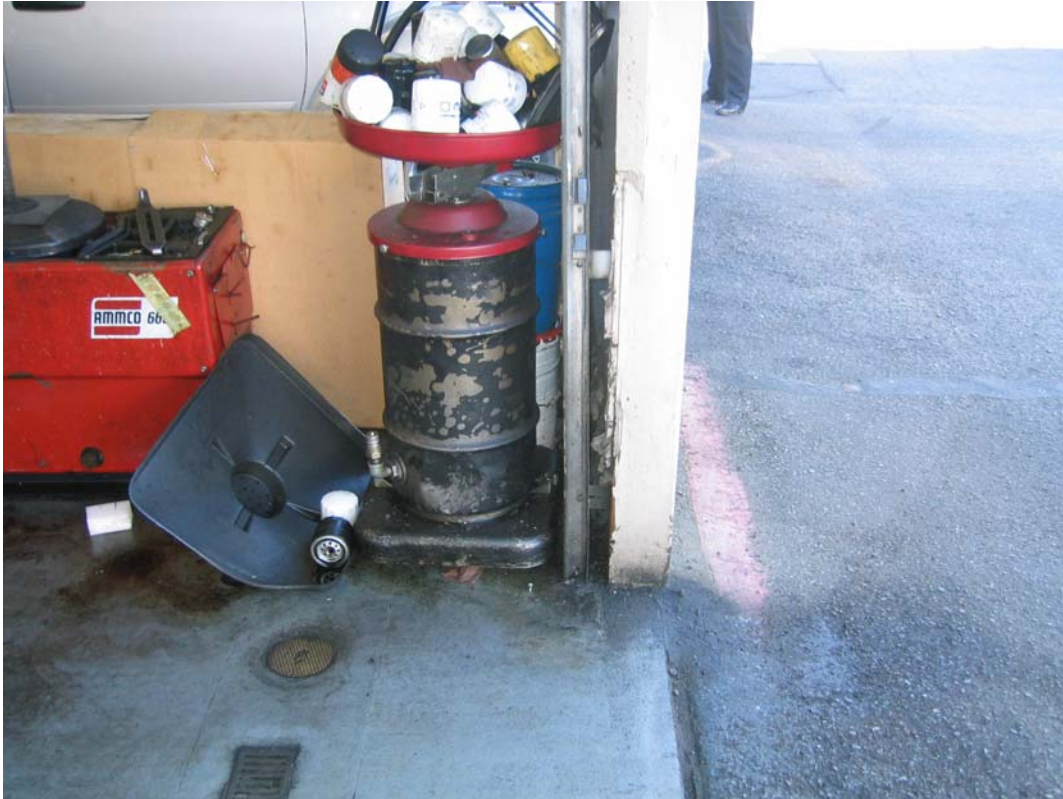
Photo 13. View looking west along the north side of one of the Dodge of Bellevue service bays. Note the overloaded mobile container for used oil filters and the evidence of oil staining on the floor and out the door to the right.

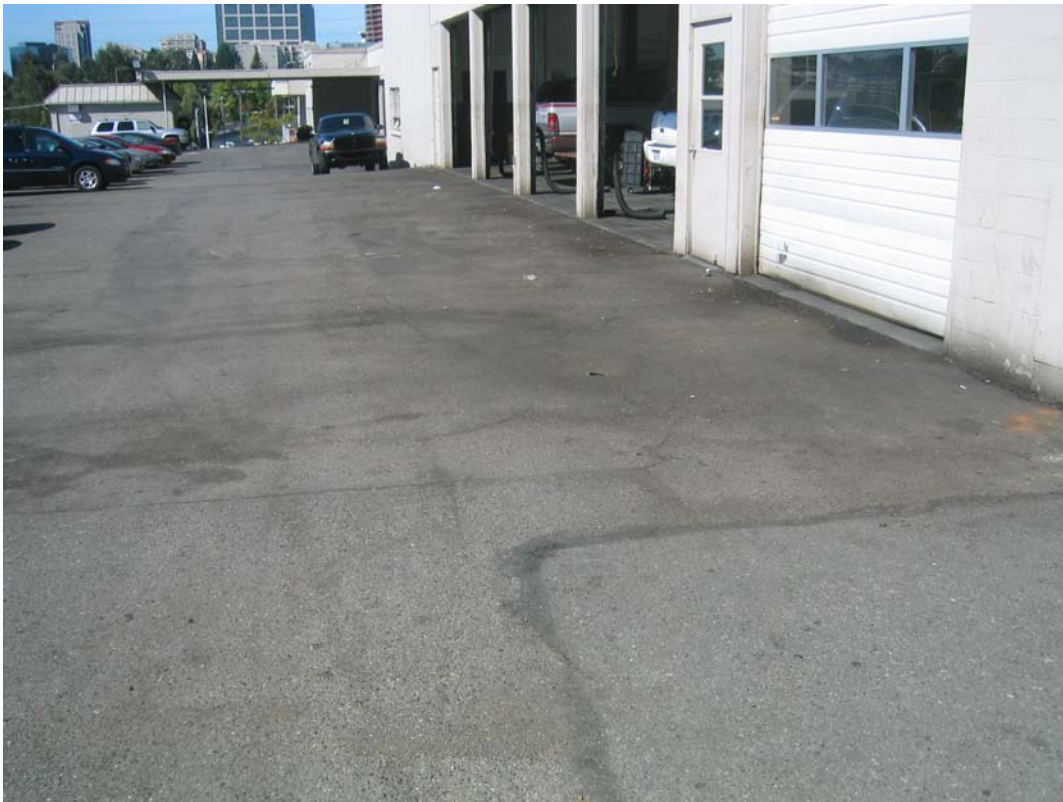
Photo 14. View looking west along the south side of the Dodge of Bellevue service bays. Note the staining on the pavement. Staining low on the walls and doors is also apparent, likely from water splashing oily dirt onto the vertical surfaces.
