WASHINGTON RANKING METHOD

ROUTE SCORES SUMMARY AND RANKING CALCULATION SHEET

Site name: Holden Mine Tailings Region: CR0
 City, county: Holden, Chelan

SUMMARY SCORE SHEET	
Site Name: Holden Mine Tailings	ID No:
Site Location: (City, County, or Section/Township/Range) Holden Village, Chelan, Section 7, T21N, R17E	
Site Description: (Attach a sketch/map) Eight million tons (80 acres) of mine tailings from copper/zinc/gold/silver mining corporation. Adjacent to Railroad Creek which feeds into Lake Chelan 12 miles to the east. Located at Holden Village. Within the Wenatchee National Forest, elevation 3,200 feet.	
Special Considerations: Railroad Creek is eroding the base of the piles. Especially during high flow. Physical siltation and dissolved copper and zinc (& arsenic) have knocked out aquatic insects for several miles downstream and reduced fish population directly or indirectly. Large flooding/erosion would make this much worse. Railroad Creek feeds Lake Chelan. There is runoff and probably constant seepage through the tailings that enters the creek, and a small stream with high dissolved Cu & Au. An air route environmental score can be generated and other route scores can be

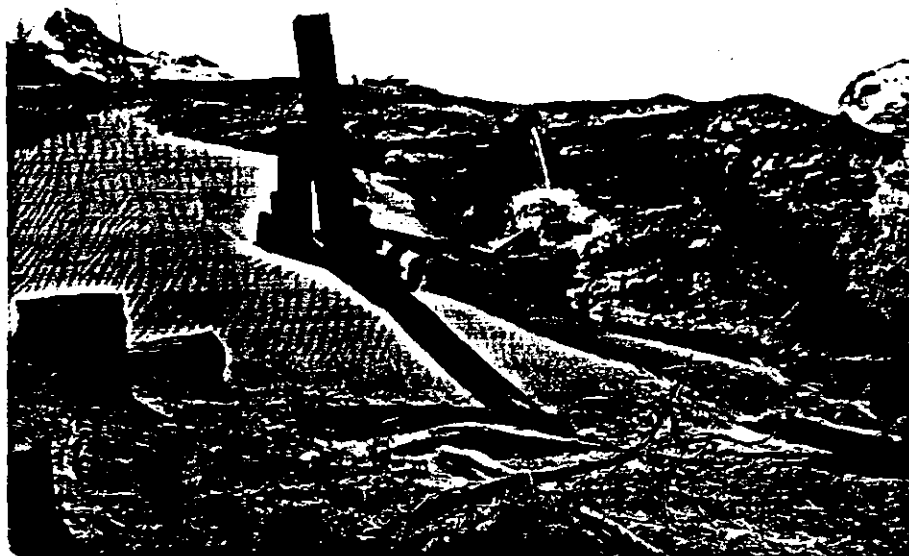
Photo No. 4. — East edge of tailings pile number 1 (photo is "off-color"). This picture shows the relative resistance to erosion of undisturbed oxidized tailings compared to wind deposited tailings. Culvert discharging stream of about 3 square inches in cross section falling 4 feet onto sloping surface of stratified tailings. Note the relatively minor erosion considering that this stream has apparently flowed, at least intermittently, for at least 20 years. No turbidity noticeable in the runoff.

When oxidized the sulfides present cement adjacent particles together with iron oxide. Fragments of this cemented material require considerable pressure to crush with the fingers and thus could be considered to have medium "dry strength" (Earth Manual, 1963, p. 391). The oxidized dike material is practically impossible to penetrate with a shovel and must be first picked to loosen. In climbing the faces of the tailings piles, it was impossible to "kick" steps but instead they had to be hacked with a pick. The effectiveness of this cementation is shown in Photo 4. Walking on "oxidized in place" material, even where underwater, had little effect on it. Wind-deposited oxidized tailings, however, were found to have practically no strength where saturated. Apparently once disturbed the oxidized grains will not bond again and are easily eroded by the wind. This wind-blown material was present only as a veneer on the lee sides of the tailings piles (Photos 1, 2, and 4) and as collars as much as a foot or so thick around the central settling ponds where moisture has stabilized the wind-blown material.
