DEPARTMENT OF
ECOLOGY
State of Washington

Monitoring, Sampling and Analysis Report

Spokane River Shoreline Sediment Sites Heavy Metals (As, Cd, Pb, Zn) Post-Remediation Monitoring

June 2019

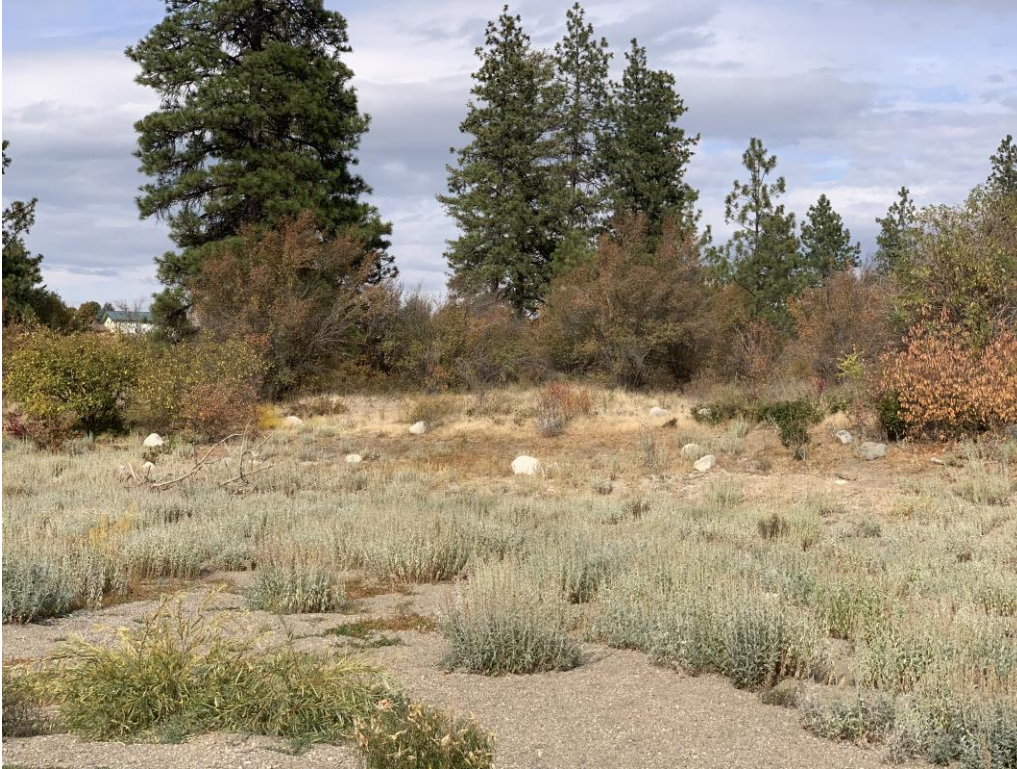
IMG_3847

- trail still present but worn due to flows.
- Some fabric visible underneath trail
- Signs still present

- coin fabric is starting to tear and become tattered in a few areas

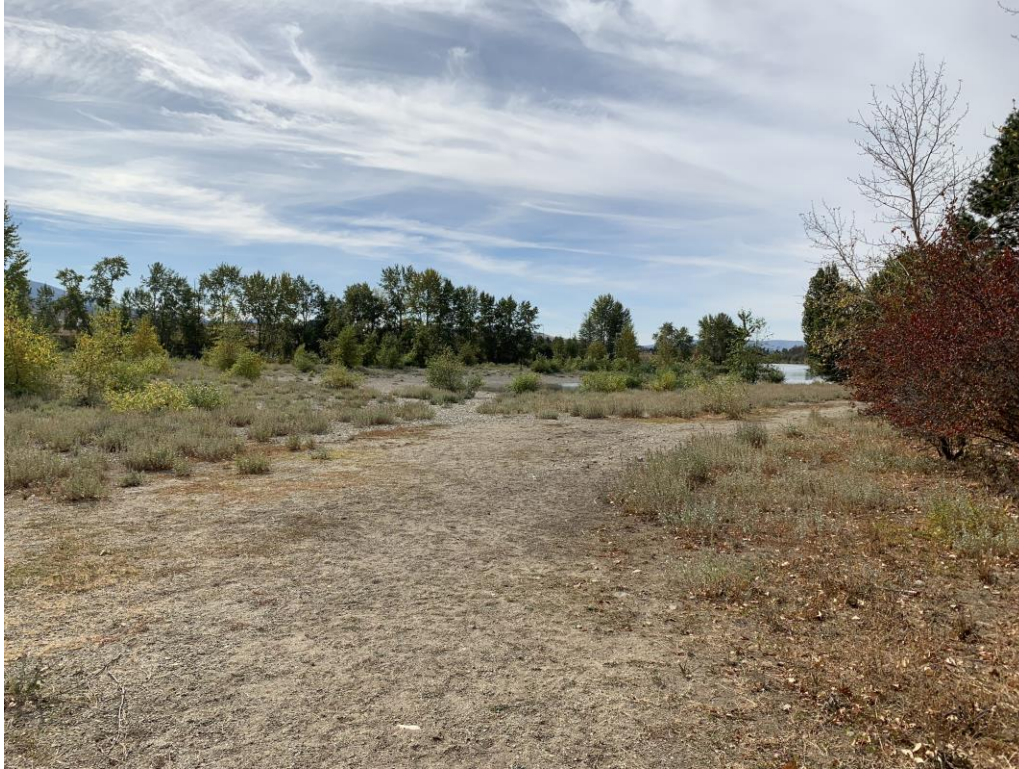
IMG_3879

- overgrown with weeds
- some erosion at edges
- signs present

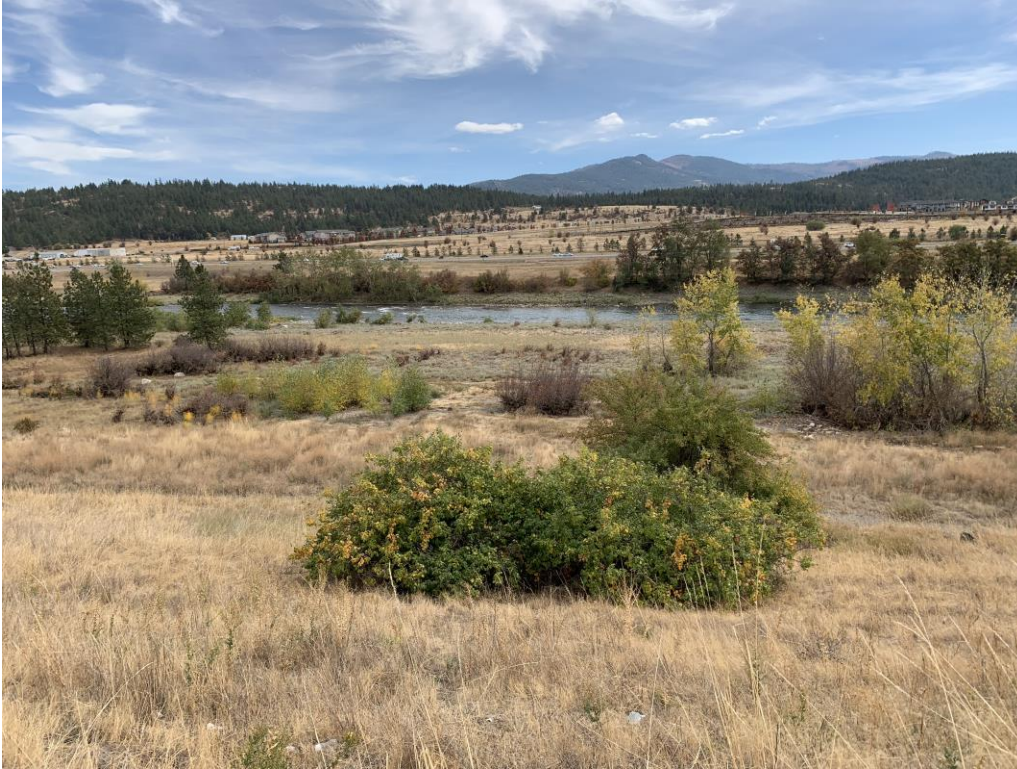
IMG_3889

- Caps A/B Fairly intact; Cap C some minor damage due to water flows
