SITE HAZARD ASSESSMENT

SITE NAME: Texaco 211577 Monterey

Completed on 5/7/2019 for inclusion

on the August 2019 Hazardous Sites List.

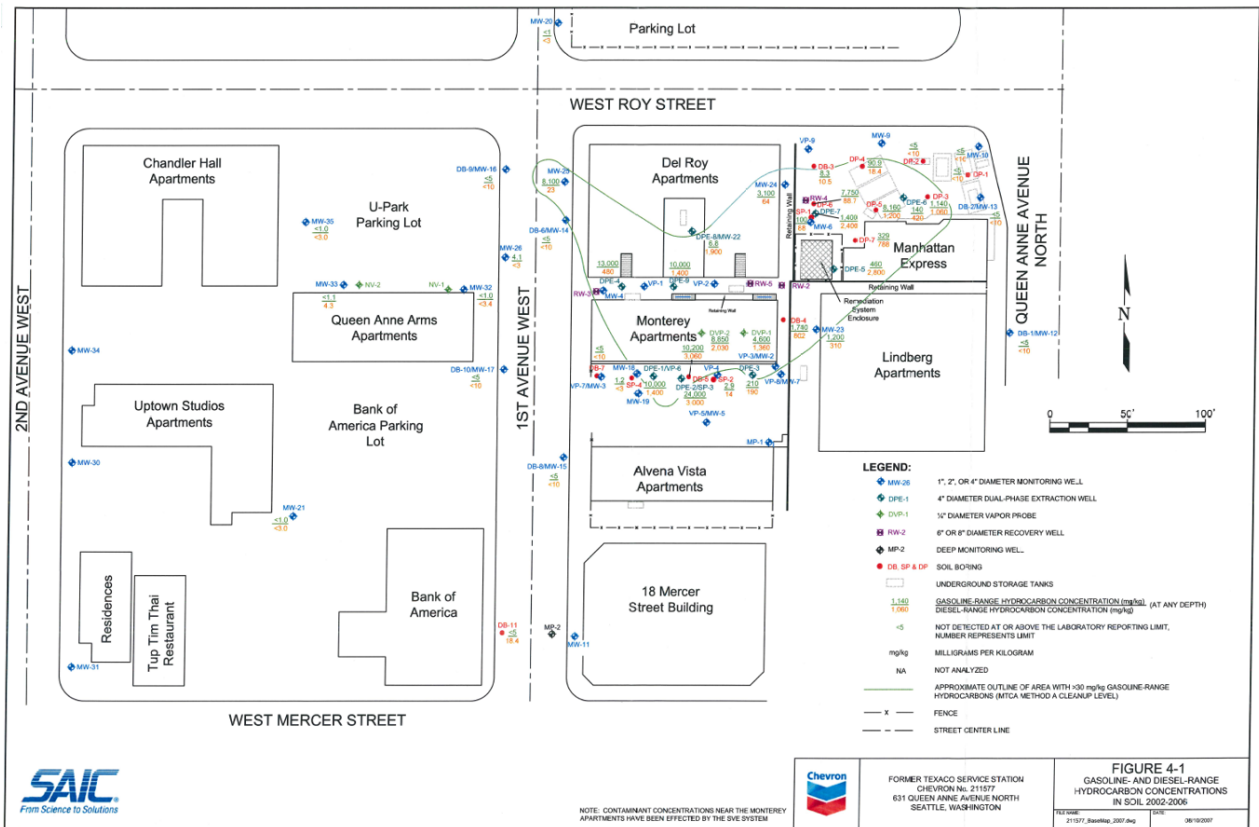
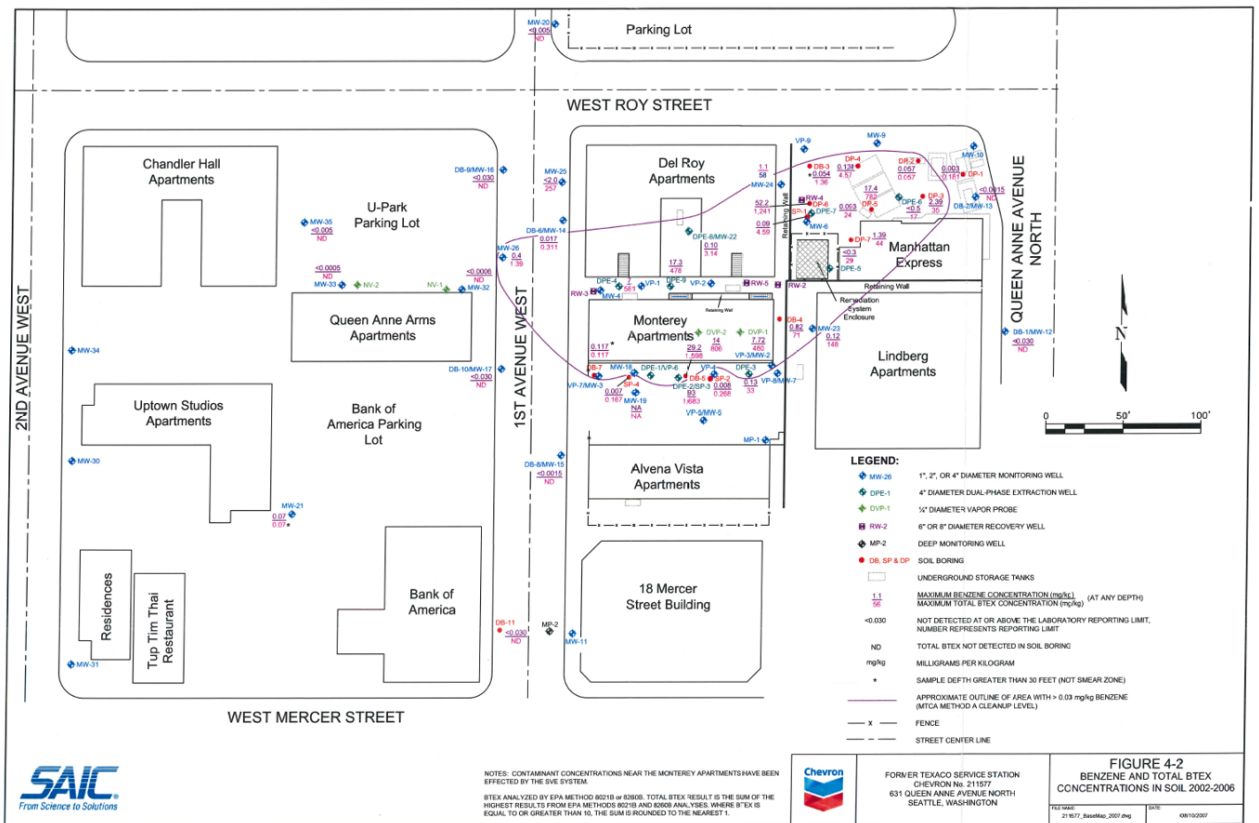
Based on samples collected between 2002 and 2006, soil contaminated with TPH or BTEX above MTCA Method A cleanup levels was present on the Texaco, Del Roy, Monterey, and Bungalows parcels and extended under 1st Avenue West. The extent of contamination is indicated on Figure 4. Since all monitoring wells on Site had not been sampled at the same frequency, a conservative estimate of the extent of contaminated groundwater was established including all wells that had an exceedance of cleanup levels prior to the RI. These boundaries are indicated on Figure 5 for TPH and BTEX. The area of contaminated groundwater extends onto all seven parcels identified as part of the Site. Within these boundaries are VP-9, MW-10, and MW-12. These wells are considered to be up- or cross-gradient of the Texaco source, and cleanup level exceedances in these wells are indicative of contamination from an off-Site source. The last time groundwater from these wells contained a chemical above cleanup levels was 2004, indicating that any potential off-Site sources were no longer actively contributing contamination to this Site by the time of the RI in 2007.

Figure 4. Areas of TPH (top) and BTEX (bottom) contaminated soil as of the 2007 Remedial Investigation. (figures from SAIC 2007 Remedial Investigation Report)

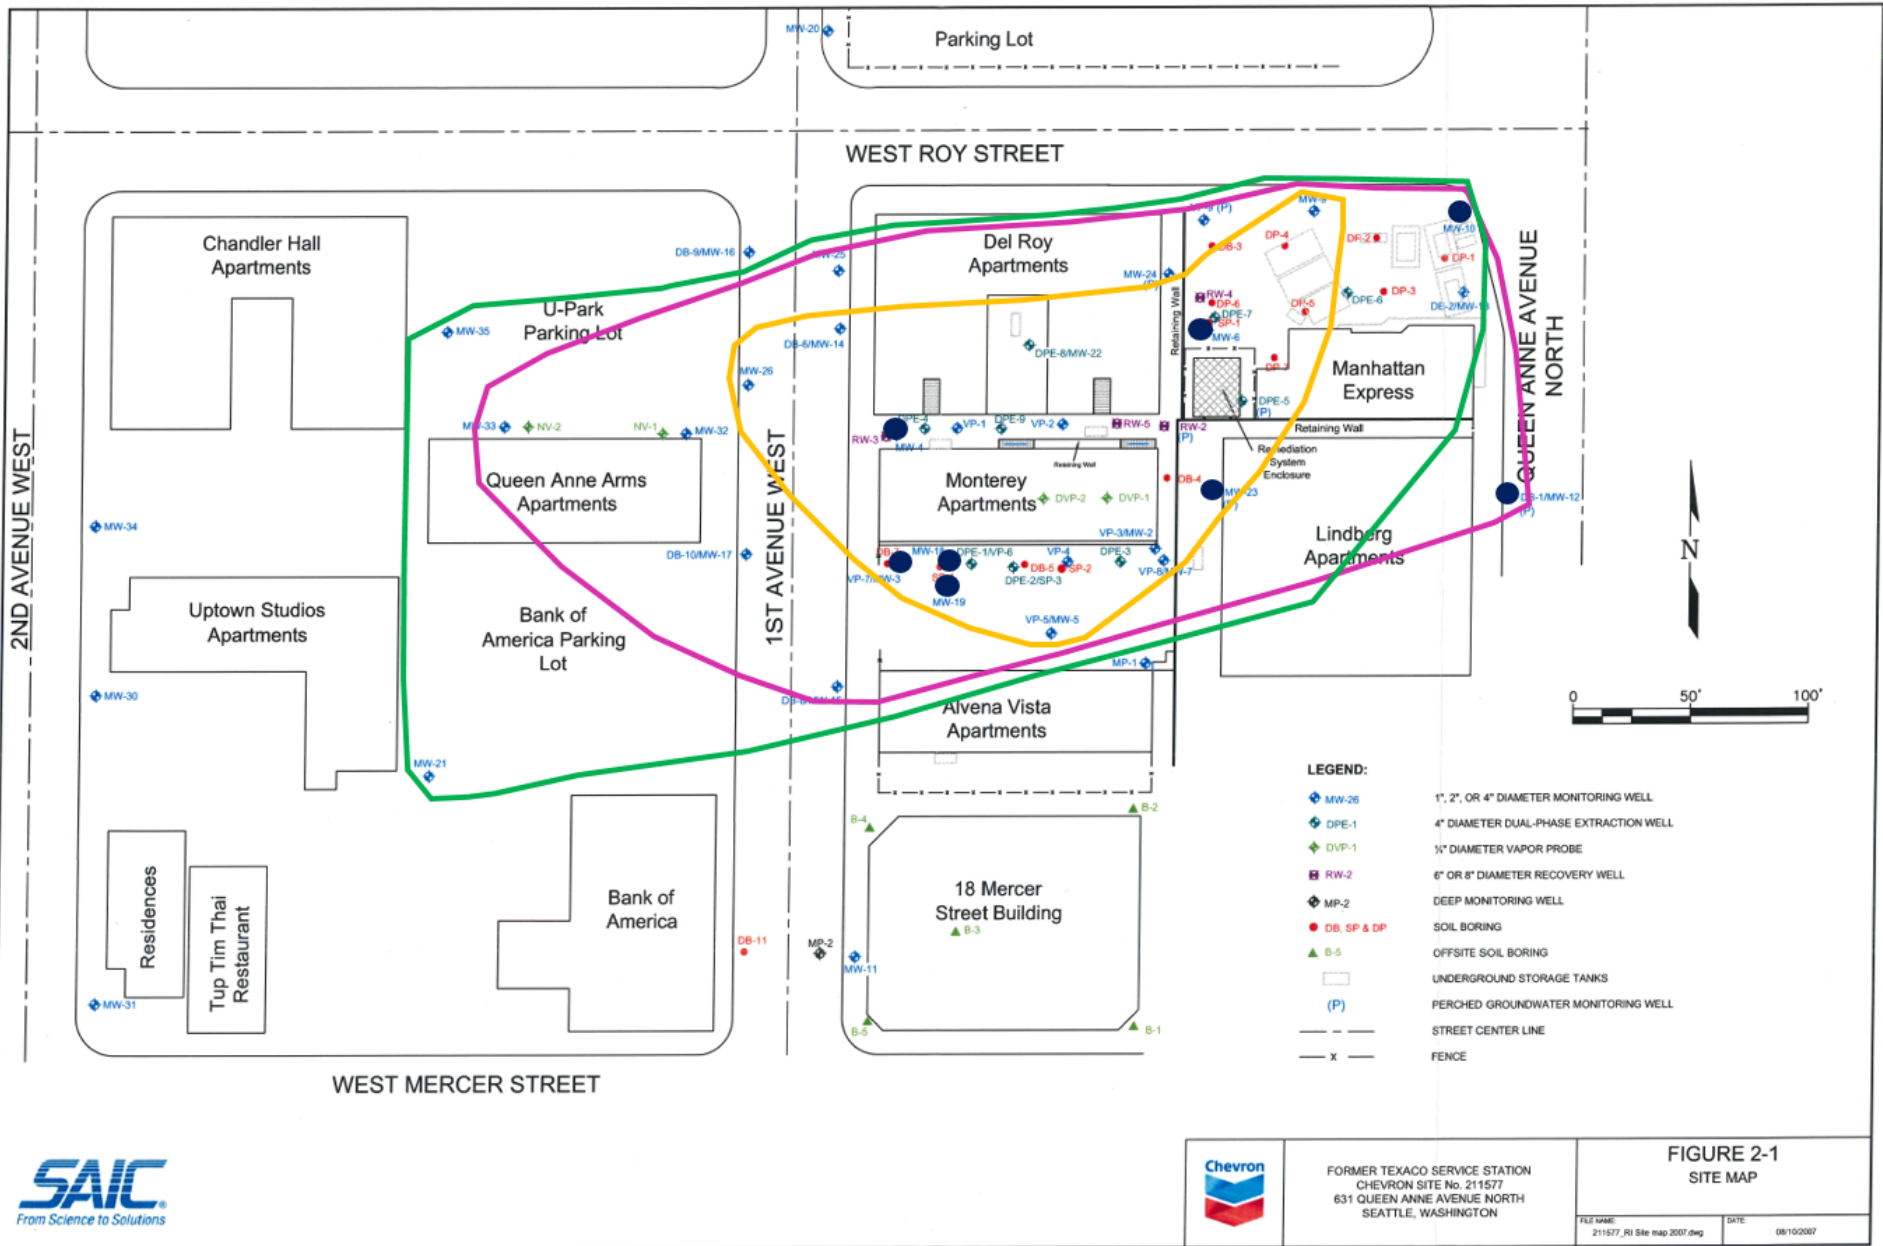
Chlorinated solvents have also been confirmed to be present above cleanup levels in groundwater collected from some wells on Site (see Figure 5). No on-Site sources of these contaminants has been identified, and the identity of the off-Site source has not been confirmed. The last sample with solvents above cleanup levels was collected in 2004, though post-RI samples have not routinely been analyzed for these contaminants.

Figure 5. Areas of groundwater contamination as of the 2007 Remedial Investigation, as determined by including any well with a sample containing contaminants above cleanup levels prior to 2007. Moving from interior to exterior, the shapes surround wells with toluene, ethylbenzene, or xylene above cleanup levels (orange), TPH above cleanup levels (pink), and benzene above cleanup levels (green). Dark blue dots indicate wells where chlorinated solvents had been detected. (base figure from SAIC 2007 Remedial Investigation Report)

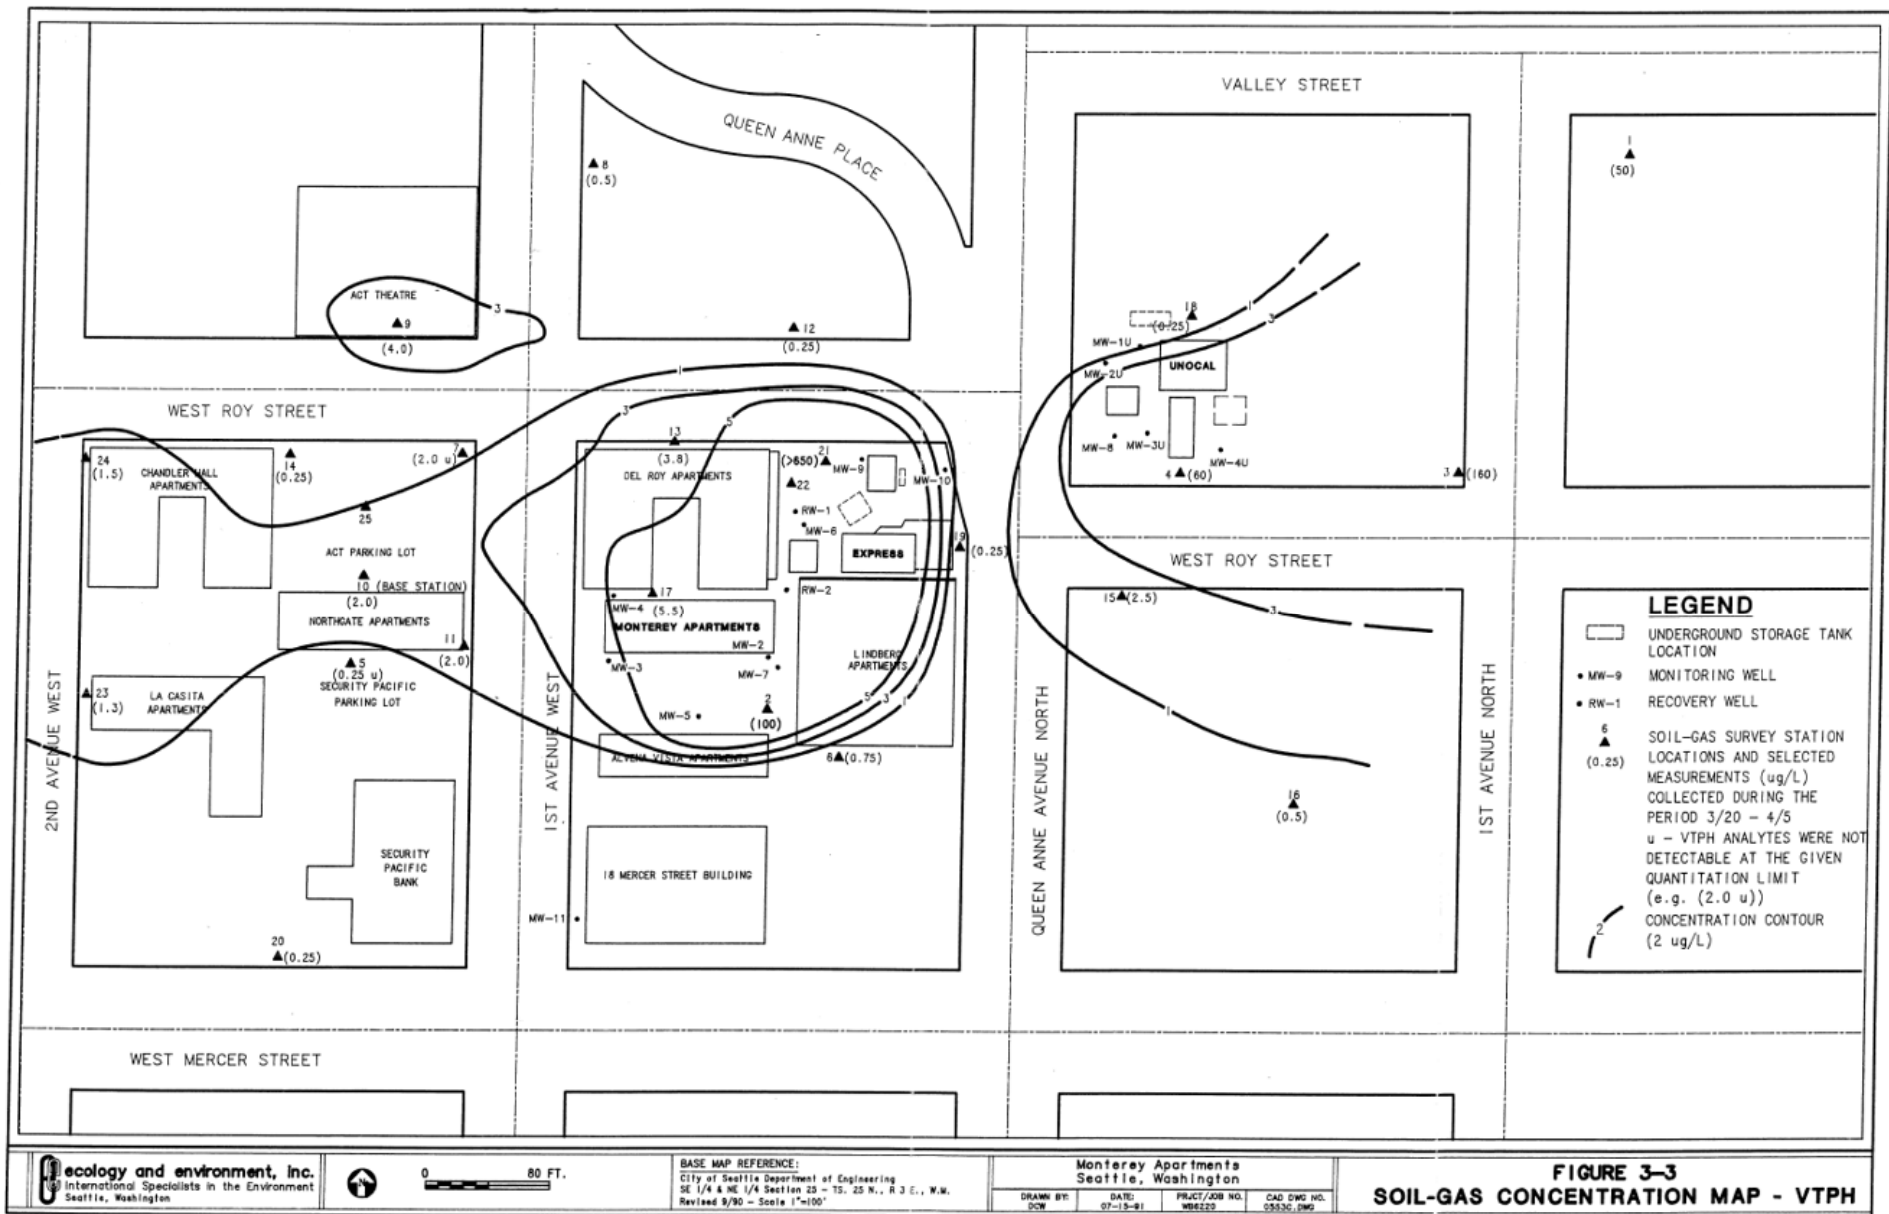
The most geographically extensive soil vapor sampling event occurred as part of the 1991 Phase I Remedial Investigation. Sampling locations and concentrations of volatile TPH (VTPH) are below in Figure 6. The highest concentrations were observed in soil gas collected on the Texaco property (location 21) and near the northeast corner of the Alvena Vista Apartments (location 2). An area of elevated soil gas VTPH was observed within the Unocal property (location 4), but based on results from all sampling locations, this was considered to be part of a separate contaminated soil gas plume.

Figure 6. Concentrations and contours of soil gas concentration of volatile TPH from the extensive 1991 soil gas sampling event. (figure from E&E 1991 Phase 1 Remedial Investigation Report)

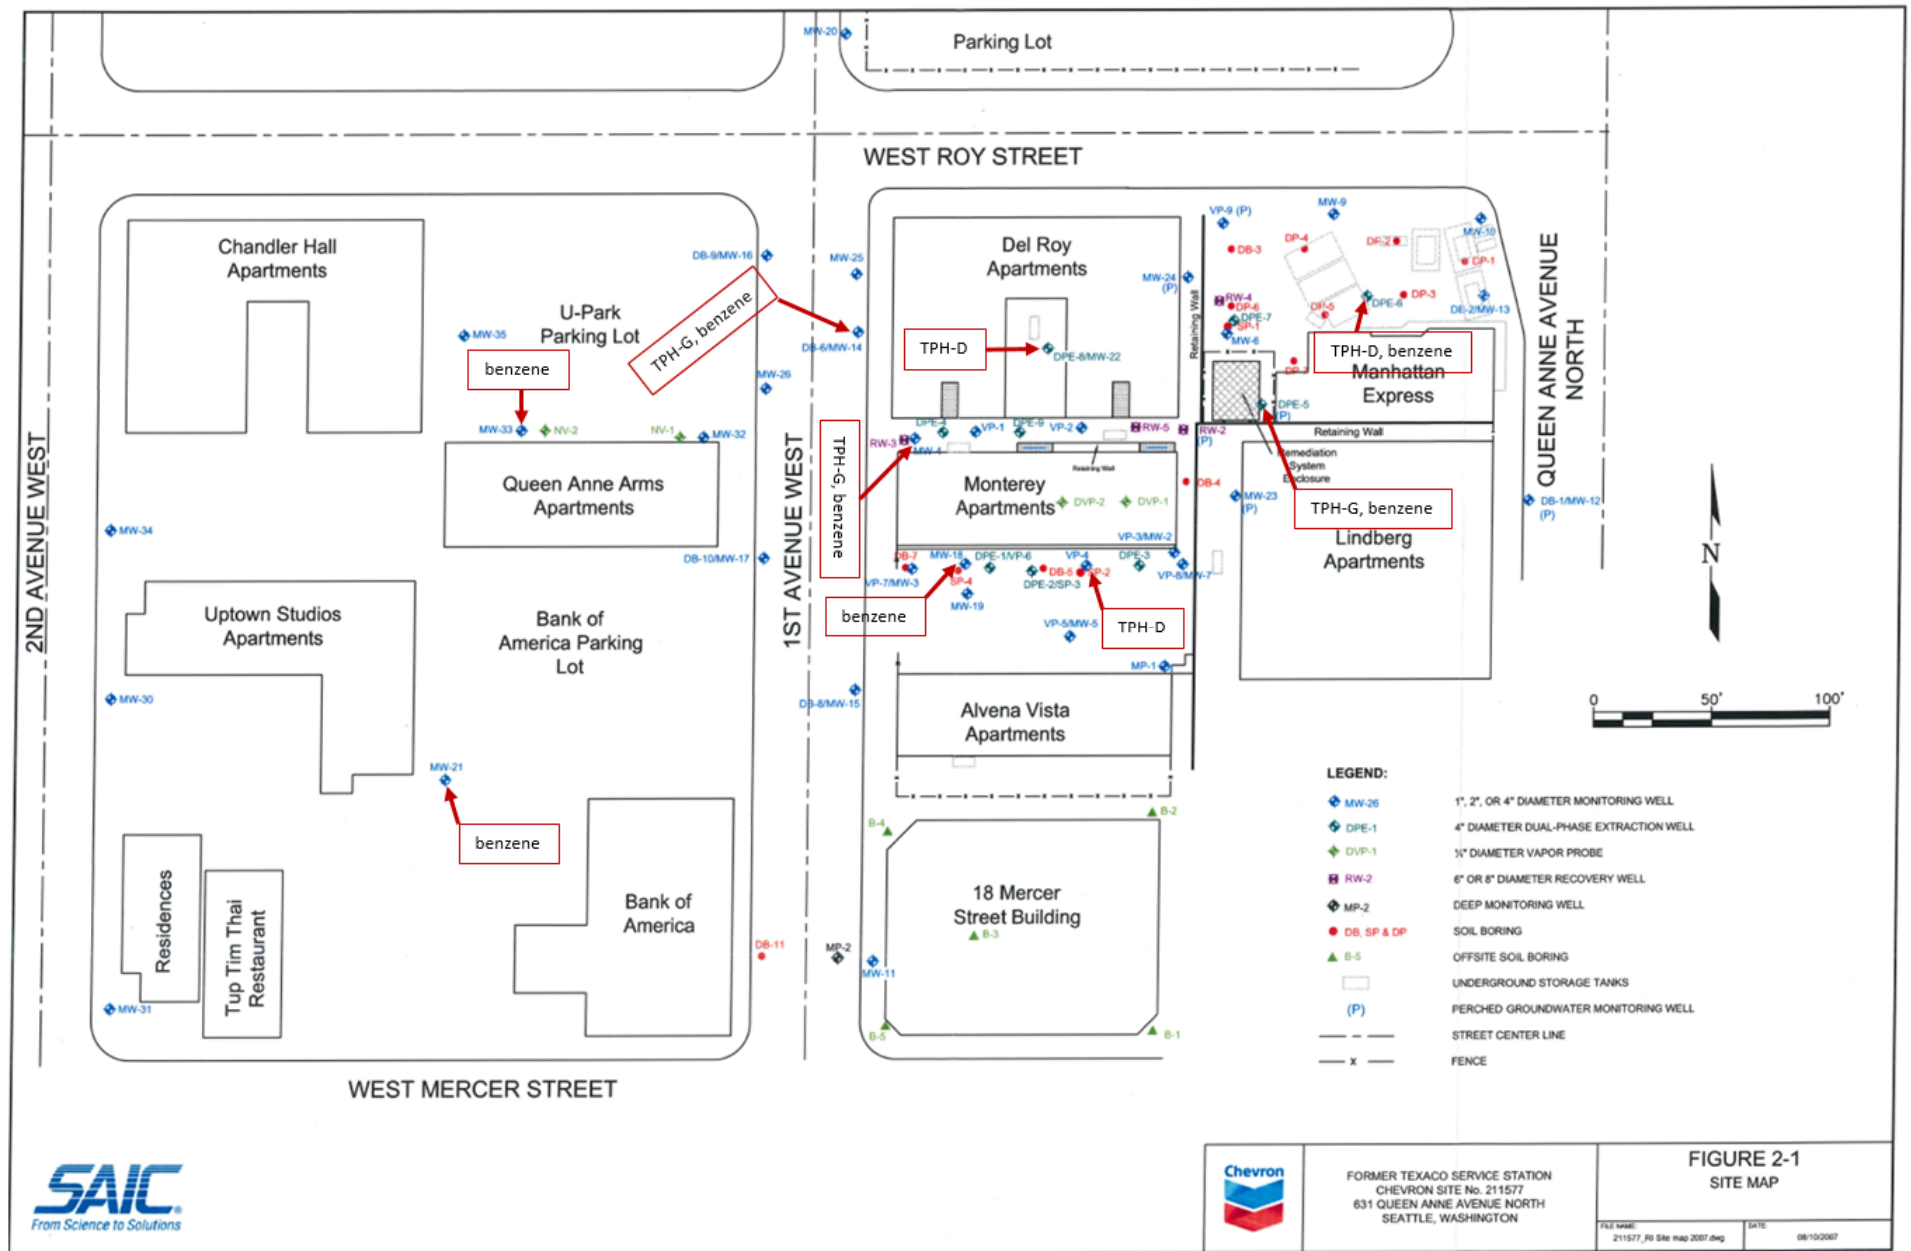
The last report available to Ecology with groundwater sampling across the entire Site covers the sampling event in November 2013. Samples were collected from 25 wells, and depth to water and presence of NAPL was determined for 41 wells. Sampling results indicate that contamination with diesel-range petroleum hydrocarbons (TPH-D) above cleanup levels remained in some wells located between Queen Anne Ave N and 1st Ave W. Gasoline-range petroleum hydrocarbon (TPH-G) contamination extended into wells located within the 1st Ave W right-of-way. Benzene contamination above cleanup levels was observed in wells west of 1st Ave W. (see Figure 7)

Figure 7. Location of contamination above Method A cleanup levels as of November 2013 groundwater monitoring. (base figure from SAIC 2007 Remedial Investigation Report)

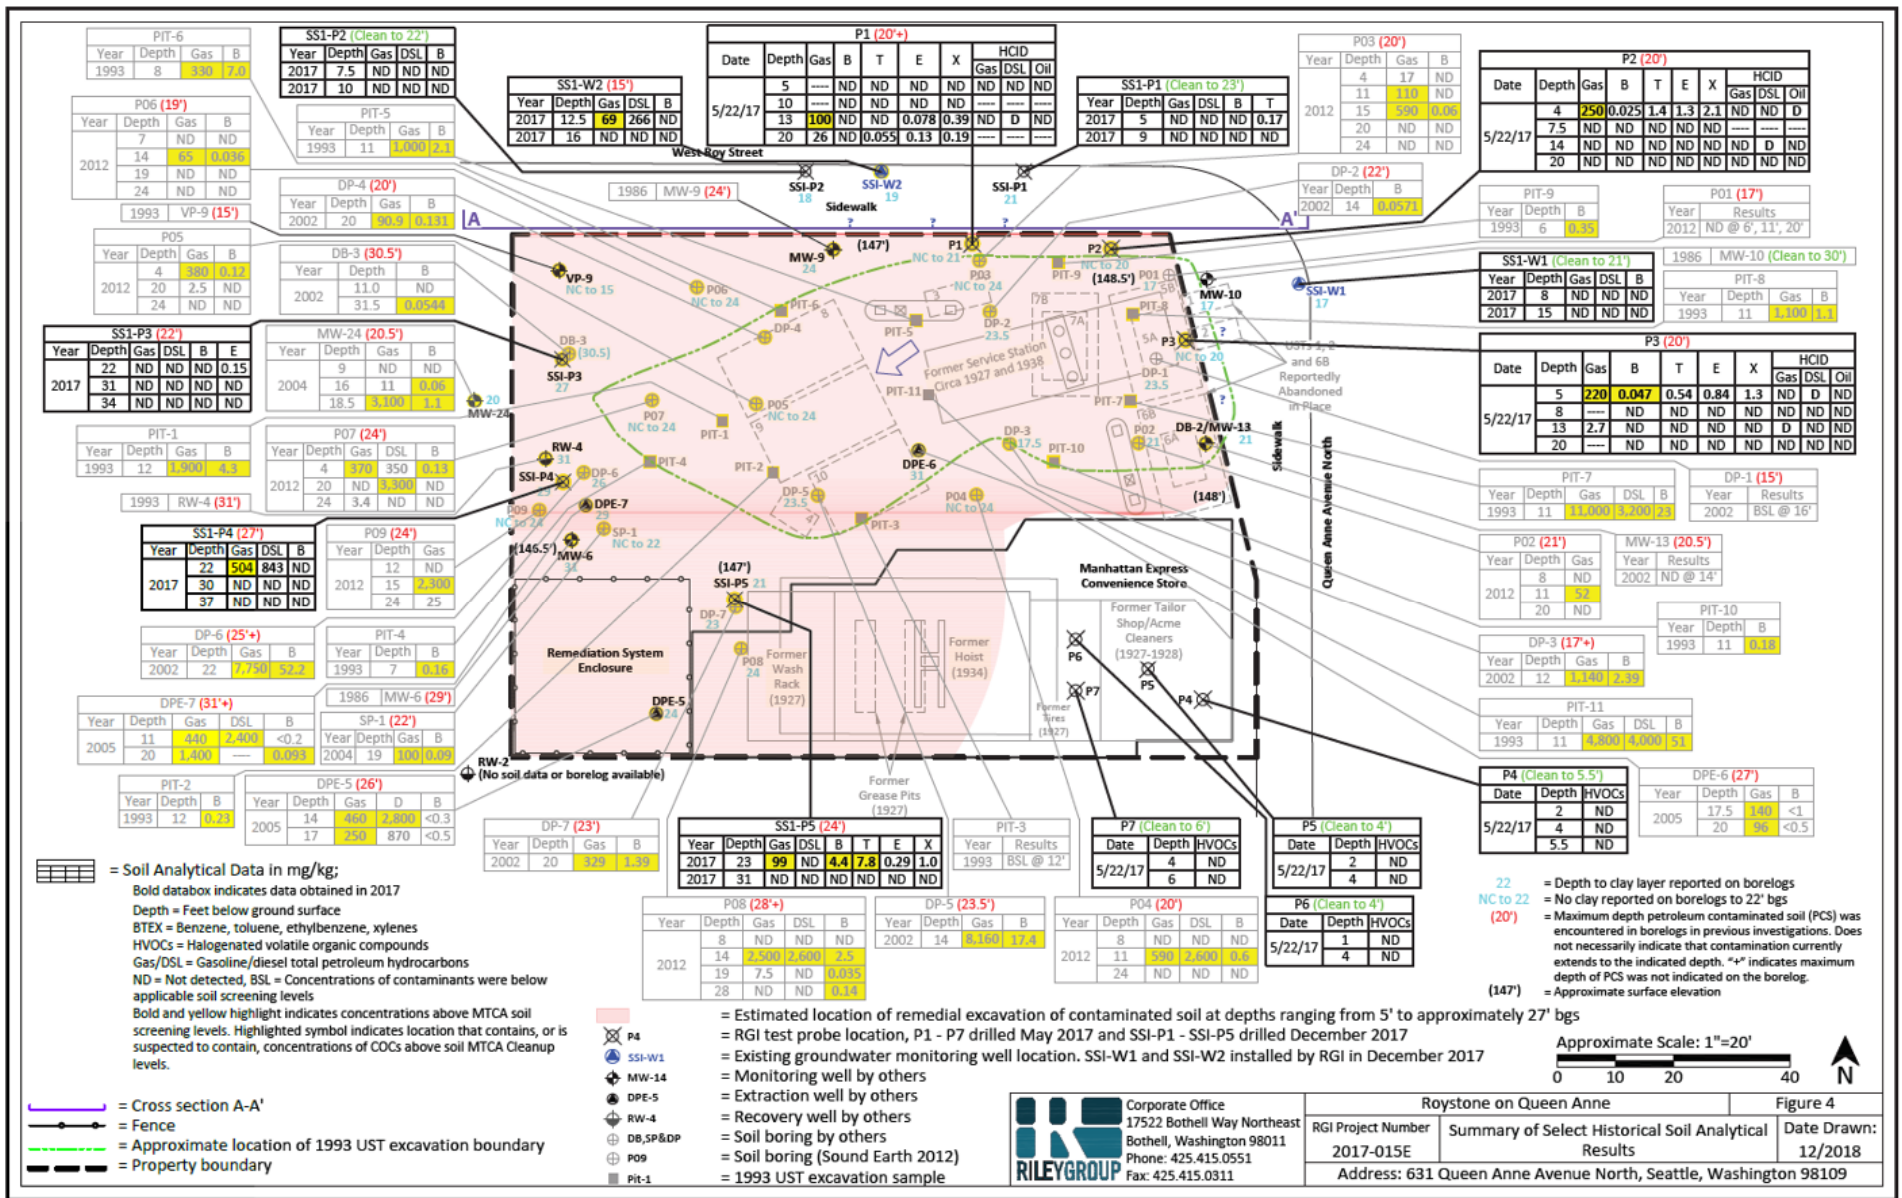
SoundEarth Strategies collected soil samples from nine boring locations on the Texaco parcel in 2012 to determine the remaining extent of petroleum contaminated soil on the property. Samples were collected at multiple depths bgs at each location and analyzed for TPH and BTEX. The Riley Group (Riley) continued the characterization of on-property contamination in 2017. Fourteen soil borings were advanced across the property and in the sidewalk areas to the north and east of the property. Two of these sidewalk borings were completed as monitoring wells SSI-W1 and SSI-W2. Samples were analyzed for TPH, BTEX, and/or chlorinated solvents. The extent of on-property soil contamination and a summary of recent groundwater sampling results are included below on Figures 8 and 9, respectively.

Figure 8. Area of Texaco property with remaining petroleum contaminated soil including information from 2012 and 2017 on-property investigations. (figure from Riley 2018 Cleanup Action Work Plan)

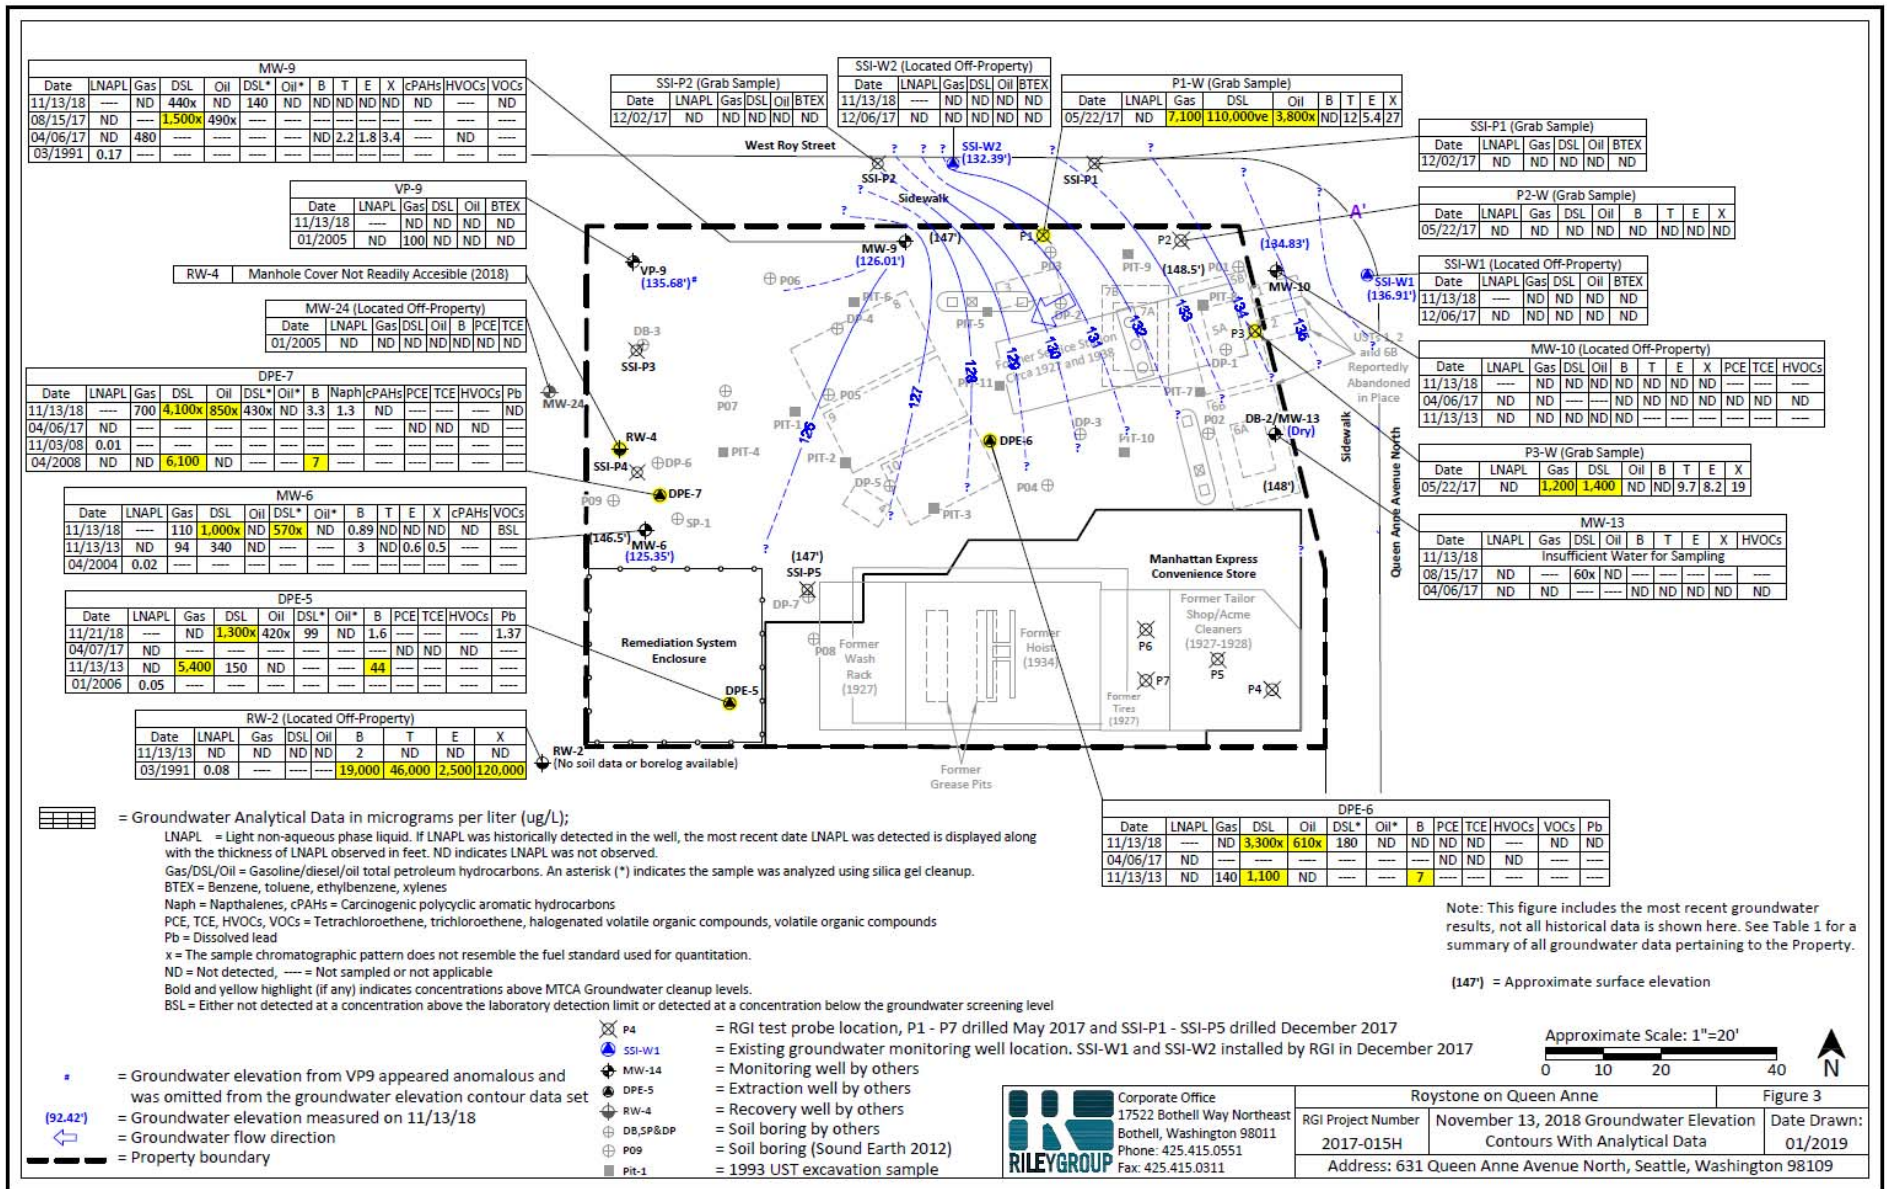
Figure 9. Results of recent groundwater sampling events on the Texaco property. (figure from Riley 2019 Groundwater Monitoring Report)

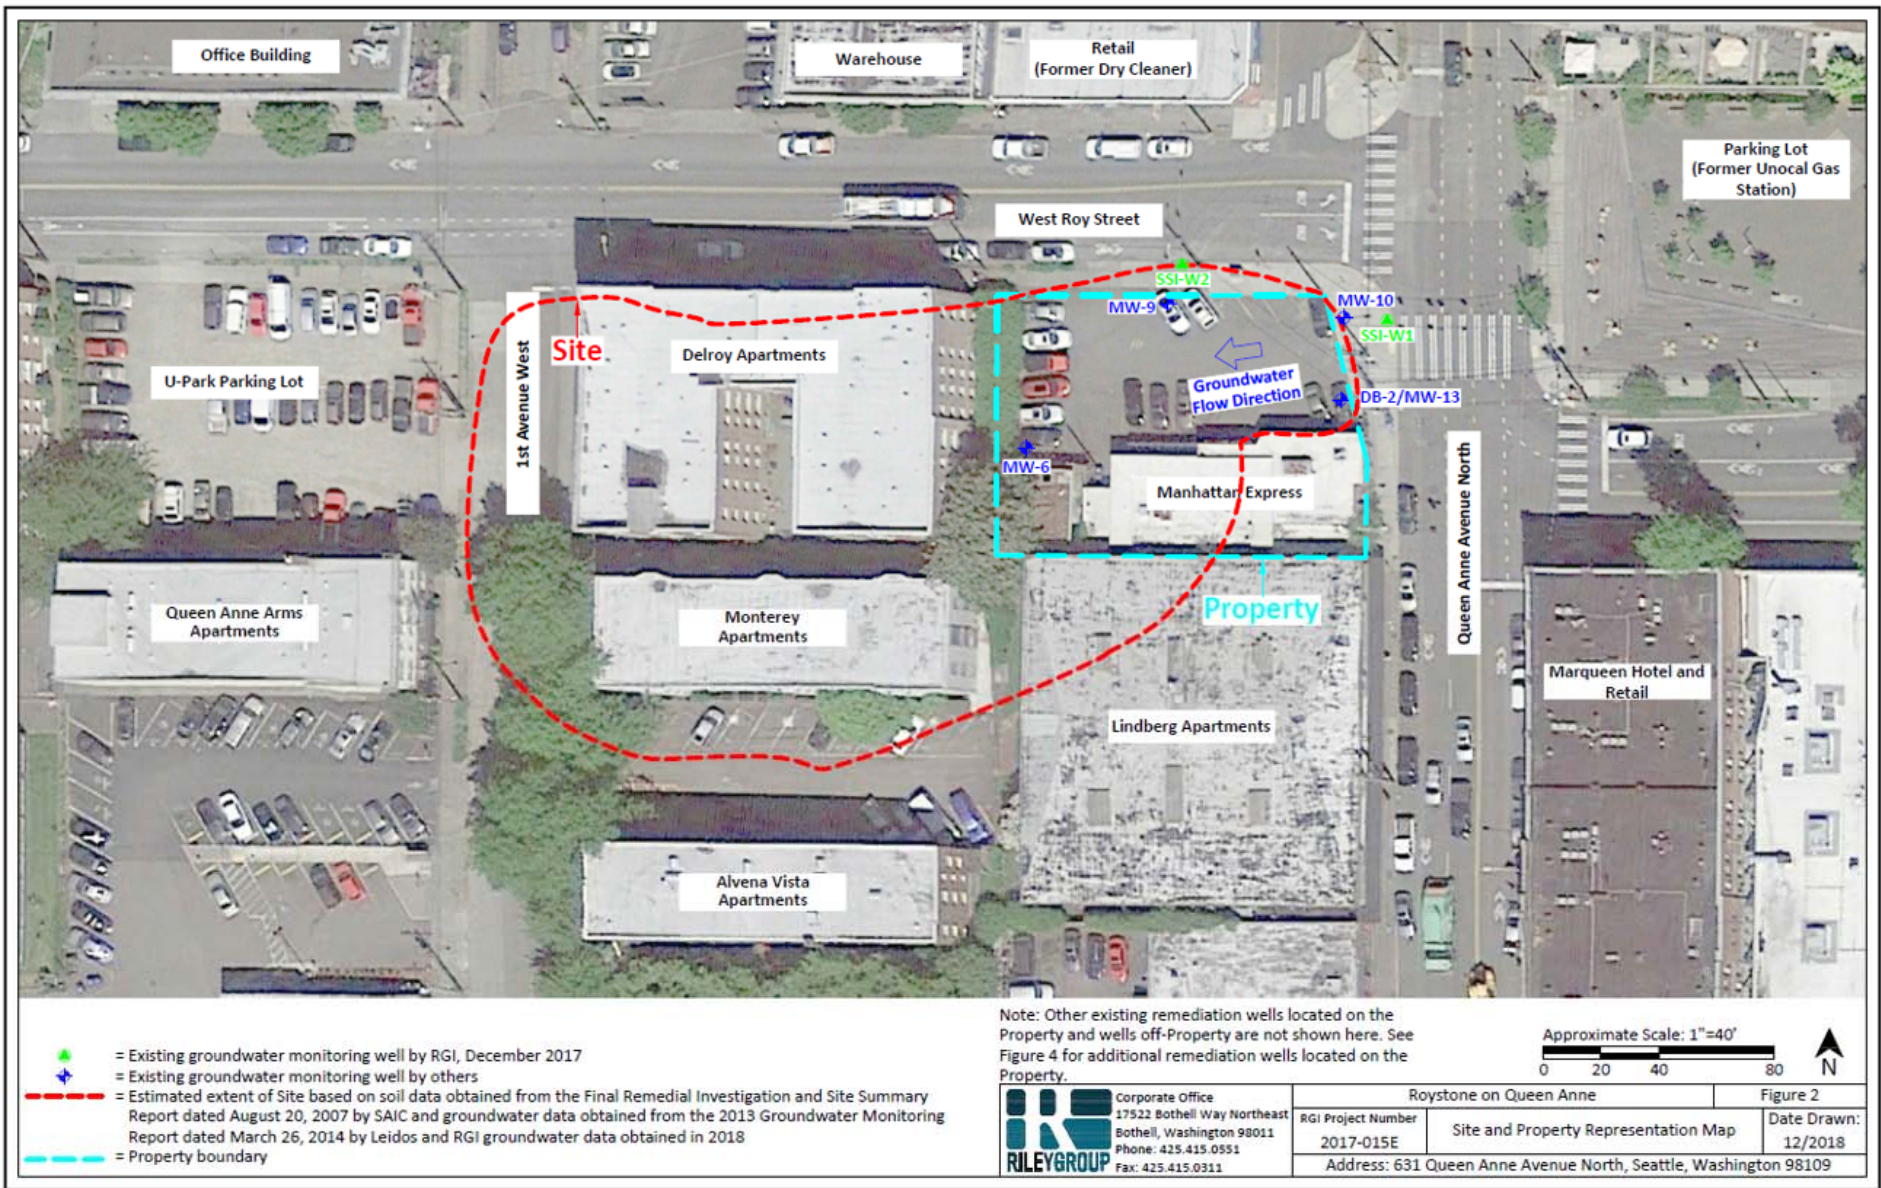
The area of contamination used for scoring was based on the area designated in the Cleanup Action Work Plan (Riley 2018). This area is indicated in Figure 10. It is acknowledged that this area may underestimate the remaining extent of contamination downgradient of the source parcel, but based on the available data, this was determined to be a good estimate for scoring.

Figure 10. Estimated are of remaining contamination used for scoring. (figure from Riley 2018 Cleanup Action Work Plan)

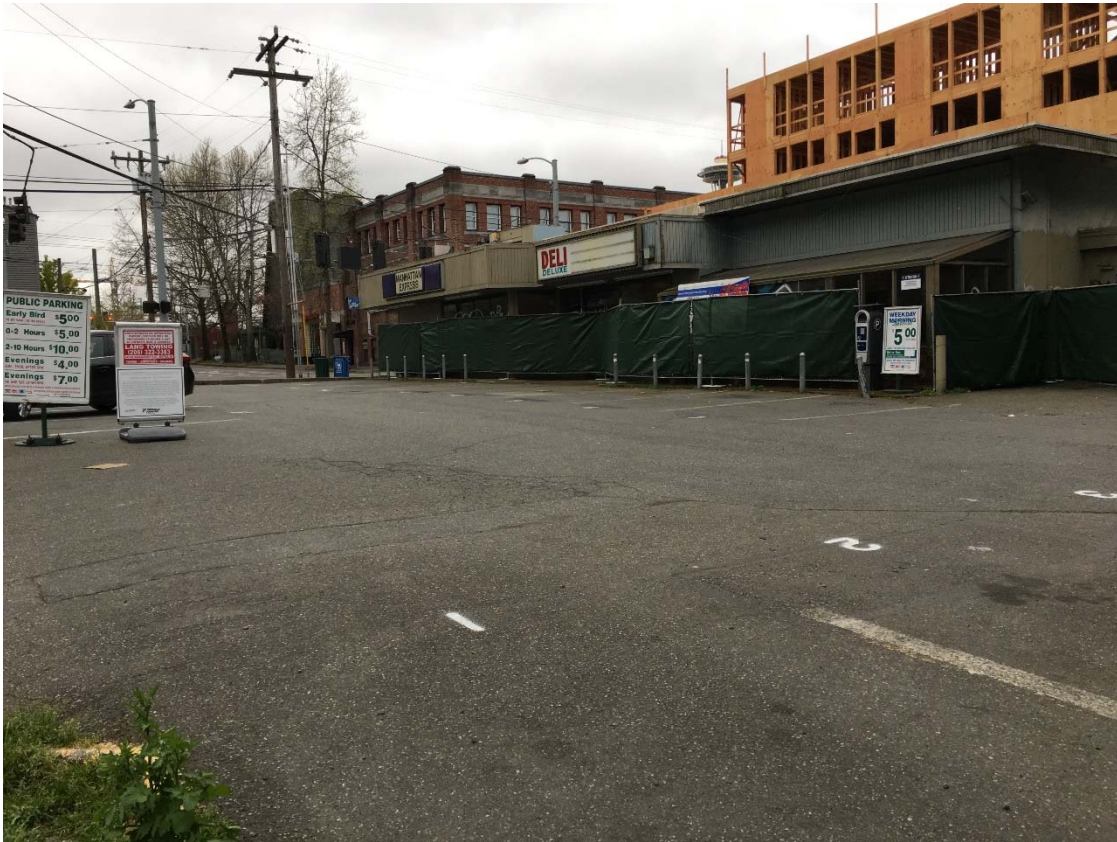
Former Manhattan Express building, with Bungalows construction visible above the building. (all photos from 4/10/19 site visit)

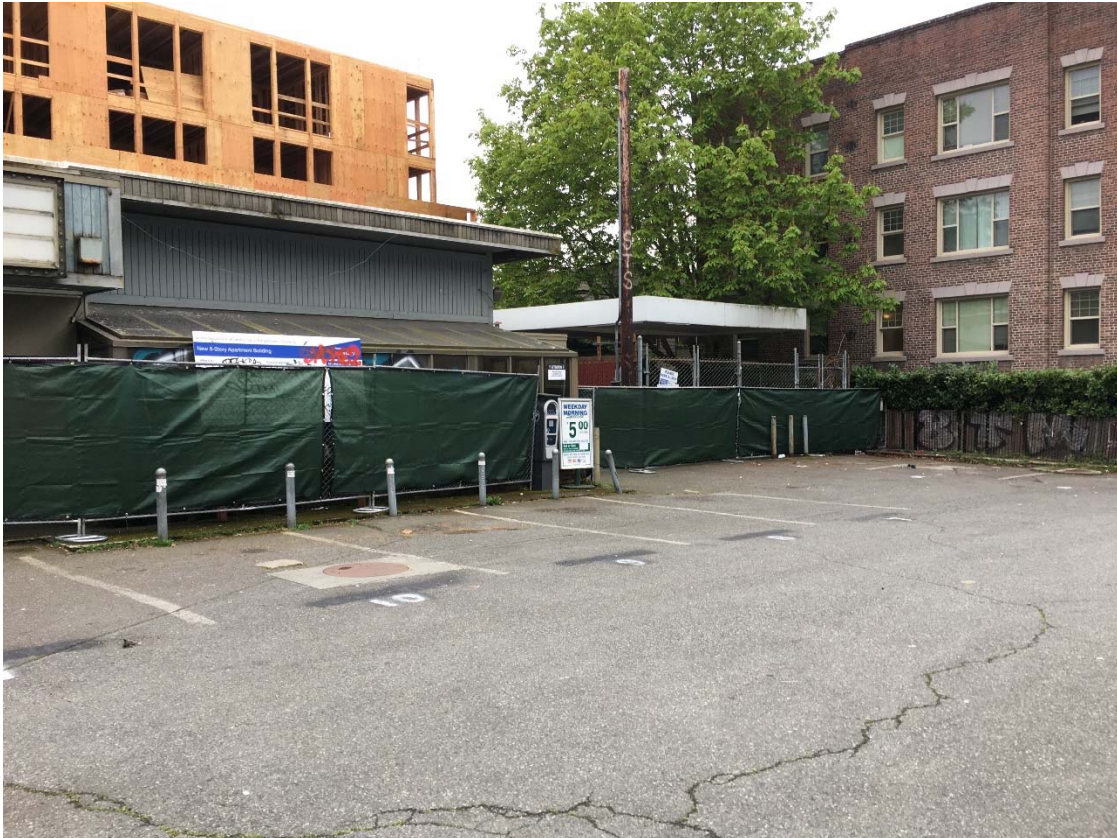
West side of the former Manhattan Express building and area that formerly housed remediation system equipment. Building visible on the right is the Del Roy Apartments.

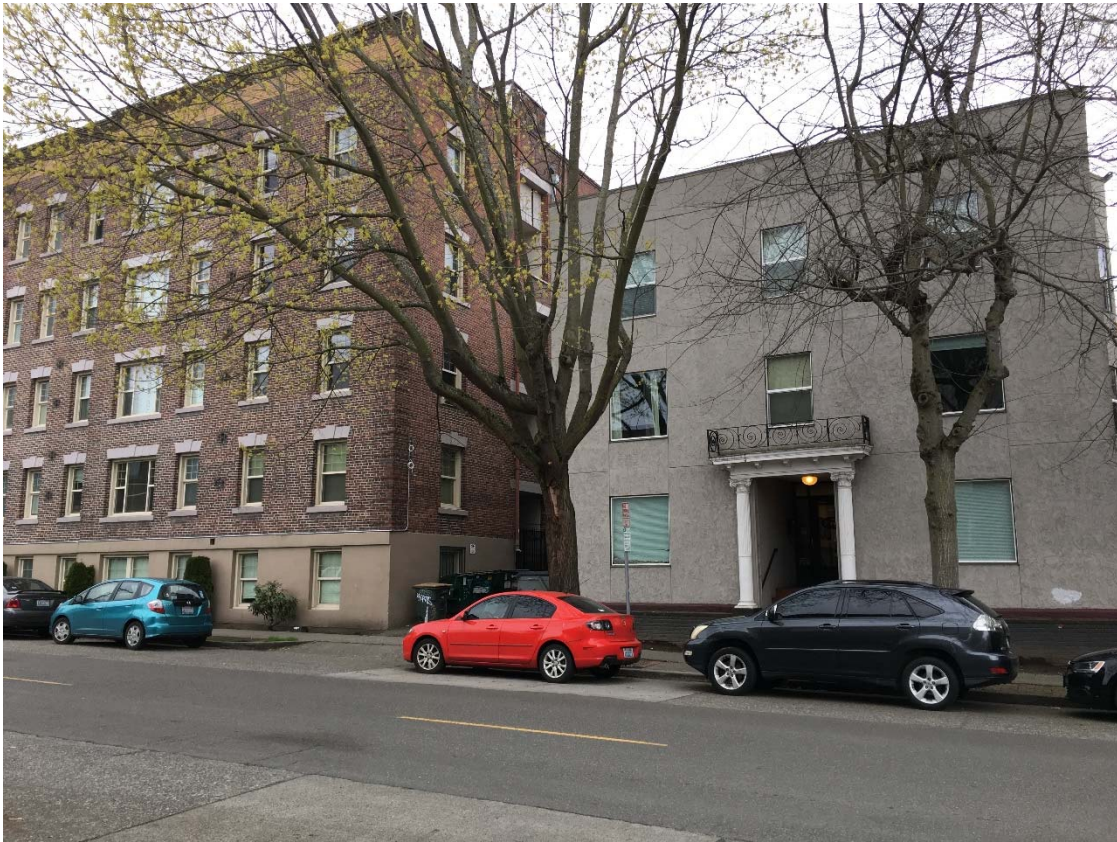
Western side of the Del Roy (left) and Monterey (right) Apartments, taken from across 1st Avenue W.

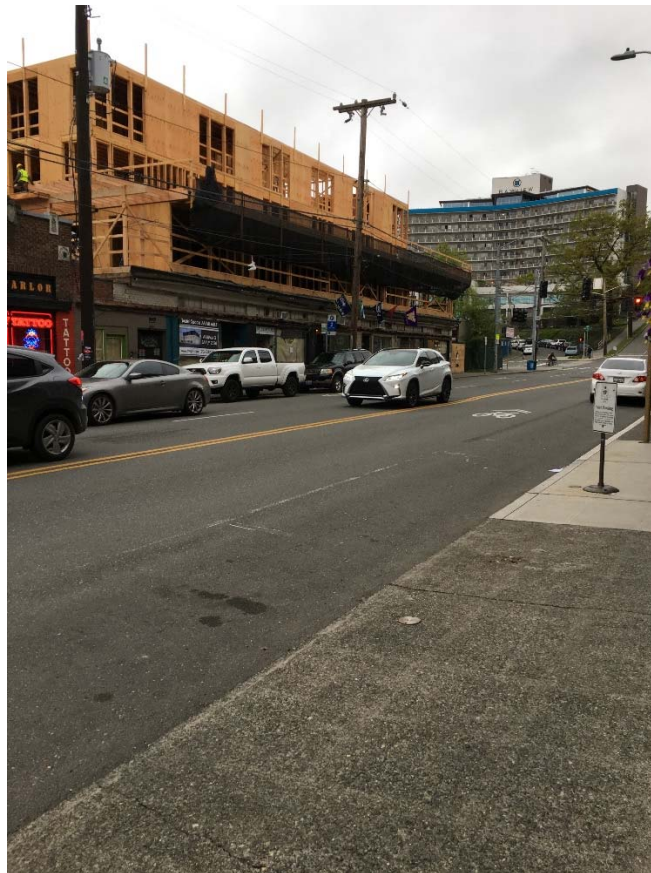
Eastern side of the Bungalows with construction visible above first floor retail. The main building of the Bayview residential community is visible in the background. (taken from across Queen Anne Ave N)
