STATE OF WASHINGTON
DEPARTMENT OF ECOLOGY

RE: Early Notice Letter Regarding the Release of Hazardous Substances at the Cascade Millwork & Supply - Tacoma (existing site name),
AKA: Ballard Refinishing & Loyola Stripping Services
Located at: 6220 S. Tacoma Way, Tacoma WA 98409
Facility Site Identification Number: 16169643 (existing)
ISIS Cleanup Site ID No.: 11925

INITIAL INVESTIGATION FIELD REPORT

ERTS Number: 624792

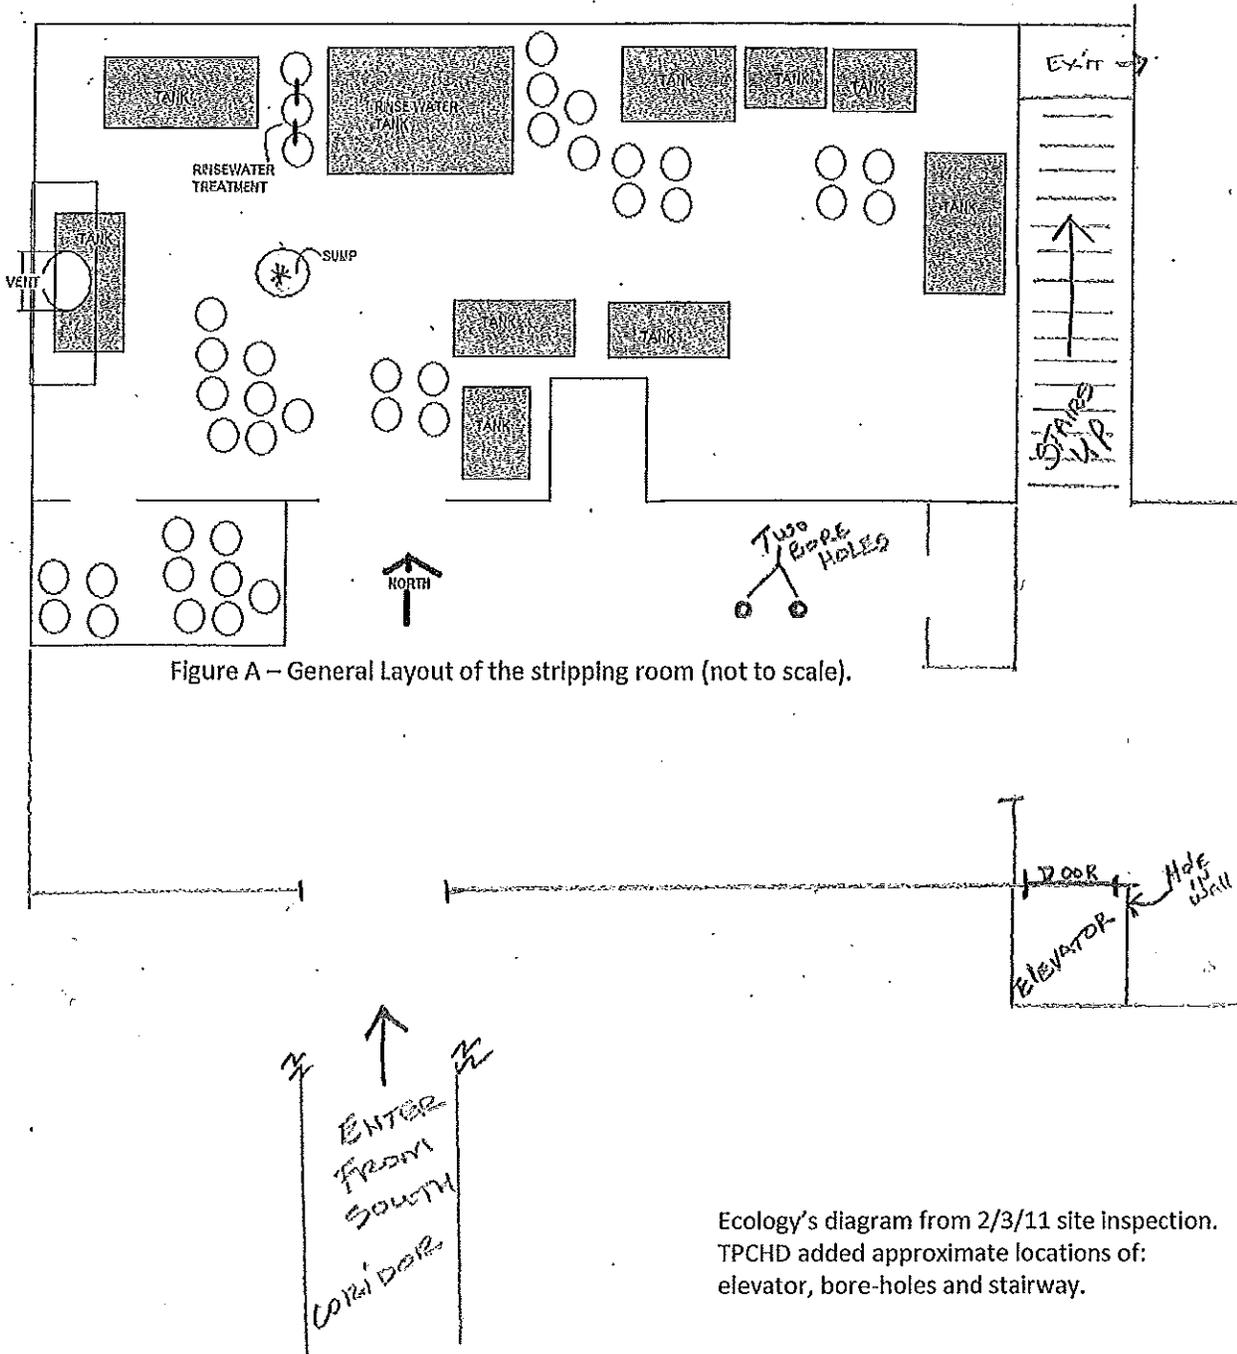
Figure A - General Layout of the stripping room (not to scale).

Ecology's diagram from 2/3/11 site inspection.
 TPCHD added approximate locations of:
 elevator, bore-holes and stairway.
