2017 Annual Operation and Maintenance Report

Operable Unit 1

Naval Base Kitsap

Keyport, Washington

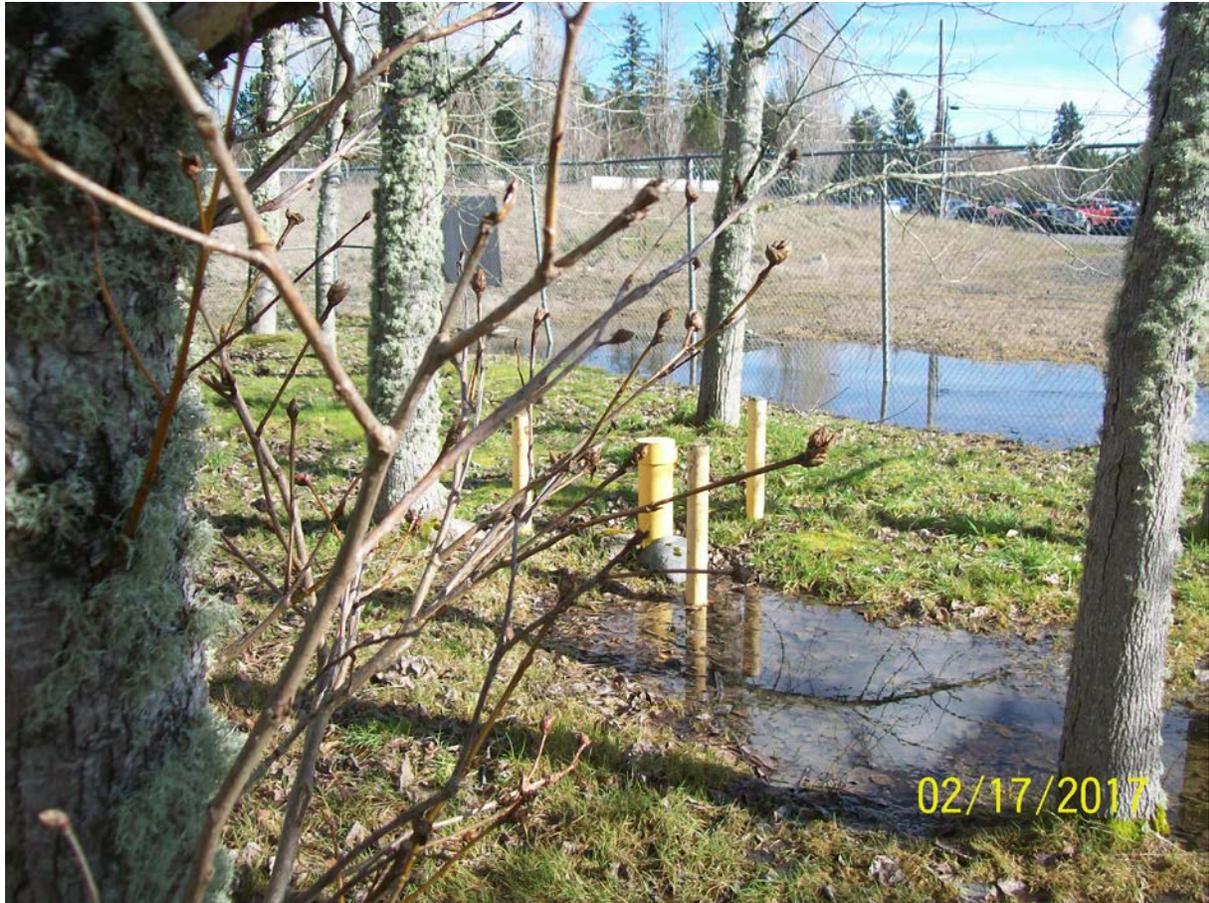
Photograph 1: Large developed buds on a tree in the northeastern portion of the North Plantation, with areas of standing water from recent heavy precipitation. Moss growth and cracks in bark (tree at right) are prevalent throughout the plantations.

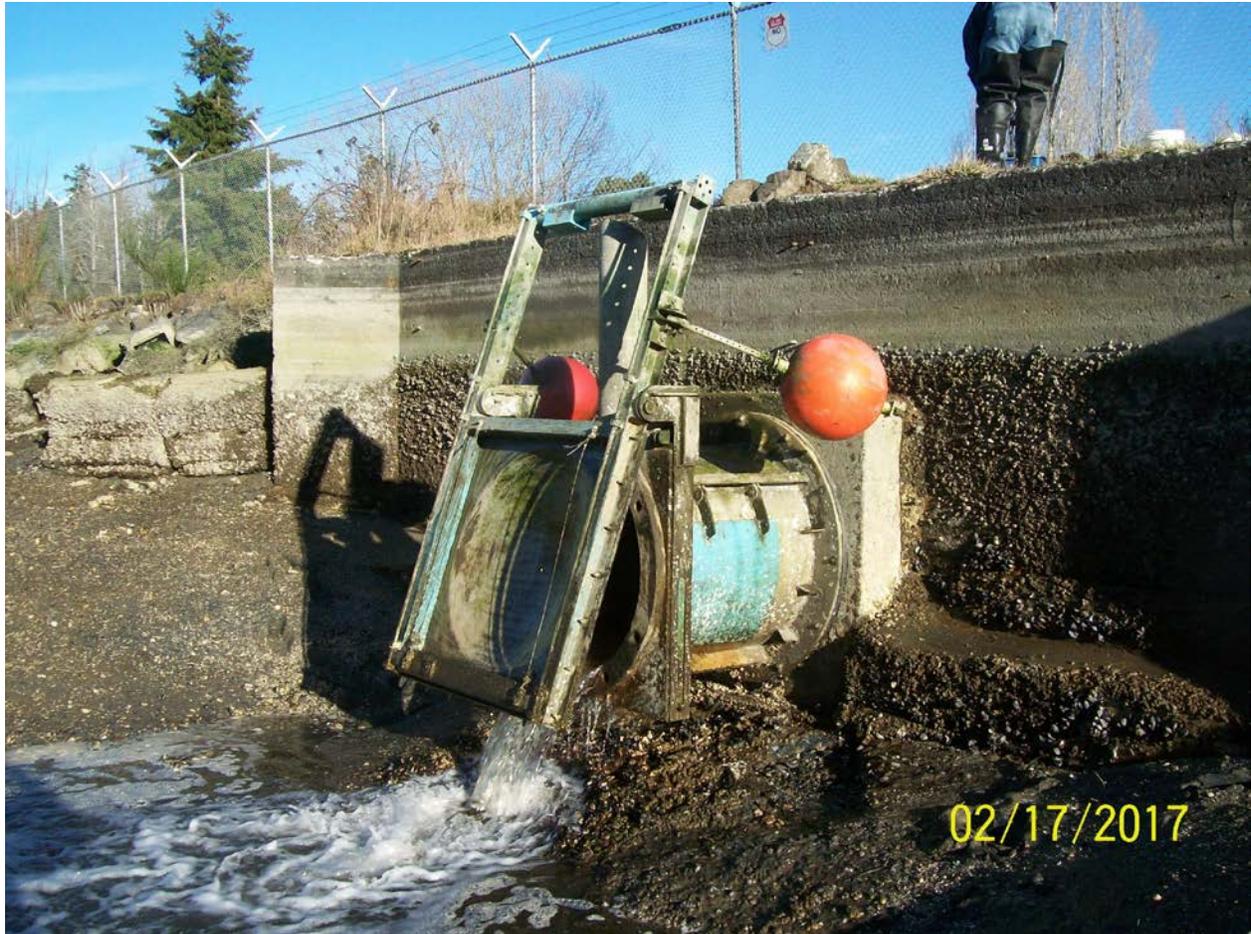
Photograph 1: Tide gate following monitoring and cleaning.

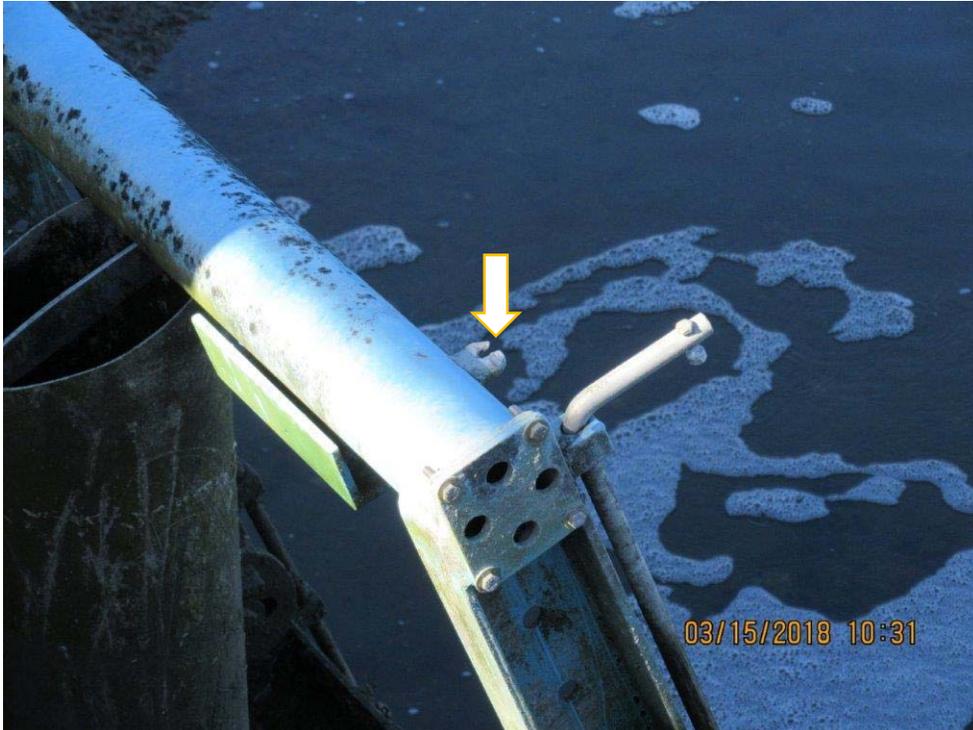
Due to high winds over the weekend, the tide gate was re-inspected on February 20, 2018, and one of the screw-hole flanges for securing the eastern-most door-float release rod (for release of the horizontal float at the base of the tide gate door) was found to be broken. The western-most door-float release rod assembly was intact and therefore the tide gate continued to operate as designed. On March 15, a temporary repair of the eastern-most door-float release rod at the top of the tide-gate door assembly was conducted using heavy-duty zip-ties to secure the float release rod to the top of the tide gate assembly. This repair will be inspected and maintained during each maintenance event until a permanent repair can be performed in late 2018. Photographs of the damaged flange and the temporary repair are attached to the February-March 2018 Tide Gate Inspection e-mail report in Appendix C.

Photograph #1: Tide gate upper door assembly showing broken screw-hole flange (indicated by arrow) for securing the eastern-most door-float release rod.

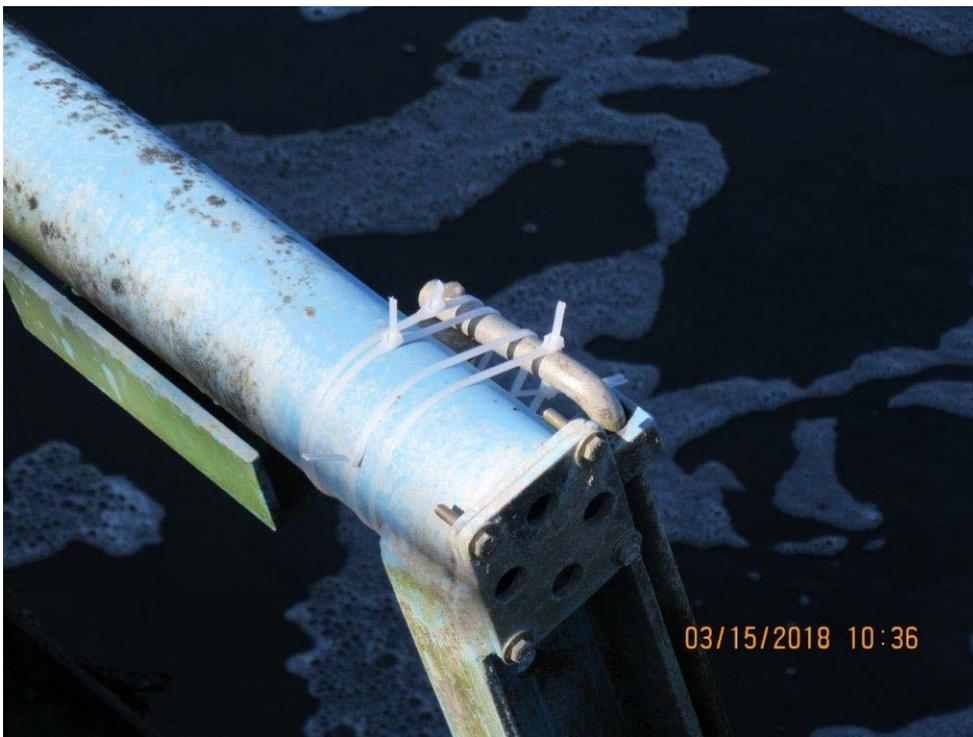
Photograph #2: Tide gate upper door mechanism after temporarily securing the eastern-most door-float release rod in its unactuated (locked) position.

Quarterly maintenance and inspection of the tide gate occurred during February, May, August, and October/November 2017, and February 2018. Due to damage from high winds in February 2018, a temporary repair was conducted in March 2018. All inspections verified the tide gate was operational. All monitoring events confirmed the tide gate closed at the prescribed water level of approximately 3 feet above the tide gate invert, and that stable water levels remained on the inland, marsh side of the tide gate culvert after closure, indicating negligible water leakage through the gate.
