**SITE CHECK
PORTAL WAY STATION
6000 PORTAL WAY
FERNDALE, WASHINGTON**

June 26, 2019

Whatcom Environmental Services
228 East Champion Street #101
Bellingham, Washington 98225

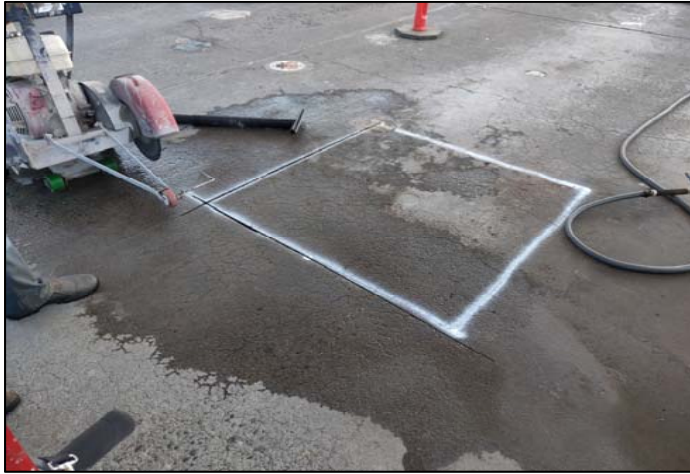
Photo 1. A view towards the northeast looking at the concrete cut with the northern HydroCon boring at the center.

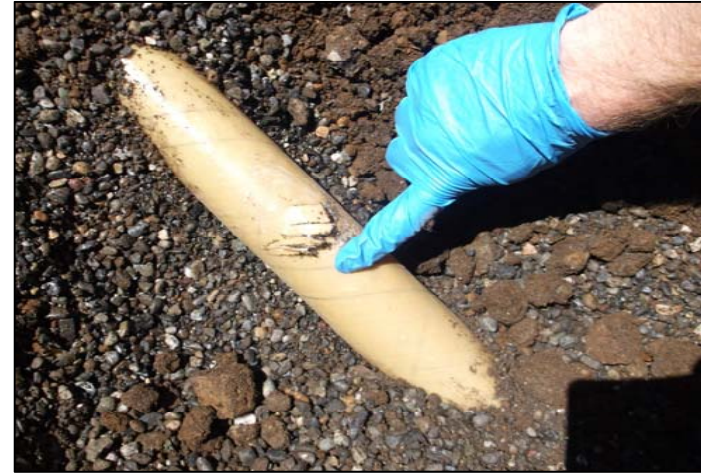
According to the station's records, approximately 199 gallons of regular gasoline were released to the ground from the damaged product line.

Field screening results and visual observations indicated that a release of gasoline had occurred from the damaged product line. A release of gasoline range TPH, BTEX constituents, and naphthalenes to shallow soil beneath the ruptured product line has been confirmed by the laboratory analytical data.

Photo 2. A view of the ruptured product line when it was first uncovered. Note the visibly stained pea gravel around the pipe.

Ultra Tank Services repaired the damaged product line on June 11, 2019. Northwest Tank and Environmental Services completed a tightness test on the repaired product line on June 13, 2019. The repaired product line passed the tightness test and was put back into service.

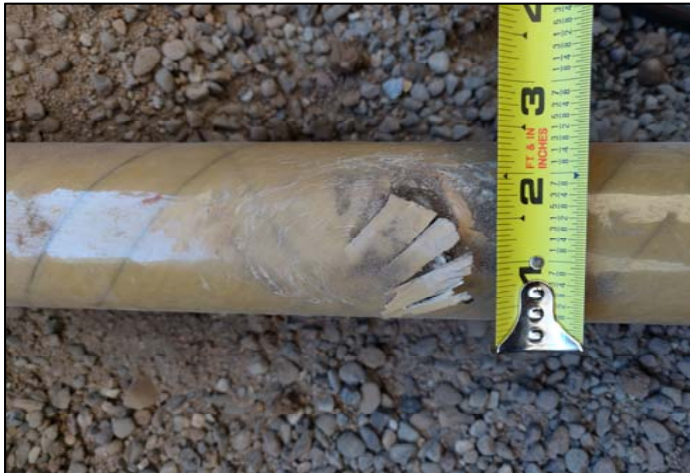
On June 4, 2019, while investigating a diesel release which occurred in May 2018 at dispenser 7/8, HydroCon LLC drilled a core with a hand auger approximately five feet north of the dispenser. Immediately following the core drilling activities, the leak detection system for Tank #3's product lines was activated indicating a fuel line had been impacted by the coring activities.

Photo 3. A closeup view of the ruptured product line showing the delaminated fiberglass caused by contact with the hand auger.

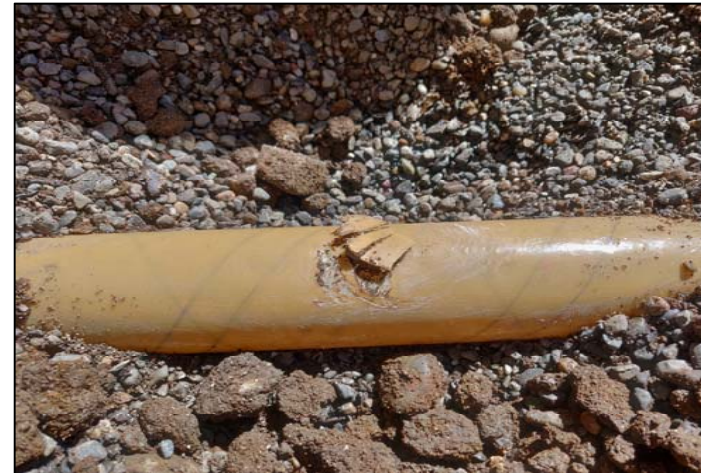
Photo 4. A closeup view of the ruptured product line. Note the auger scrape marks atop the product line.
