MEMORANDUM

Date: June 27, 2019 **RGI Project Number:** 2012-107M

Subject: 2019 Annual Inspection Summary
Alamo Manhattan Main Street
10505 Main Street
Bellevue, Washington 98004
Ecology VCP No. NW2811

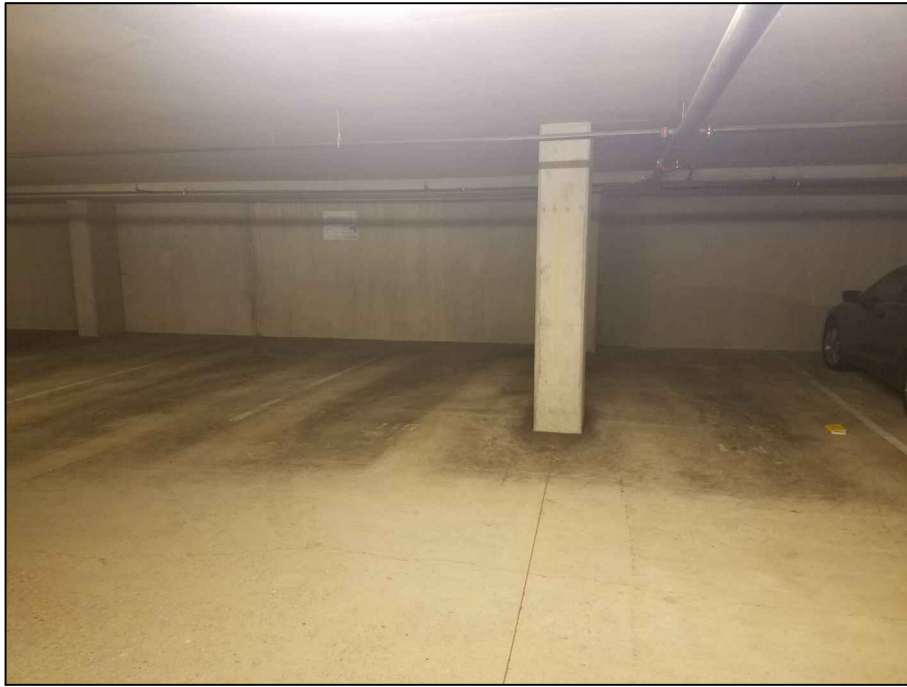
The portions of the concrete garage floor slab situated above Areas 1 and 2 were in good condition and no damage was observed (see Photos 1 through 4). Groundwater monitoring wells RW1, RW2, and MW6 were also in good condition with no damage observed (see Photos 5 through 10).

Photograph 1: View looking west representing the condition of the garage floor slab in Area 1.

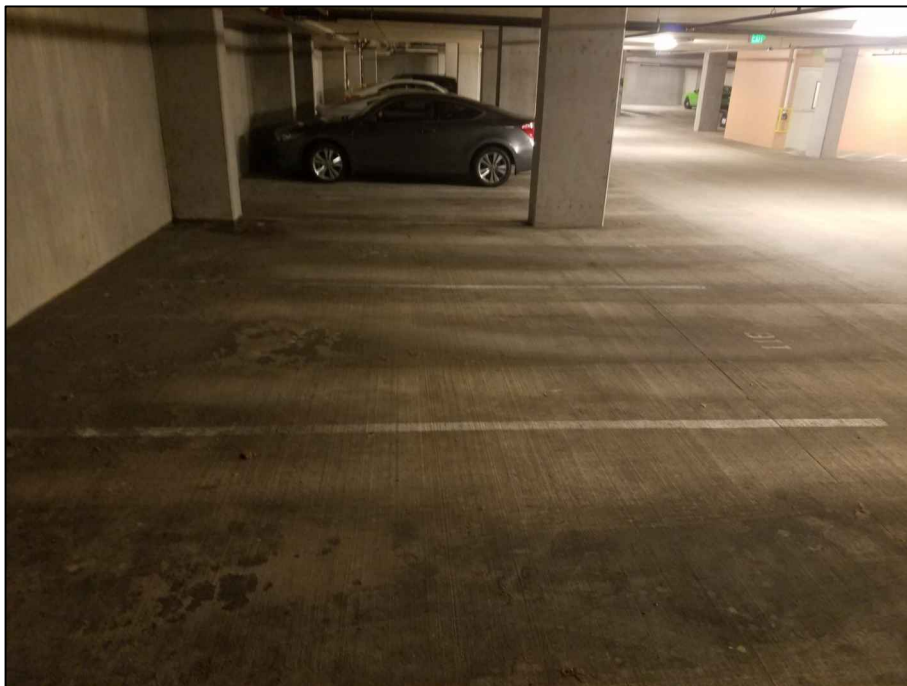
Photograph 2: View looking north representing the condition of the garage floor slab in Area 1.

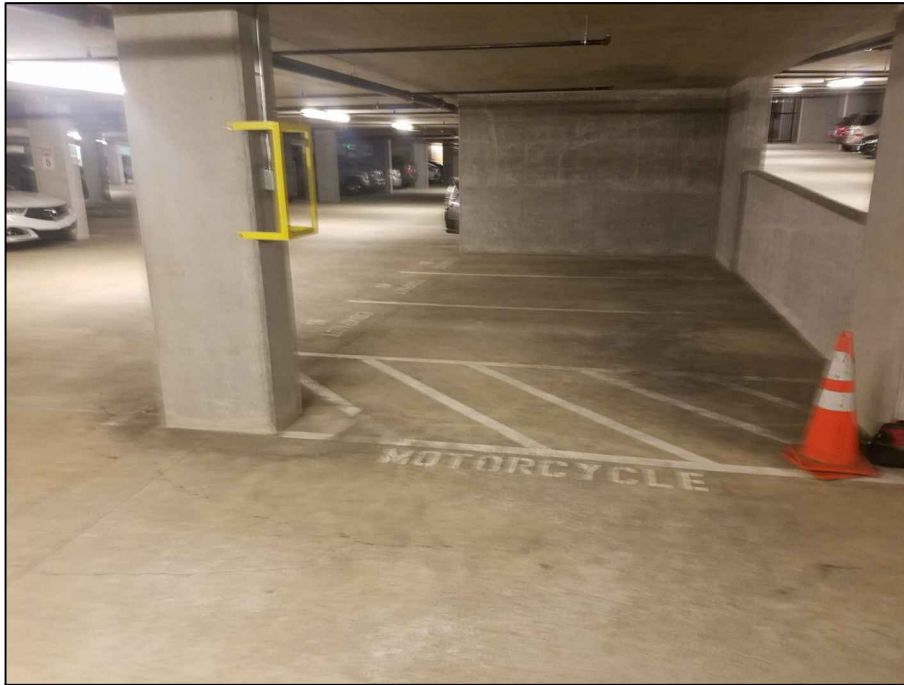
Photograph 3: View looking east representing the condition of the garage floor slab in Area 2.

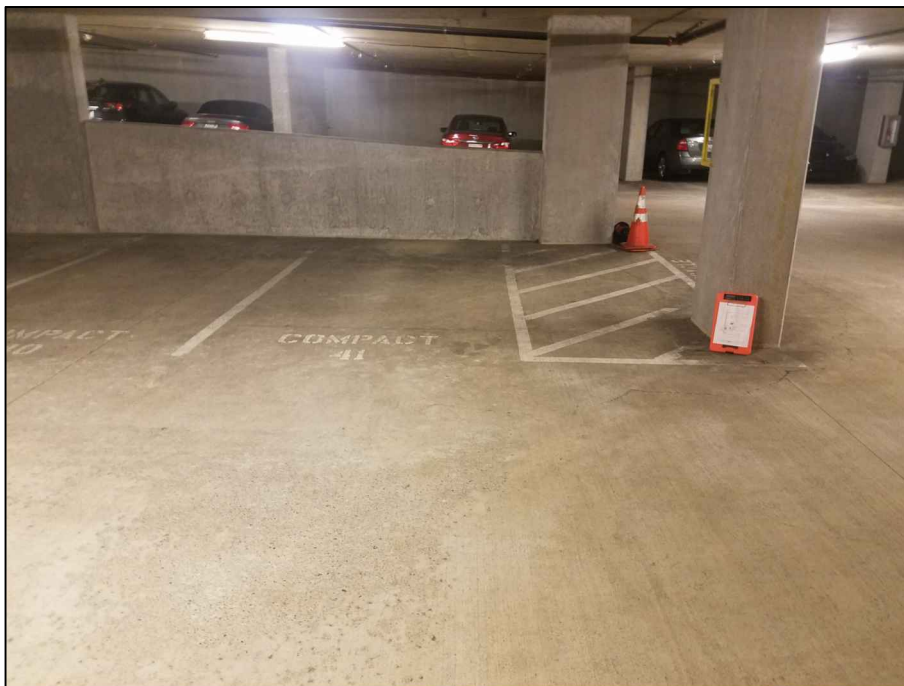
Photograph 4: View looking south representing the condition of the garage floor slab in Area 2.

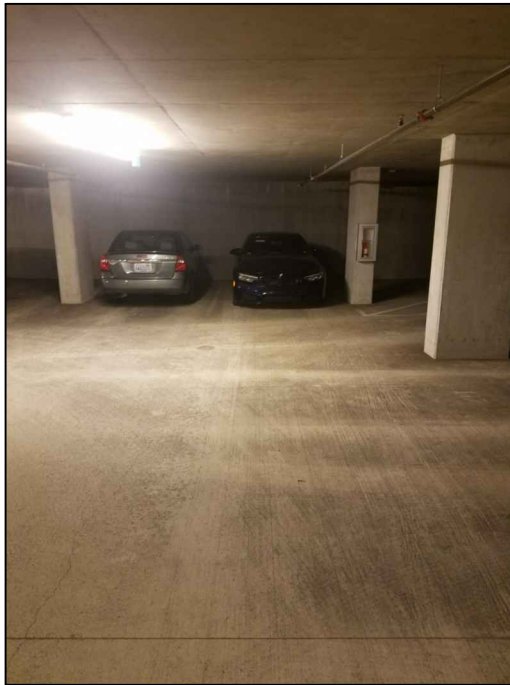
Photograph 5: View looking south at well RW1.

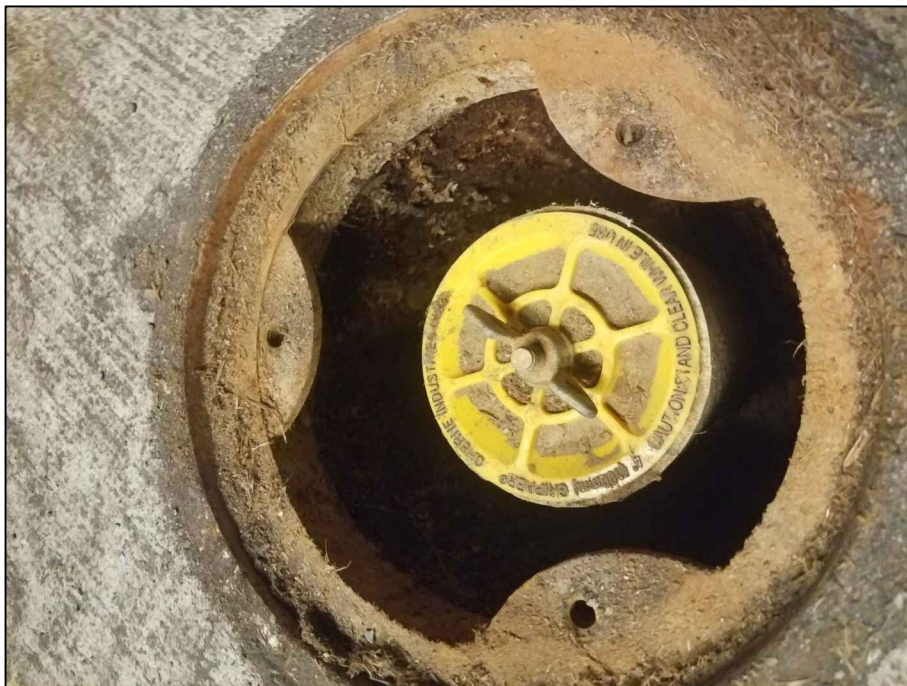
Photograph 6: View of well RW1 without the well cover.

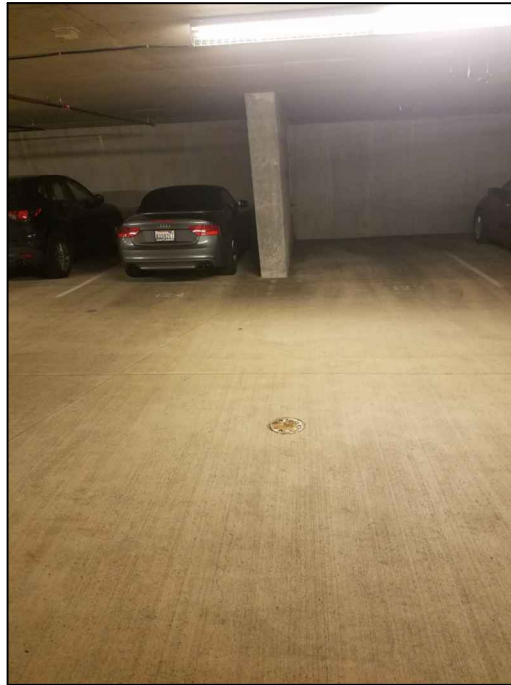
Photograph 7: View looking south at well RW2.

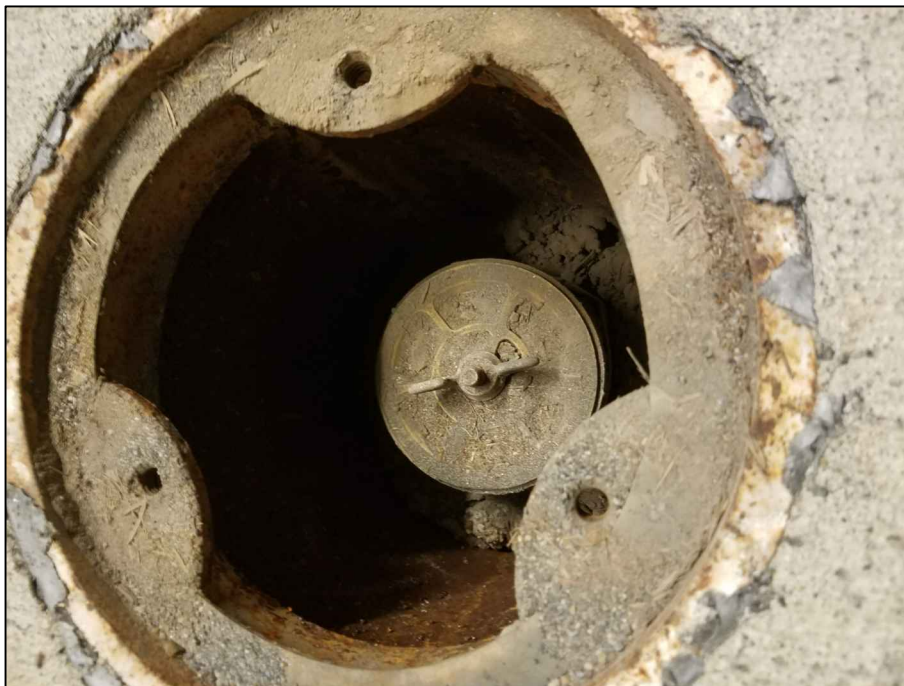
Photograph 8: View of well RW2 without the well cover.

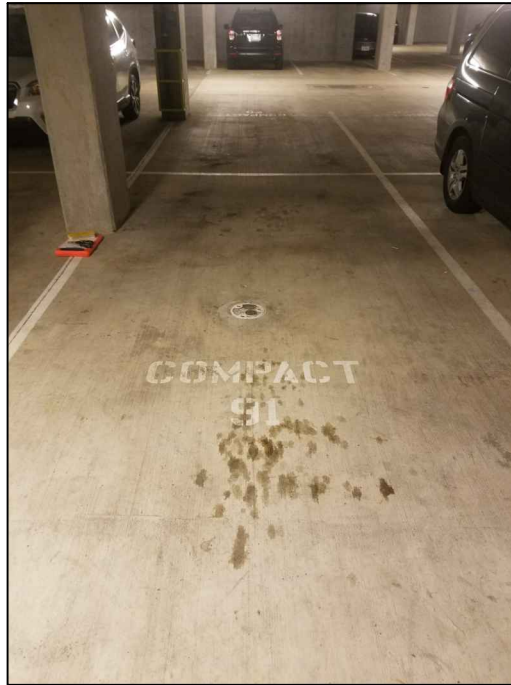
Photograph 9: View looking south at well MW6.

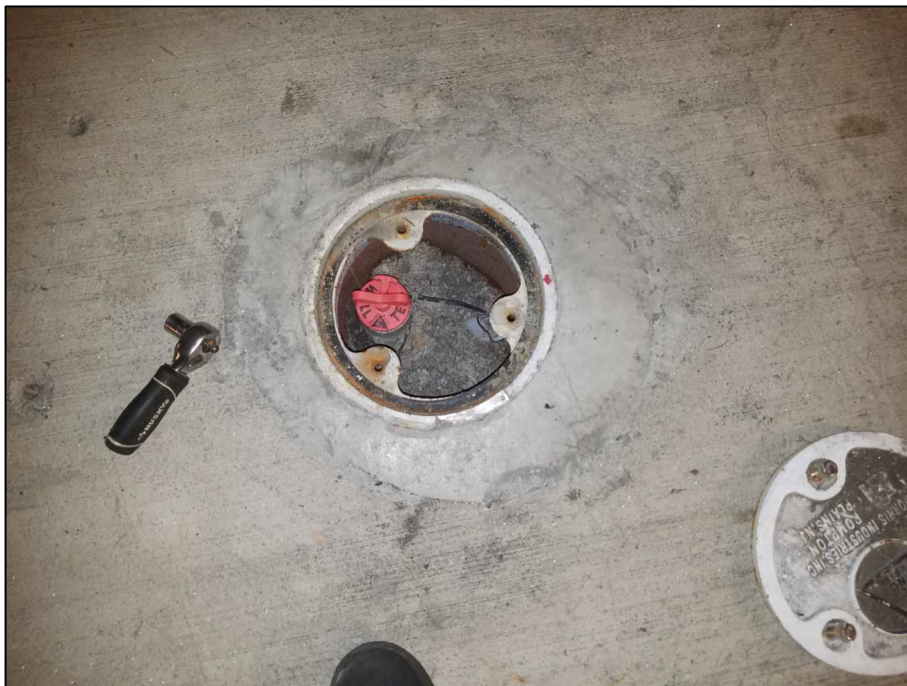
Photograph 10: View of well MW6 without the well cover.
